Former North Bierley Waste Water
Treatment Works, Cliff Hollins
Lane, Cleckheaton
**Landscape Character
Assessment**

Site ID: E1985

**KIRKLEES COUNCIL
LANDSCAPE ARCHITECTS**

SUMMER 2015

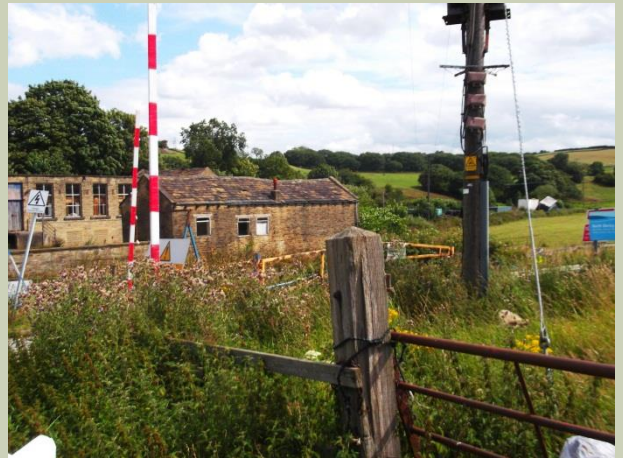
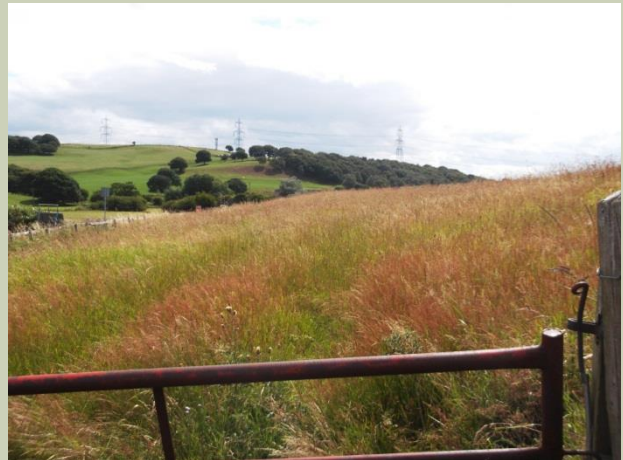
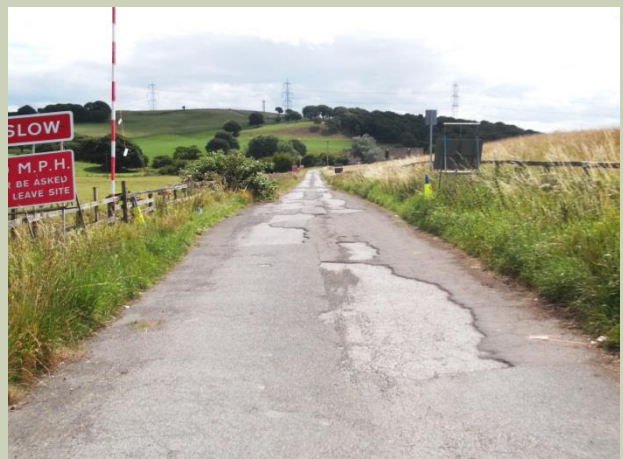
Typical images of landscape type 1

- This part of the site is semi improved grassland, pastoral in a declining condition due to its immediate surroundings.

- A struggling piece of rural land heavily affected by motorway and dereliction

The landscape character of this area is weak and its condition is declining due to the pressures of motorway and industrial dereliction nearby.

The site will be **strengthened and enhanced** by sensitive development.

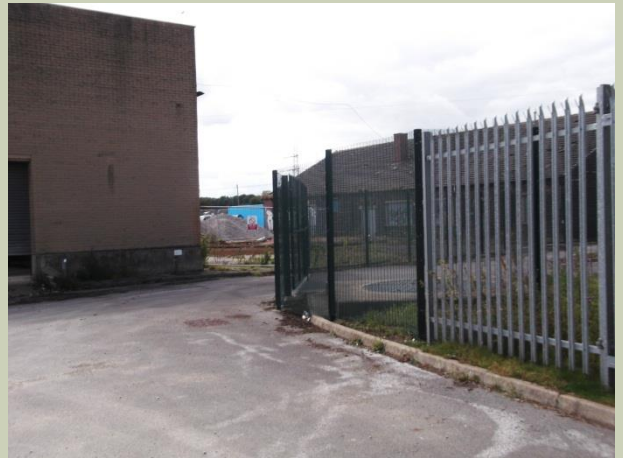
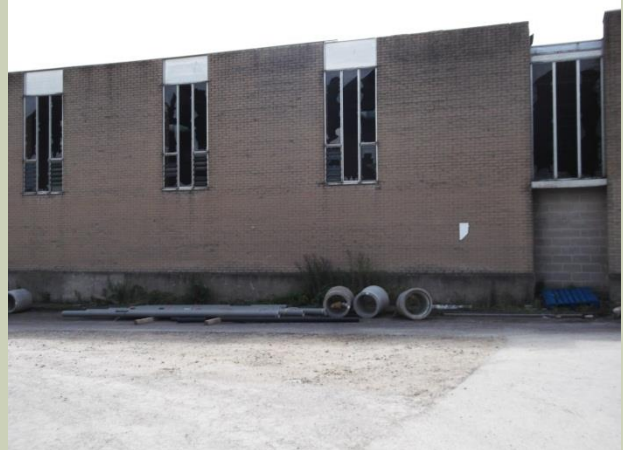
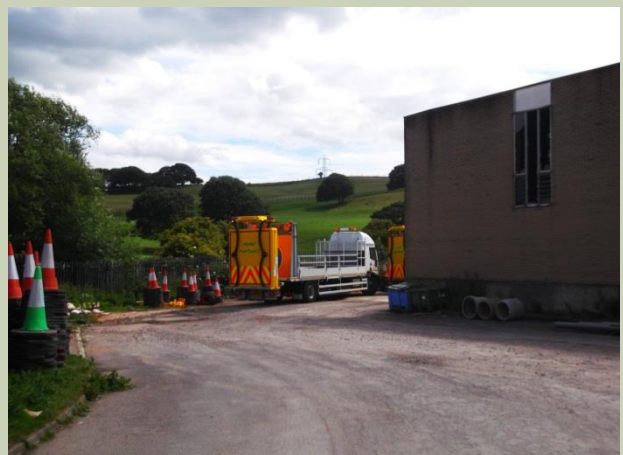
Typical images of landscape type 2

- The condition of the site is poor because of its abandoned and neglected state. Many of the buildings are empty and declining fast. The site is un-maintained.

- A struggling area of abandoned industrial land heavily affected by dereliction and motorway noise.

The landscape character of this area is weak and its condition is poor due to the industrial dereliction and abandoned usage of this site, it is declining fast.

The site will benefit by the creation of new and sensitive development.

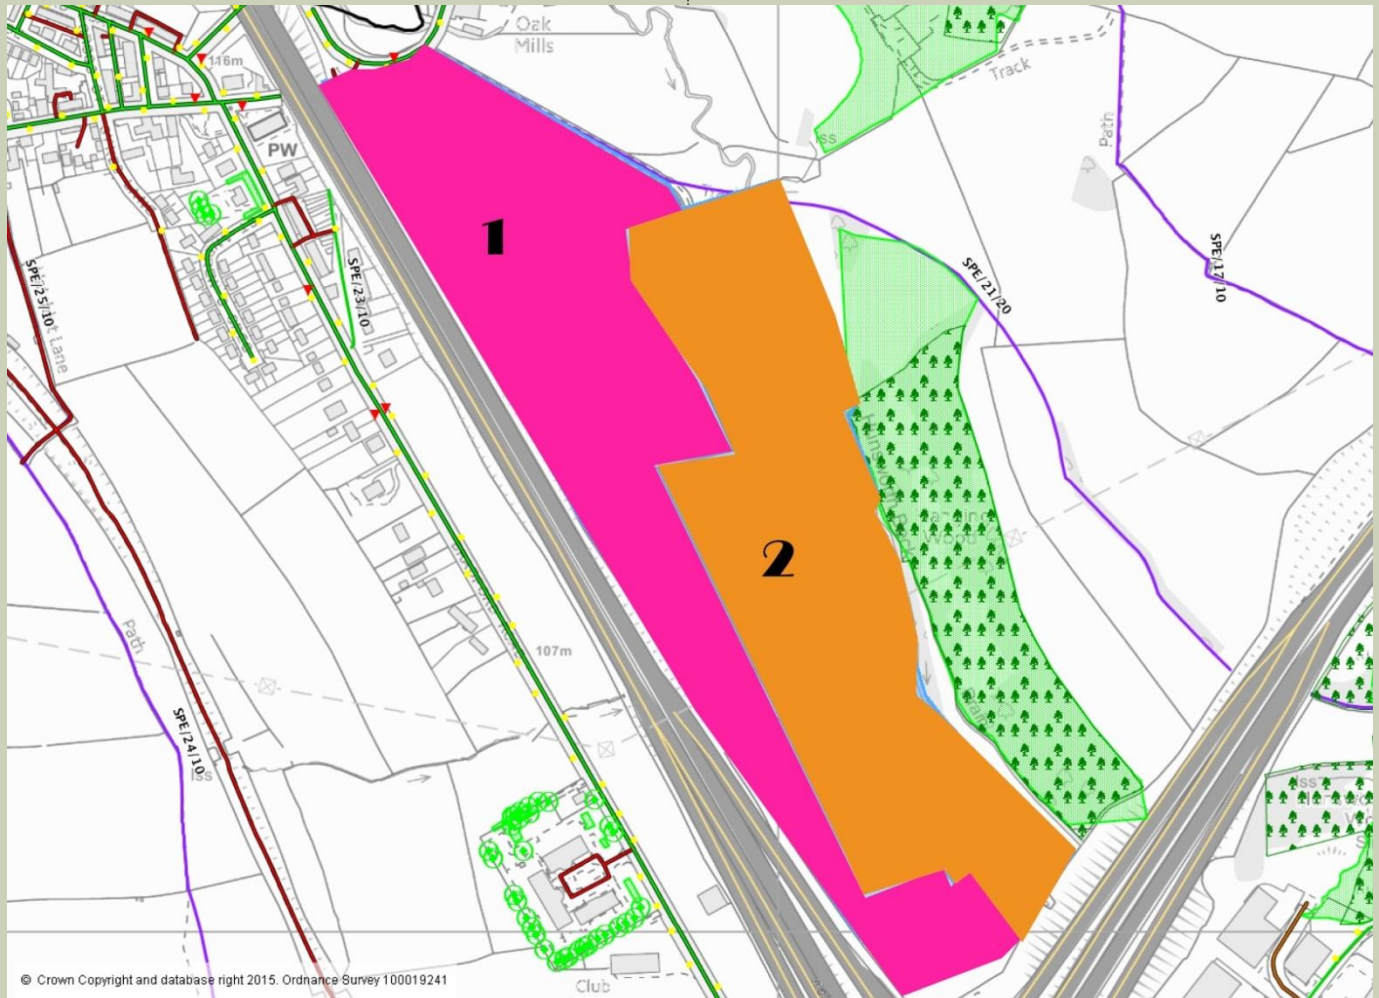
Conclusion Plan

Landscape Type 1

Character : Weak

Condition: Declining

Conclusion: Strengthen and Enhance

The landscape character of this area is weak and its condition is declining due to the pressures of motorway and industrial dereliction nearby.

Landscape Type 2

Character : weak

Condition: Poor

Conclusion: Creation

The landscape character of this area is weak and its condition is poor due to the industrial dereliction and abandoned usage of this site, it is declining fast.

The site will be strengthened and enhanced by sensitive development.

The site will benefit by the creation of new and sensitive development.
