# Netherwood Farm, Marsden

## Bat Survey Report

23<sup>rd</sup> August 2017

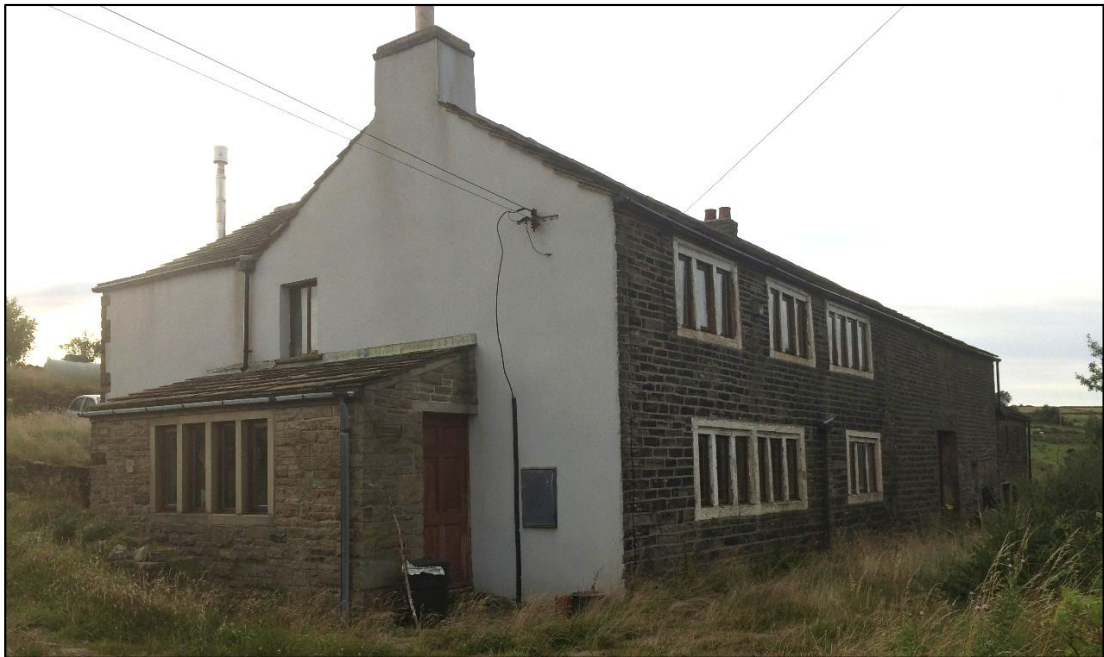
- 5.2.2 The site consists of an old two storey stone built farm house and adjoining barns situated on a north-south orientation. The farm house is 'L' shaped with a west extending wing (extension) with a York stone pitched roof with ridges, valleys and gables whilst the barns on the north end of the complex have single ridges and gables (see Plates 1, 2 & 3).

**Plate 1. South facing gable and east elevation**

- 5.2.3 The south gable of the farm house is cement rendered (see Plate 1) and the remaining masonry on the east and west elevations has been well maintained. Therefore only the masonry of the adjoining barns have holes in mortar joints (see Plate 3). Along both the east and west elevations is a wood fascia with a gap behind in several places. Additionally, like all roofs of this type, there is an abundance of access opportunities for bats under slates and at the roof verges above gables.

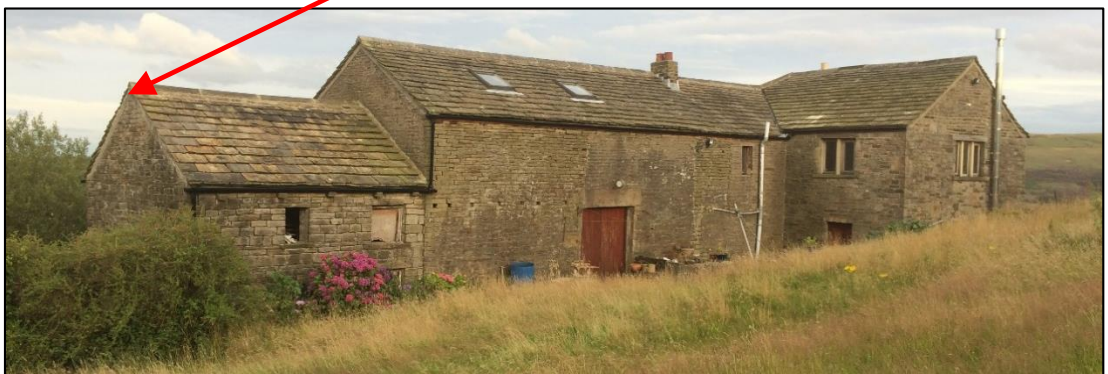
**Plate 2. West elevation (north end)**

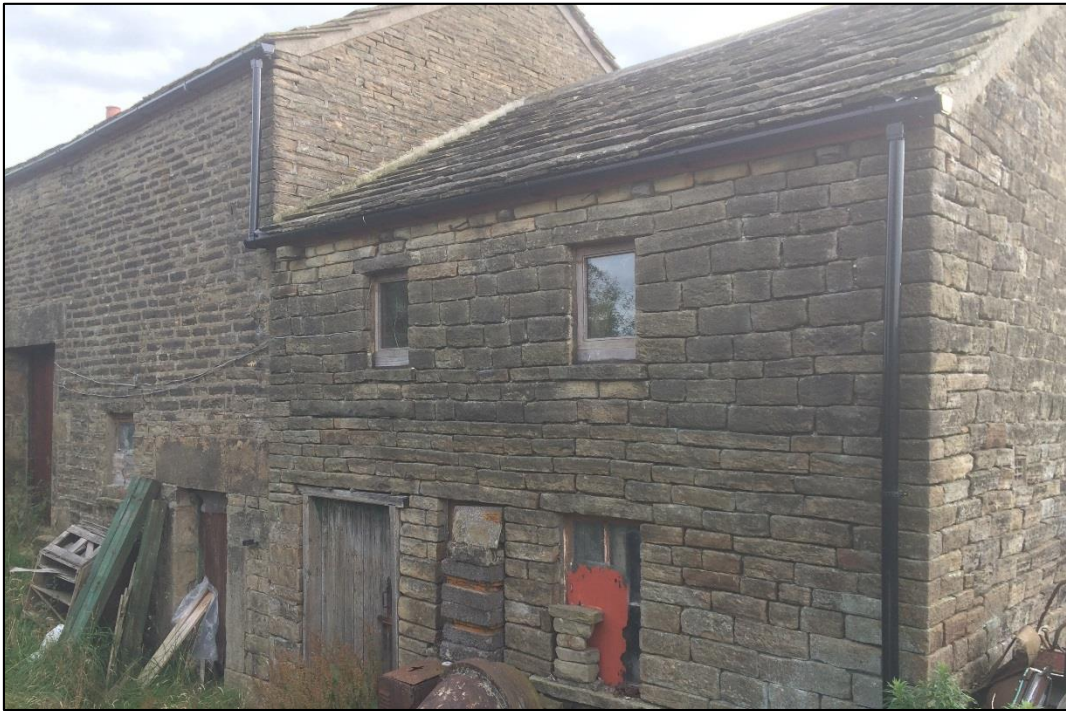
**Plate 3. Small barn at north end of complex**

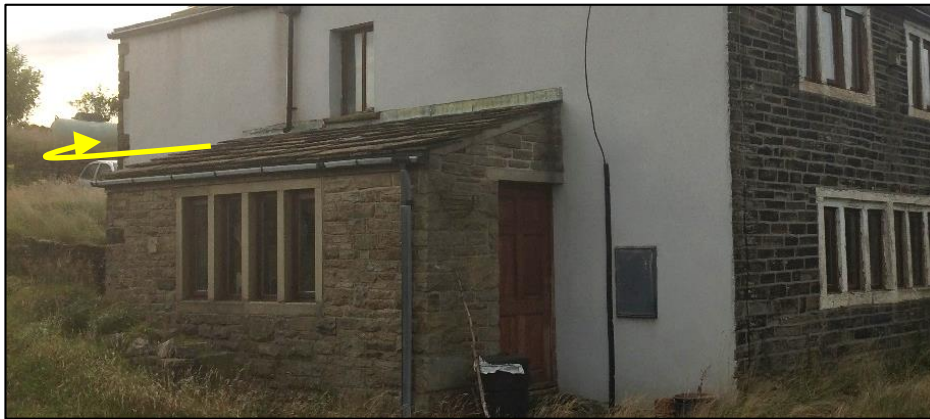
before sunset) and did so intermittently throughout the survey. At 20:40 two common pipistrelles emerged from beneath slates at the roof verge of the porch on the south facing gable (see Plate 3). A common pipistrelle foraged intermittently thereafter and a *Myotis* species was recorded at 21:20.

**Plate 3. Place of emergence, as indicated by arrow**

- 6.4.1 The building supports one common pipistrelle day roost, supporting a maximum count of two bats during a single survey visit. The roost is situated under slates on the roof of the single storey porch on the south facing gable. The roof of the house and porch will not be affected by the plans for the proposed development of the site and therefore it is not considered necessary to either register the site on the Bat Low Impact Class Licence (BLICL), or to obtain a European Protected Species (EPS) mitigation licence. It is however recommended that a tool box talk be given to contractors at the onset of works to avoid any impacts on roosting bats during the construction phase of the development.

- 6.3.1 In order to provide continued bat roosting opportunities within the re-developed building, traditional Type F1 bituminous roofing membrane must be used during re-roofing of both barns. Bats are known to become entangled and die in modern filamentous Breathable Roofing Membrane resulting in the membrane becoming damaged. Given the stone tiles on the barn roofs and their location, it will not be possible to prevent bats entering the crevice between the roof tiles and underfelt in the future, were this desired.

- 6.3.2 It is recommended that a tool box talk be given to contractors at the onset of works to avoid any impacts on roosting bats during the construction phase of the development.
