Heritage Impact Assessment

Land at Cliff Hill, Leak Hall
Crescent, Denby Dale, Huddersfield

H690

Kirklees Council

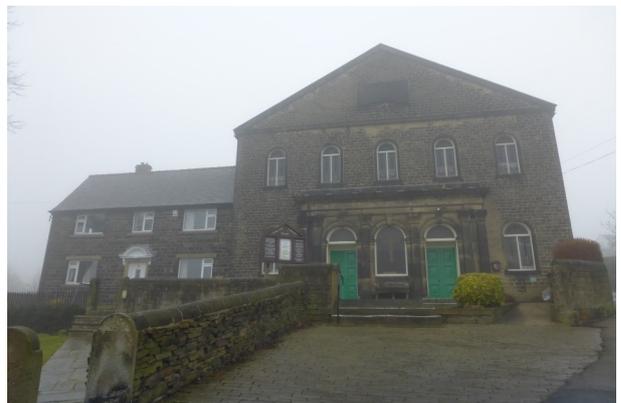
Figure 3 - South facing elevation

- 4.10 **Aesthetic Value** - The classical design of the southern façade and the symmetry of the elevation provides aesthetic value as does the

uniformity of the window openings with the arched heads. The structure to the west appears on the OS map dated 1907 and as such we can assume that it was constructed in the late 19th century. This structure has been altered and extended (particularly to the north) throughout the 20th century and is of limited aesthetic value.

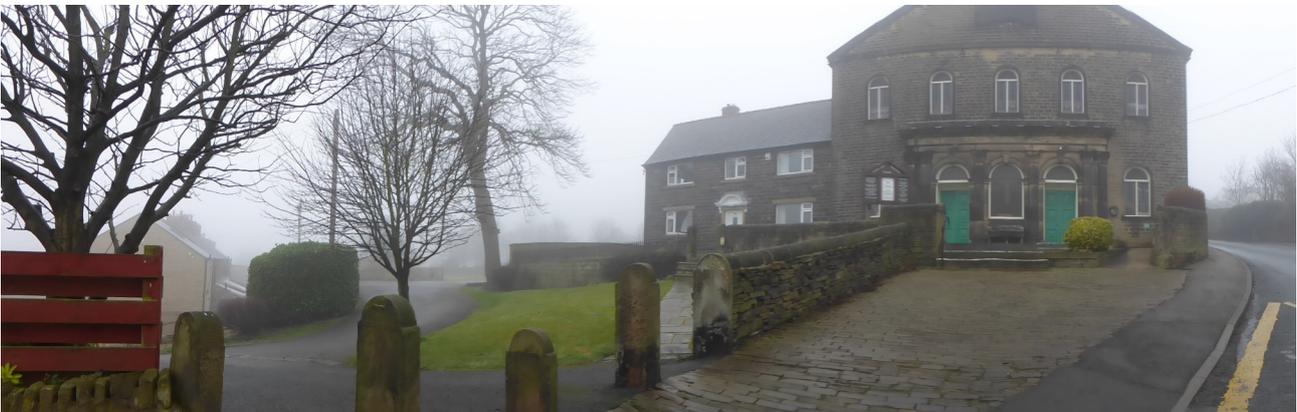
Figure 4 - Photograph showing setting to south

4.14 **Aesthetic Value** - The setting immediately to the south of the Church has retained its historic layout, including the retention of the cobblestones in front of the entrance and the retention of the historic boundary walls which provide a historic setting and aesthetic value.

- 4.13 **Historical Value** - Wesley Terrace has illustrative historical value as this appears as a footpath on the first edition OS dated 1854 and would have been a historic approach to the Church. Cumberworth Lane would have been the primary historic approach and would have been considerably wider than currently shown and would have potentially been fully cobbled. Indeed the existing stone wall with the round copings leading down the hill from the south elevation gives an indication of the width of this historic route up to the church and provides an indication of how prominent the Church would have been. The fact that the main entrance addressed this section of the road and not the footpath gives the impression that the church has almost taken ownership of the road in this area. These external landscaping features give an indication of the historic setting of the church and provides illustrative historical value.

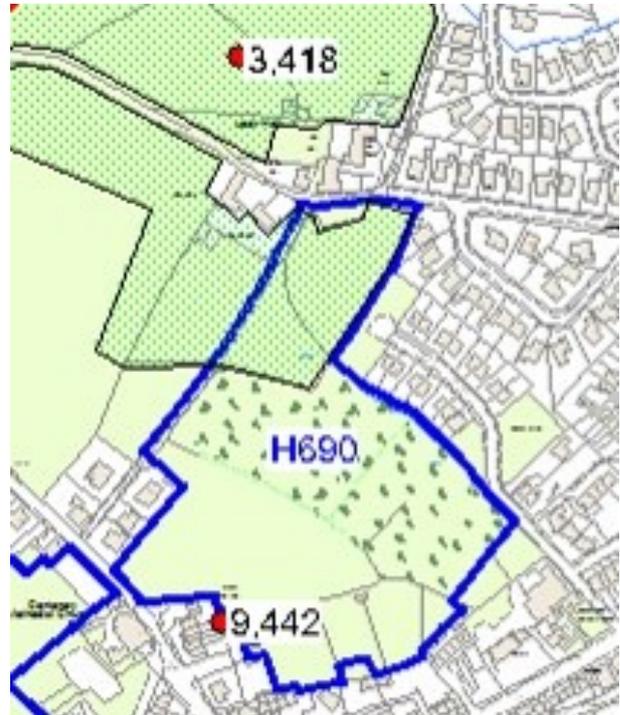
Figure 5 - Map showing location of site of archaeological interest

4.16 **Evidential Value** - There is potential evidence provided by WYAAS of a Medieval Settlement at Leak Hall, Cumberworth Half which is partially located within the northern boundary of the allocated site as shown on the attached excerpt from the Historic environment records. Further investigation would need to be undertaken to ascertain if this is the case but there is a high likelihood that there is further evidential value in this area.

- 5.5 **Medieval Settlement: High Significance** - The areas of the site that are located within the assumed location of the Mediaeval settlement are of high archaeological significance due to the potential for there to be significant finds within the site.

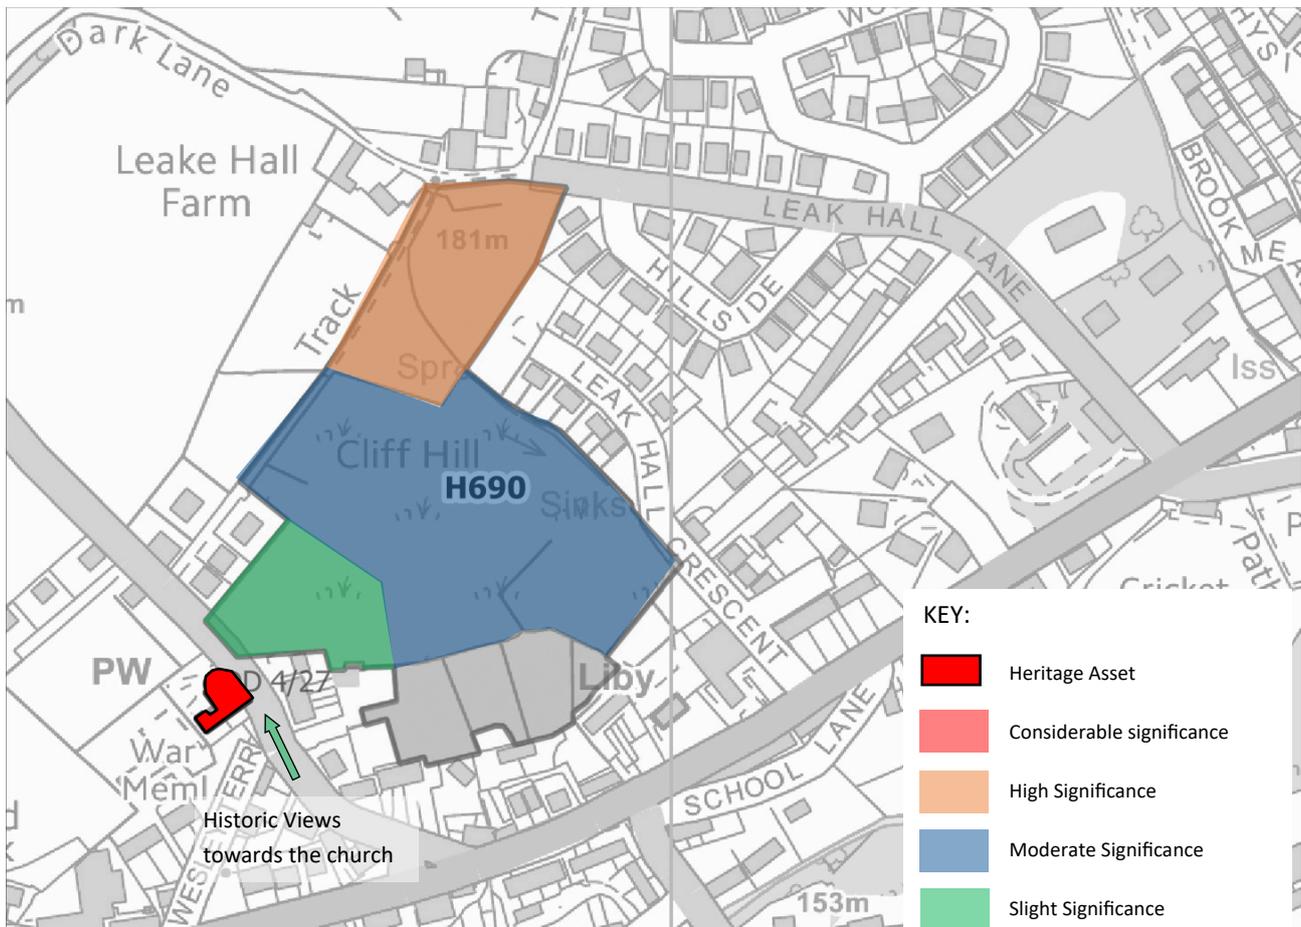
Figure 7 - Site Plan showing areas of significance

5.2 **Area of land immediately to the north-east: Slight Significance** - This area of open land immediately to the north-east of the church is of slight significant to the historical setting of the Church.

5.3 **Views towards the heritage asset from the south: Slight Significance** - This view of the Church is a historic view and would have been open to agricultural land beyond when the church was first constructed. This view has changed throughout the last hundred years with the construction of the Memorial Hall on the land opposite which has now been demolished and replaced with housing.

5.4 **Wider setting to the east: Moderate Significance** - The central areas of the allocated site contribute to the open nature of the setting but they are sufficiently removed from the asset to ensure that the loss of these areas would have little effect on the significance of the asset. Due to the proximity of this land to the Medieval Settlement there is the possibility that the area contains

significance evidence of past human activity and as such has moderate archaeological significance.

- 6.2 The areas of the site that have been identified as having high and medium archaeological significance require mitigation prior to determination of any application relating to the site. This report recommends that a pre-determination Evaluation is undertaken in accordance with requirements set out by the conservation team at Kirklees Council.
