# **Heritage Overview Report**

Cooper Bridge Strategic Employment Site

January 2018

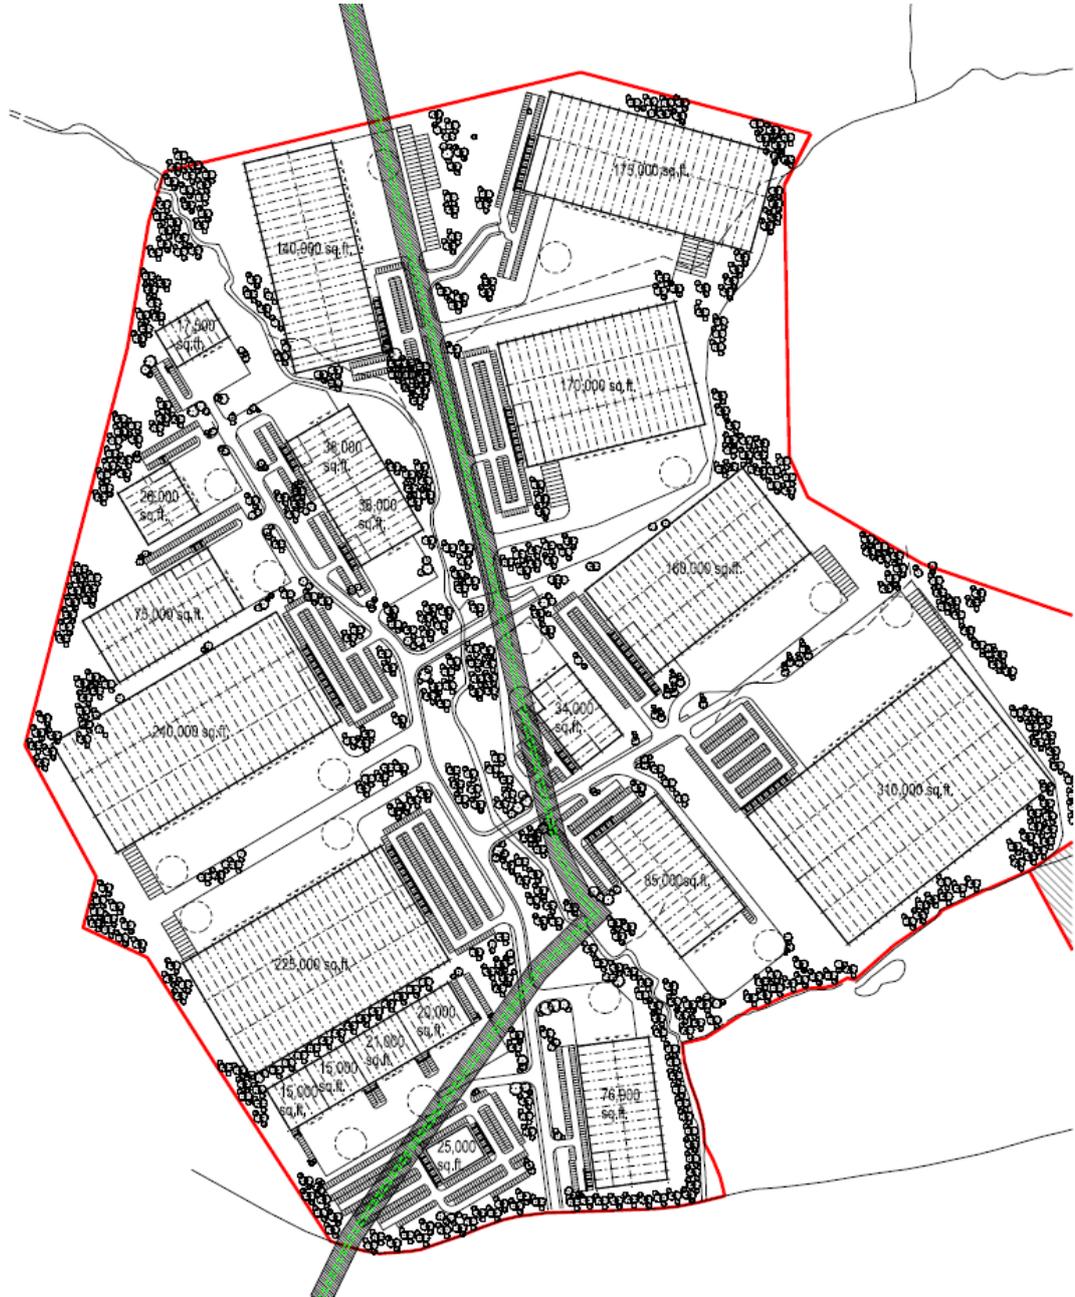
- 2.1 The development of this site has been considered for a number of years, with the proposed masterplan evolving considerably over that time. The original scheme, proposed before the Kirklees Estate land became a Registered Park and Garden, involved development within the Deer Park itself:

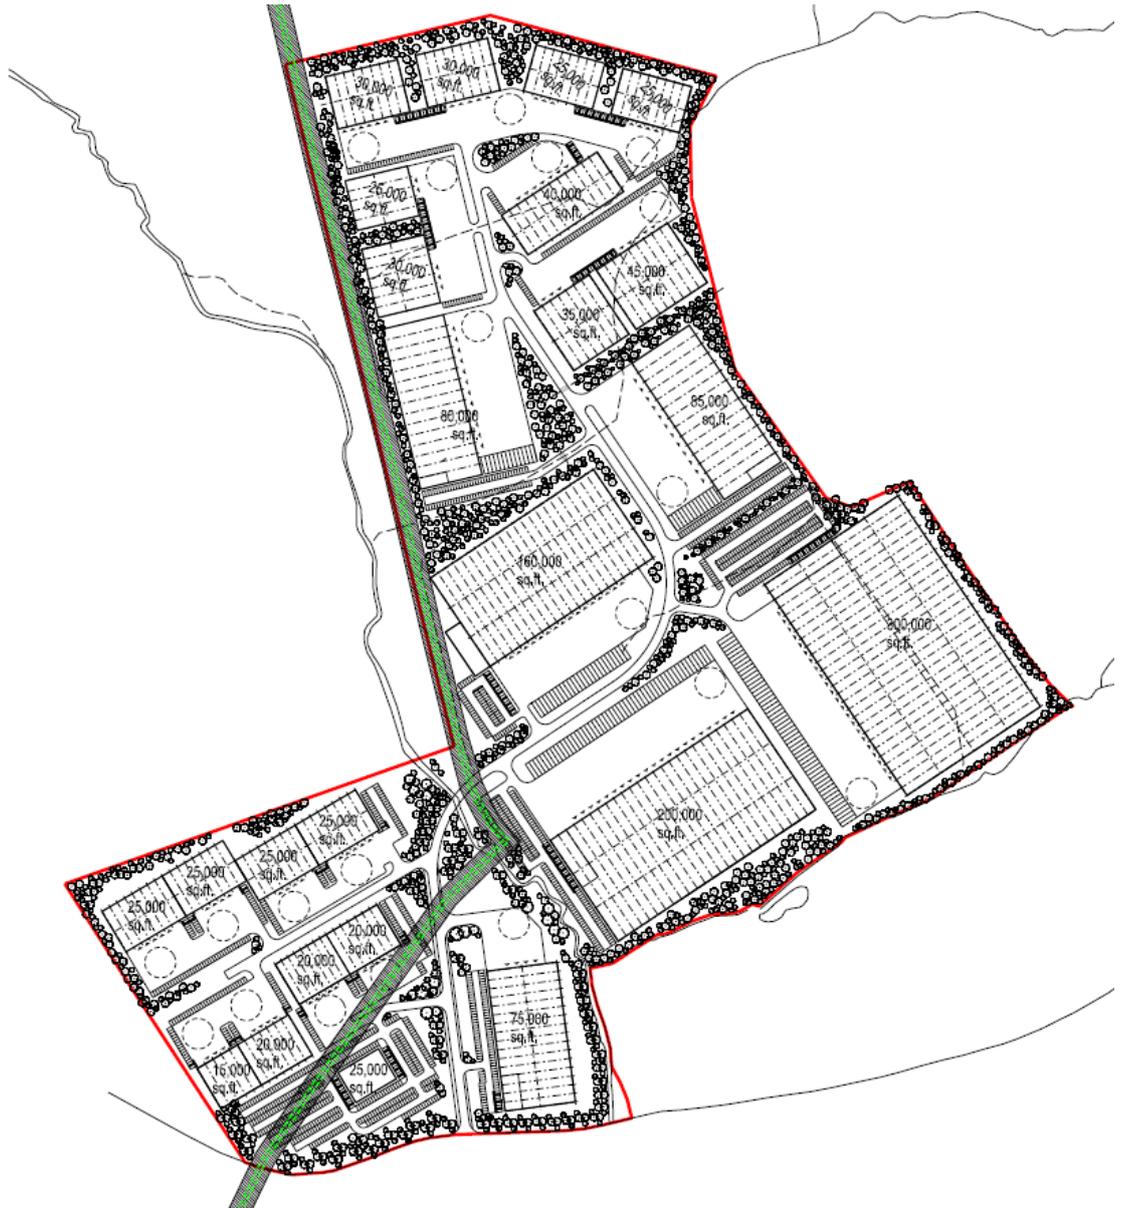
- 2.2 Discussions with Historic England and the Council resulted in the development being reduced in both extent and scale, to keep development outside the Deer Park boundary wall.

- 2.3 This scheme, including limitations on building heights in areas of the site, was agreed as being an appropriate response to the heritage context at that time.
- 2.4 Following this, part of the Kirklees Estate was designated as a Registered Park and Garden. In response the proposed site allocation boundary was amended and a further master plan prepared, as shown below:

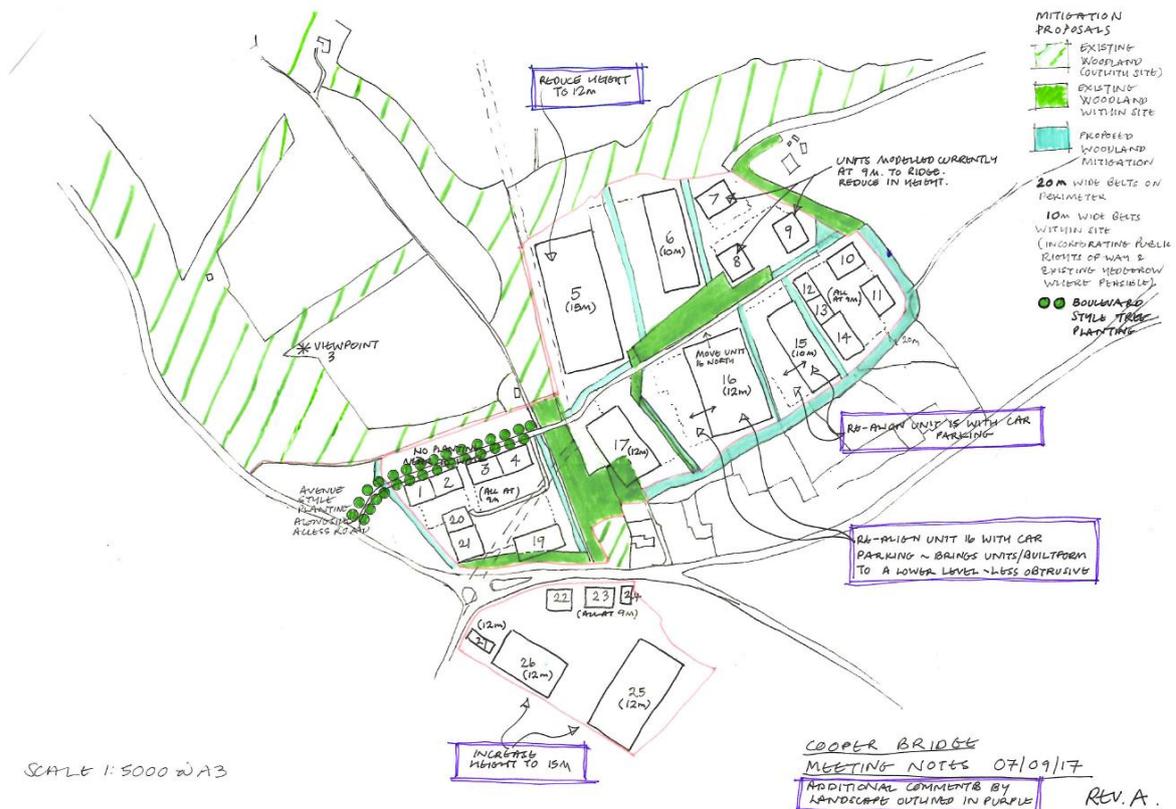
2.11 The sketch above shows a working drawing of the proposed scheme changes. These include:

- Removing infrastructure, development and planting from the Deer Park wall, leaving a substantial open buffer to allow appreciation of the wall and it's role in defining the southern extent of the Park & Garden;
- Creating a new planted boulevard as the site access point;
- Creating a feature of the original southern access route, leaving this open to pedestrians and cyclists, in a new landscaped setting that emphasises views up to the park entrance, the stream corridor and feature wall / bridge in this area;
- Reducing the height of certain buildings;

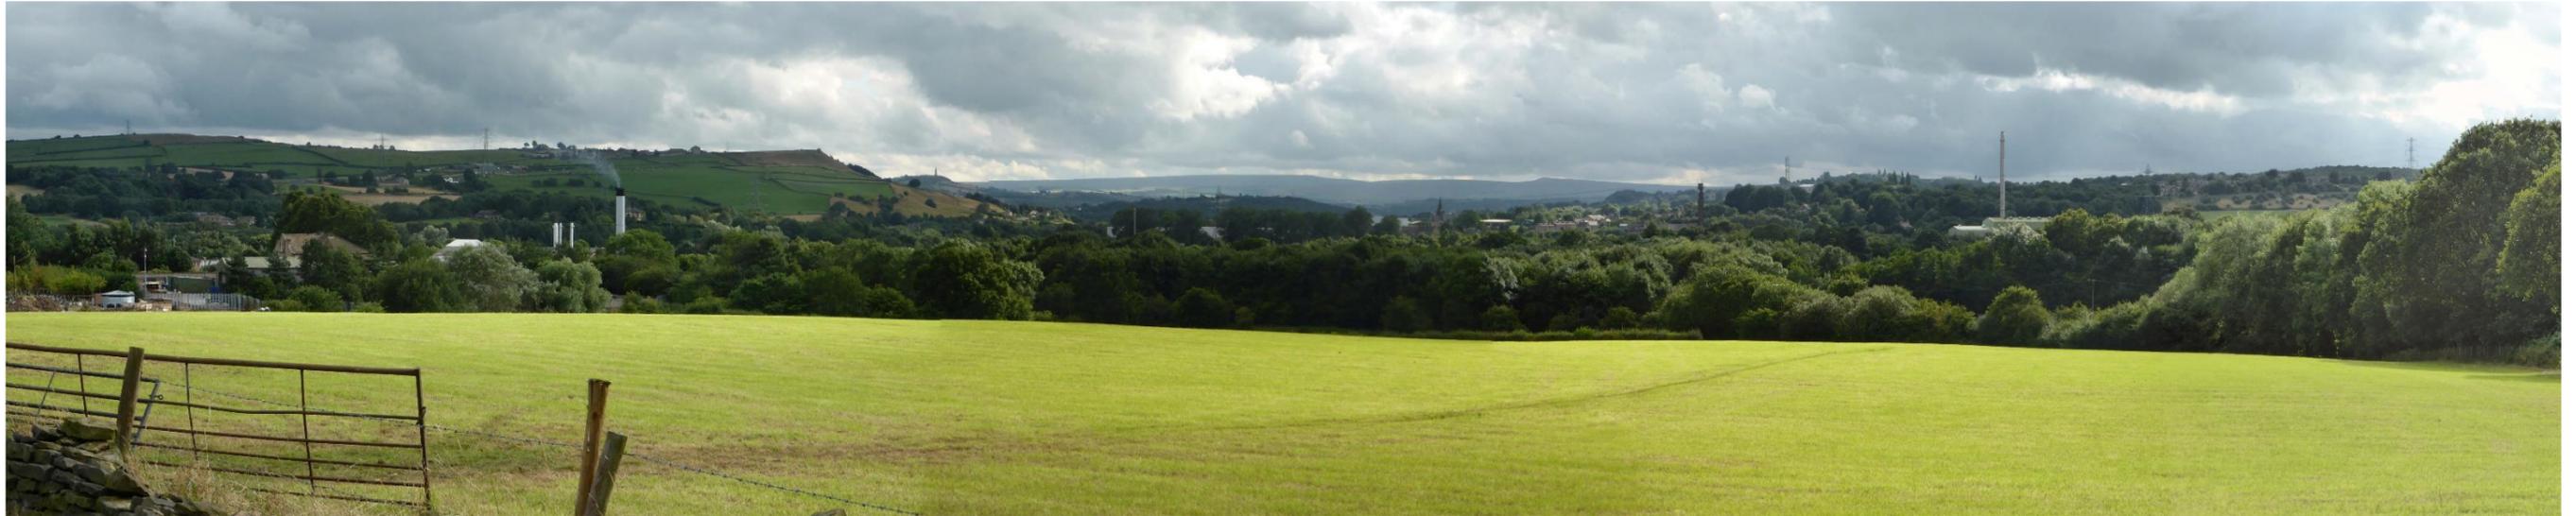
**LOCAL LANDSCAPE CHARACTER : SHEET 1**  
**View from Kirklees Estate looking North East towards Leeds Road**

VERTICAL FEATURES OF CHIMNEYS  
AND TRANSMISSION MASTS ON  
SKYLINE

SETTLEMENT VISIBLE ON SKYLINE

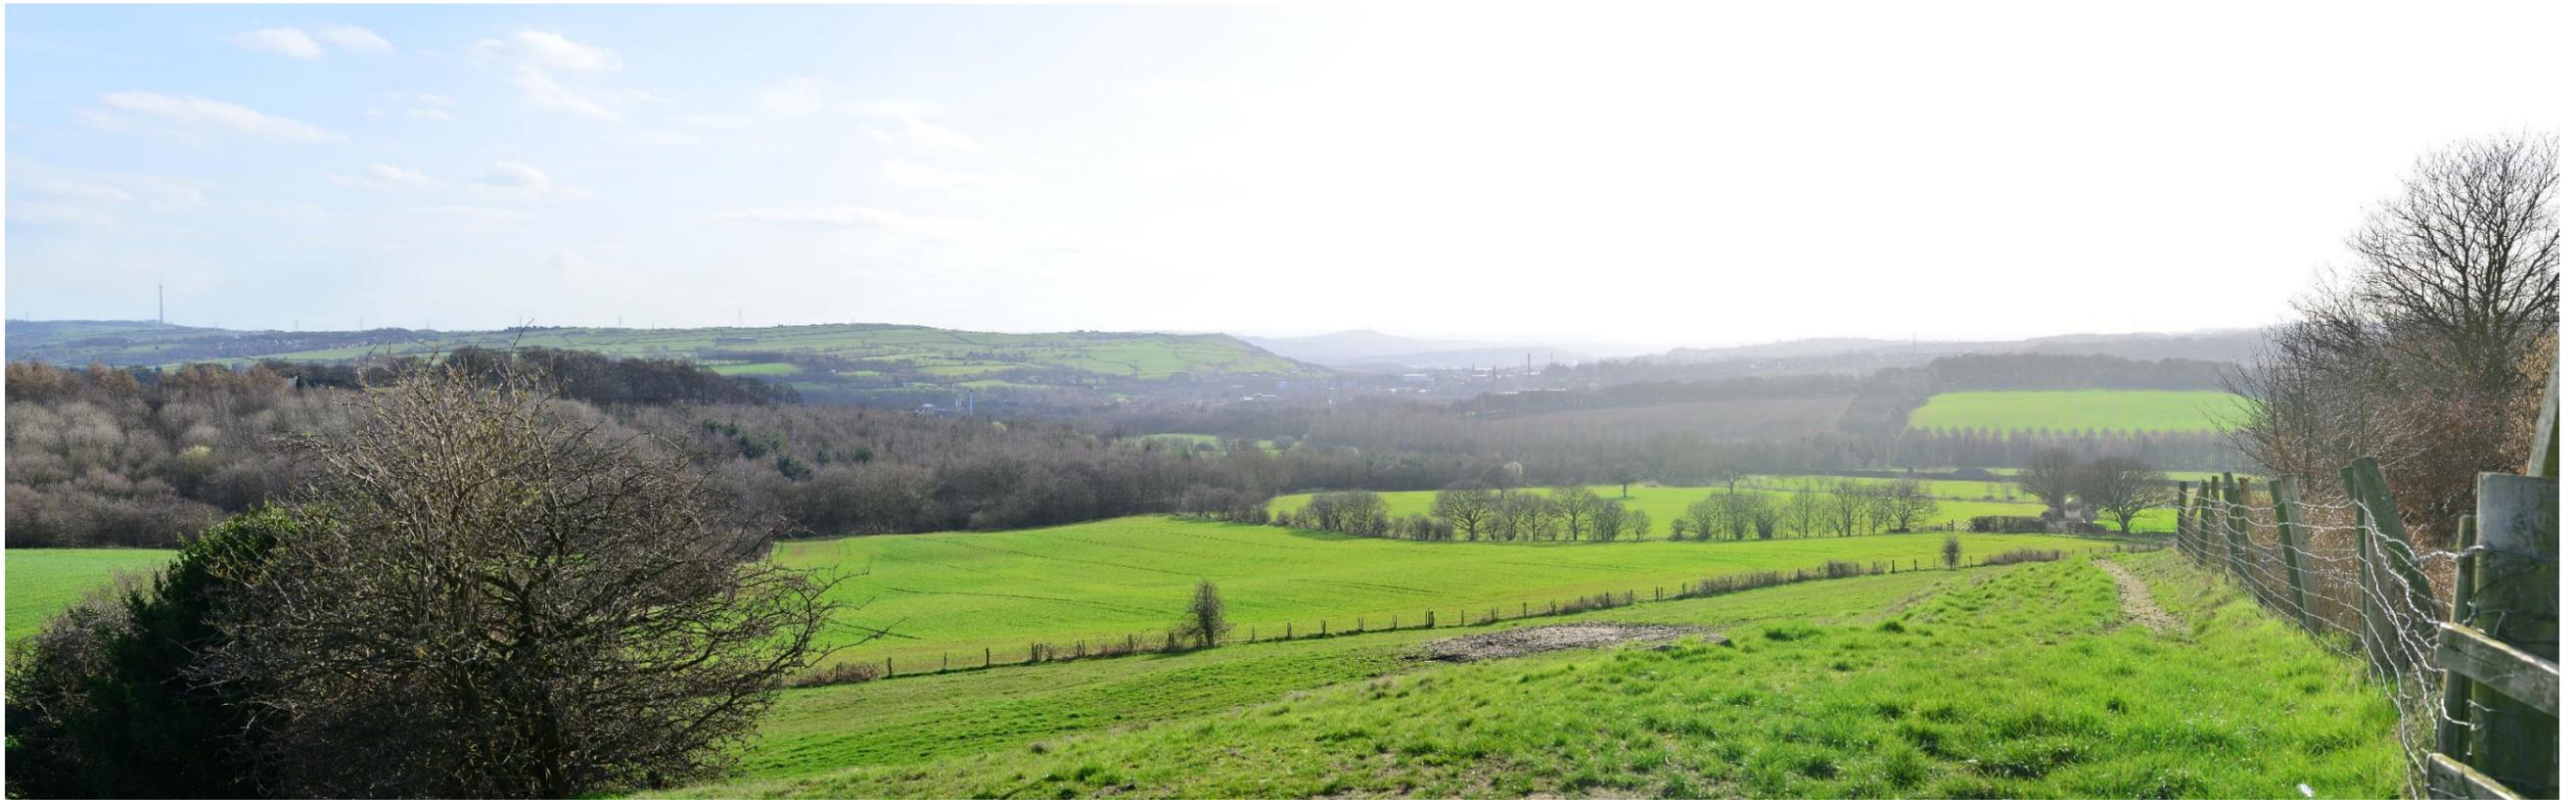
**View from PROW Luddite Trail, looking South West**

VERTICAL MASTS AND  
SETTLEMENT ON  
HILLTOP RIDGES –  
CASTLE HILL, EMLEY  
MOOR MAST - LOCAL  
LANDMARKS

LARGE SCALE  
INDUSTRIAL  
DEVELOPMENT SITED IN  
VALLEY BOTTOM

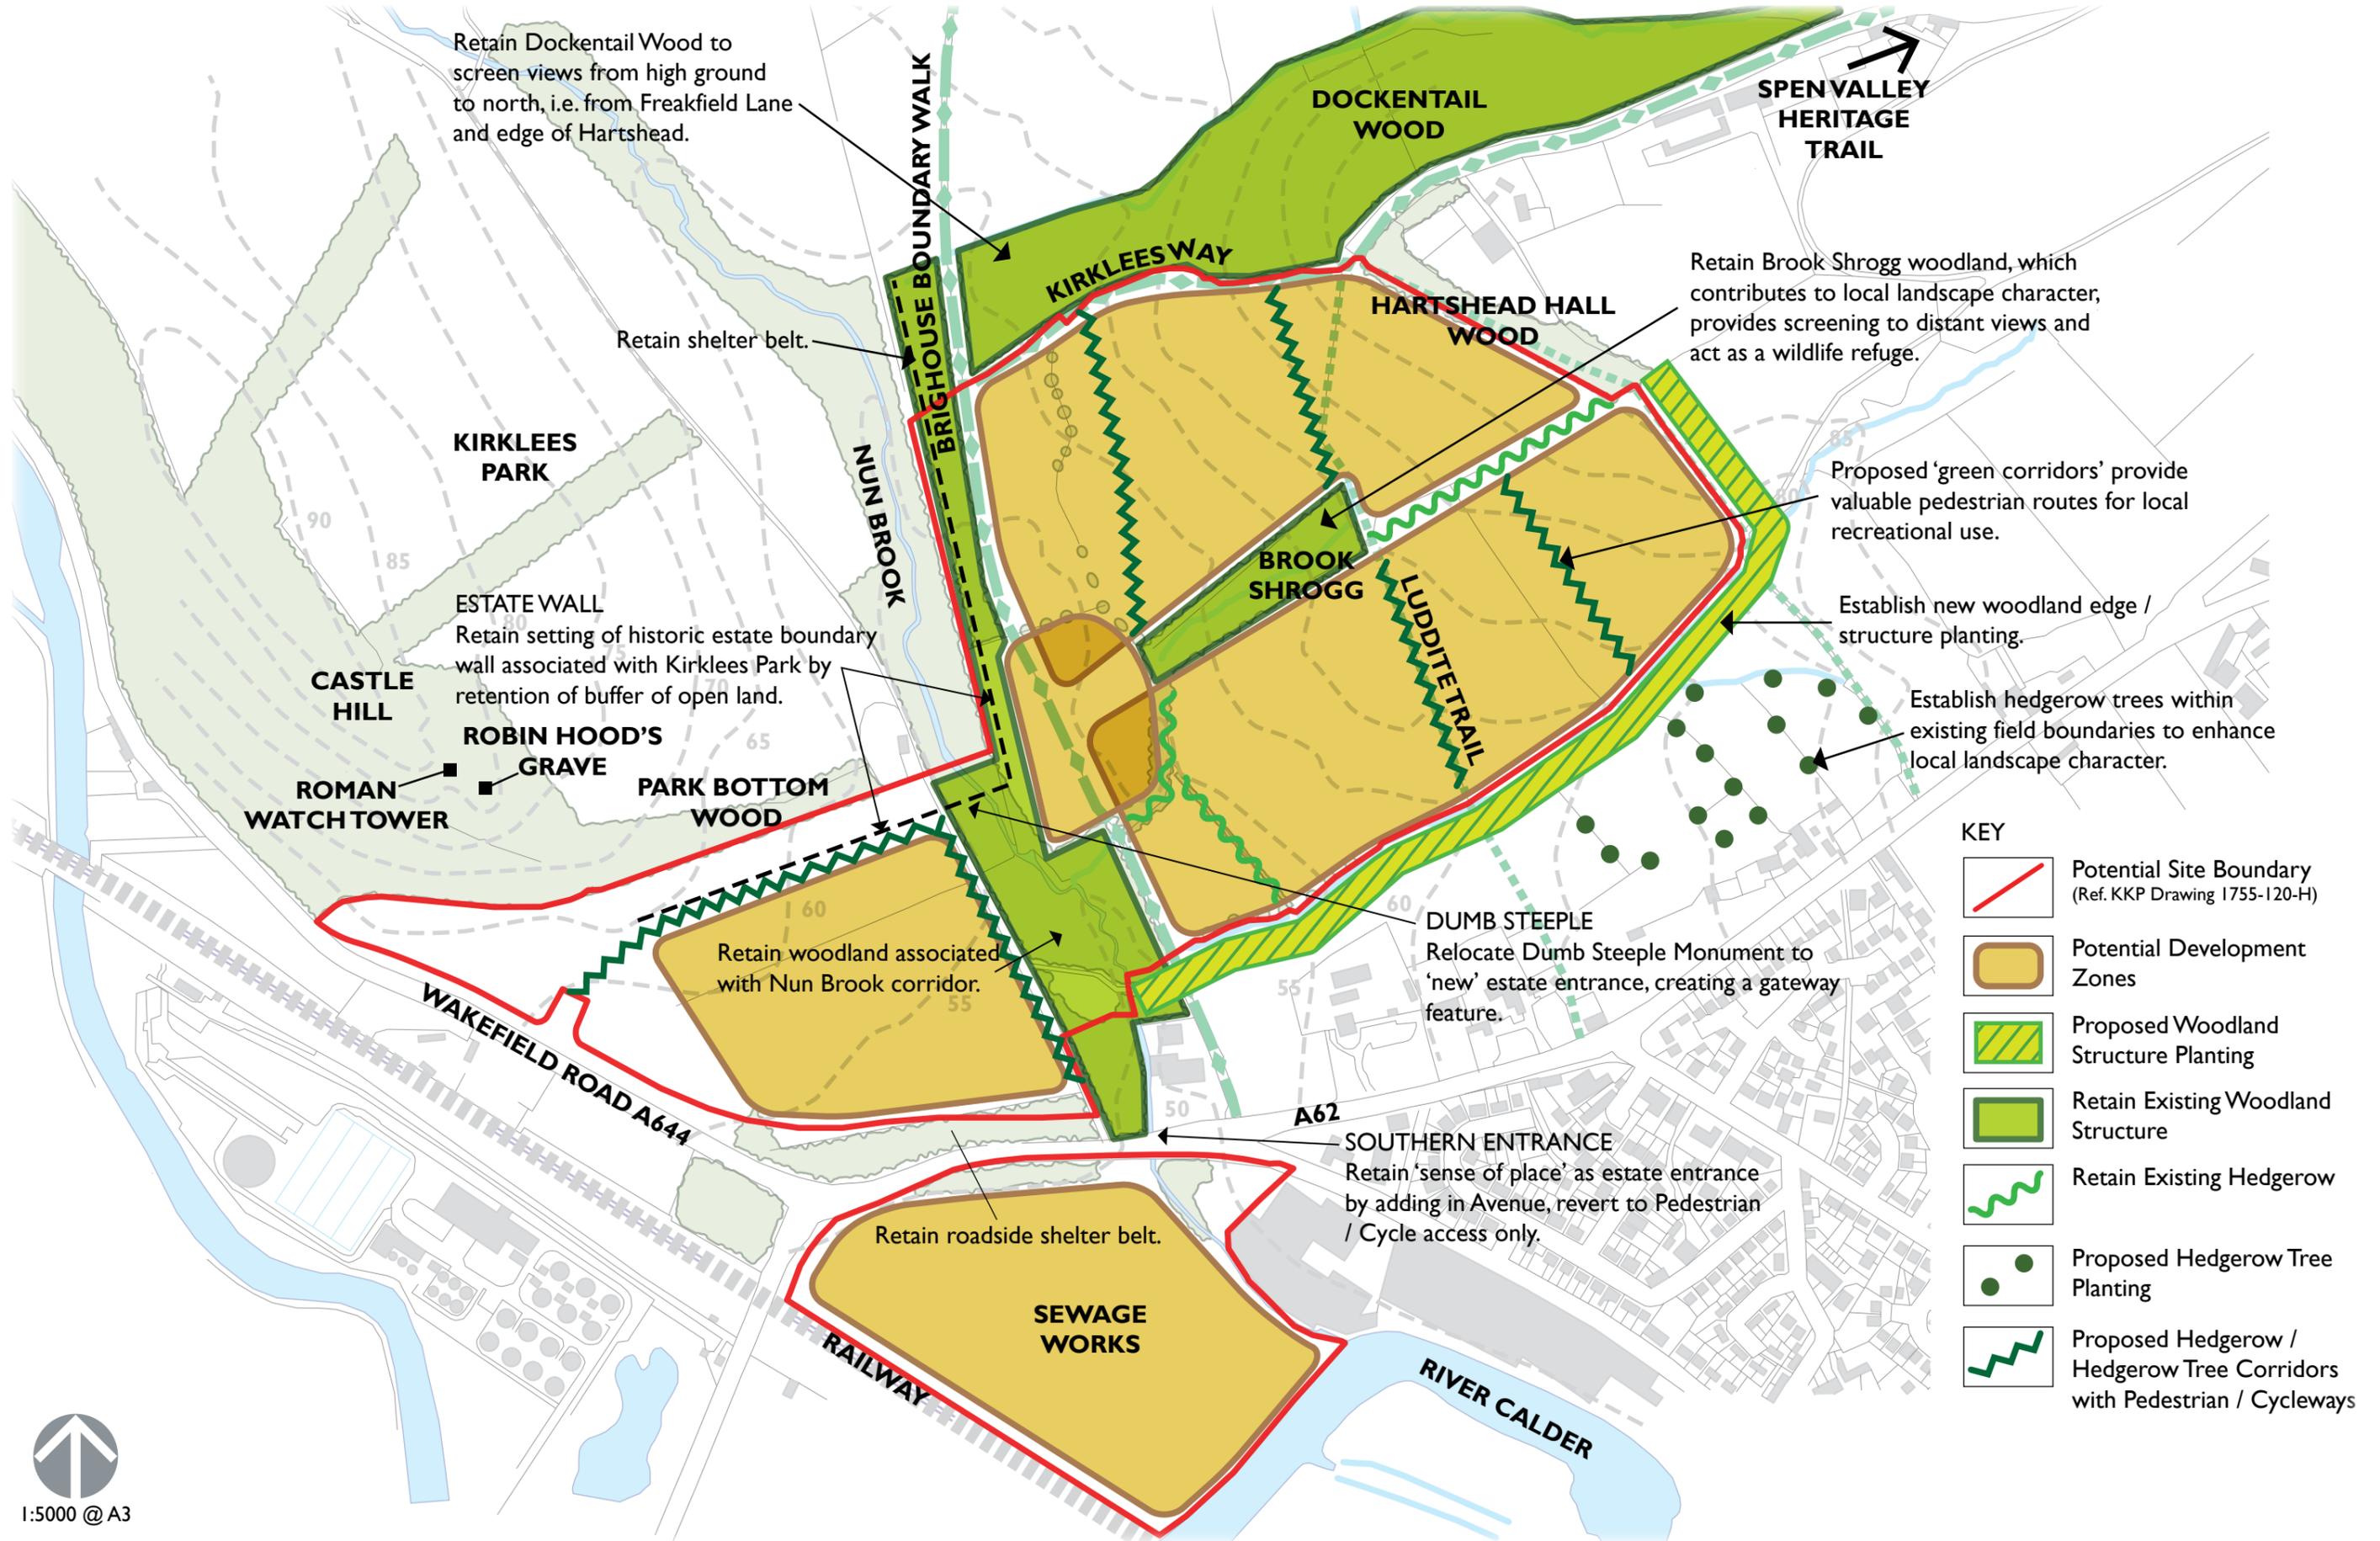
## **Appendix 2: Landscape Principles and Masterplan**

Retain Dockentail Wood to screen views from high ground to north, i.e. from Freakfield Lane and edge of Hartshead.

Retain shelter belt.

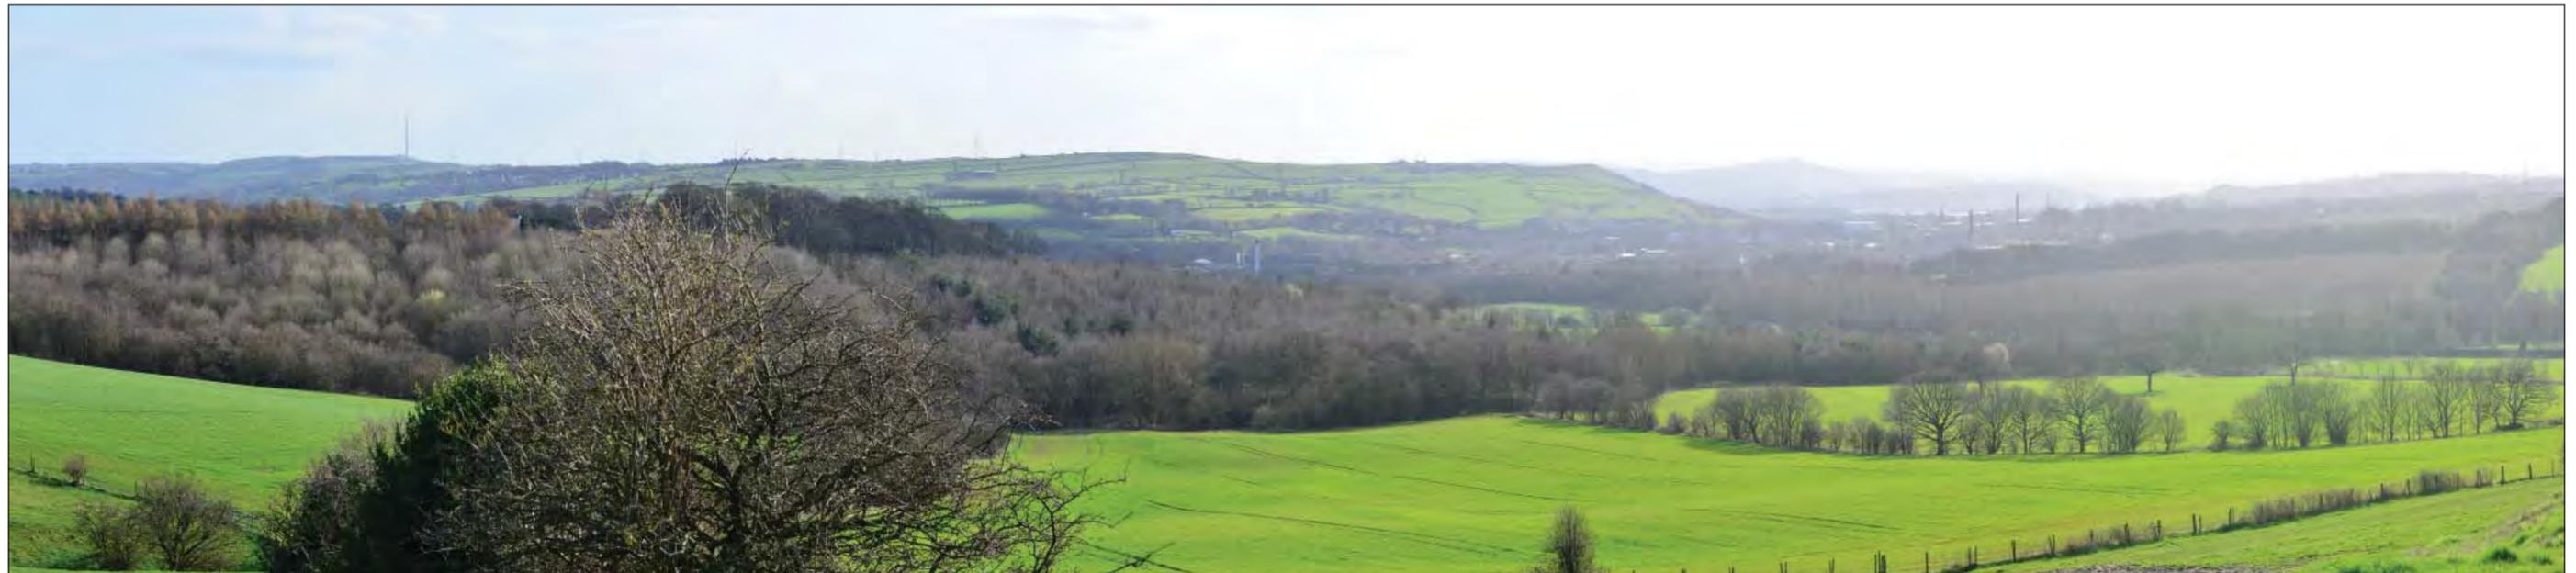
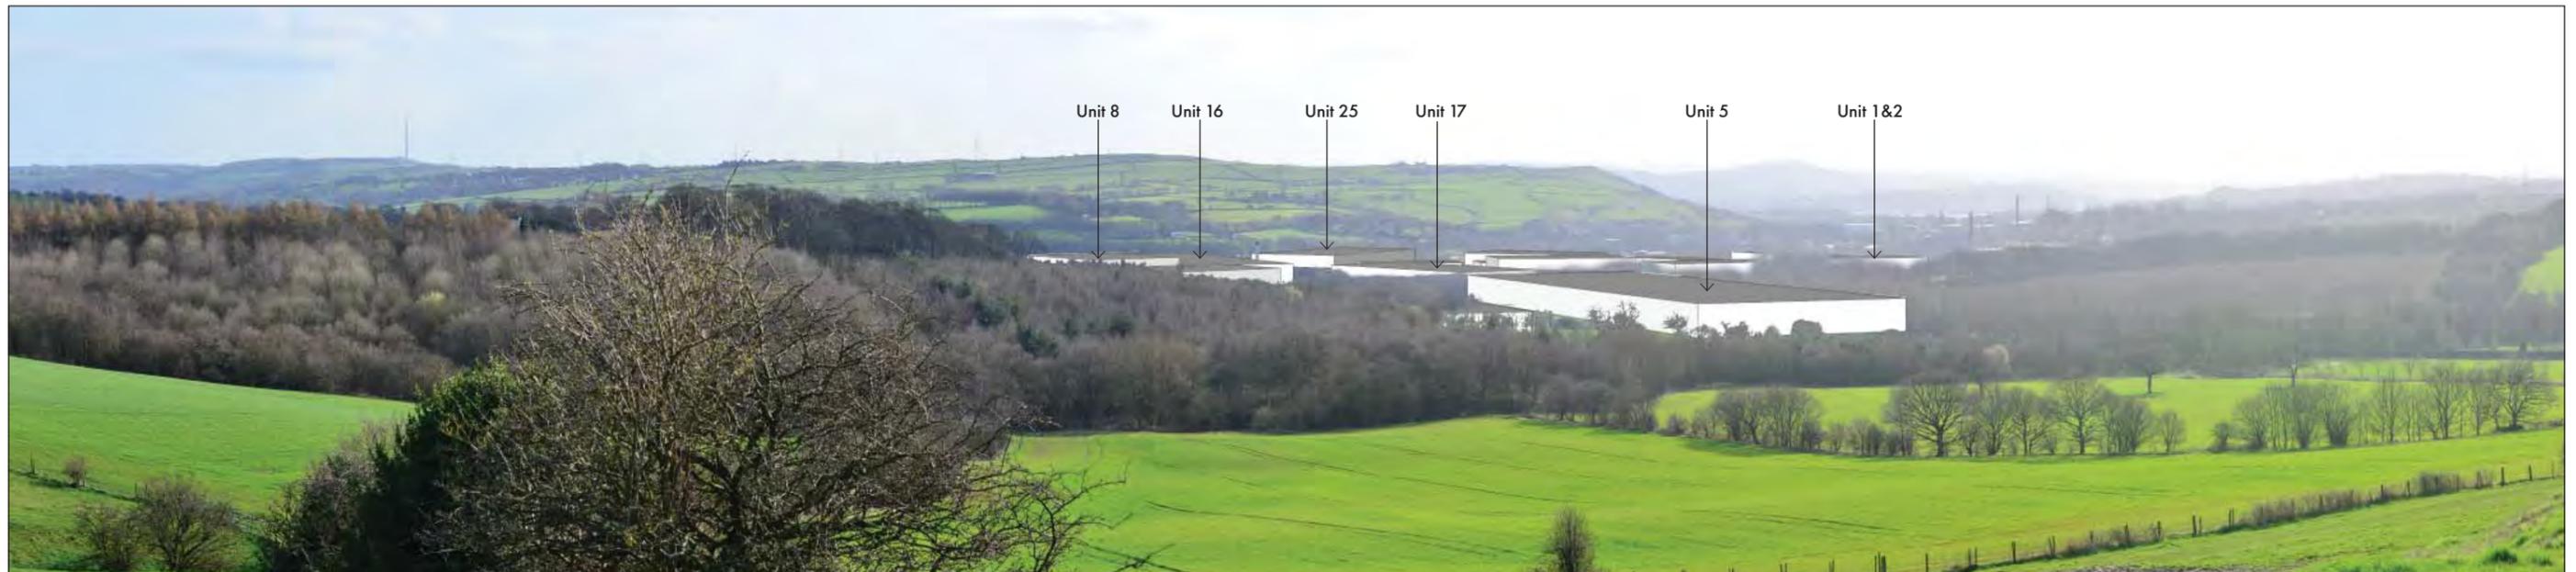
## Viewpoint 1: Kirklees Way - PROW No SPE/159/50, at junction with Cross Lane Track Existing and Proposed Photomontages

Existing Situation

Proposed Photomontage

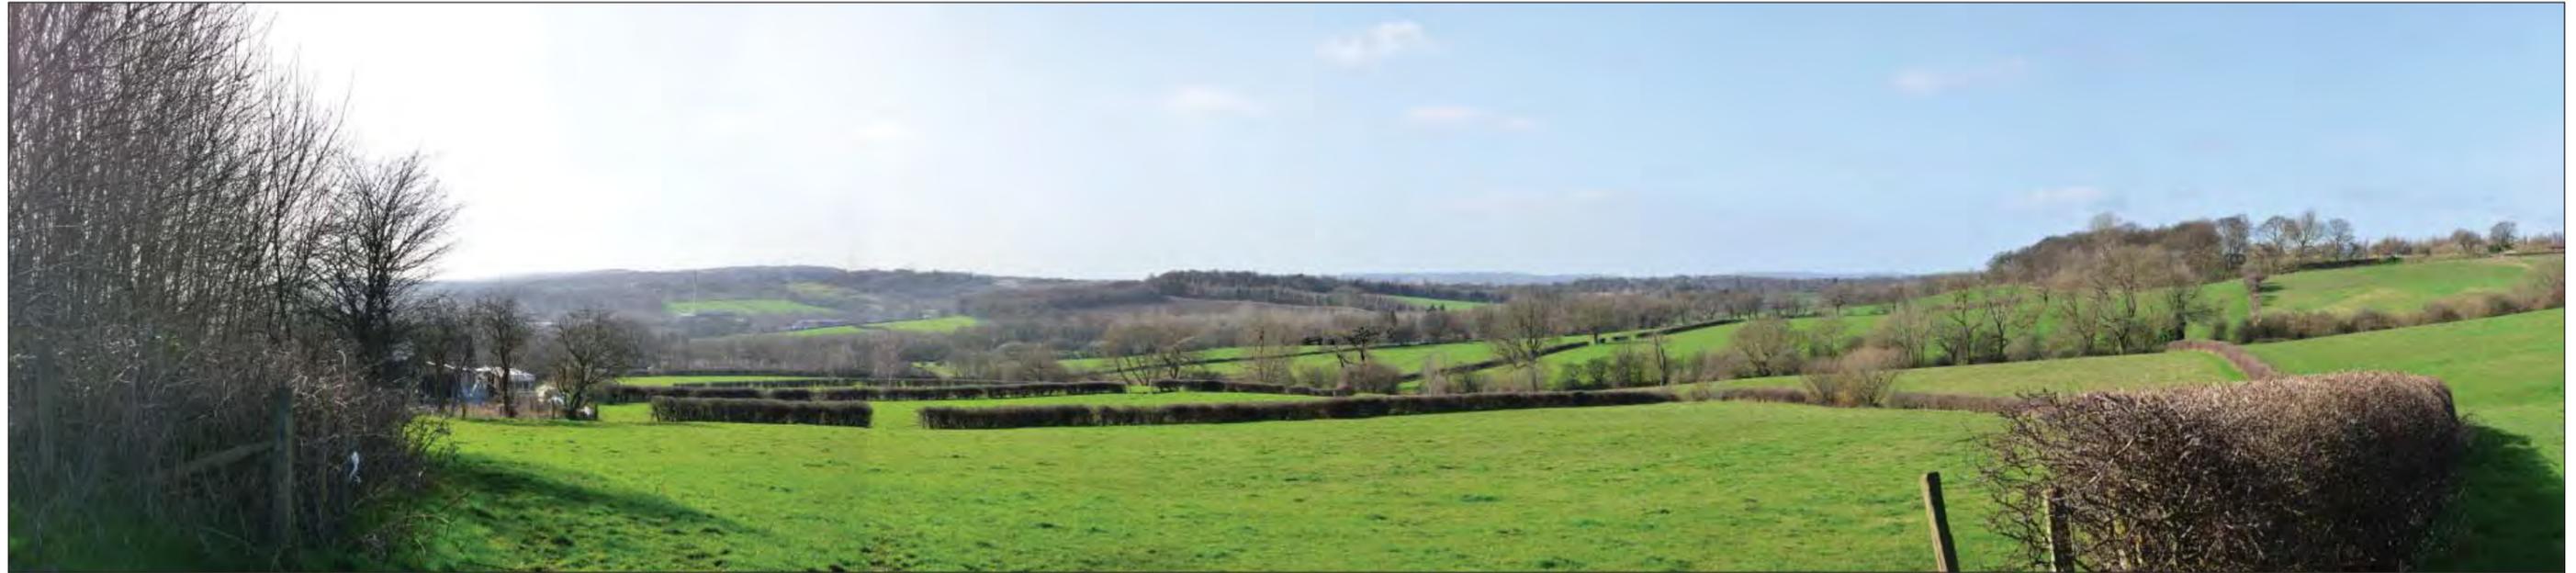
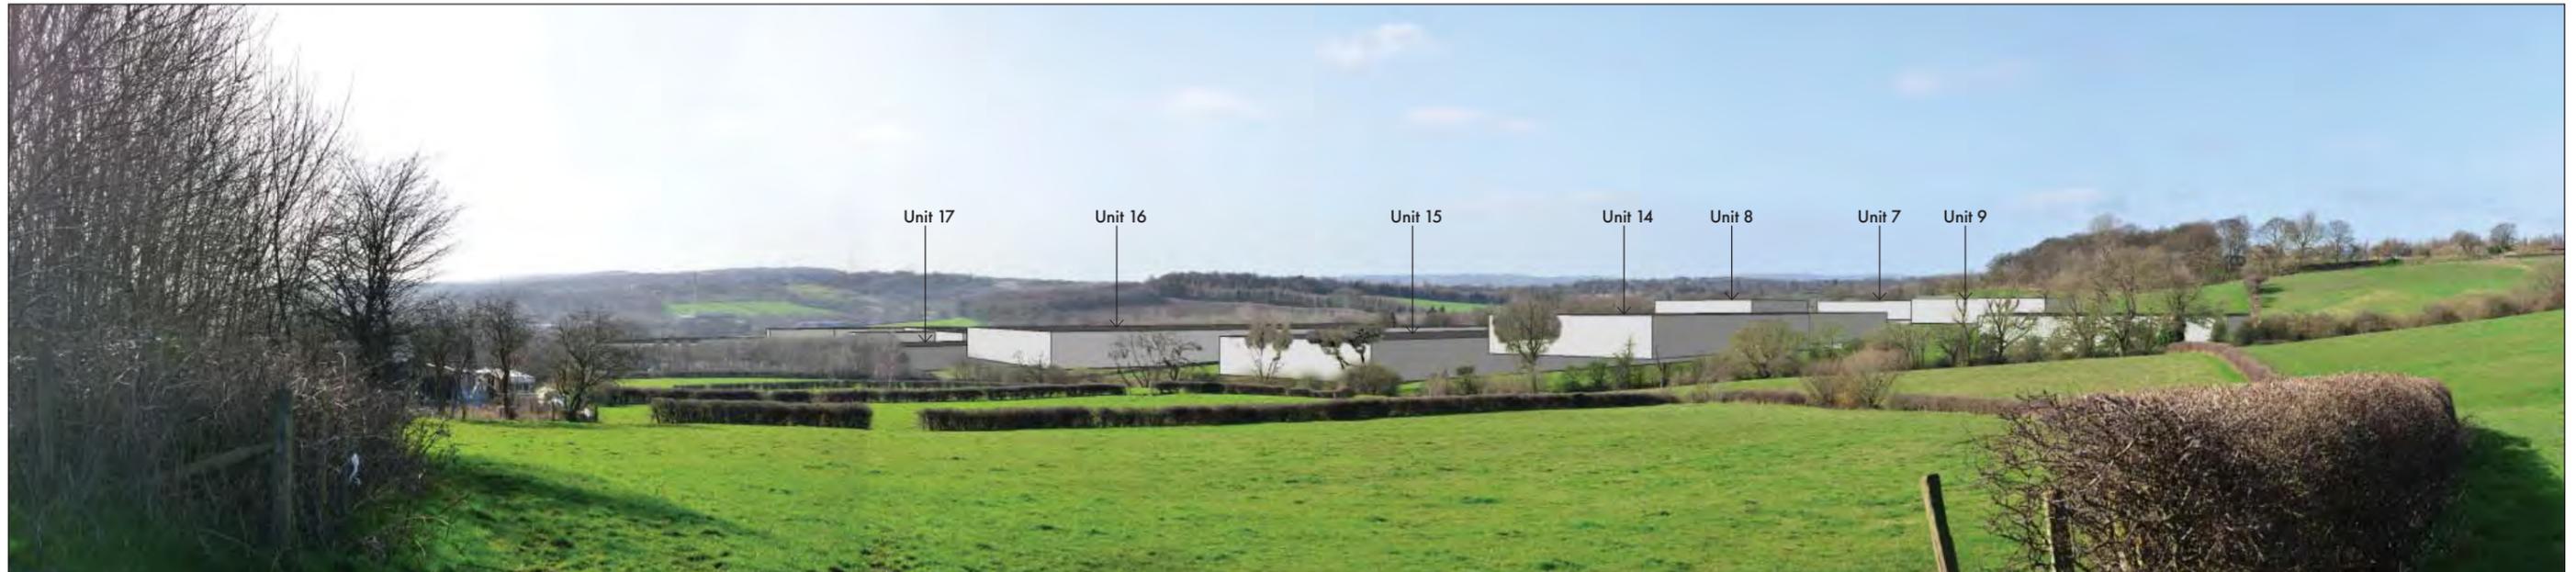
## Viewpoint 2: PROW No MIR/26/10, from A62, looking West Existing and Proposed Photomontages

Existing Situation

Proposed Photomontage

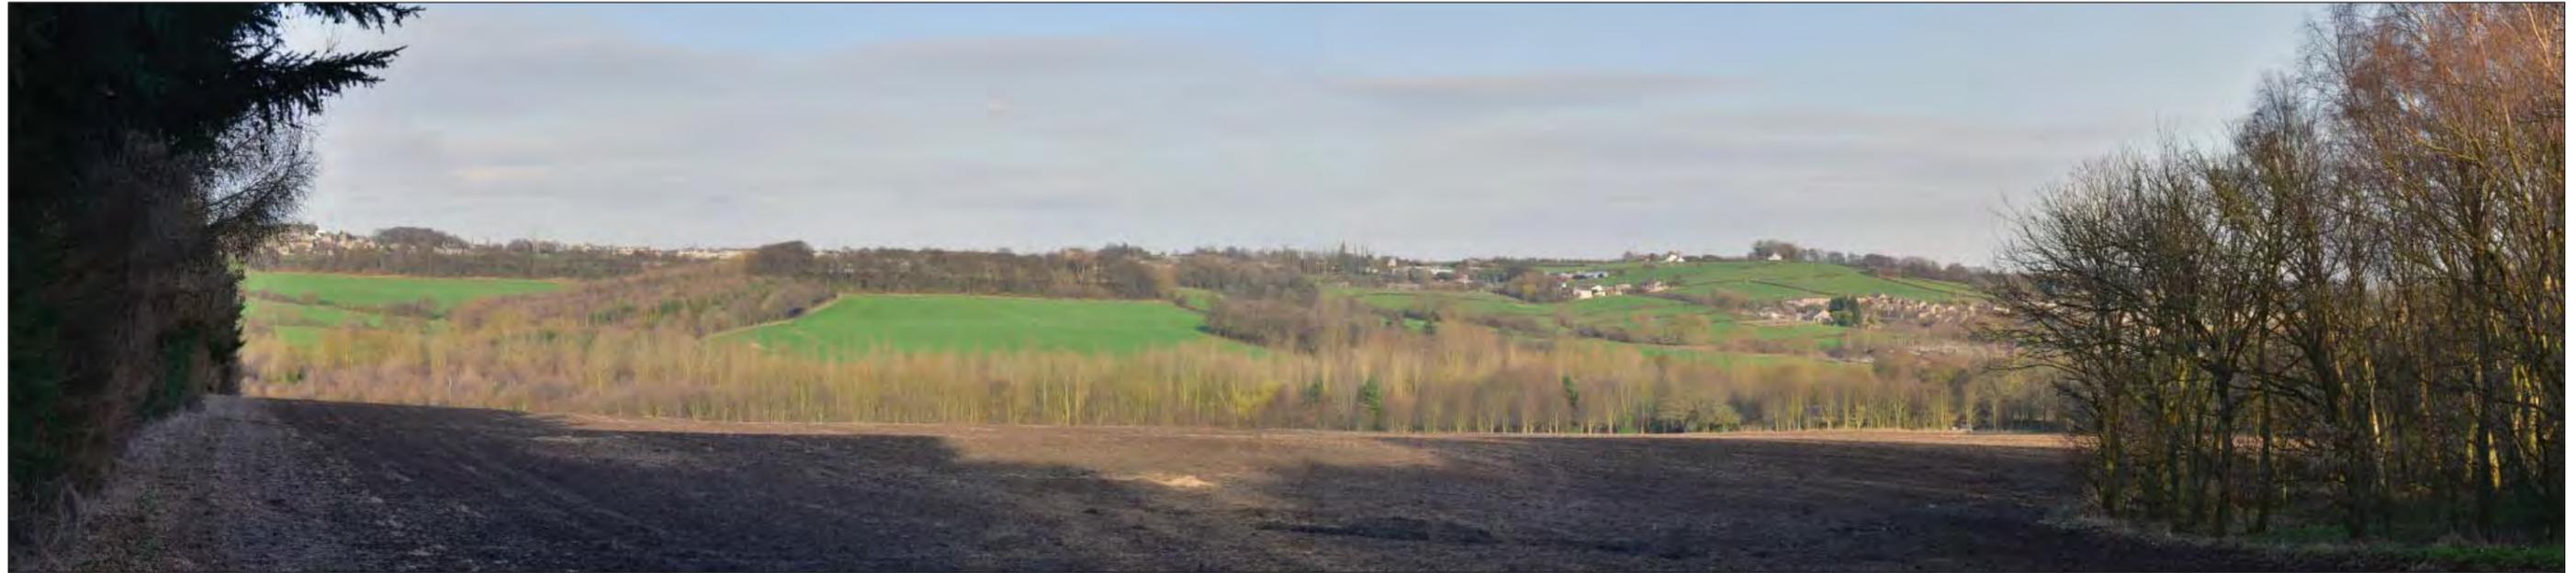
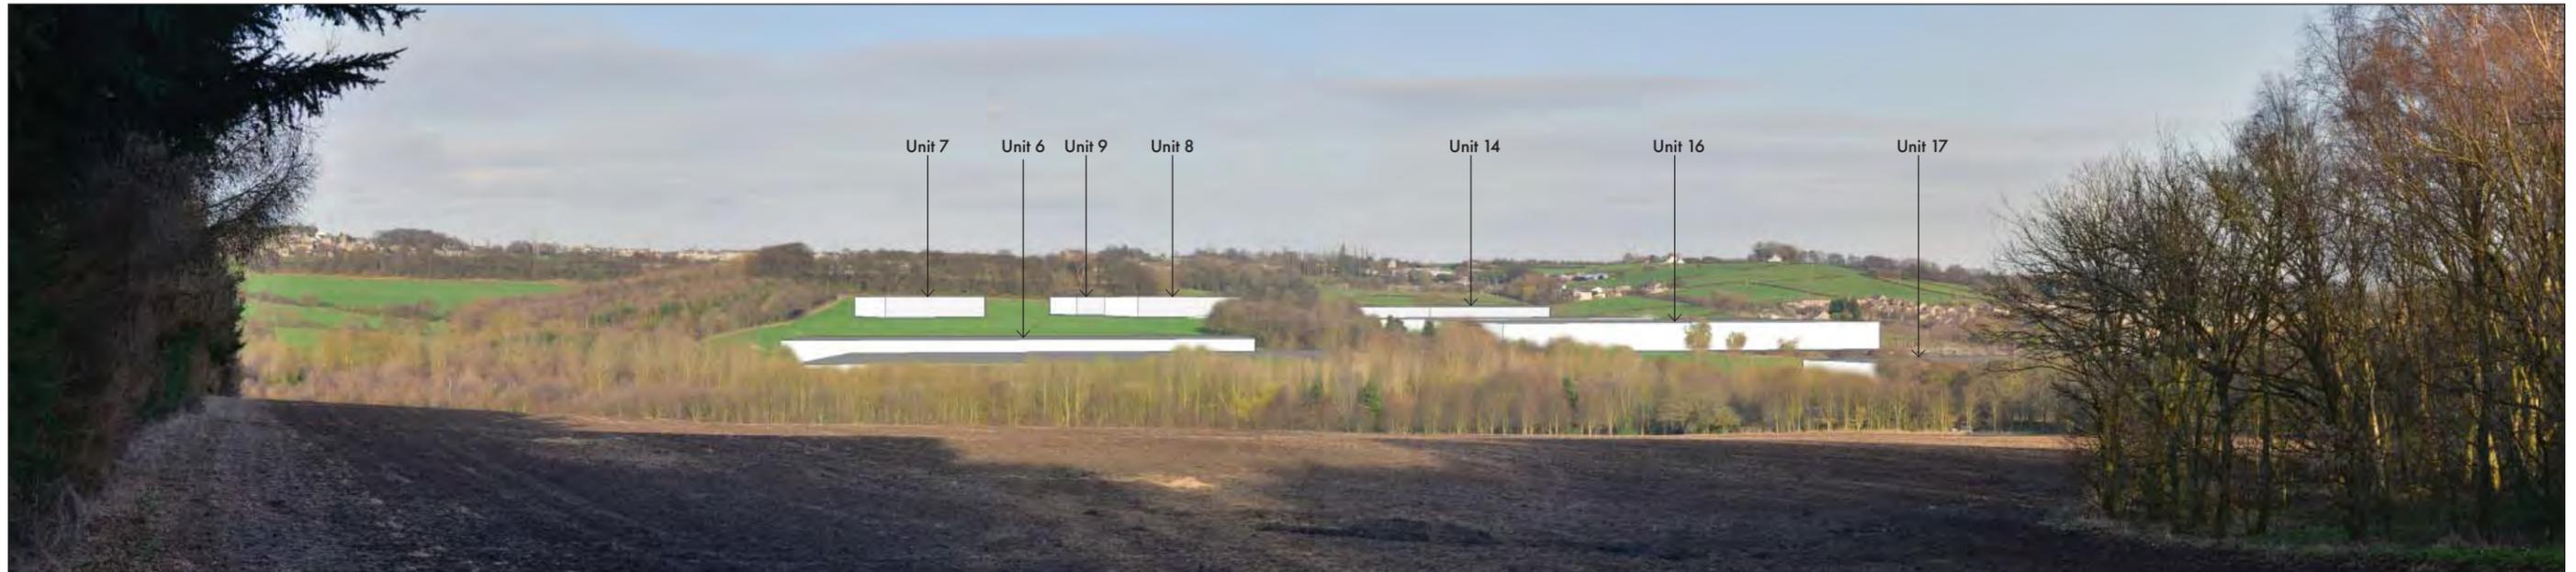
## Viewpoint 3: Within Kirklees Park, South West of Hall, in field corner Existing and Proposed Photomontages

Existing Situation

Proposed Photomontage

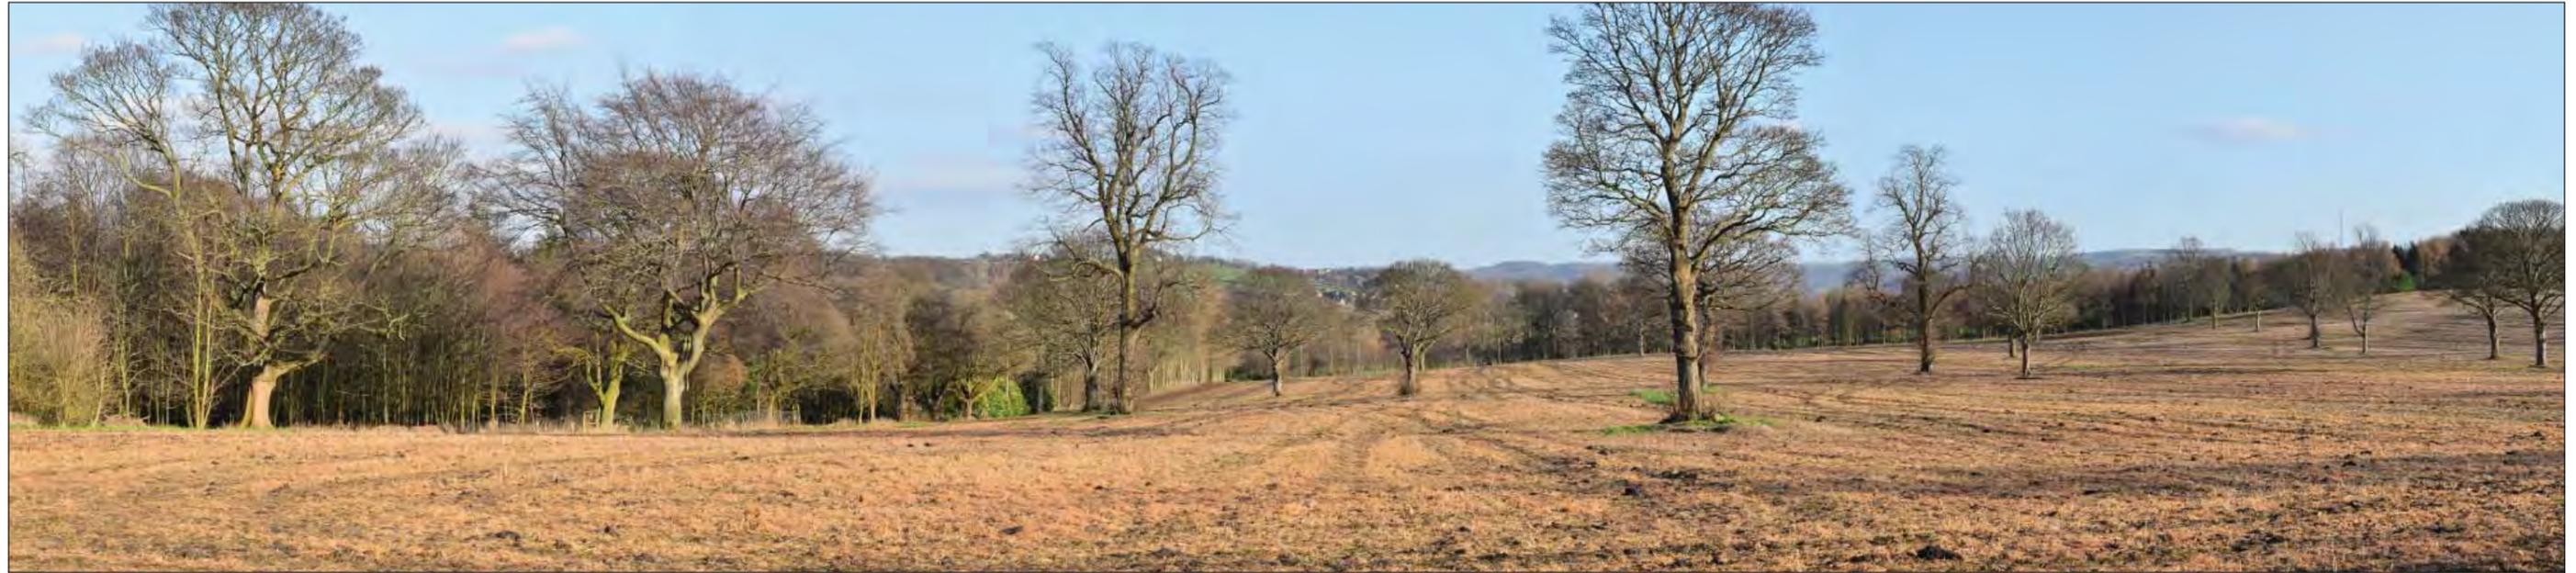
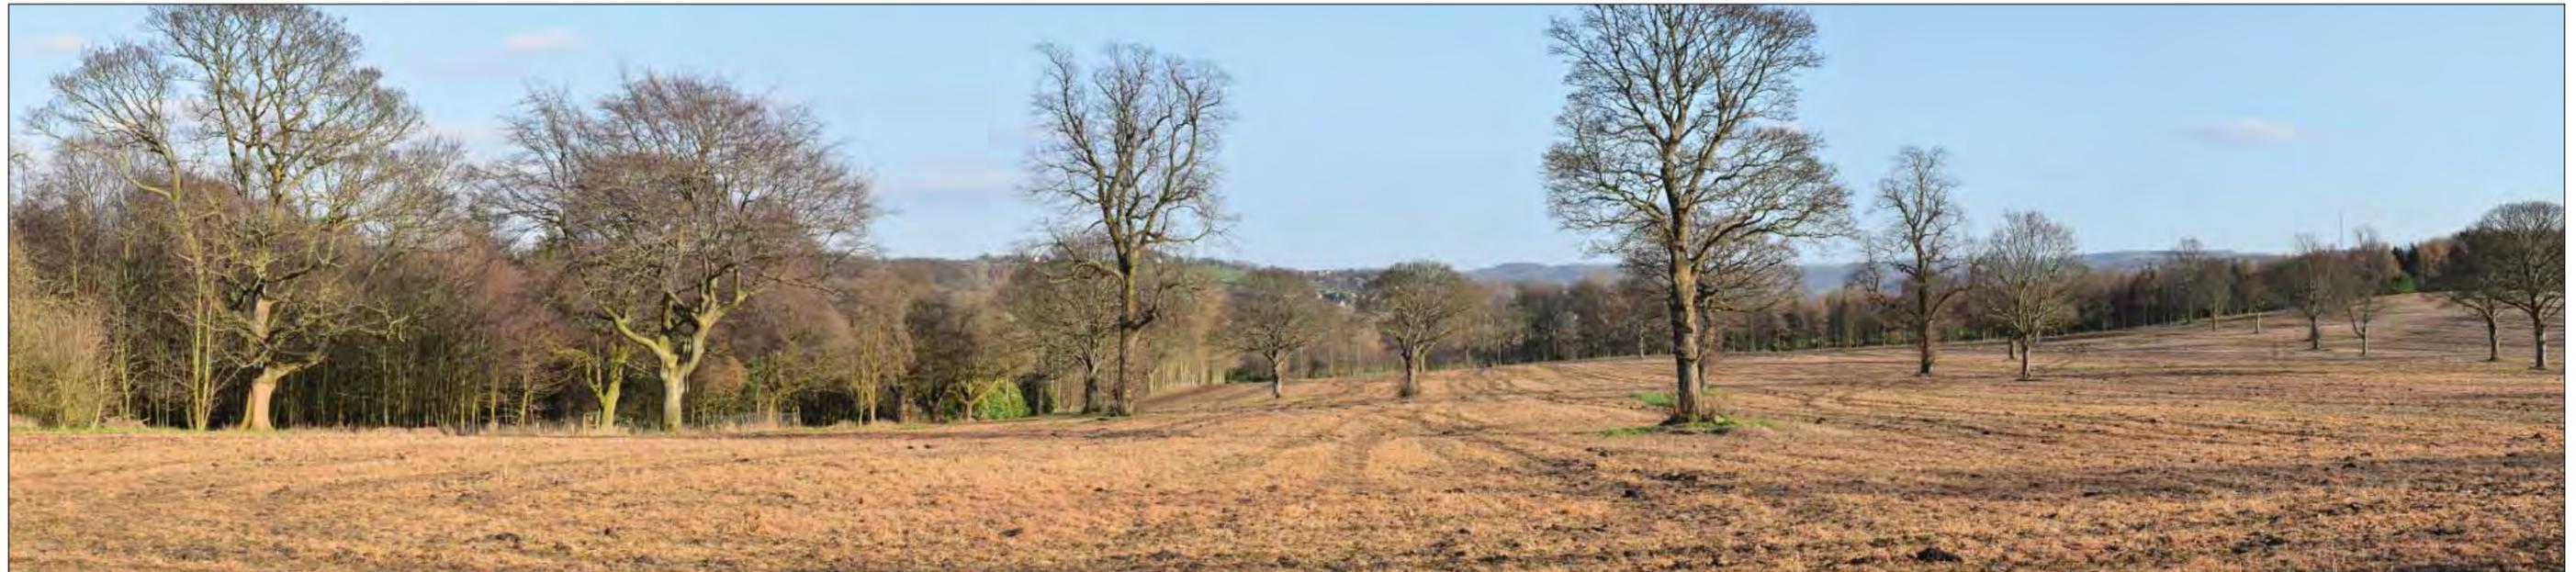
## Viewpoint 4: Kirklees Hall, in front of the house, at ground floor level Existing and Proposed Photomontages

Existing Situation

Proposed Photomontage
