# **Heritage Overview Report**

Cooper Bridge Strategic Employment Site

January 2018

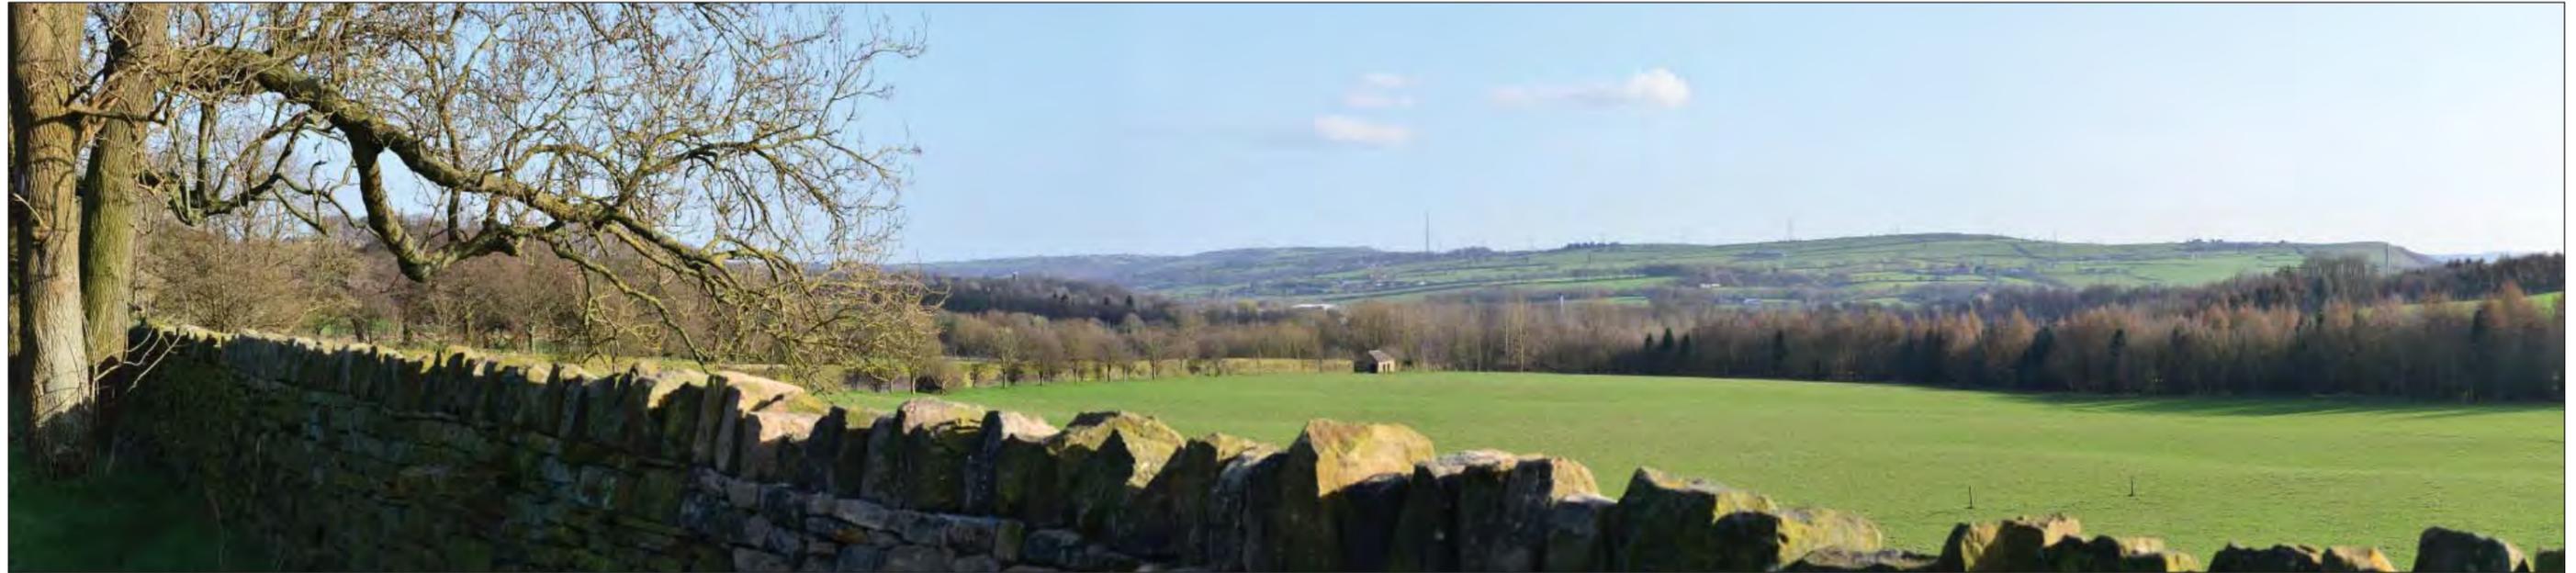
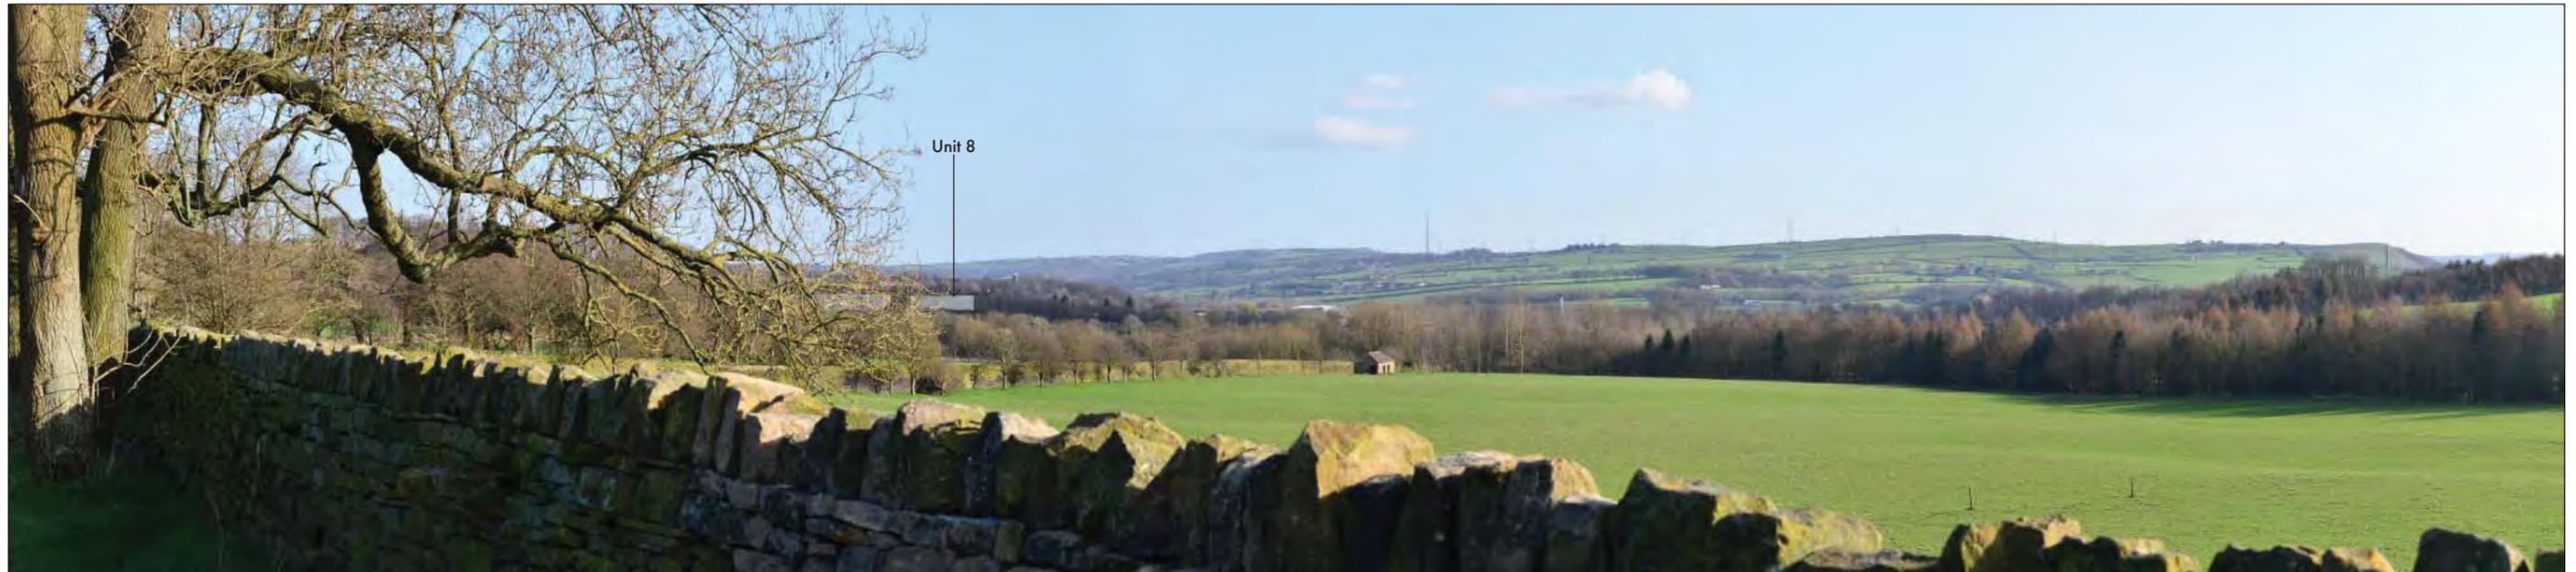
## Viewpoint 5: Within Kirklees Park, on track, North East of Home Farm Existing and Proposed Photomontages

Existing Situation

Proposed Photomontage

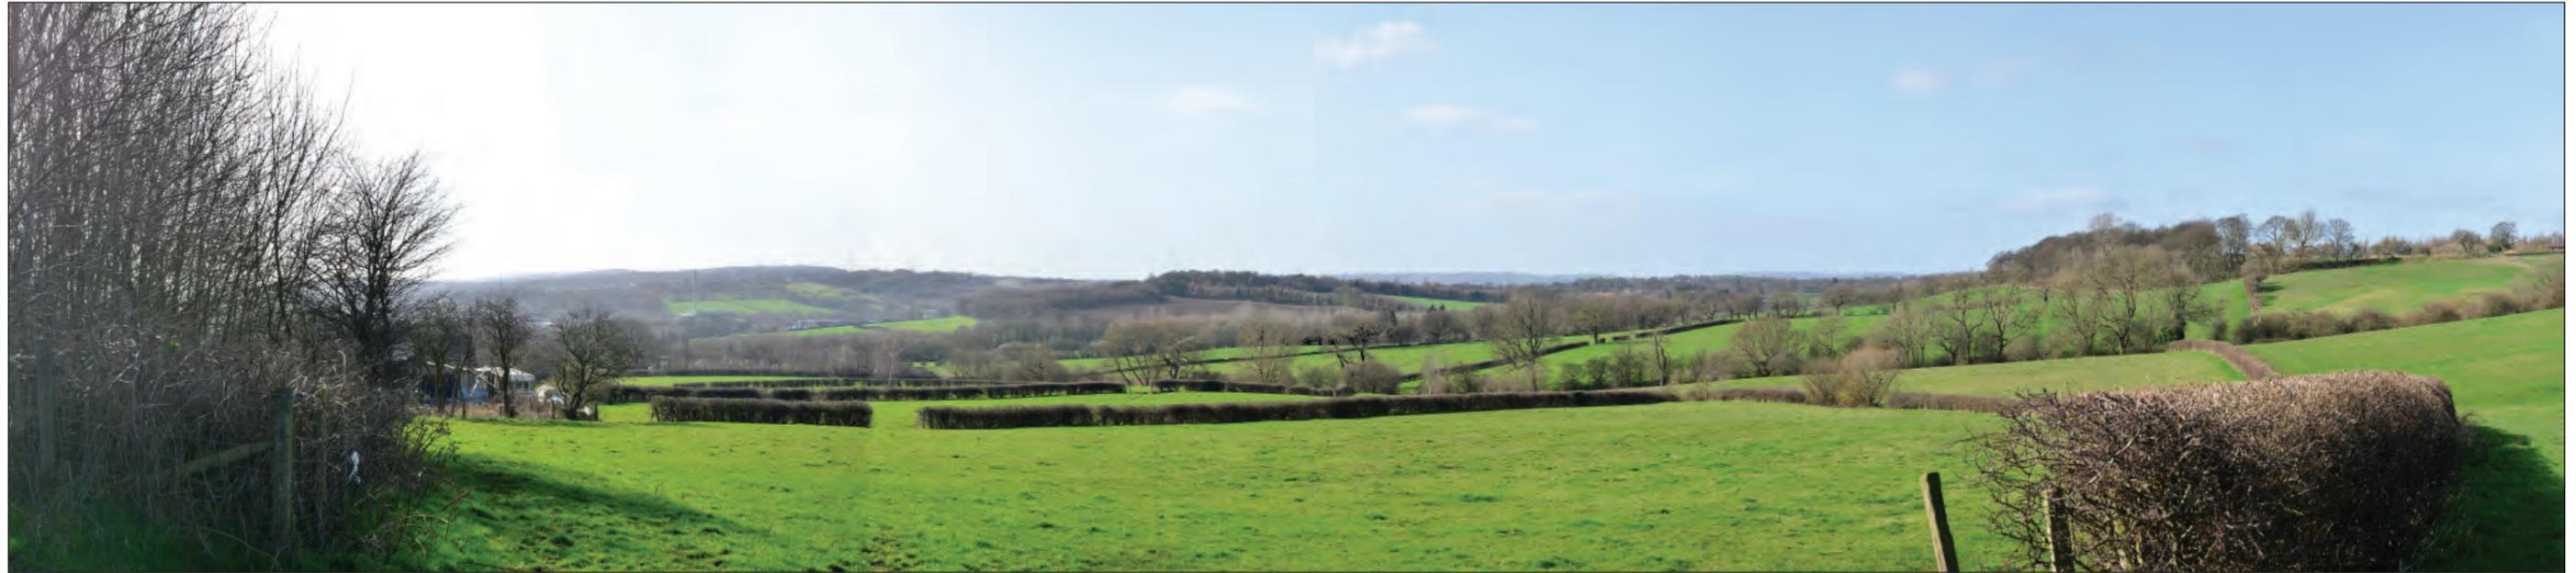
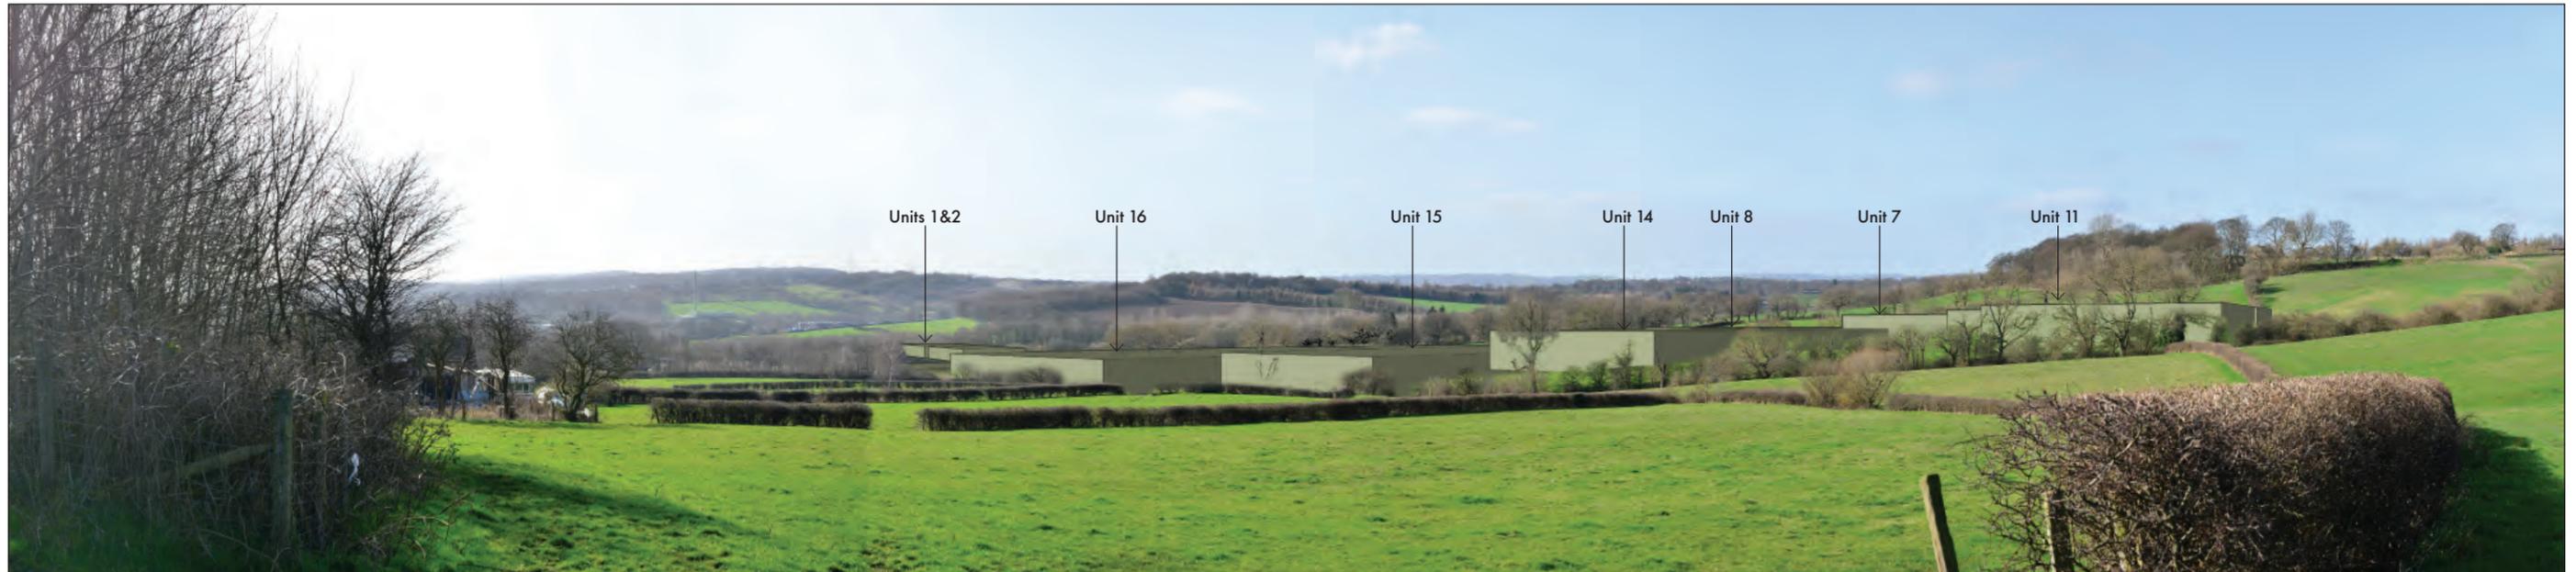
## Viewpoint 2: PROW No MIR/26/10, from A62, looking West Existing and Proposed Photomontages - Year 1

Existing Situation

Proposed Photomontage (Year 1)

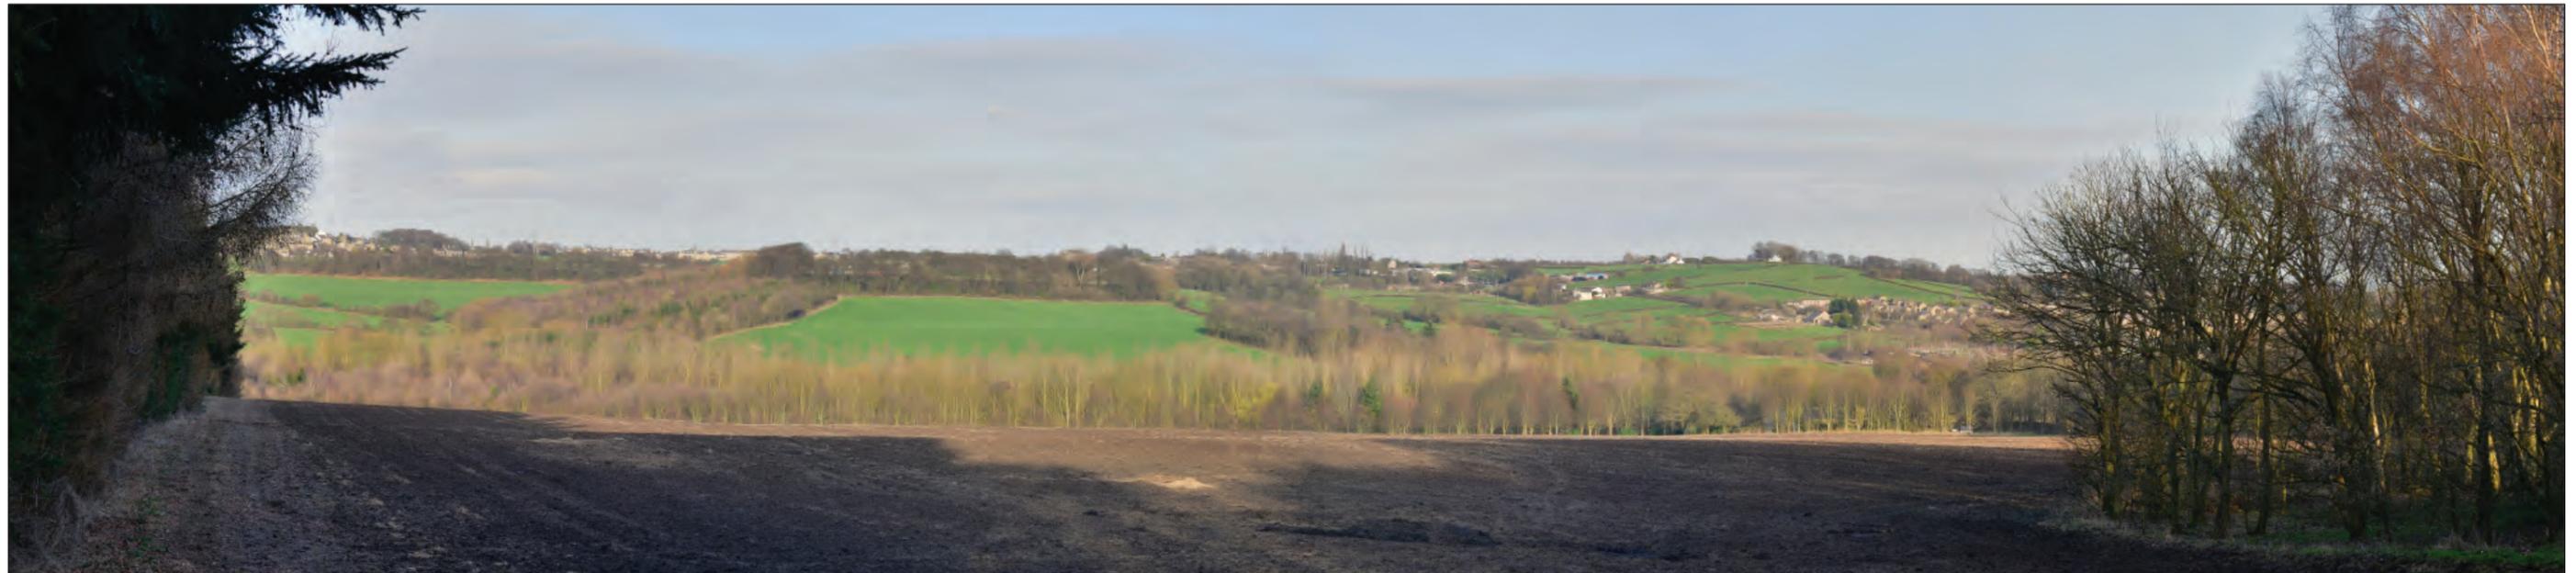
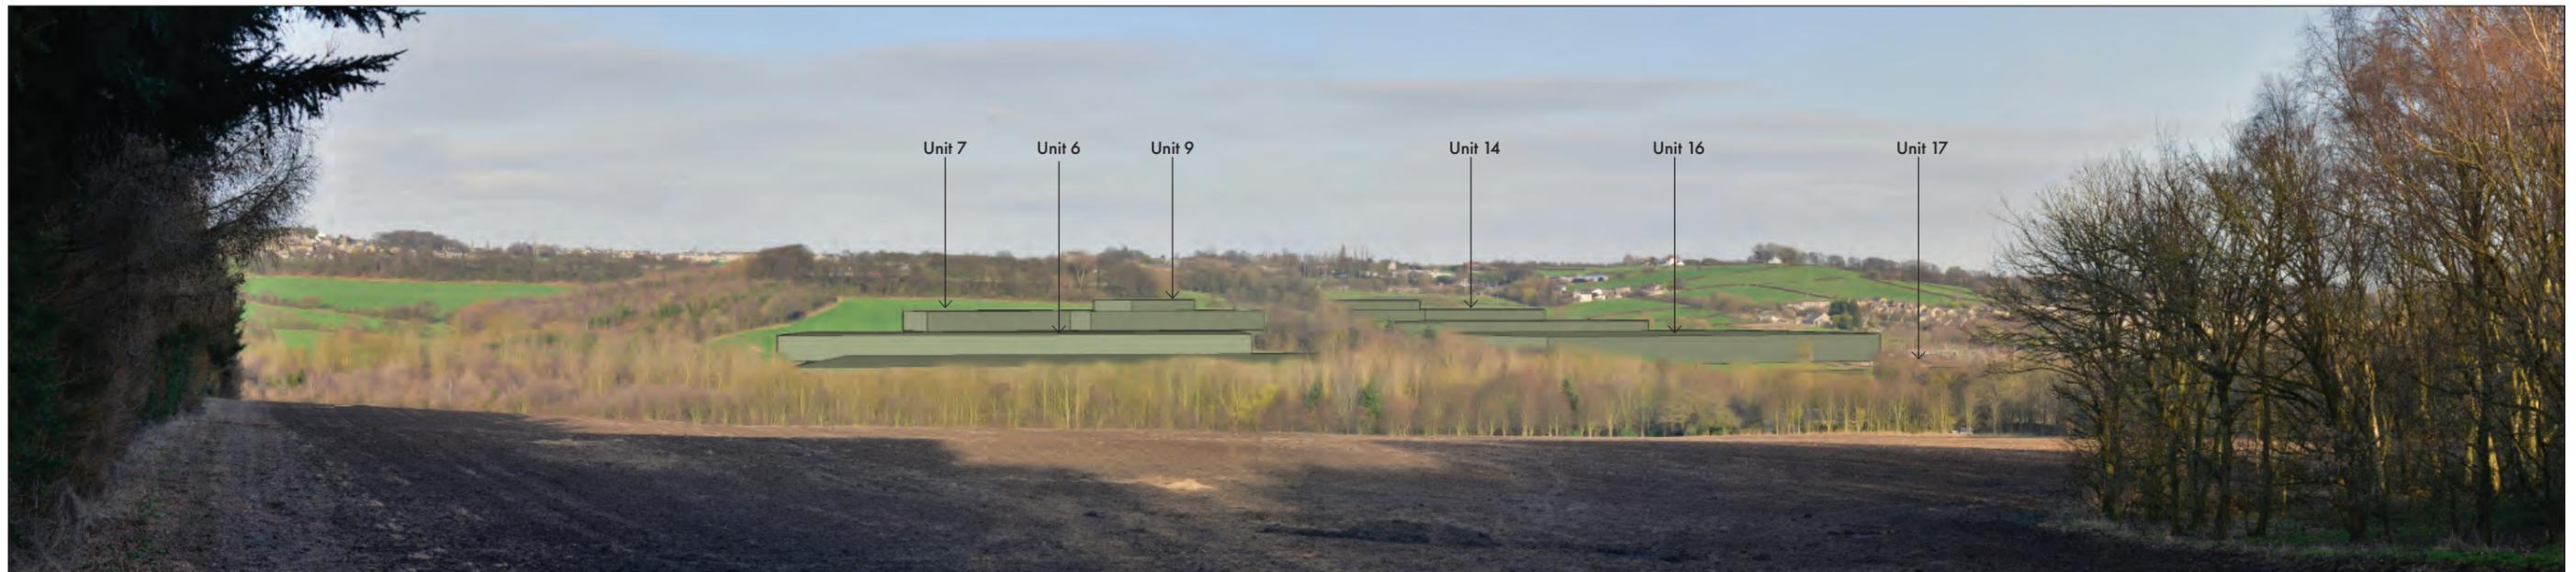
## Viewpoint 3: Within Kirklees Park, South West of Hall, in field corner Existing and Proposed Photomontages - Year 1

Existing Situation

Proposed Photomontage (Year 1)

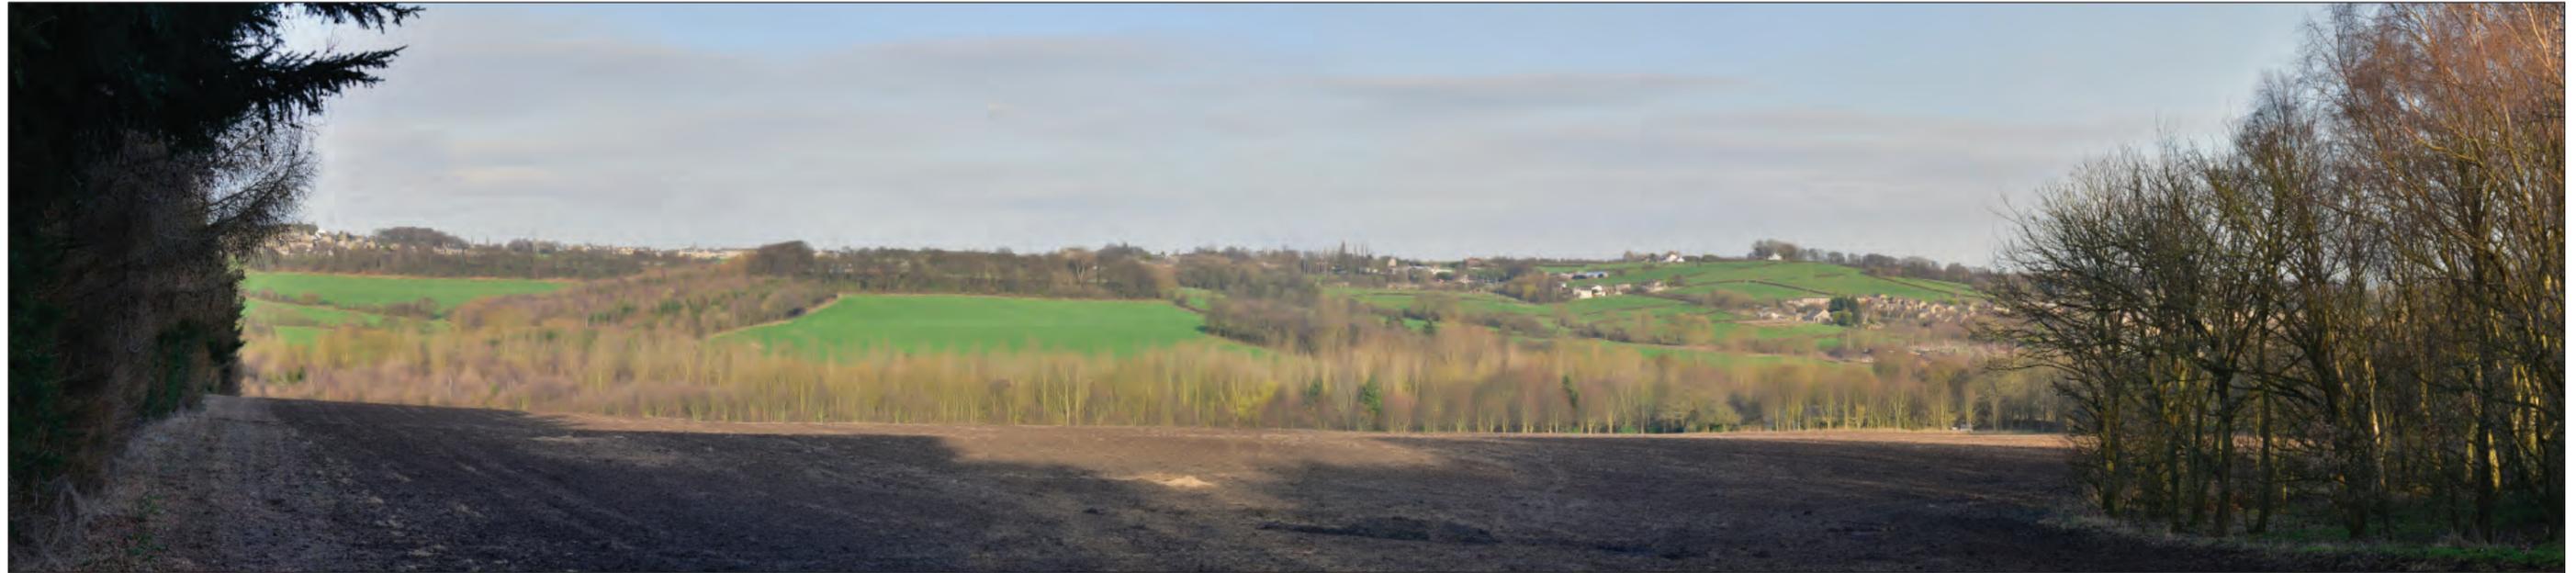
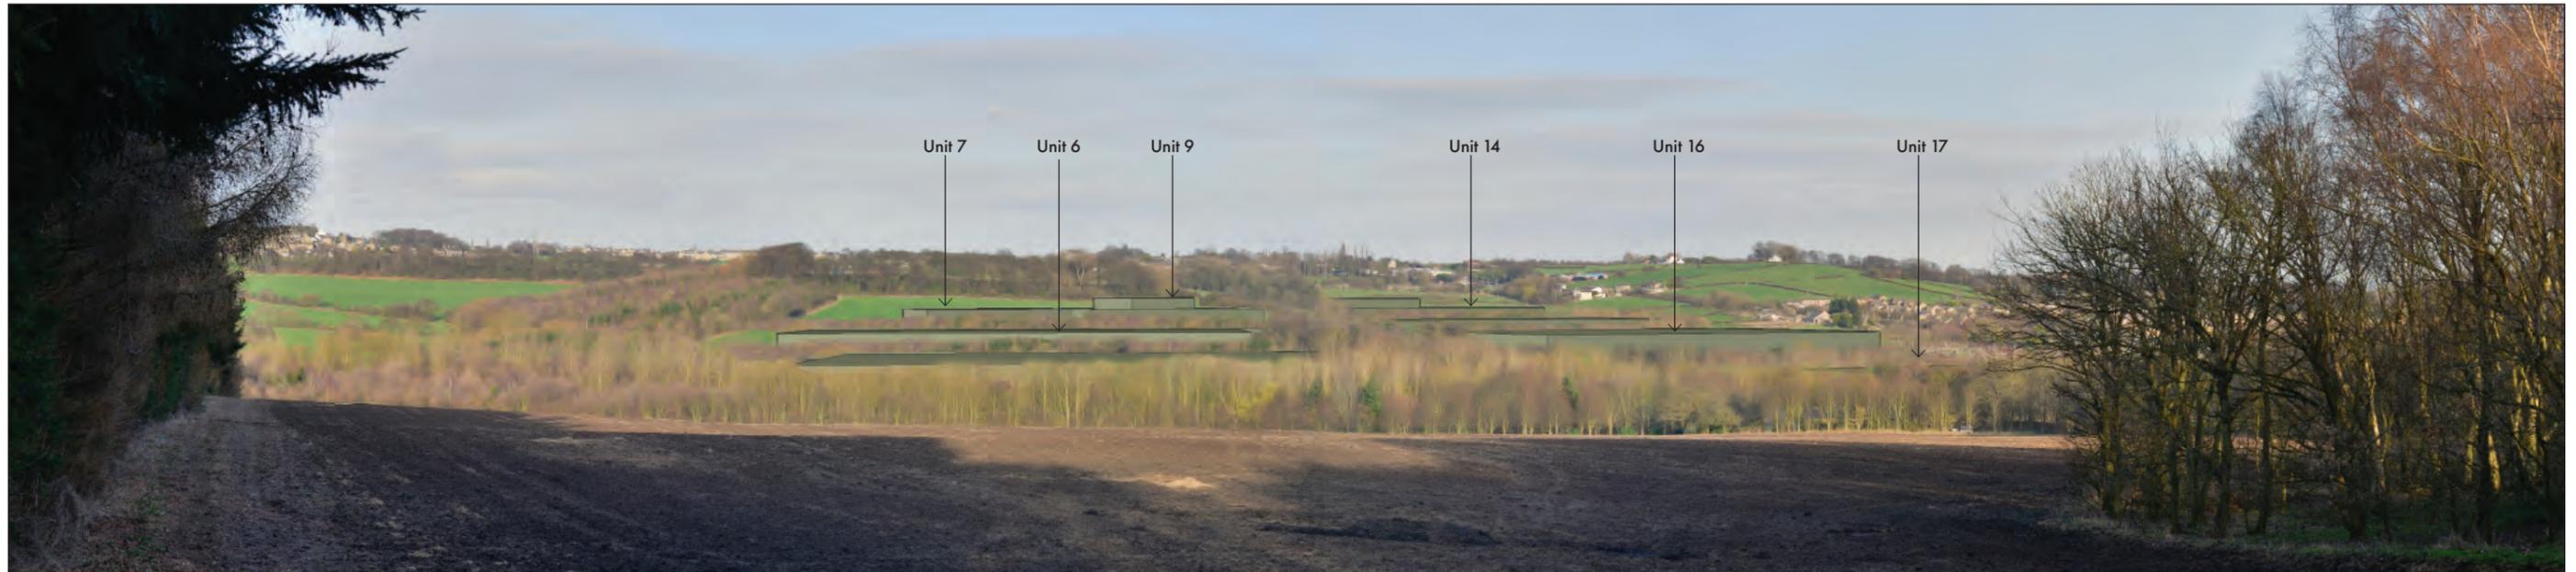
## Viewpoint 3: Within Kirklees Park, South West of Hall, in field corner Existing and Proposed Photomontages - Year 10

Existing Situation

Proposed Photomontage (Year 10)

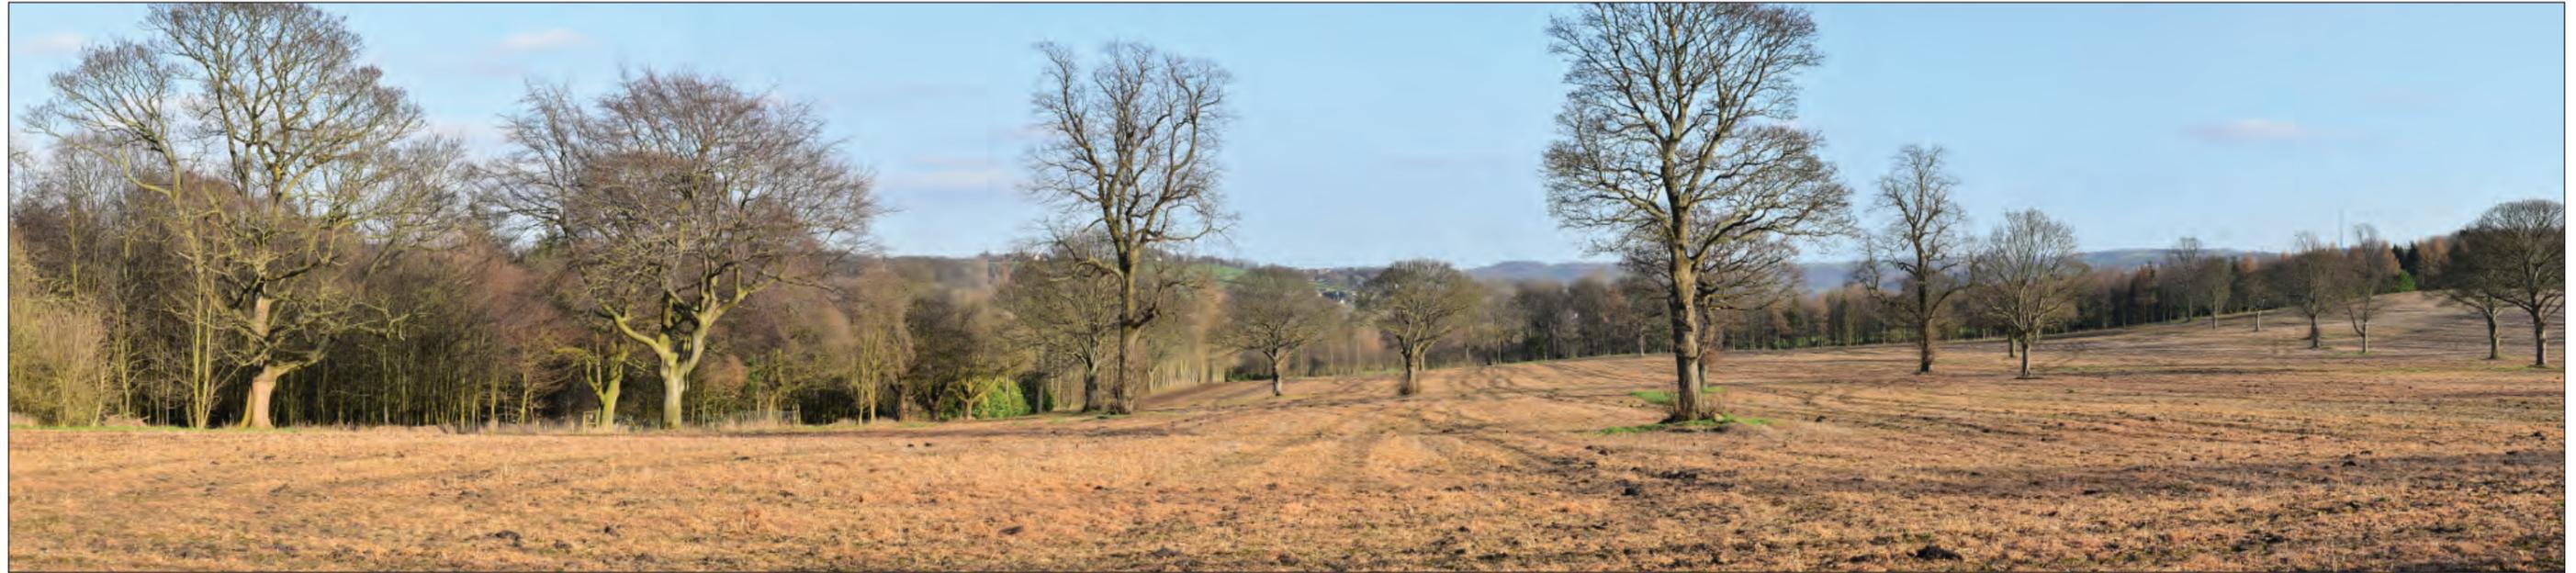
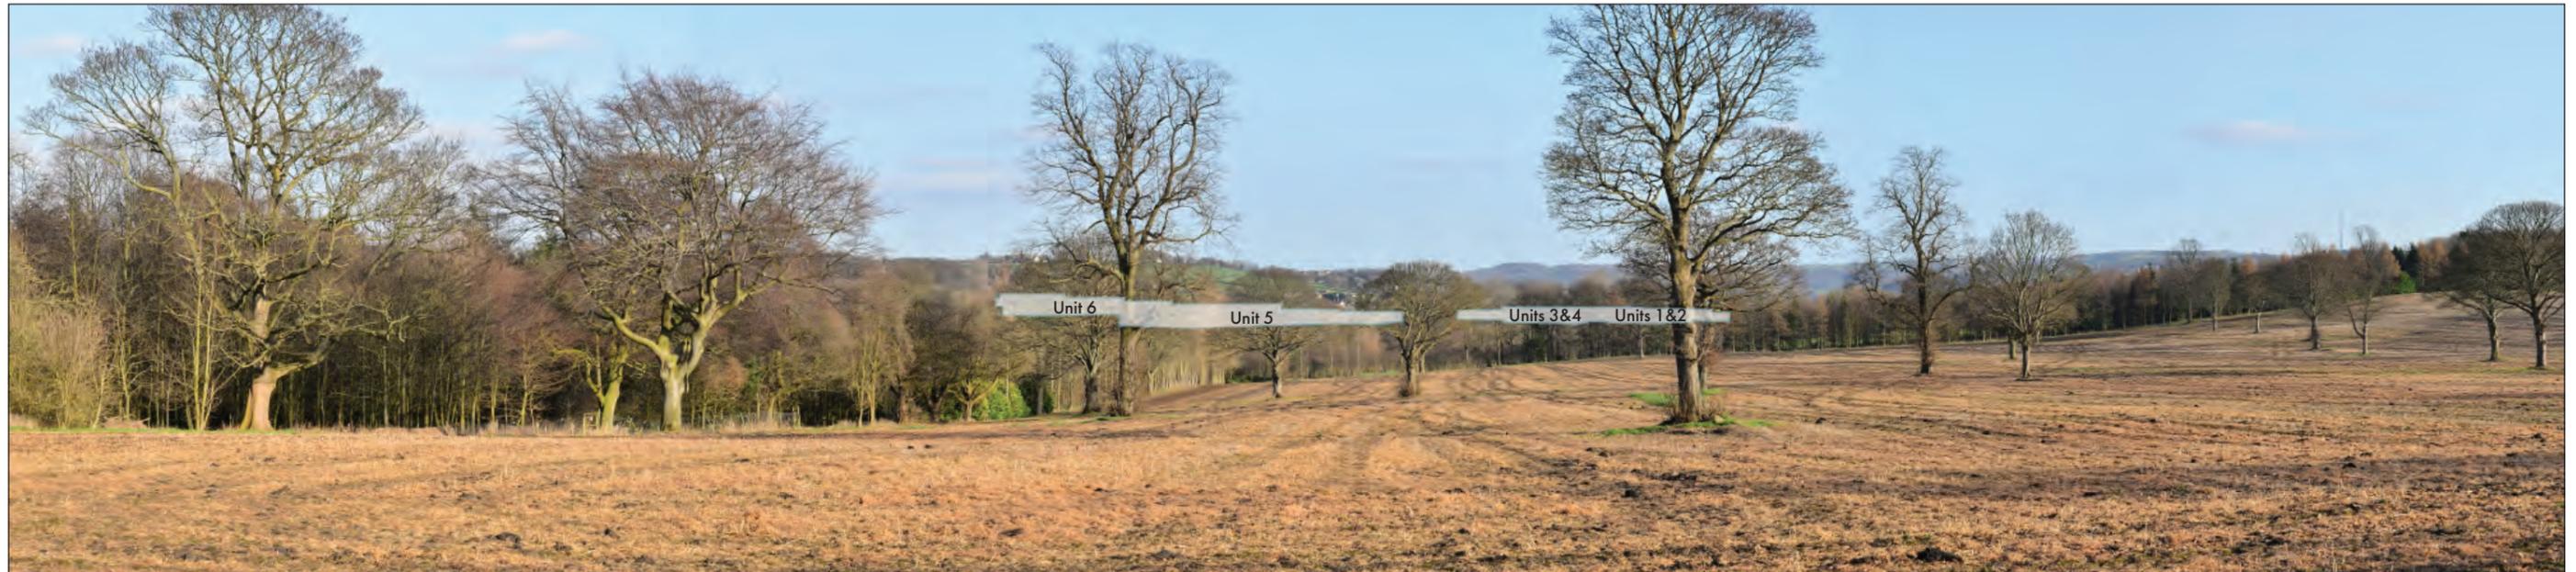
## Viewpoint 4: Kirklees Hall, in front of the house, at ground floor level Existing and Proposed Photomontages

Existing Situation

Proposed Photomontage (Year 1)

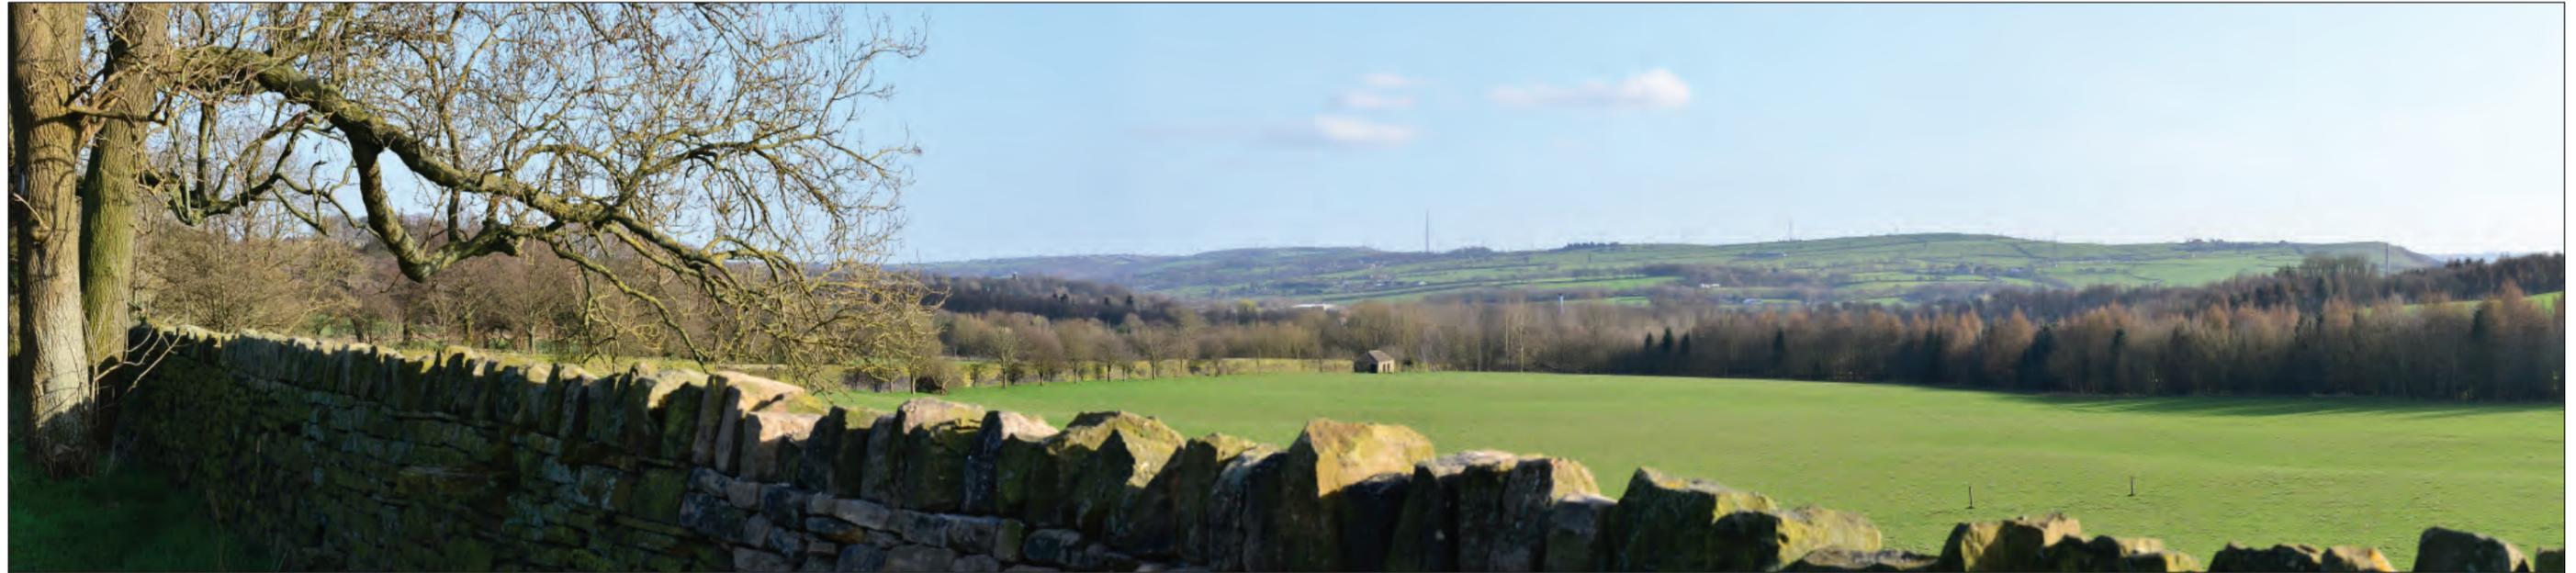
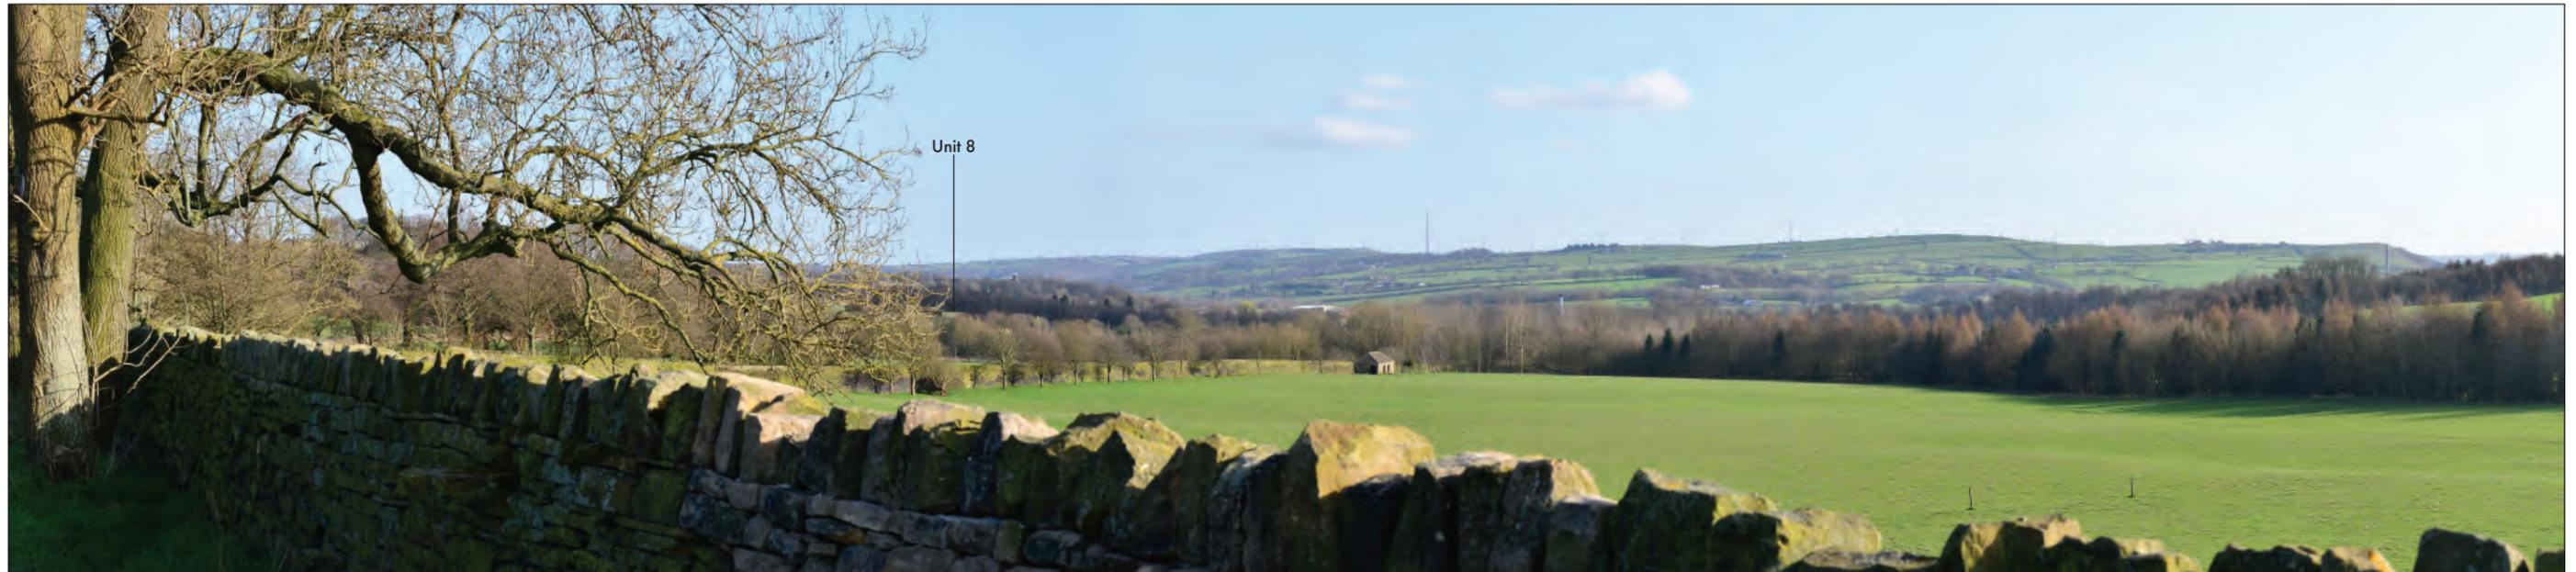
## Viewpoint 5: Within Kirklees Park, on track, North East of Home Farm Existing and Proposed Photomontages - Year 1

Existing Situation

Proposed Photomontage (Year 1)

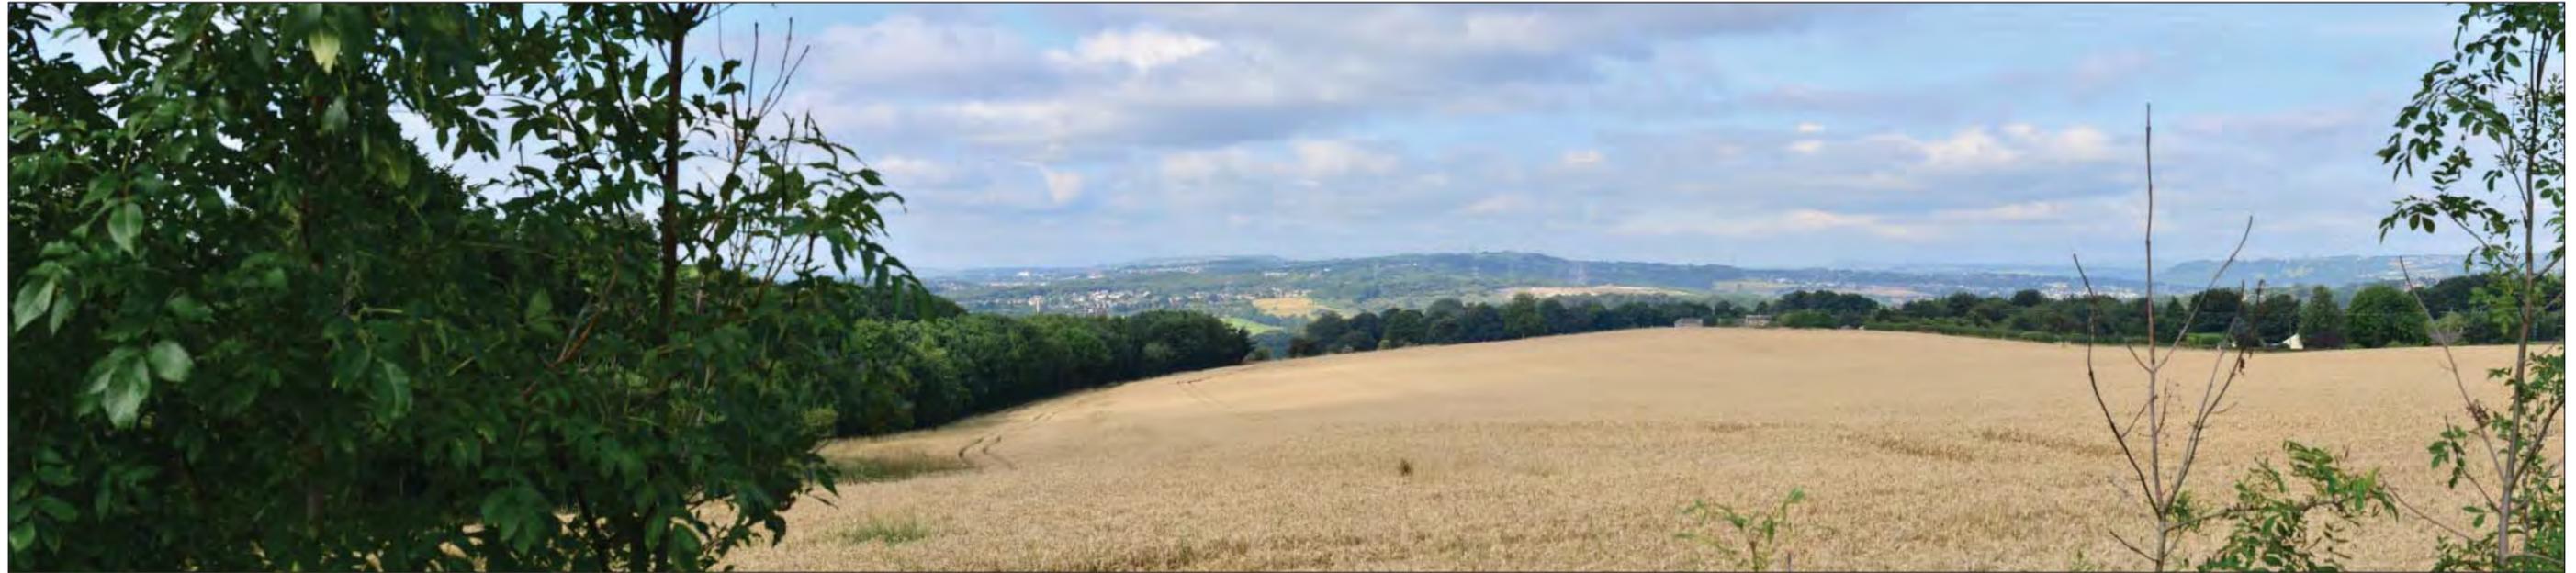
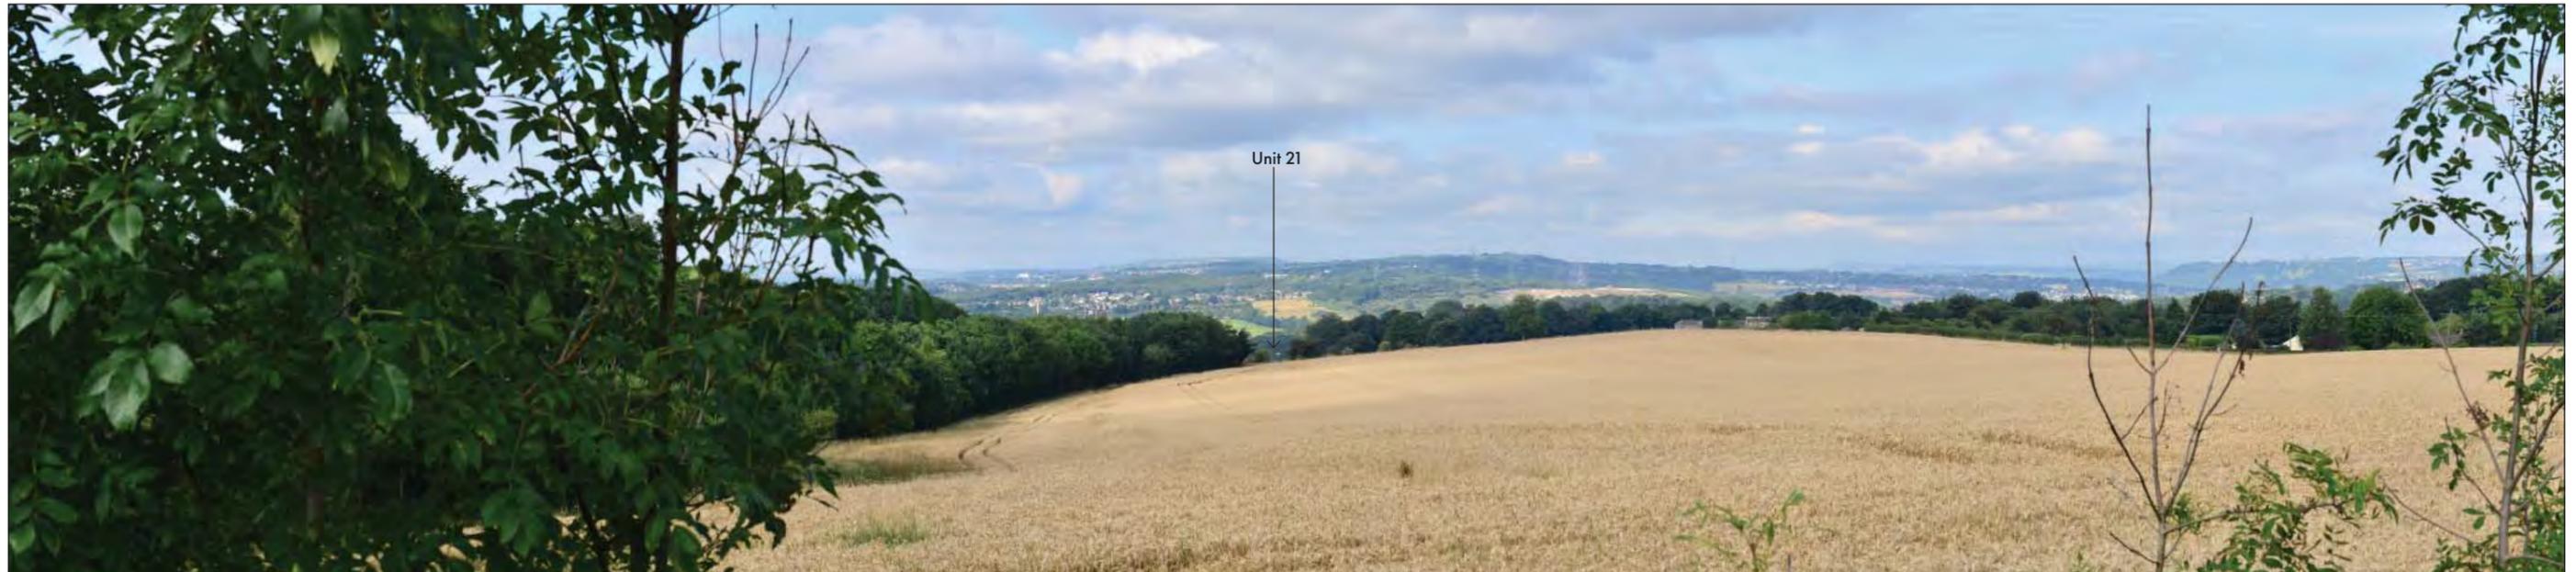
## Viewpoint 7: Fall Lane – Opposite Haigs Farm Shop on the road verge Existing and Proposed Photomontage - Year 1

Existing Situation

Proposed Photomontage (Year 1)
