# **Heritage Overview Report**

Cooper Bridge Strategic Employment Site

January 2018

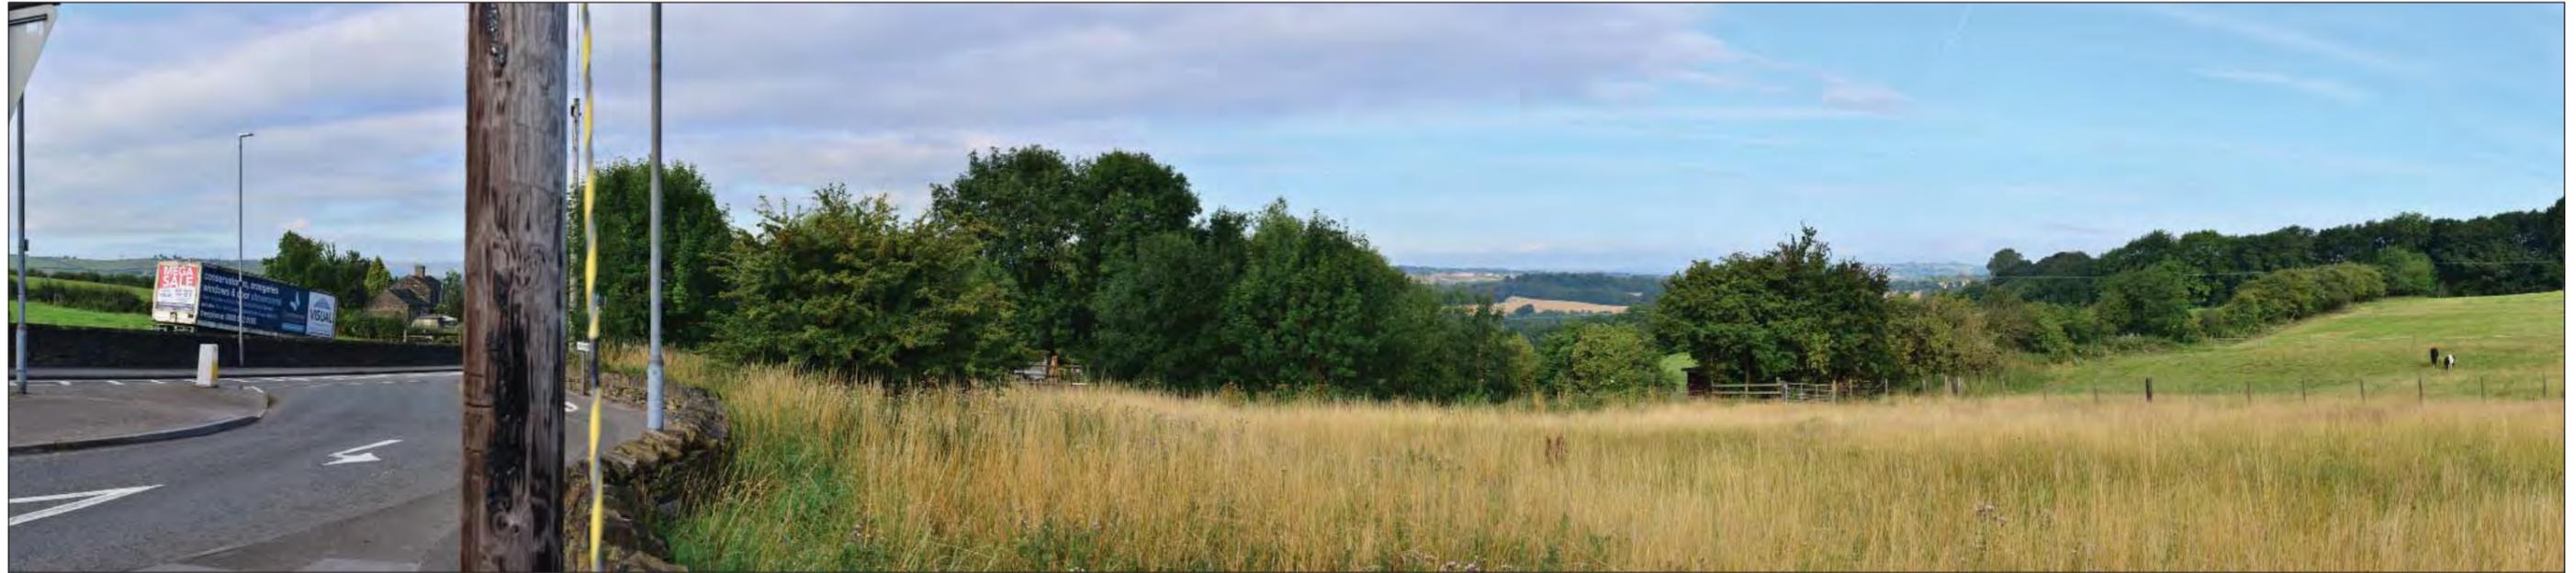
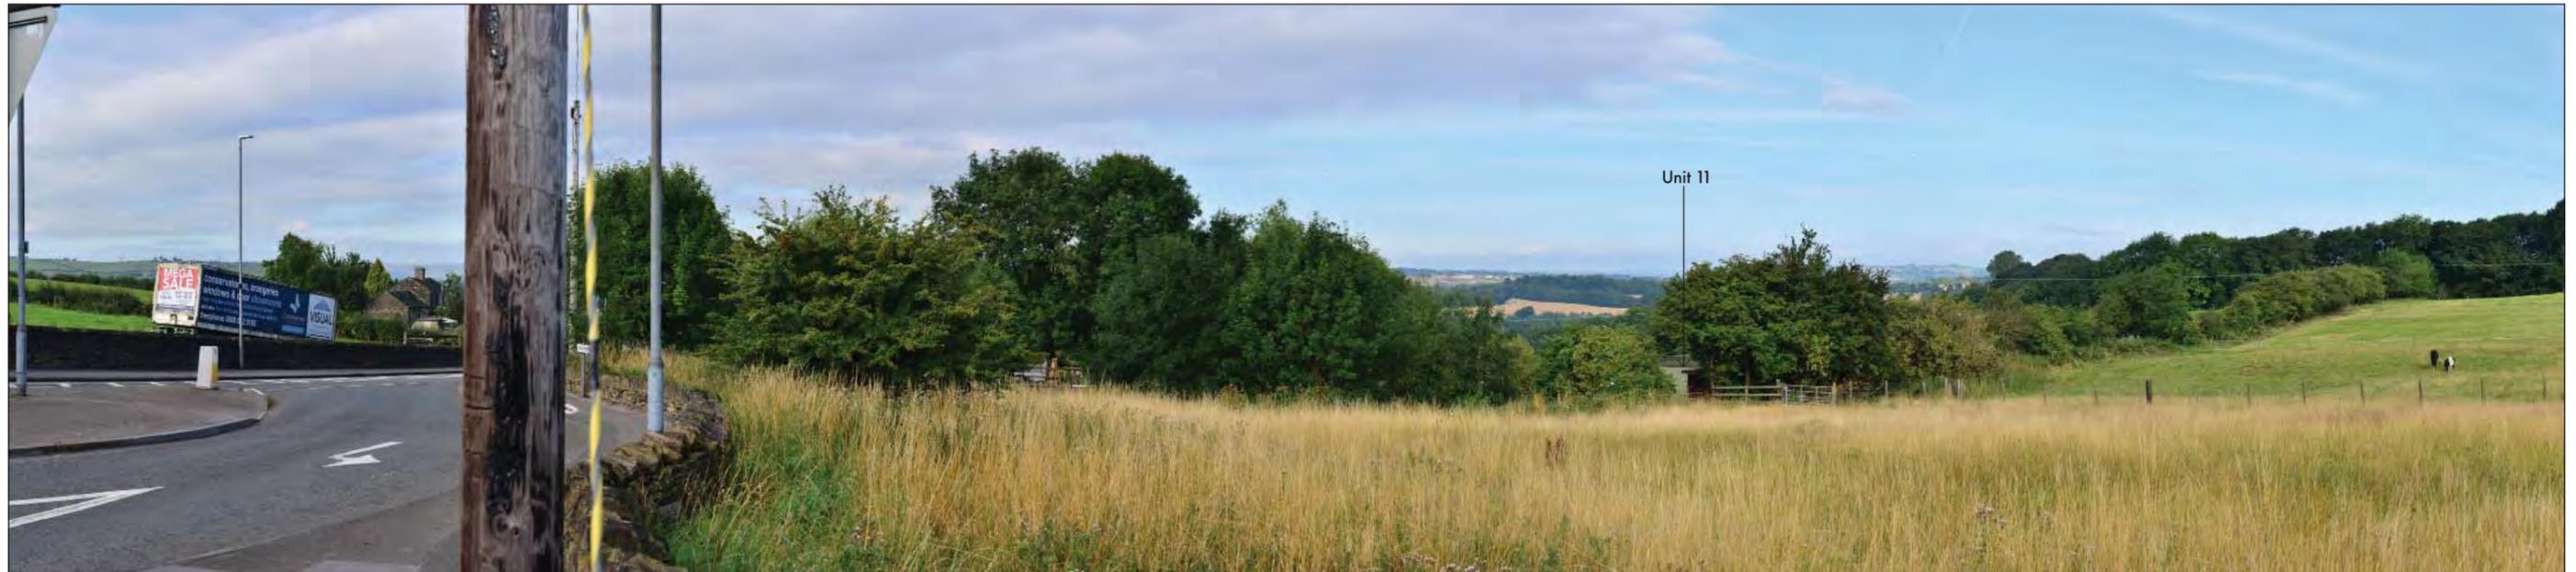
## Viewpoint 8: Southern end of Farcommon Road, opposite pub car park Existing and Proposed Photomontage - Year 1

Existing Situation

Proposed Photomontage (Year 1)

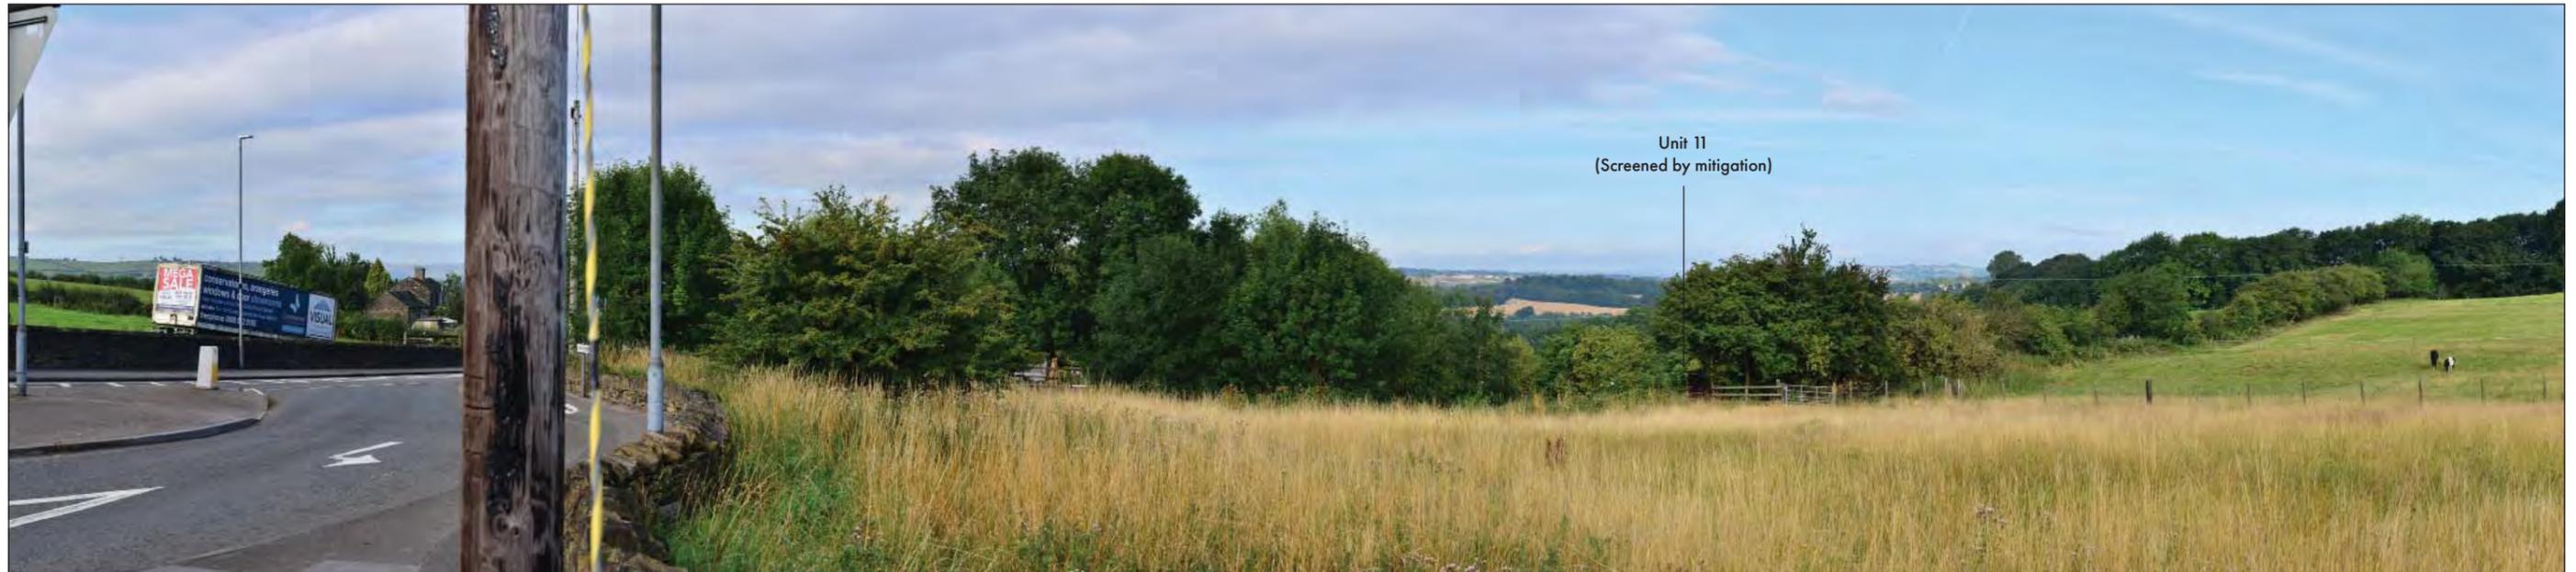
Proposed Photomontage (Year 10)

Grid Reference	418982E 421563N
Ground Height	98.6m AOD
Viewer Height	1.55m
Included Angle	120°
Distance to Proposed Development	376m
Viewing Distance	945m
Camera Used	Nikon D610 Full Frame SLR 50mm Fixed Lens

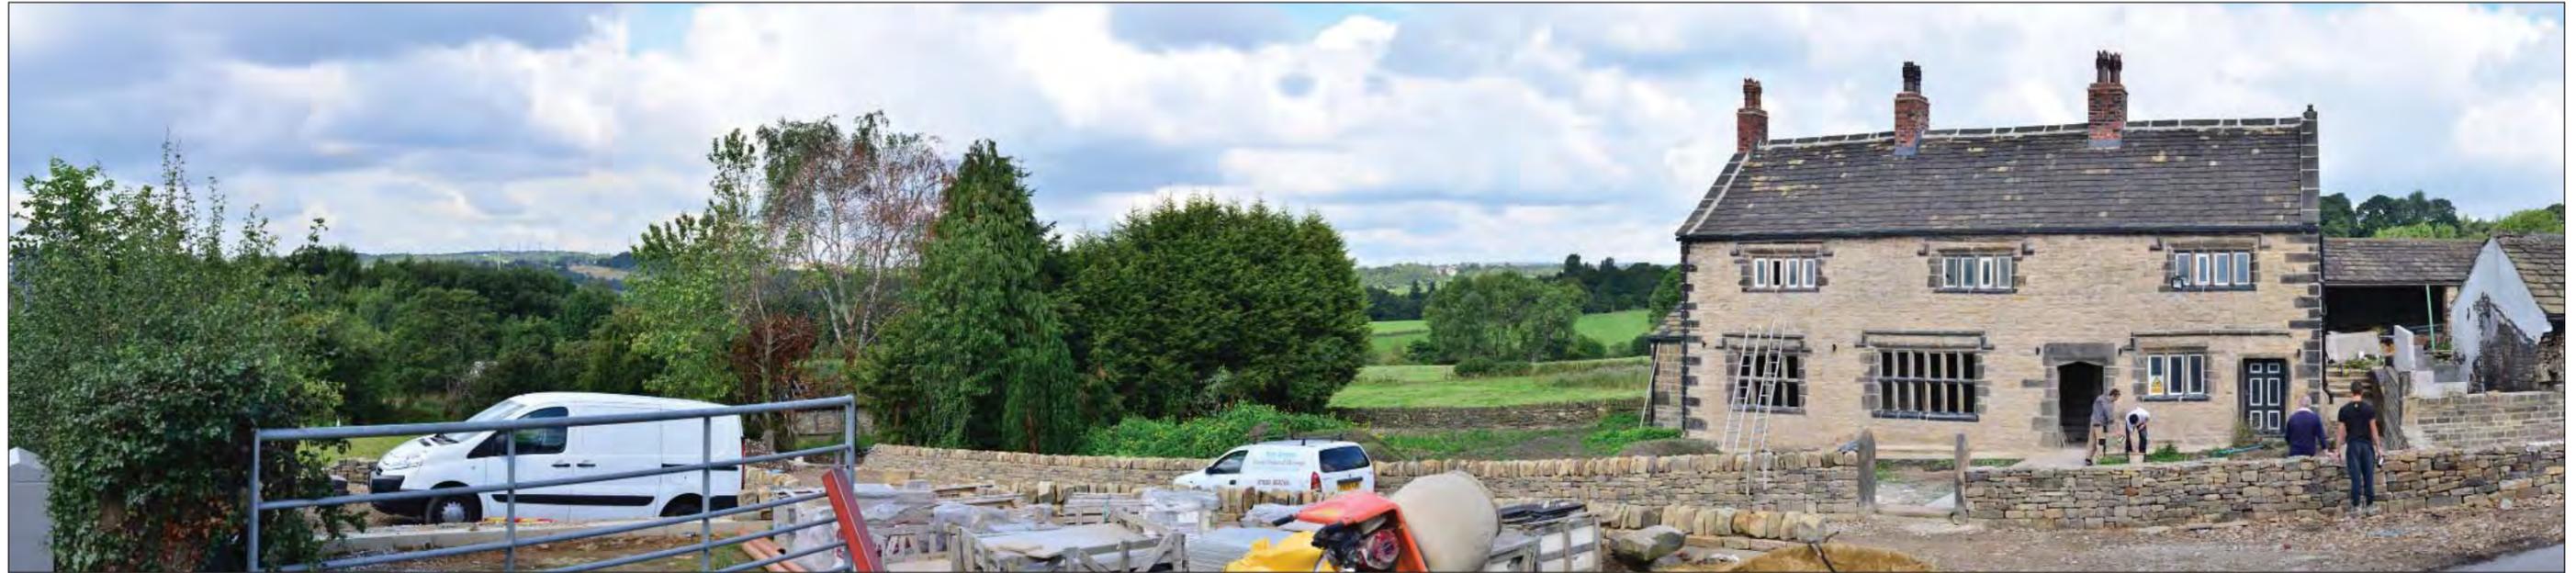
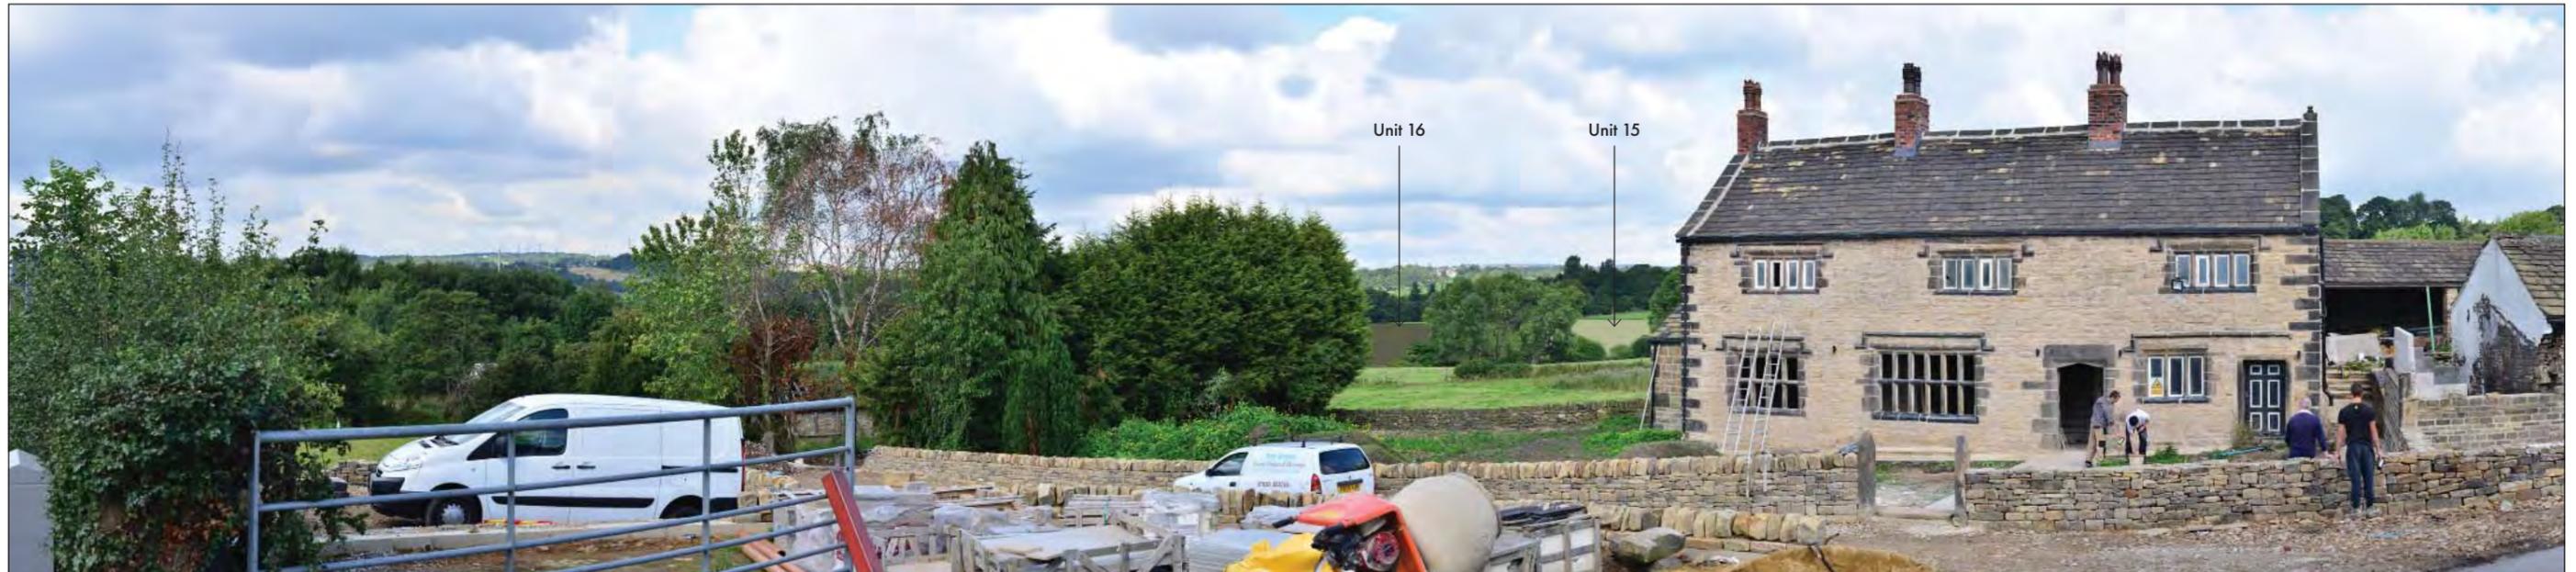
## Viewpoint 9: Entrance to Mock Hall Farm Existing and Proposed Photomontage - Year 1

Existing Situation

Proposed Photomontage (Year 1)

Grid Reference	418663E 421319N
Ground Height	75.4m AOD
Viewer Height	1.55m
Included Angle	120°
Distance to Proposed Development	222m
Viewing Distance	945mm
Camera Used	Nikon D610 Full Frame SLR 50mm Fixed Lens

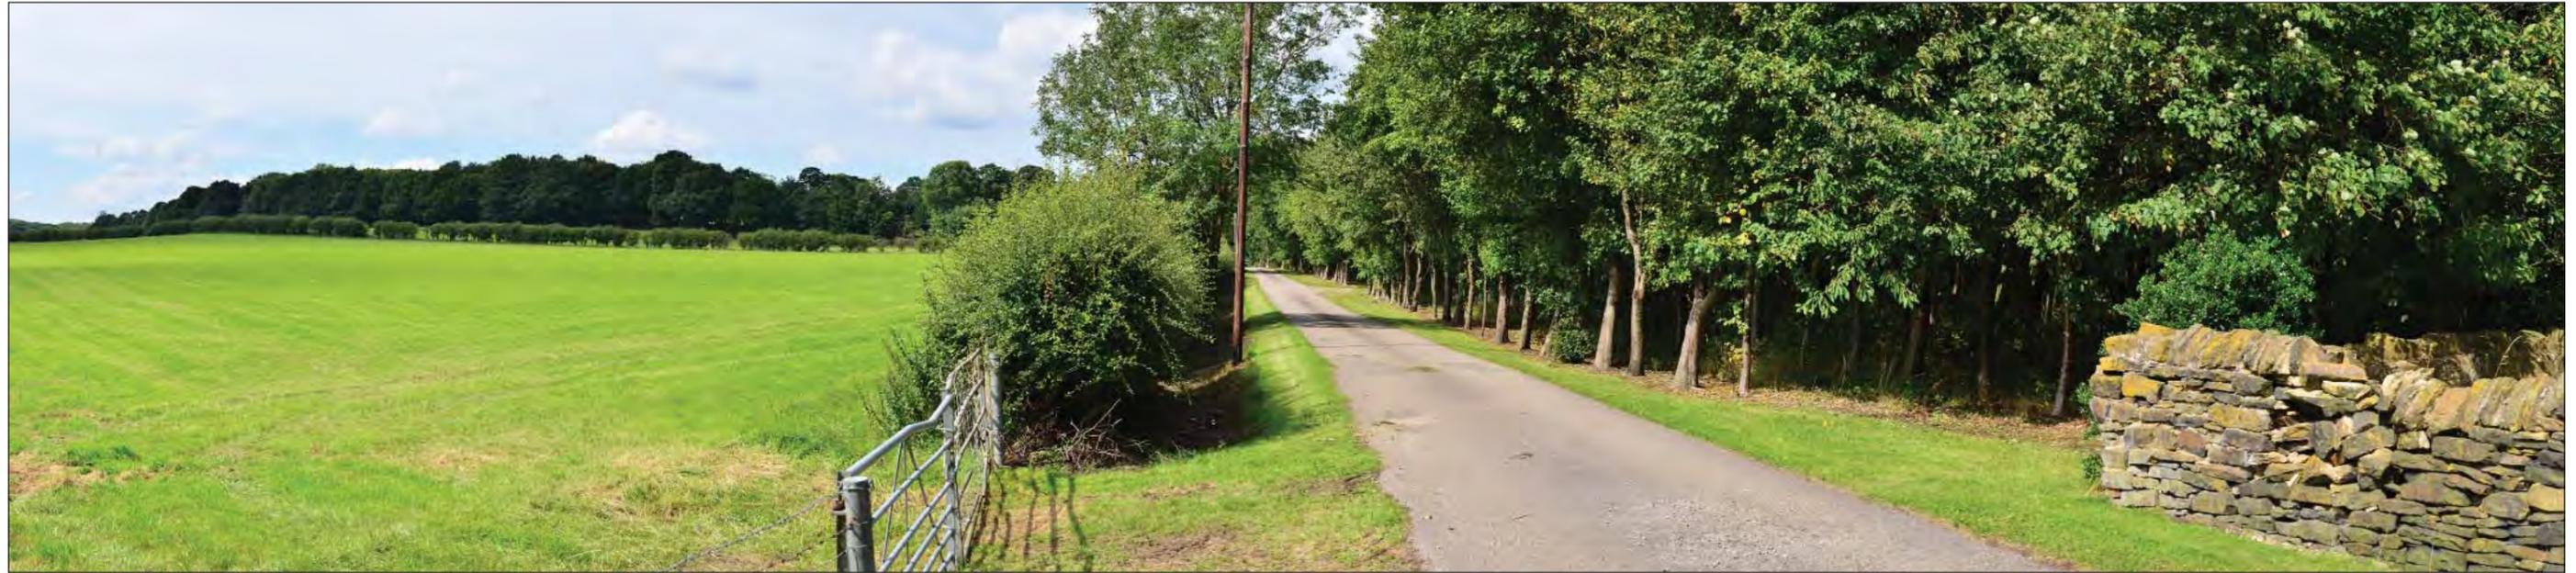
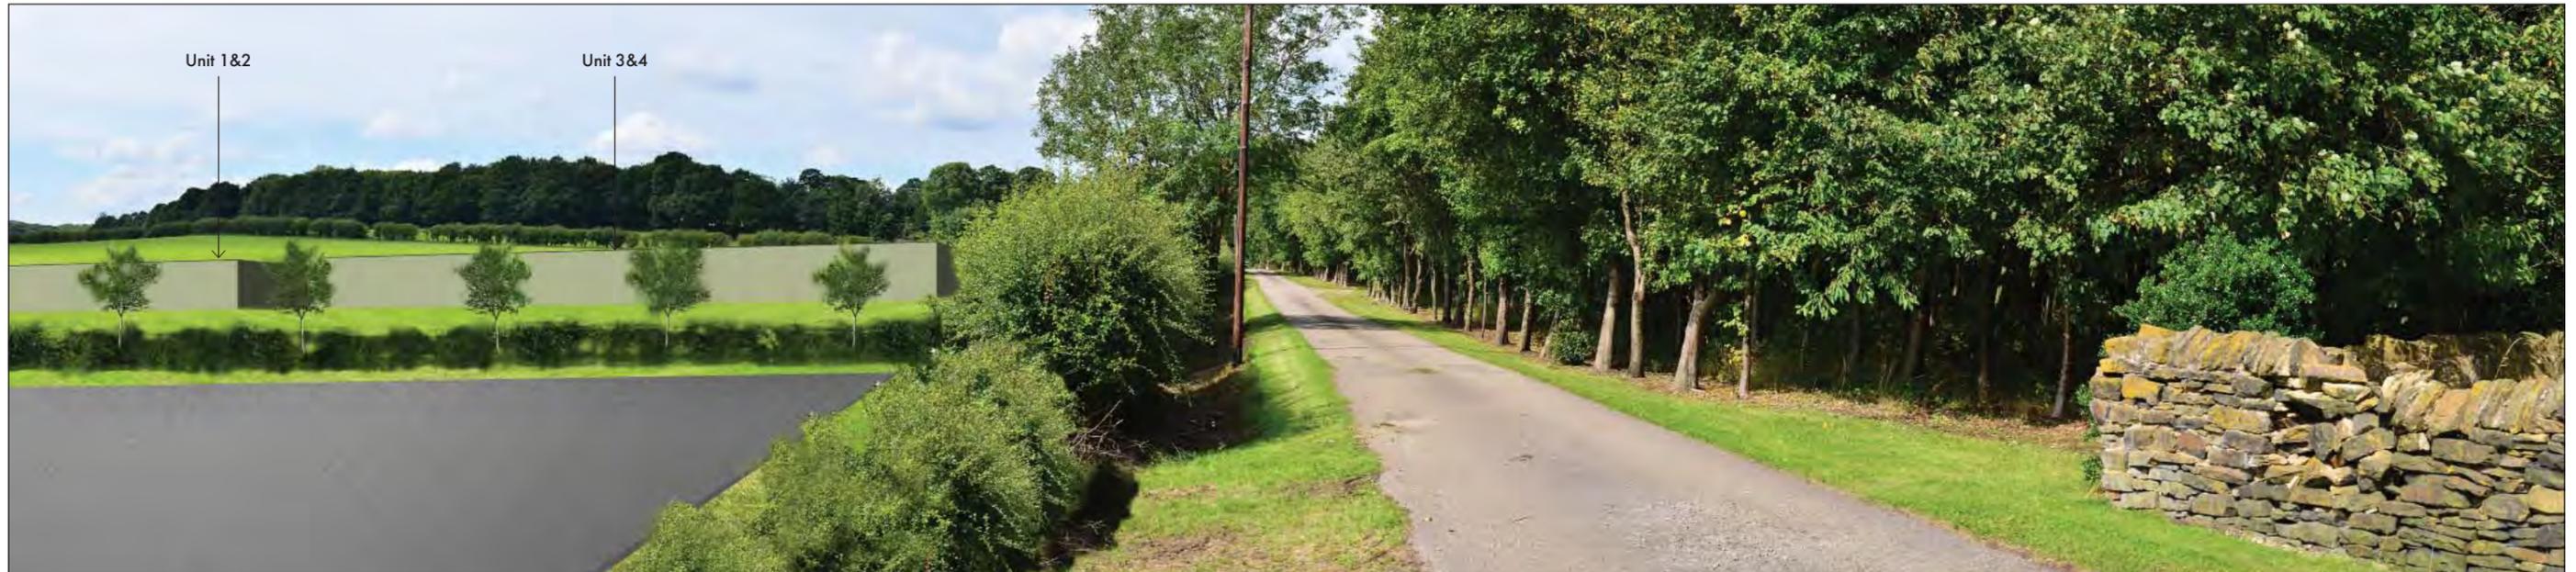
## Viewpoint 10: Entrance Driveway Existing and Proposed Photomontage - Year 1

Existing Situation

Proposed Photomontage (Year 1)

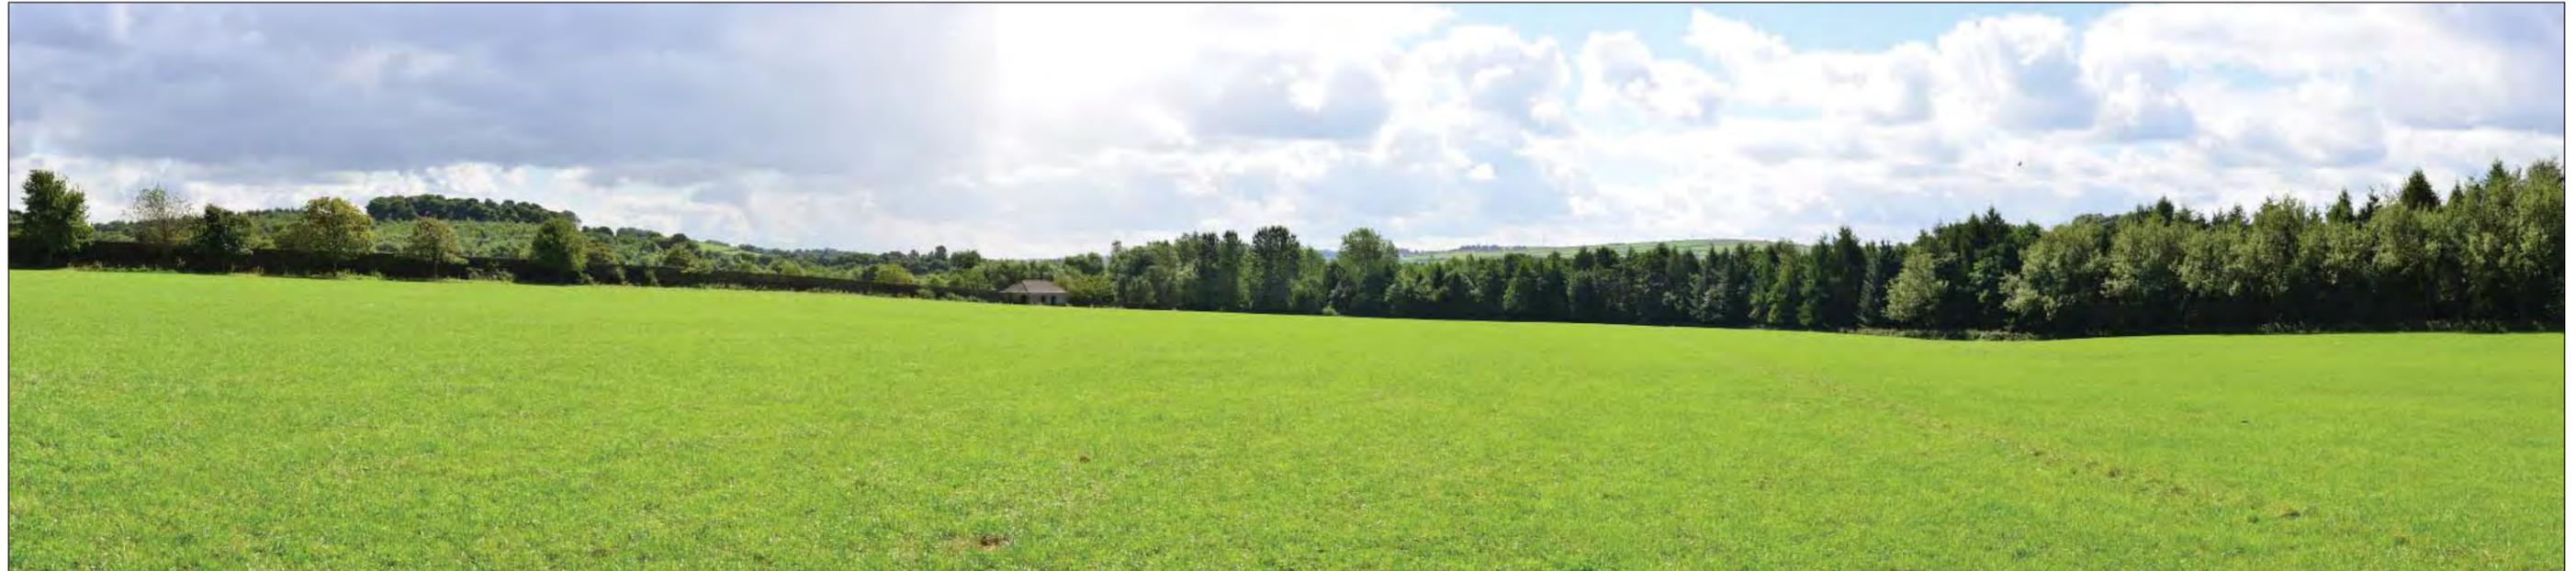
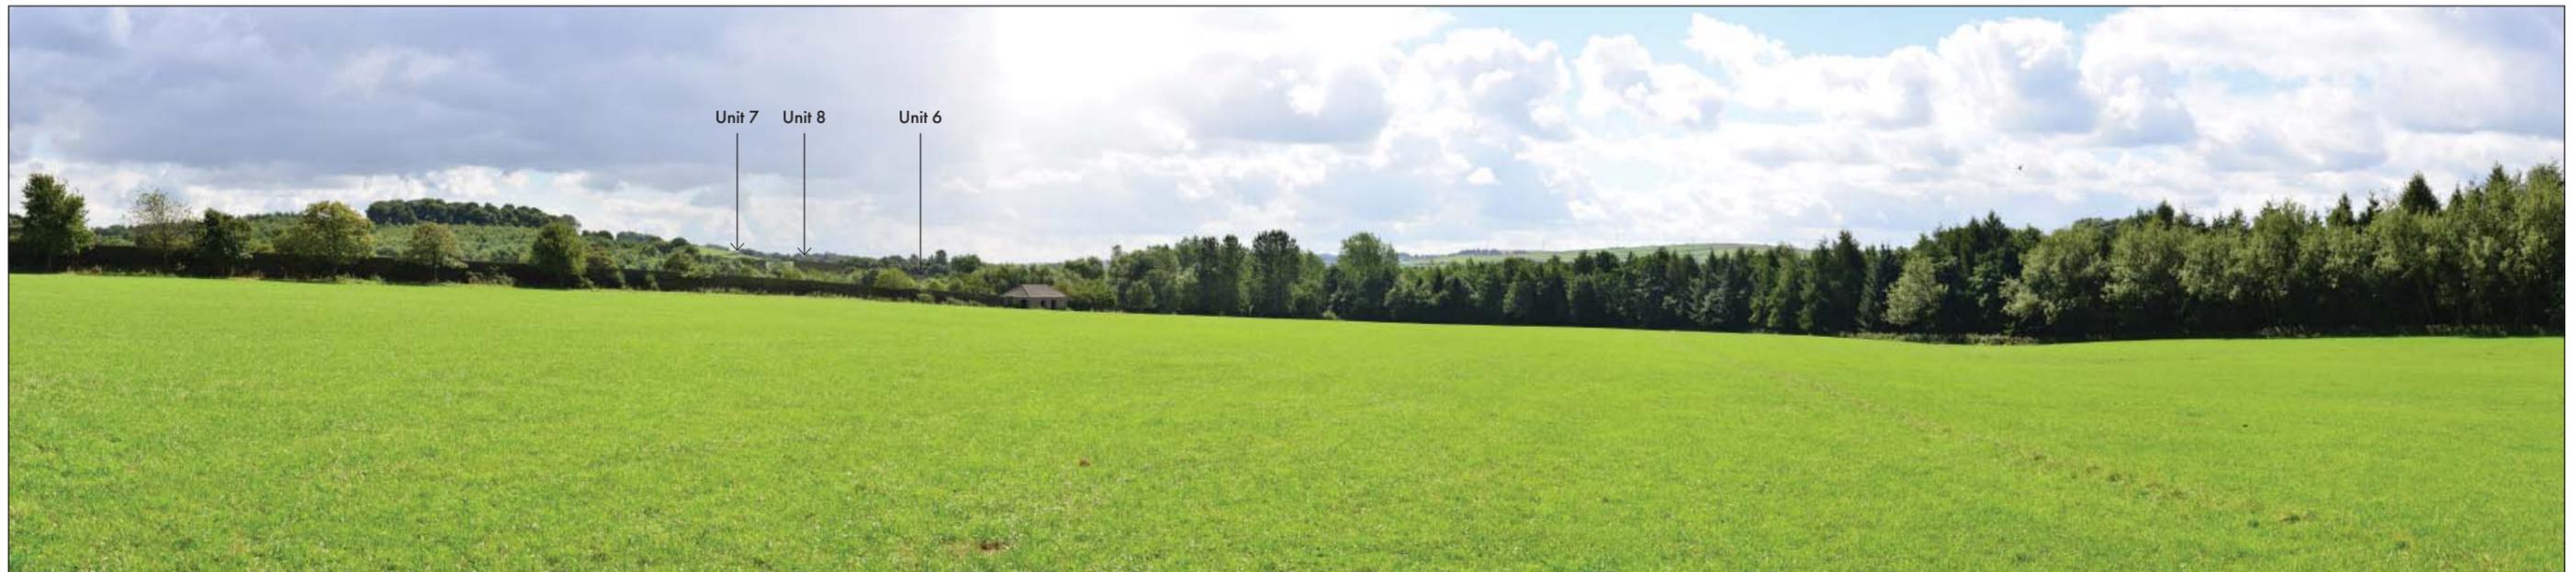
## Viewpoint 12: Deer Park Field Existing and Proposed Photomontage - Year 1

Existing Situation

Proposed Photomontage (Year 1)

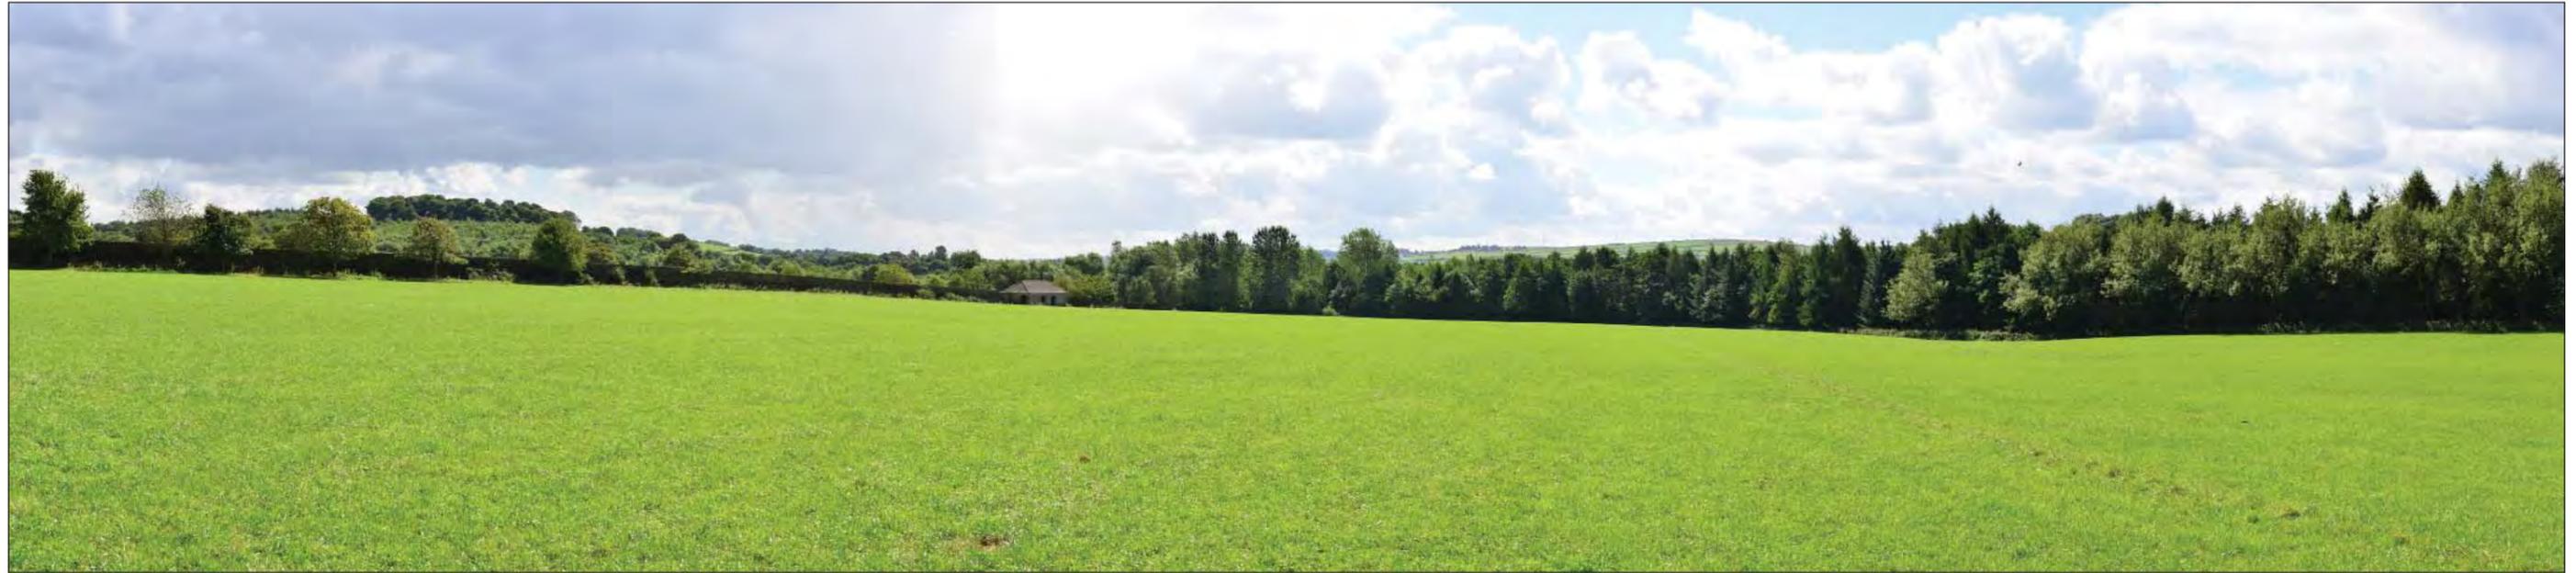
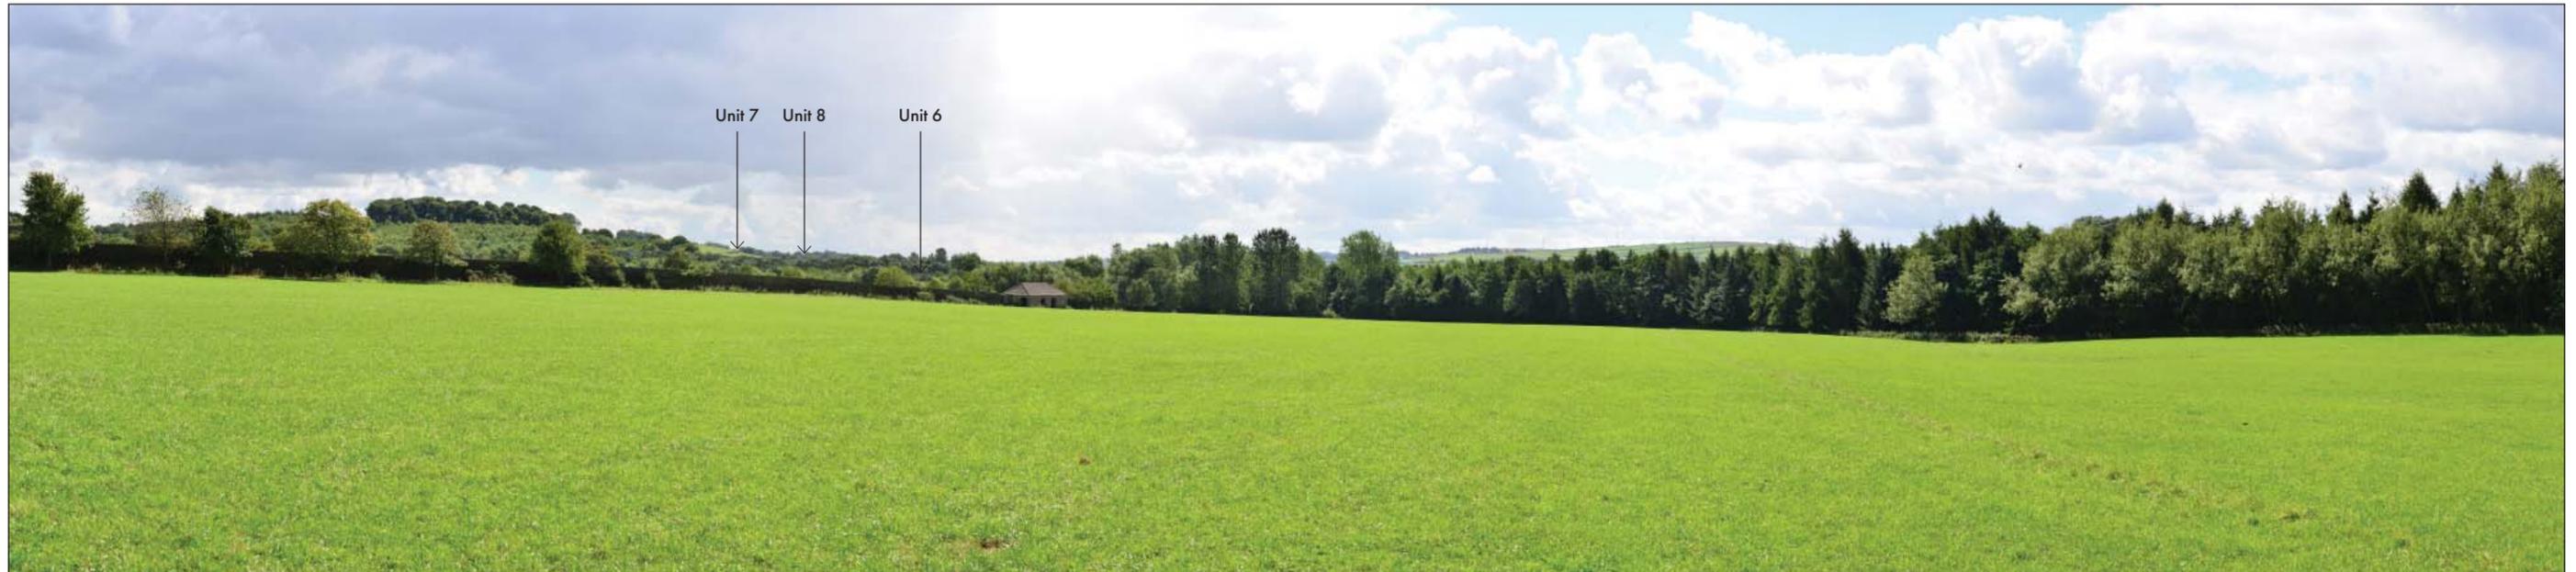
## Viewpoint 12: Deer Park Field Existing and Proposed Photomontage - Year 10

Existing Situation

Proposed Photomontage (Year 10)

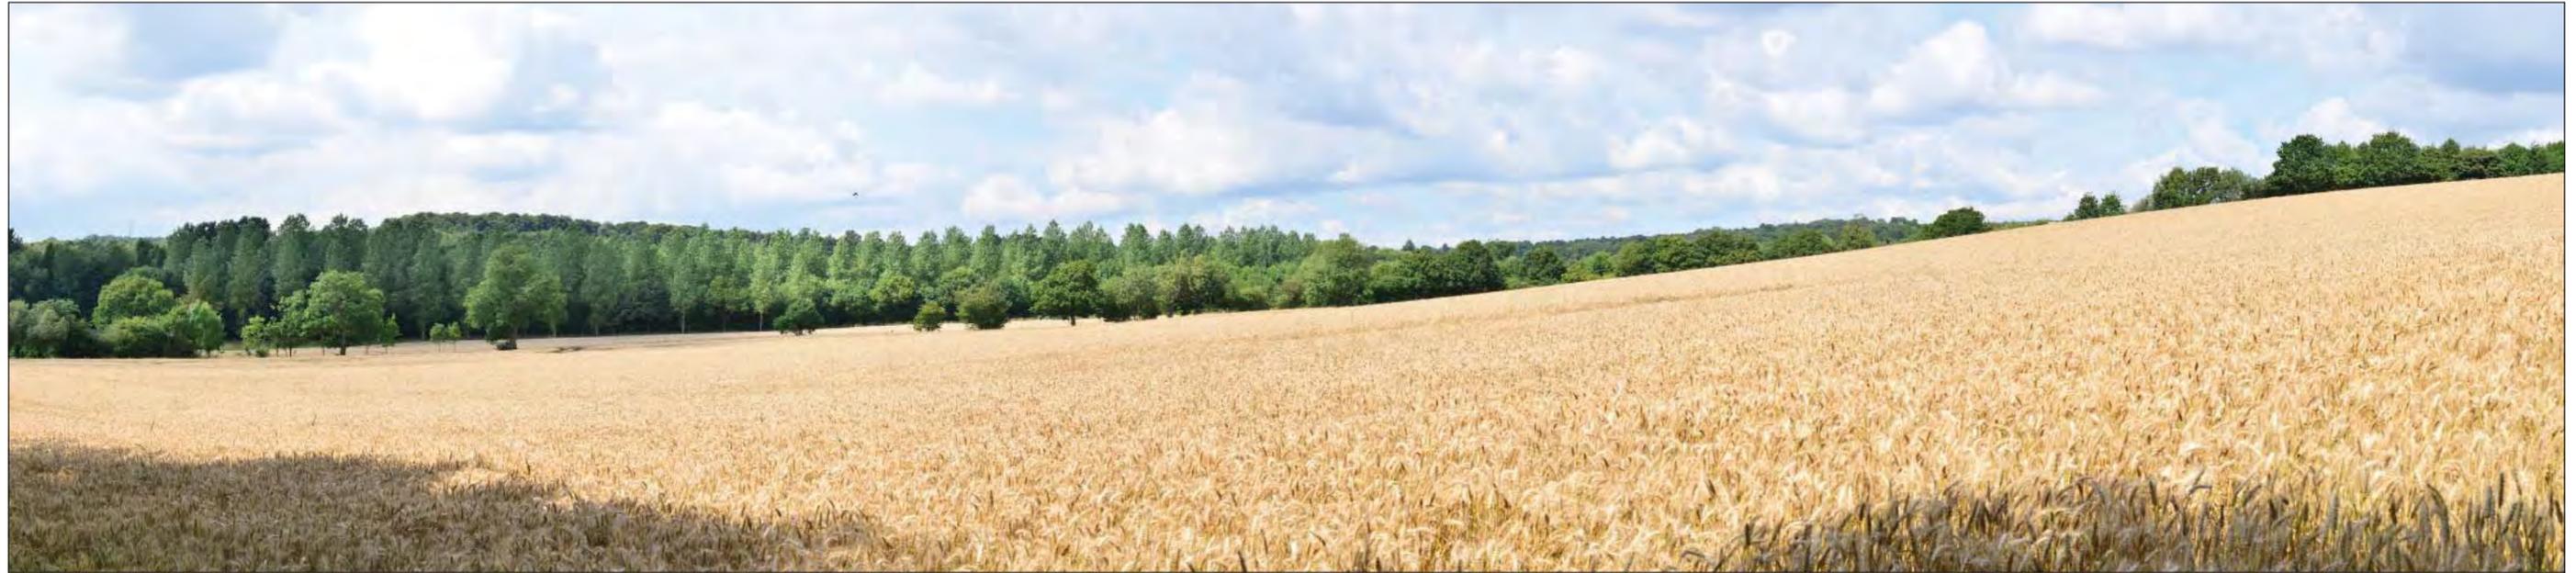
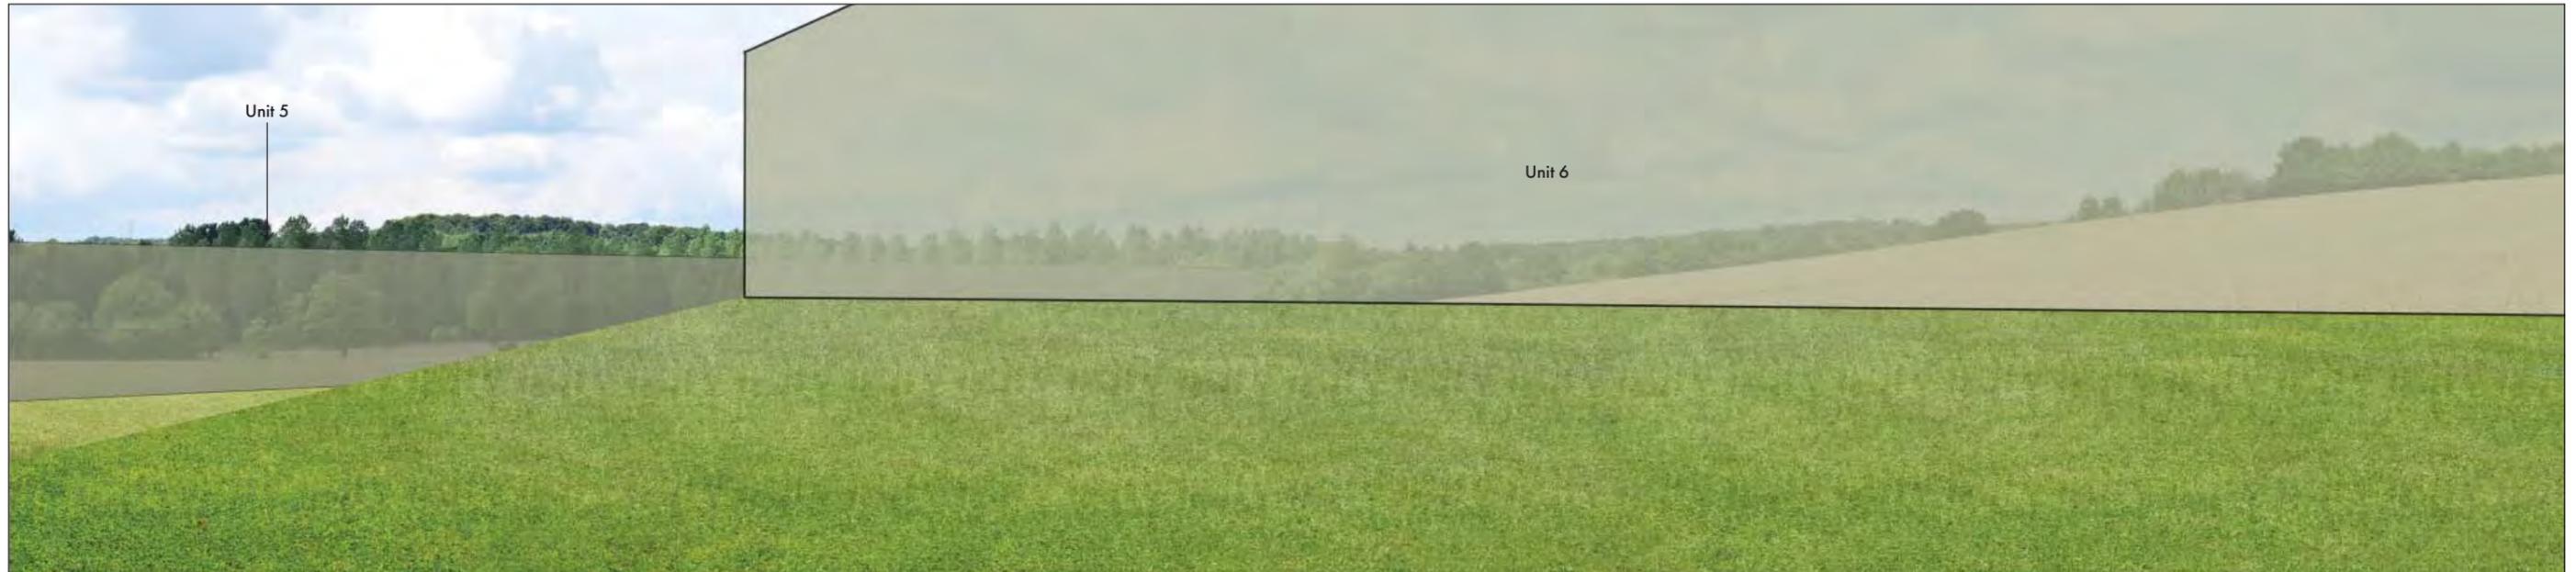
## Viewpoint 13: North side of Brook Shrogg Wood looking towards Kirklees Hall Existing and Proposed Photomontage - Year 1

Existing Situation

Proposed Photomontage (Year 1)

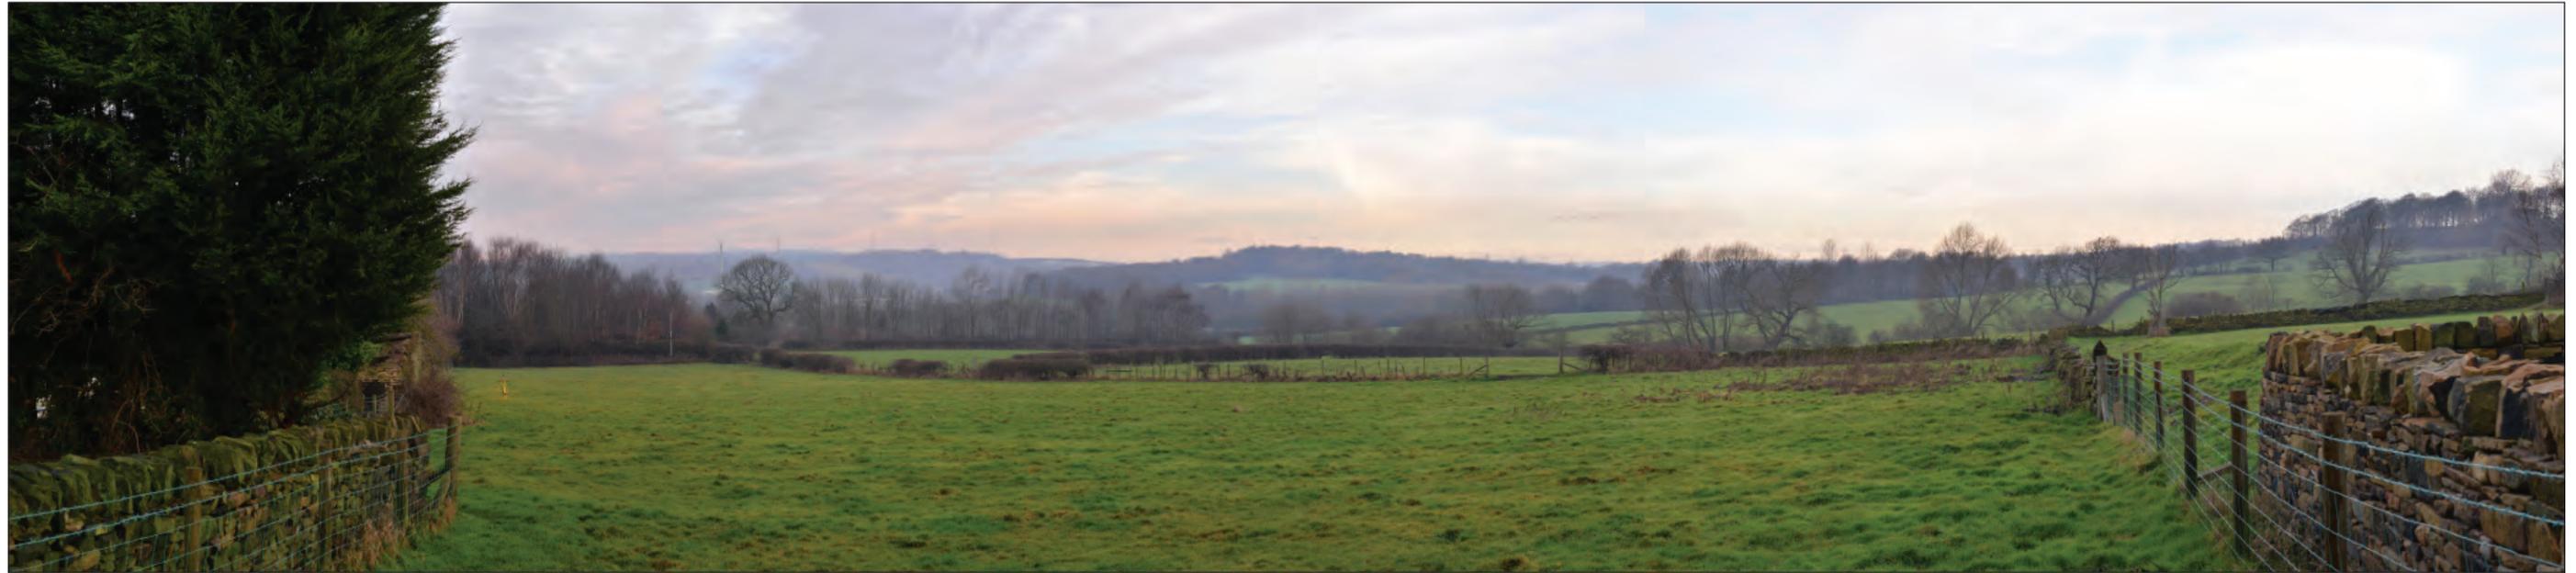
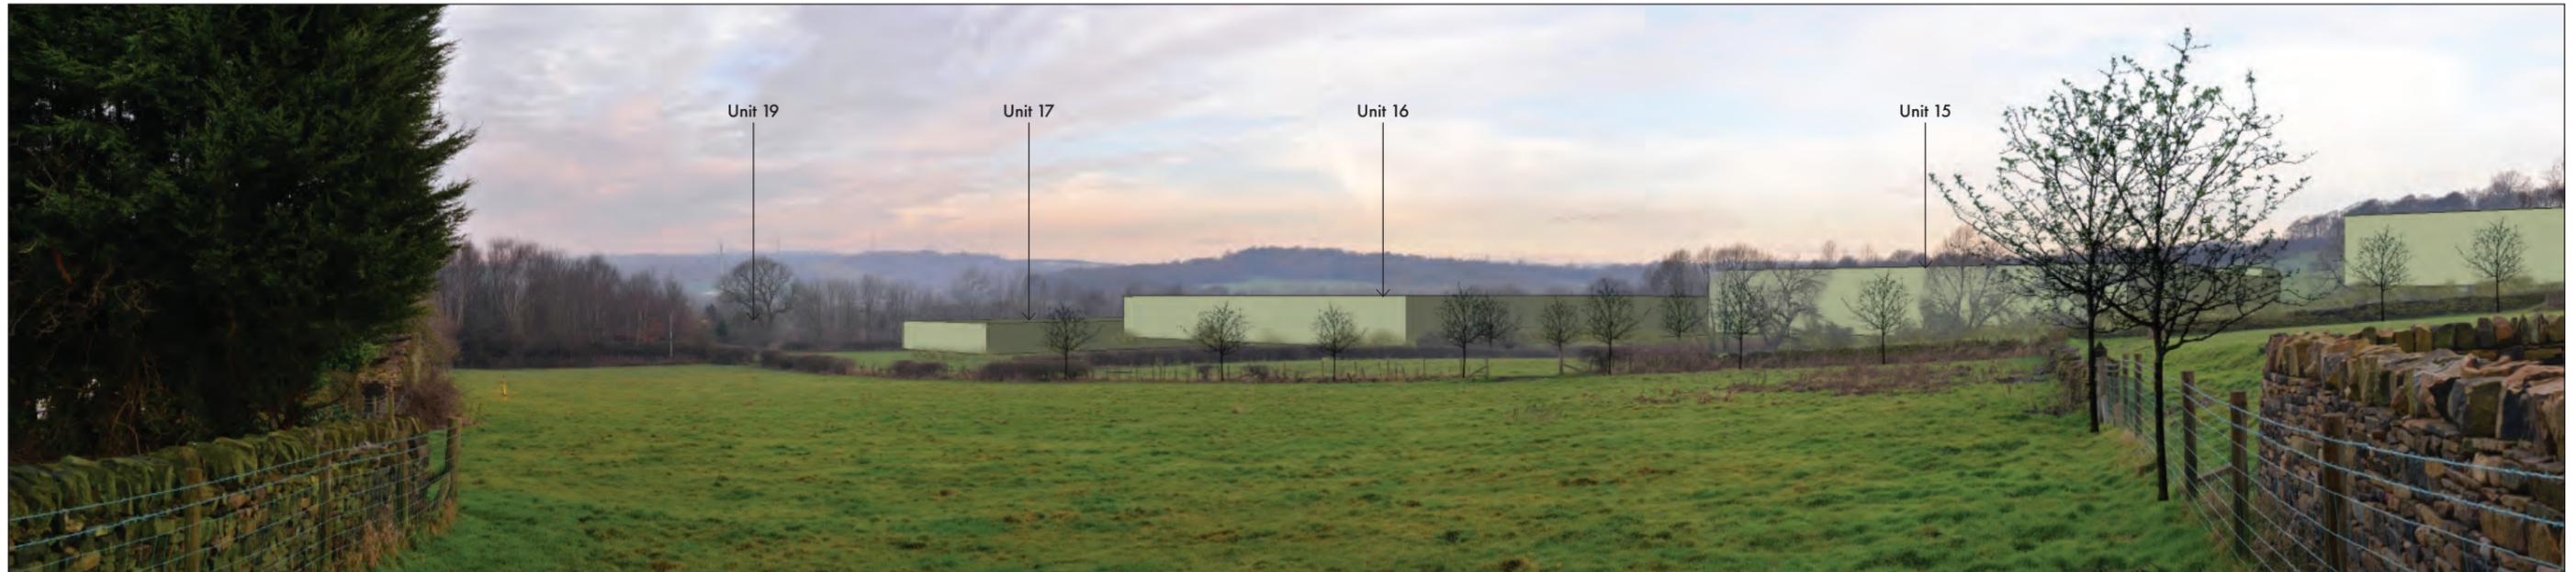
## Viewpoint 14: Private land to rear of Mock Hall, Listed Building Existing and Proposed Photomontage - Year 1

Existing Situation

Proposed Photomontage (Year 1)
