# **Heritage Overview Report**

Cooper Bridge Strategic Employment Site

January 2018

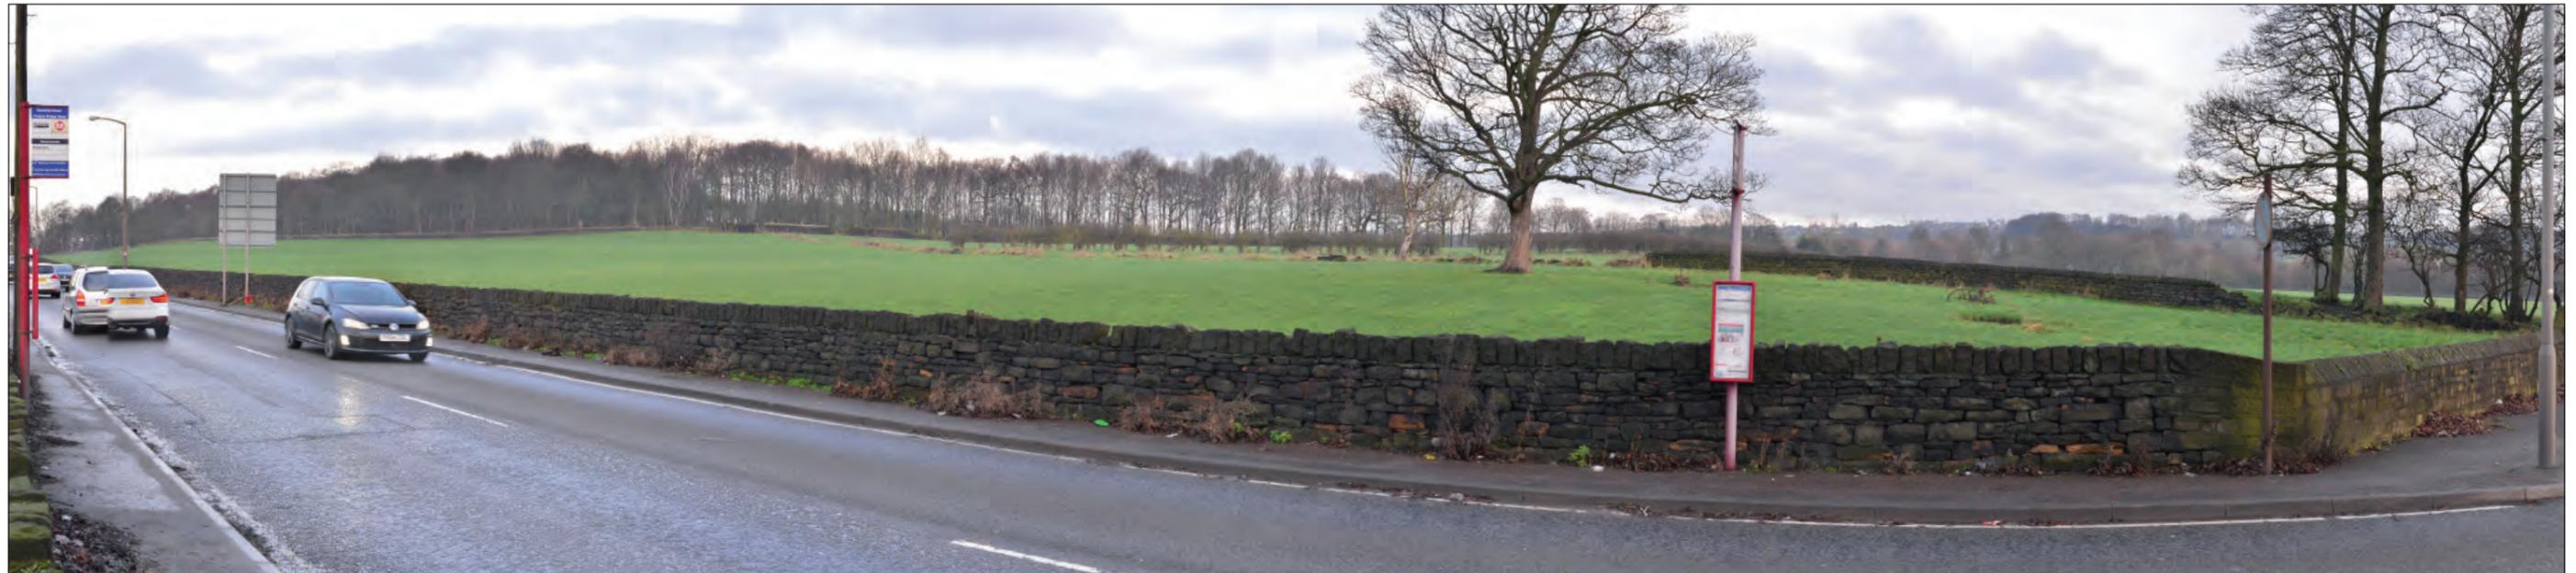
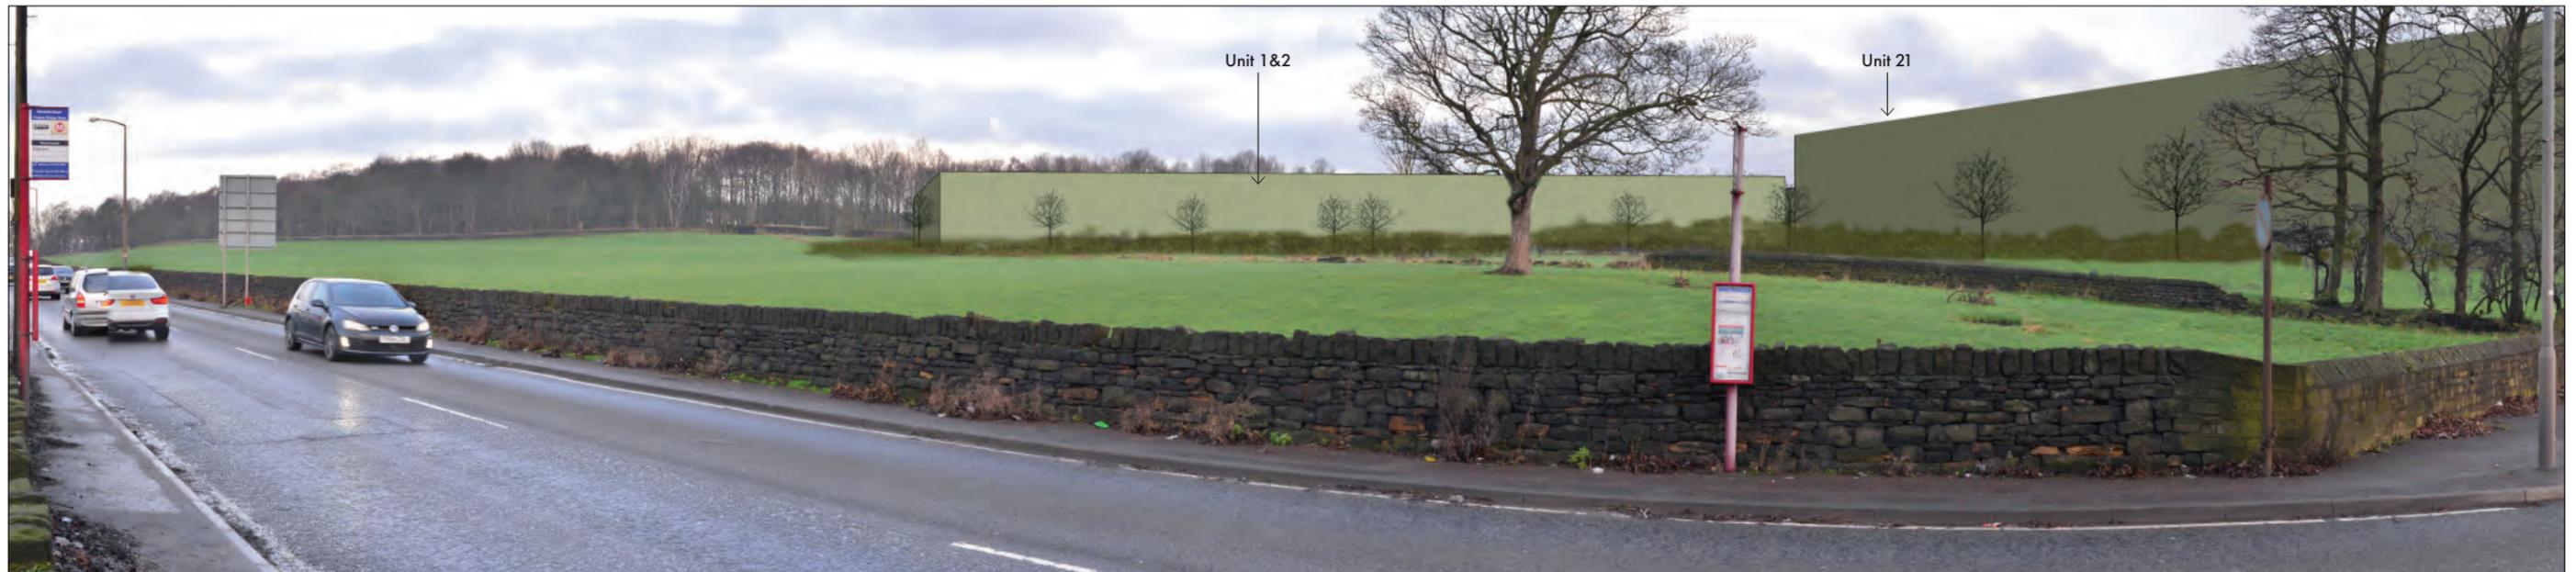
## Viewpoint 15: A644 Leeds Road at entrance to service depot, looking north Existing and Proposed Photomontage - Year 1

Existing Situation

Proposed Photomontage (Year 1)

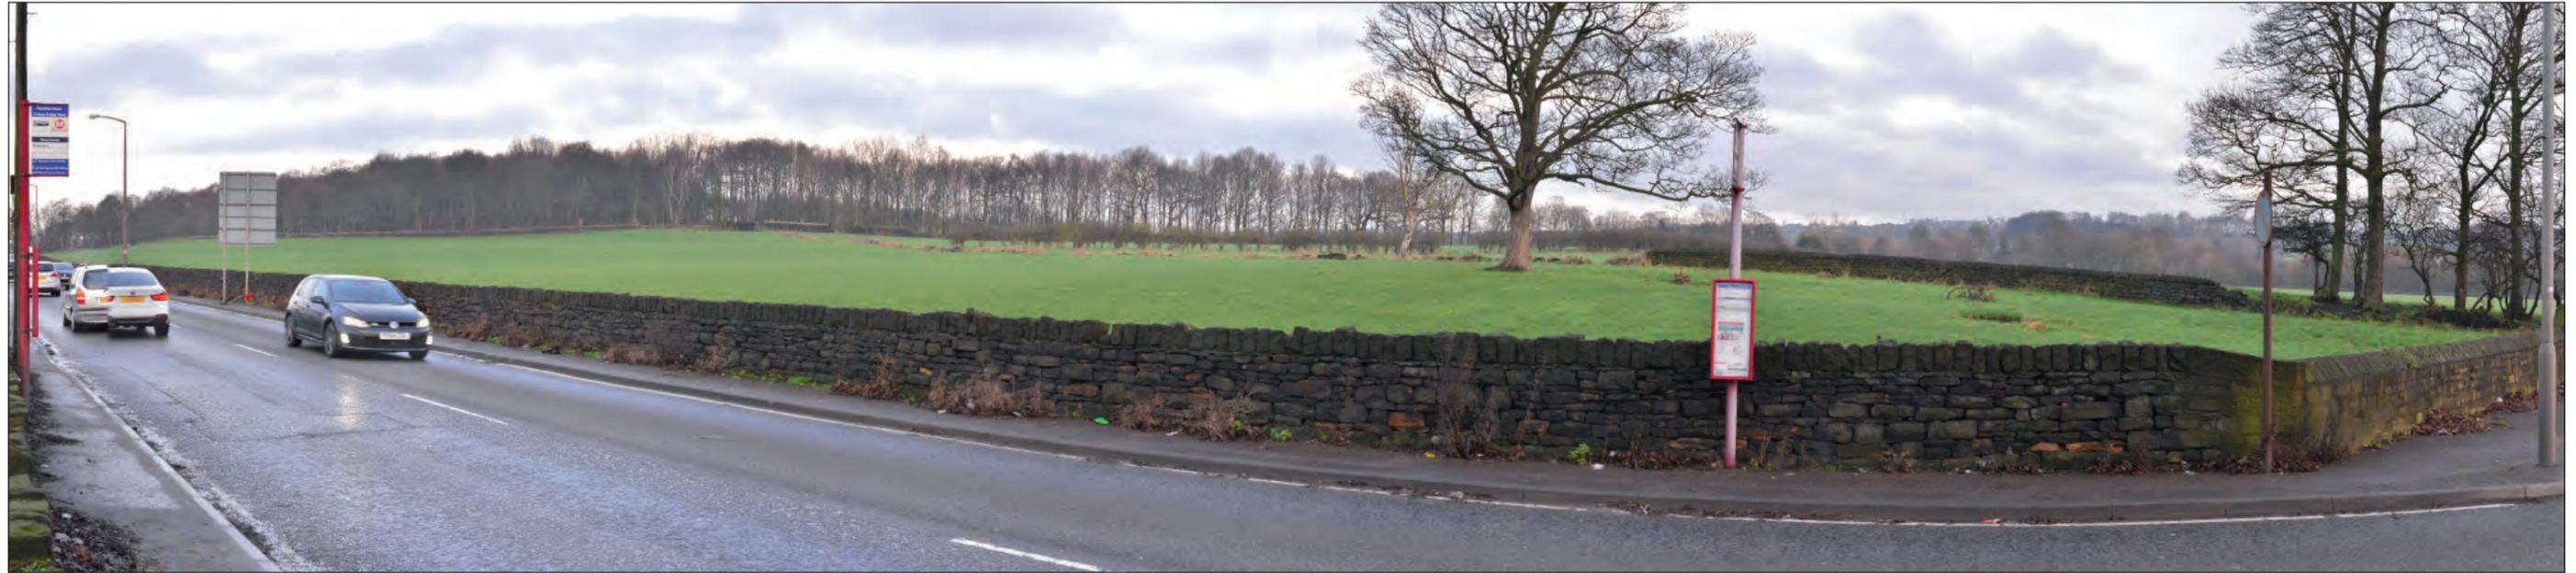
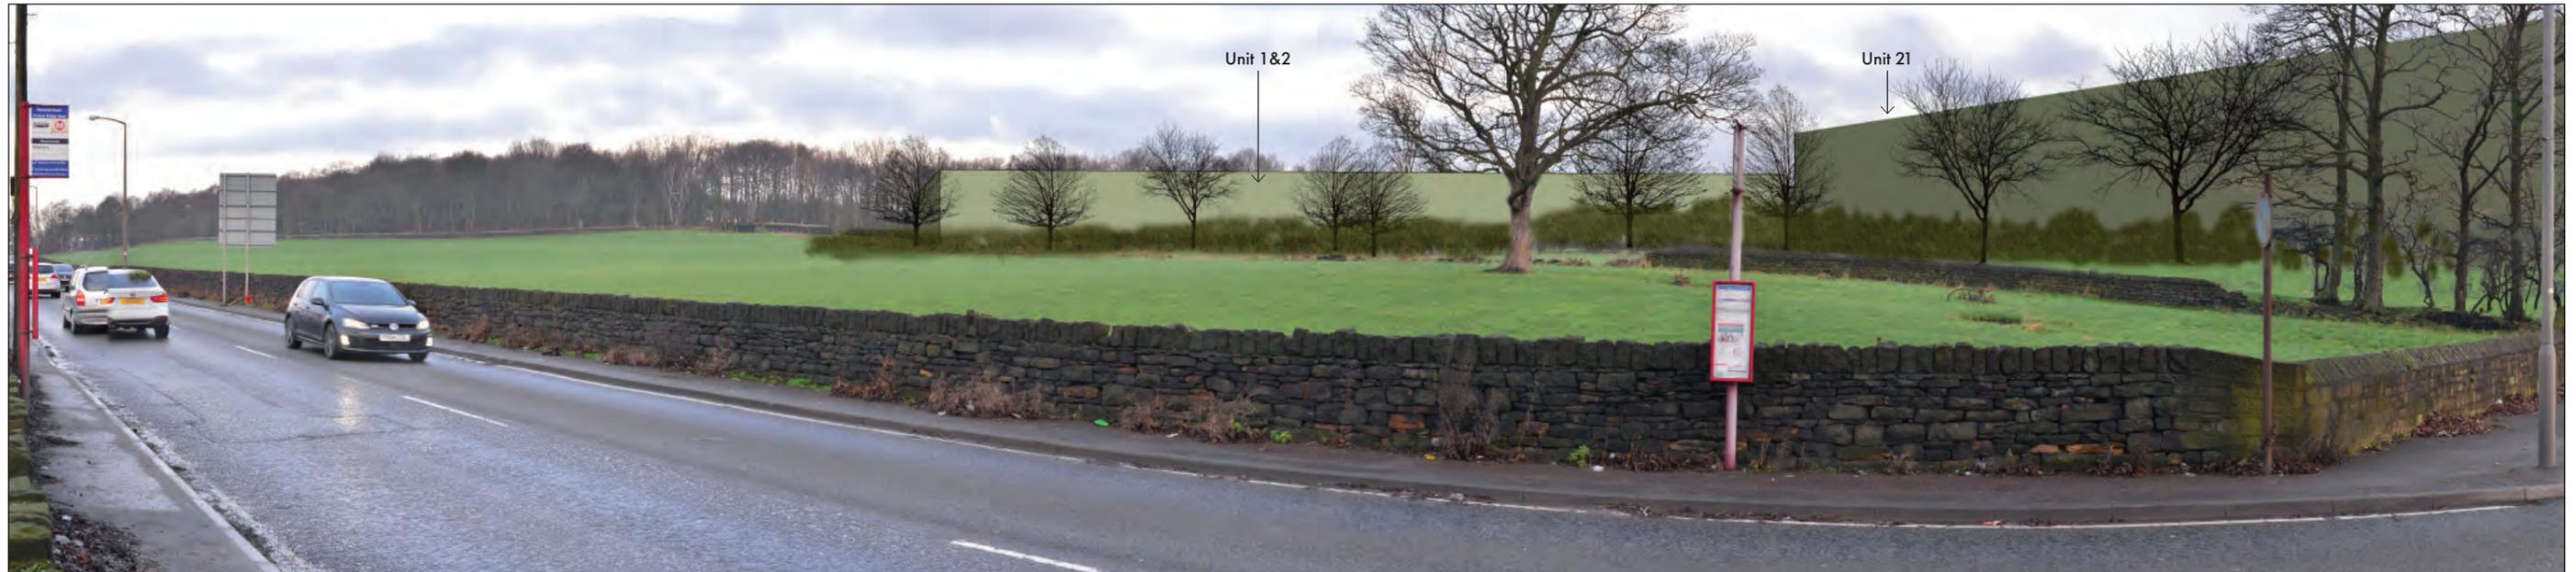
## Viewpoint 15: A644 Leeds Road at entrance to service depot, looking north Existing and Proposed Photomontage - Year 10

Existing Situation

Proposed Photomontage (Year 10)

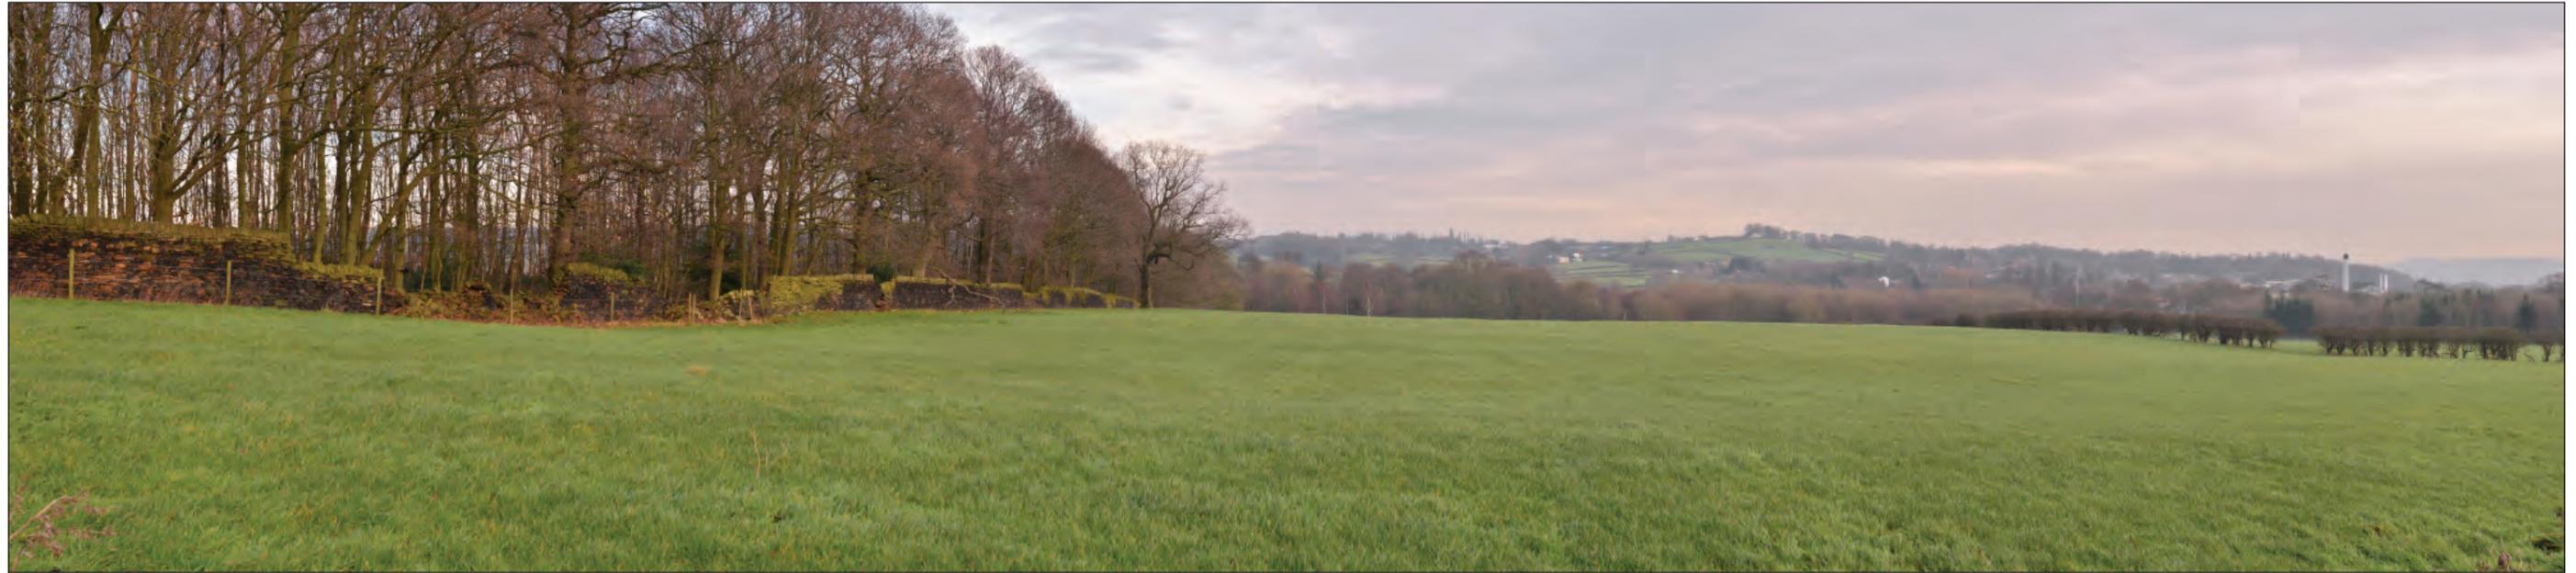
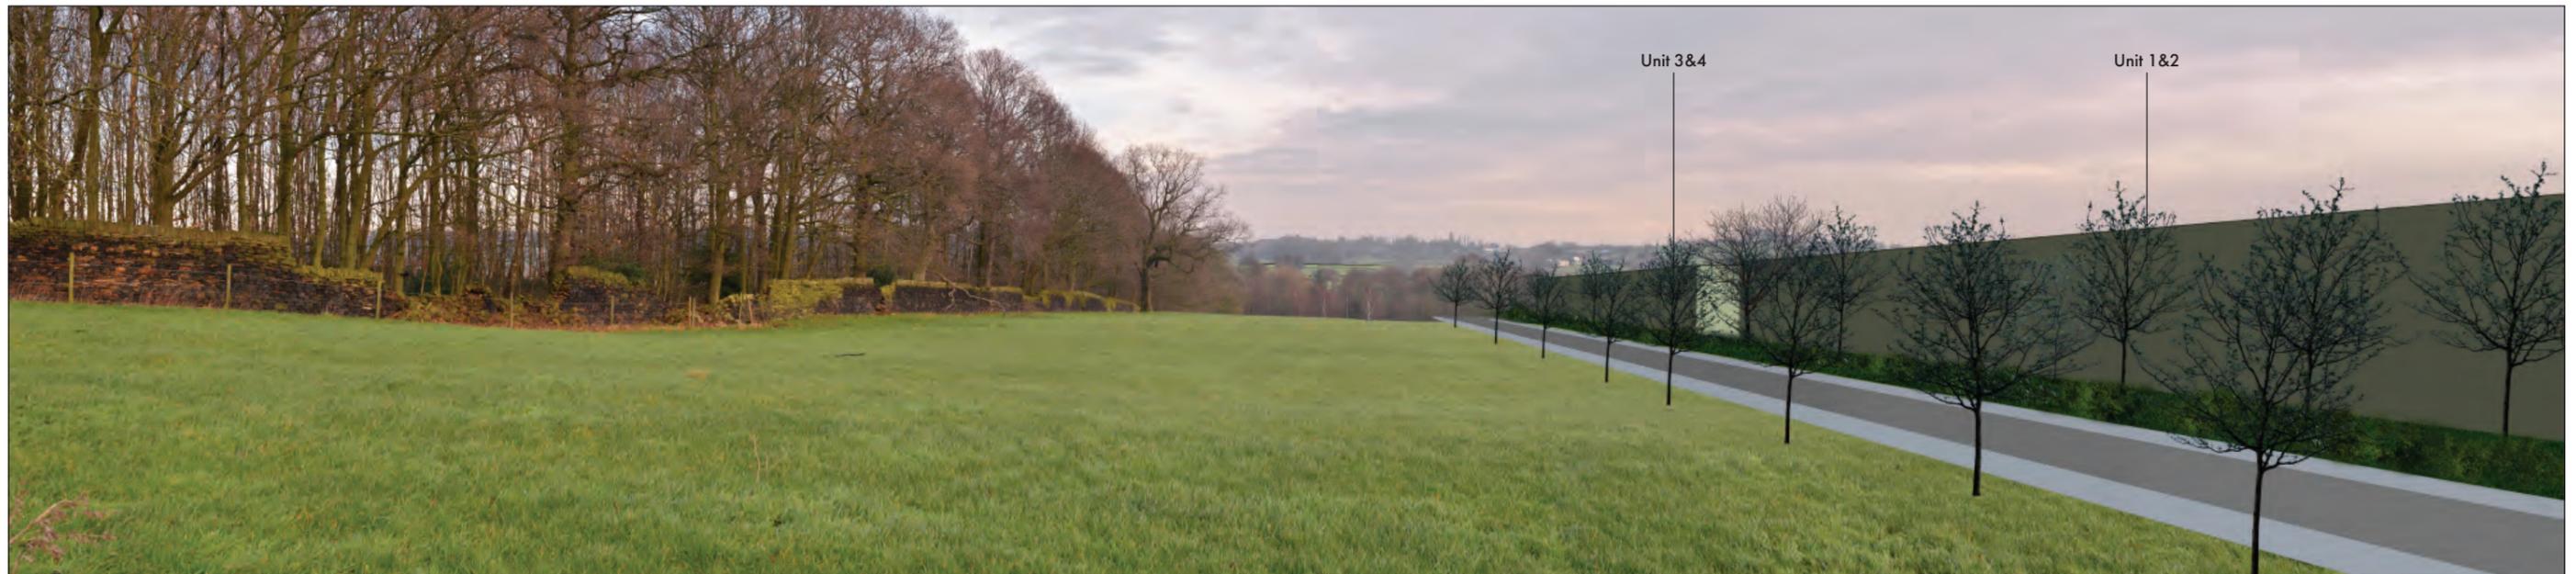
## Viewpoint 16: Land south of the Kirklees Estate, looking east Existing and Proposed Photomontage - Year 1

Existing Situation

Proposed Photomontage (Year 1)

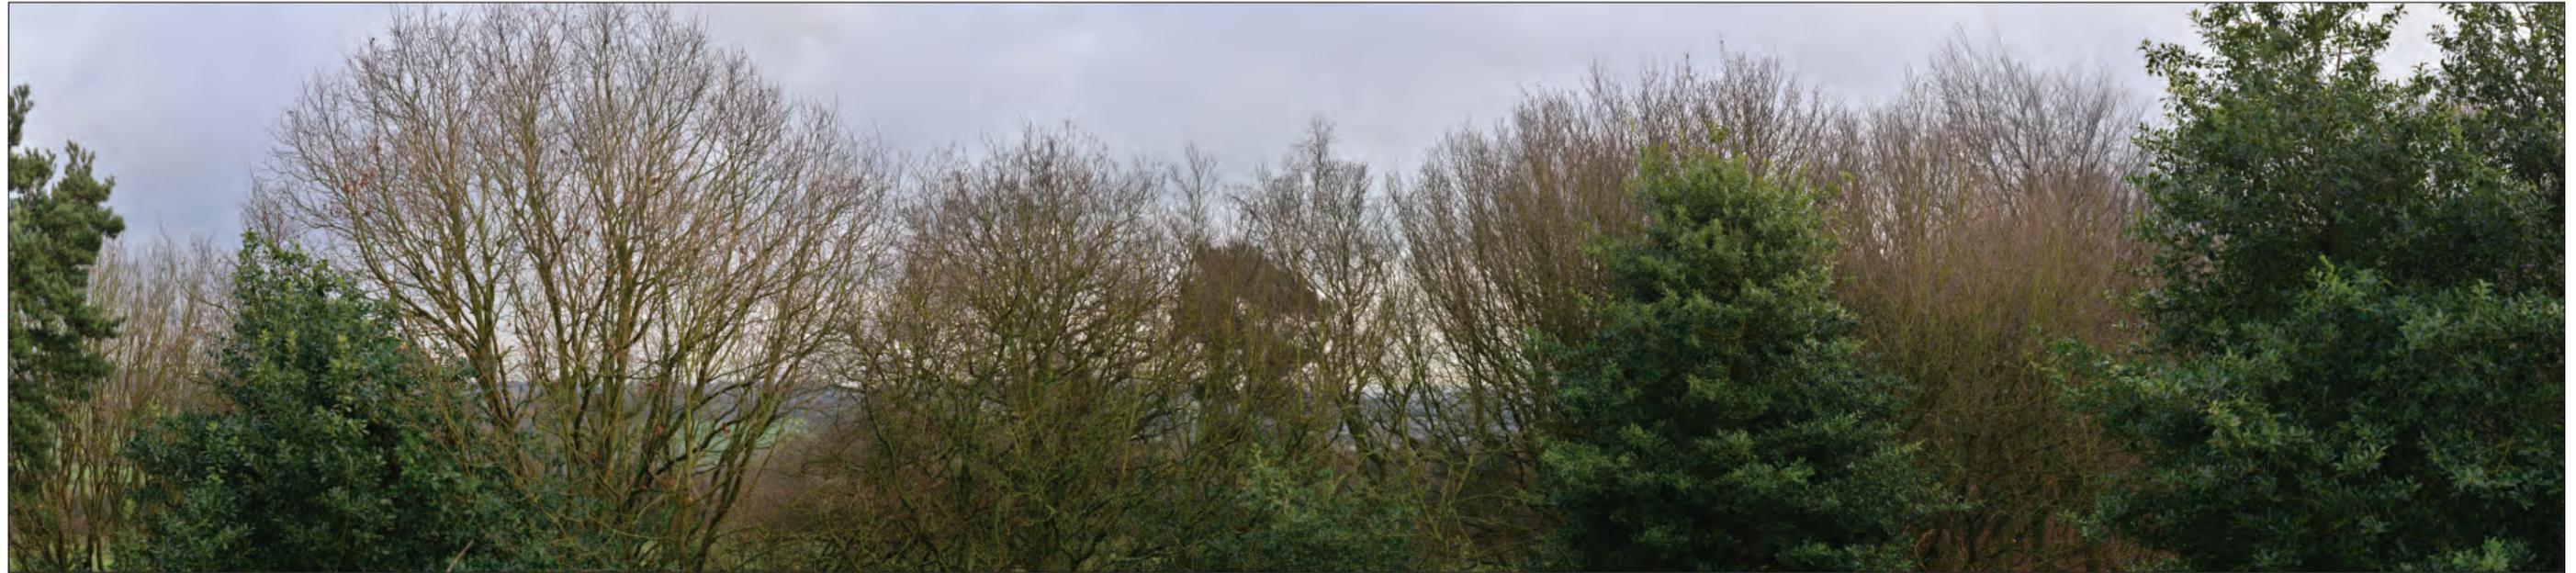
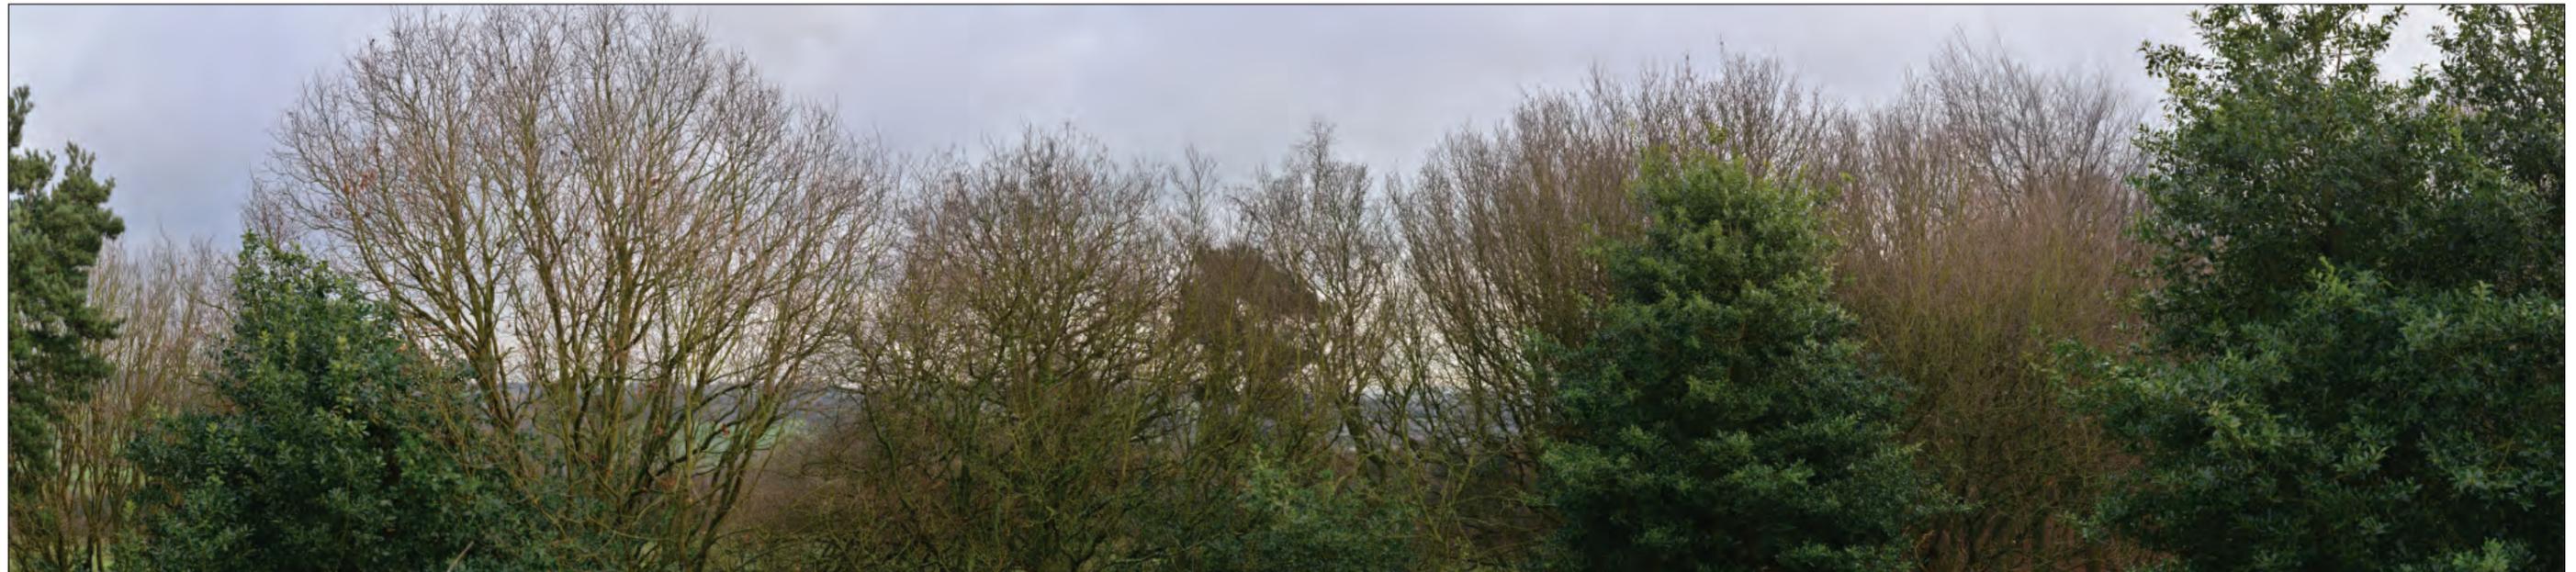
## Viewpoint 17: Top of Roman Watchtower Existing and Proposed Photomontage - Year 1

Existing Situation

Proposed Photomontage (Year 1)

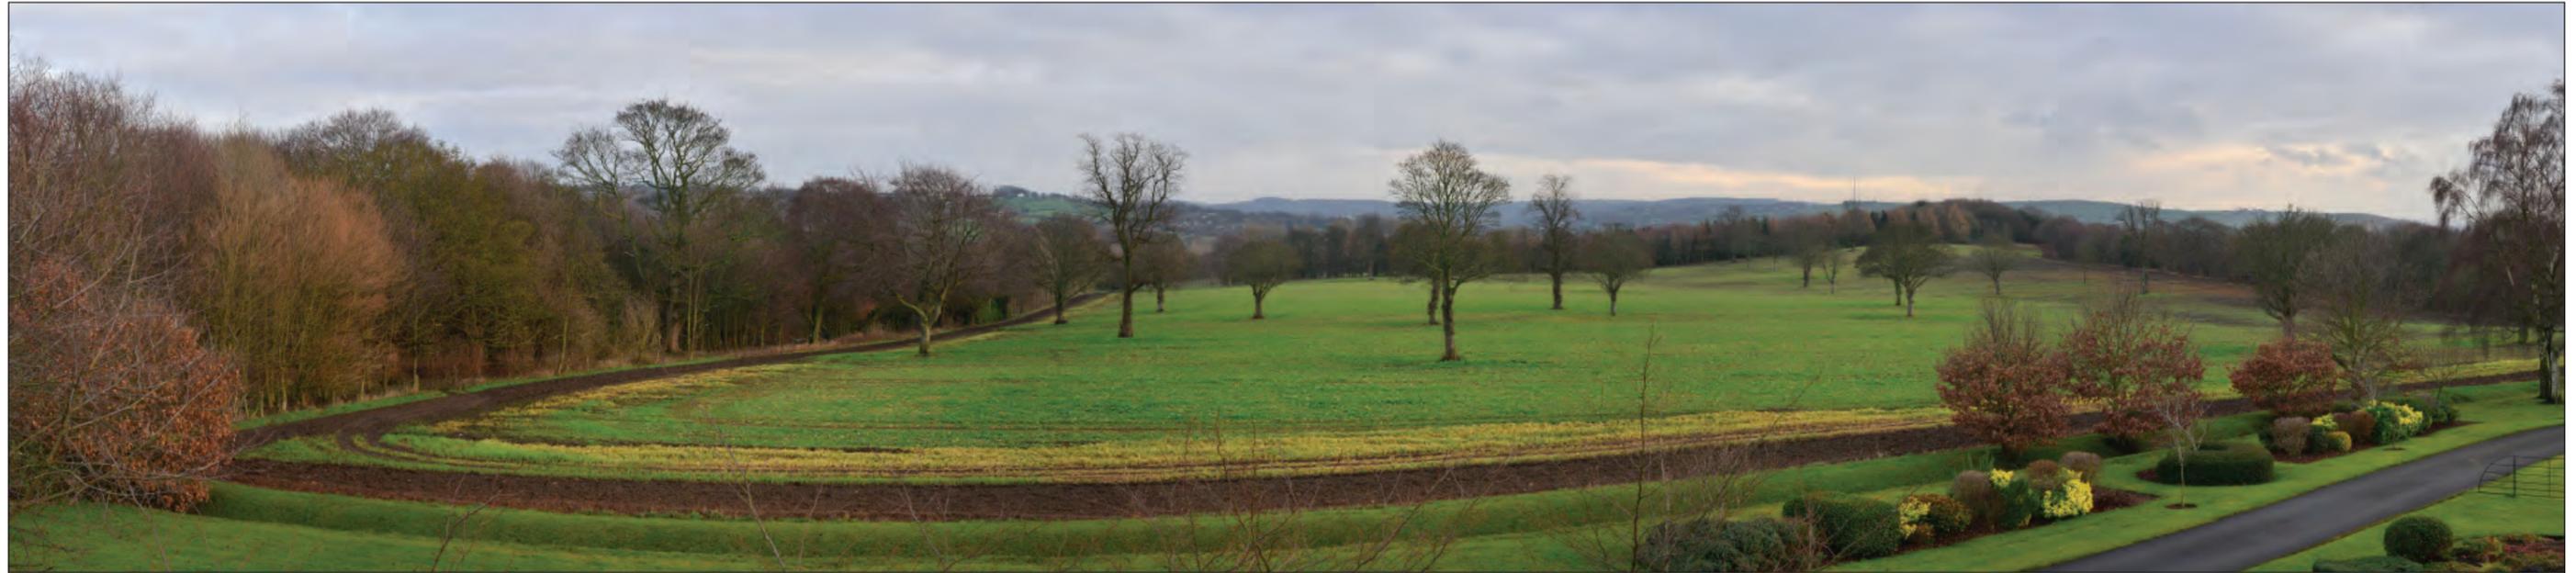
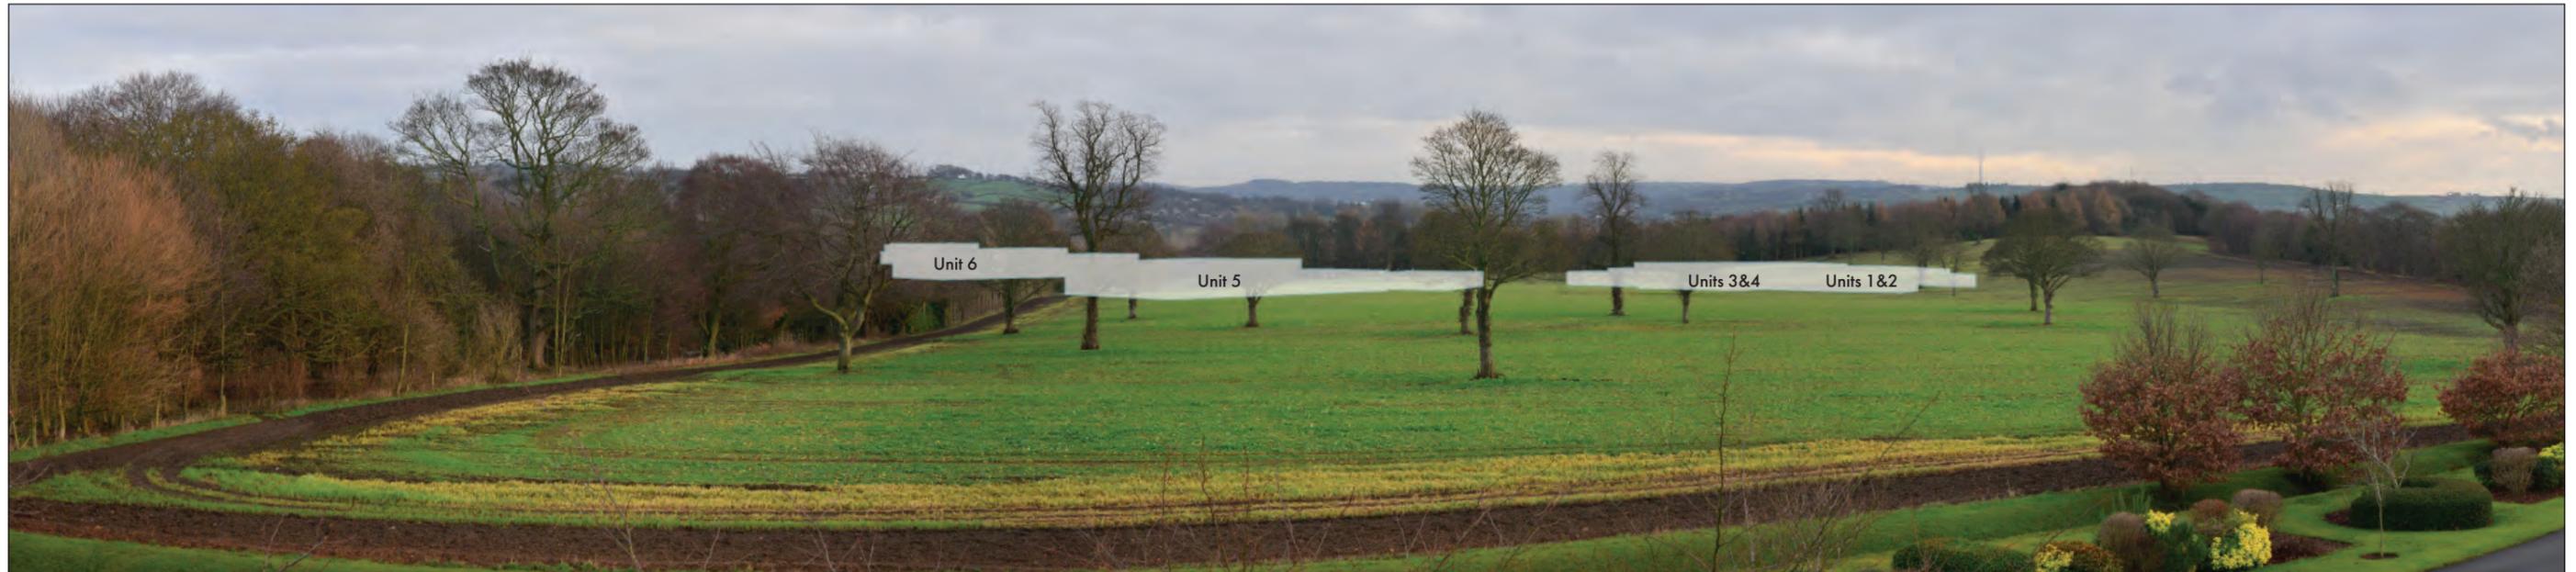
## Viewpoint 18: Kirklees Hall, First Floor Existing and Proposed Photomontage - Year 1

Existing Situation

Proposed Photomontage (Year 1)

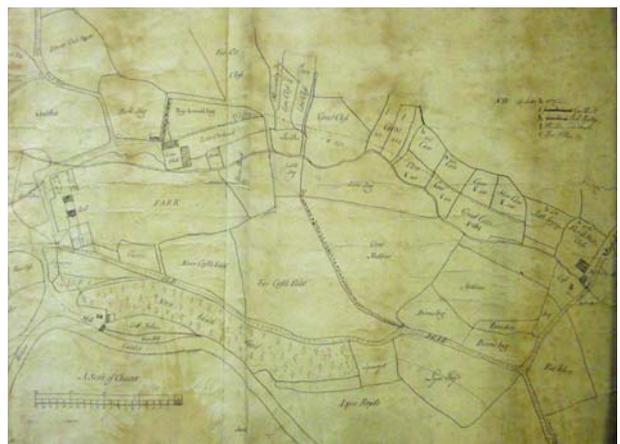
**Plate 6** 1714 plan (KM/A/1213)

A plan of 1714 shows the layout of the estate in the early 18th century (Plate 6). At that time, the extent of the park was much more restricted, with parcels of land marked as Park and Low Park. Land along Nun Brook in what is now the park is described as Carr or Ings, indicative of a wetland landscape. A road is shown crossing the area to the east, along what was the township boundary.

At the time of Richardson's plan and the 'undated plan', the Park comprised two enclosures known as 'Park' and 'Low Park' (Goodchild 1983)(see also Plate 6). Goodchild describes the arrangement:

A survey of the whole estate by Crosley in 1788 provides a valuable source for the changes that had been undertaken by that date (Plate 9), and a demonstrates how the landscape as shown on the 1714 map was overlaid with the more formal park extents. A second plan in the archives is also assigned to the mid-18th century (Plate 10), although the latter also shows the turnpike road of 1815, possibly indicating a later amendment. Together, these maps show the layout of a formal park boundary, and the removal of earlier boundaries within the parkland.

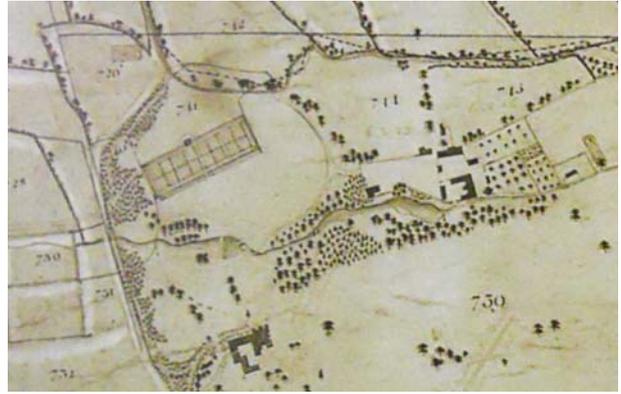
**Plate 11** Detail from Crosley's plan, showing walled garden, 1788

Woods' kitchen garden refers to a great walled garden to the north of Kirklees Hall, a position still occupied by a walled garden (HA 165). As well as the outside walls, a 'Garden House' was built, and borders and walks were dug. These features are all shown on Crosley's plan of 1788 (Plate 11). The work also included melon frames, gravel walks, and hot walls with two associated 'houses'.

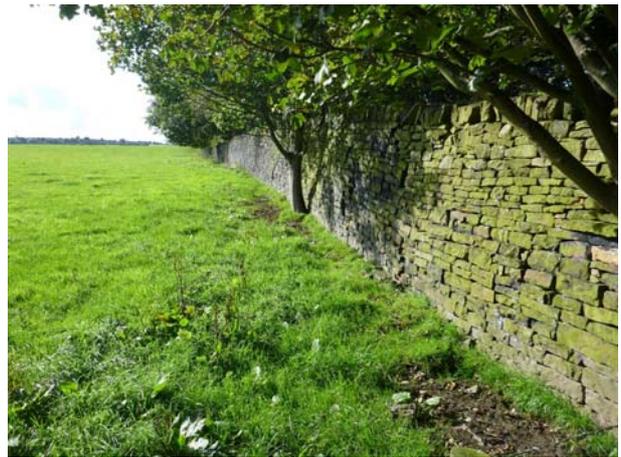
**Plate 12** Park wall, east side of Kirklees Park

Part of the changes saw the extension of parkland to include closes to southeast. A new wall around the parkland was erected 1766-1770, presumably represented to in part by that which stands today (HA 166)(Plate 12 and Plate 13), enclosing the newly extended parkland as shown on the 1788 map. The latter plan shows the township boundary as a defined boundary, but by a later plan of 1828, this had been reduced to an alignment of trees (Plate 14).

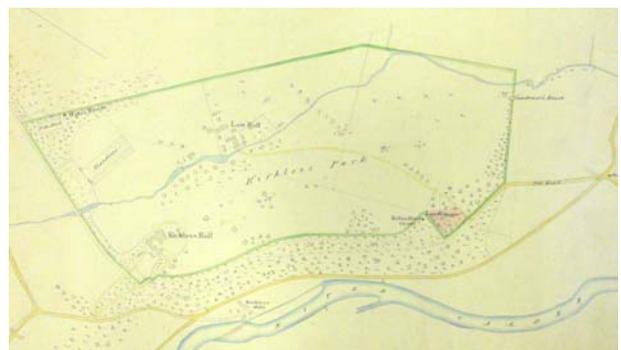
**Plate 14** Plan of Kirklees Park, 1828 (KM/A/1248)

Two plans of 1828, which were drafted for a trial involving poaching and possibly murder, show the southern part of the new park boundary clearly, labelled as Park Wall, including 'large doors which are kept locked' (Plate 14)(KM/A/1248). An associated plan also shows two small-scale quarries in this part of the park (CHA 170).

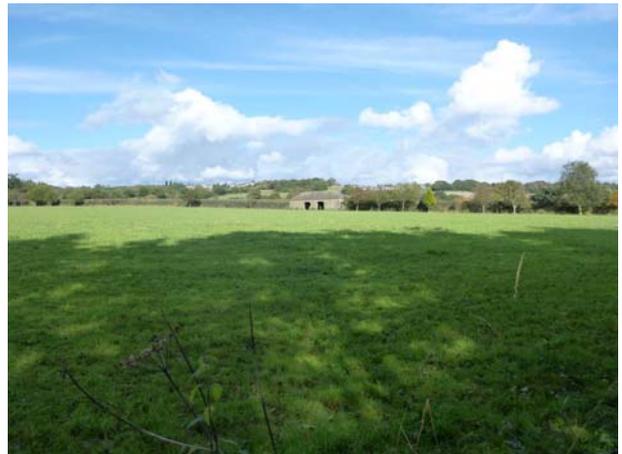
**Plate 16** The deer house, looking east

The deer house that survives within the parkland was constructed against the new length of wall, indicating a date of construction after c.1897 (HA 167) (Plate 16). Documents survive which contain weekly records of deer stock 1893-1903 (KM/B/520) and the ordering of fallow deer for the deer park at Kirklees (KM/B/521).

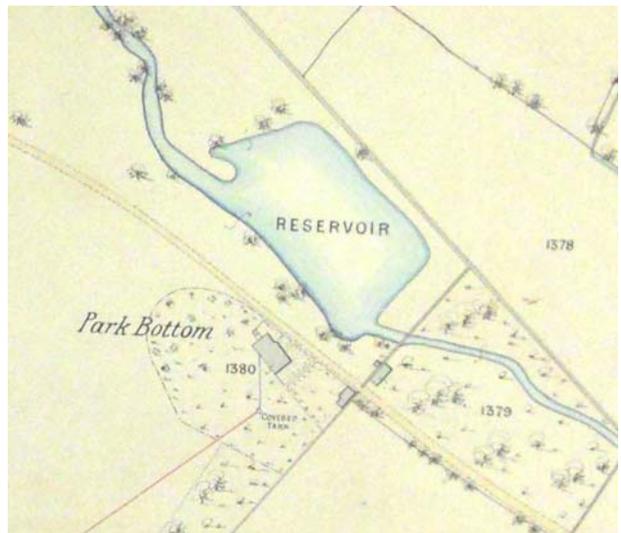
**Plate 21** Extract from plan of the estate, 1884 (KM/A/663/3-4)

The chain of ponds along Nun Brook (HA 123), planned in 1757 and shown on the 1788 plan, are apparently not mentioned in the accounts of works 1760-1771, and so Cowell suggests that they may have been a later creation. However, documents record the construction of an iron bridge at Kirklees Park in 1769, spanning a distance of 72 feet over a pond (HA 169). This would seem to be depicted on the 1788 plan across the westernmost pond on Nun Brook, suggesting that this pond at least was established by 1769. The iron bridge, believed to have been removed in the 1840s, is notable as it predated the famous structure at Ironbridge by 10 years.

The ponds themselves may have replaced earlier, medieval features; weirs and other features may survive within the proposed site, within the more modern plantations along Nun Brook. Cowell (2009, 213) notes that this feature very closely resembles Woods' design at Cannon Hall.

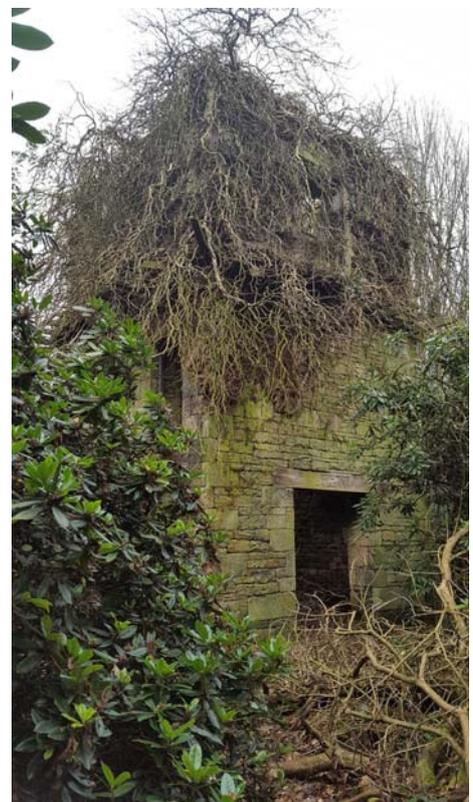
**Plate 23** Replica Roman watchtower

In 1905-6, Sir George Armytage constructed a replica Roman watchtower on the summit of Castle Hill, at approximately the same time that excavations of the enclosure were undertaken. Although now largely inaccessible, and in poor condition (HA 173)(Plate 23), photographs survive showing the nature of the folly as first constructed (Wallace 2005). The tower had a wooden parapet extending around the building at first floor level (parts of which are visible today). His obituary, published in the Yorkshire Archaeological Journal in 1920, describes how 'it was his great delight to show his guests the treasures of his house (Kirklees Hall) and park; the Roman Fort with

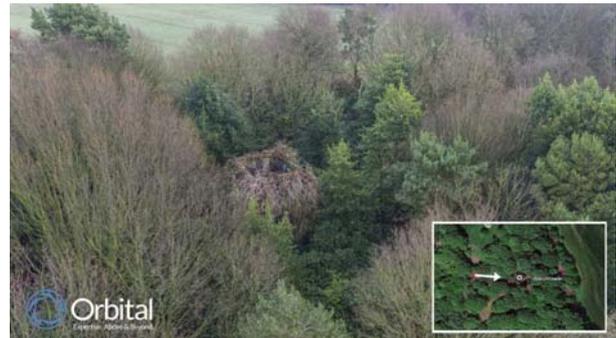
**Plate 25** Drone image of the replica Roman watchtower from the west (RSK Orbital)

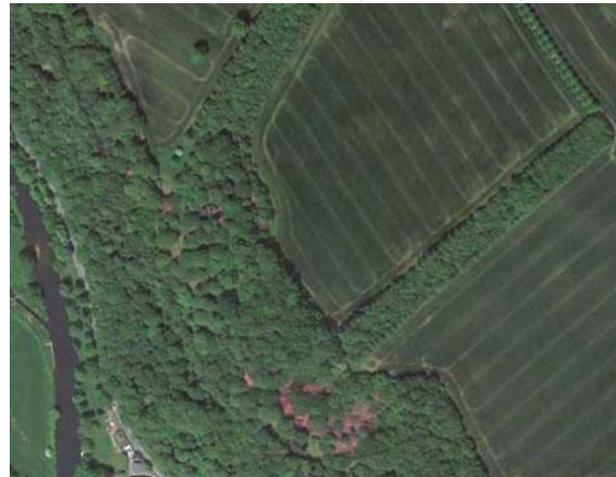
**Plate 26** Aerial view of Castle Hill and Robin Hood's Grave © 2016 Infoterra Ltd & Bluesky

The watchtower became the focal point of more formalised gardens in this part of the park, and the establishment of a more complex network of paths across this part of the site, connecting the watchtower with a clearing around Robin Hood's Grave. This arrangement is not shown on the plan of 1908, but is clear on the Ordnance Survey map of 1918-22 (Plate 24). Cleared areas form a cruciform layout, and would have commanded views to the hall, and across countryside to the northeast and southwest, now not achievable due to surrounding vegetation (Plate 25). The preponderance of Rhododendron in this area suggests an area of overgrown formalised planting (Plate 26).

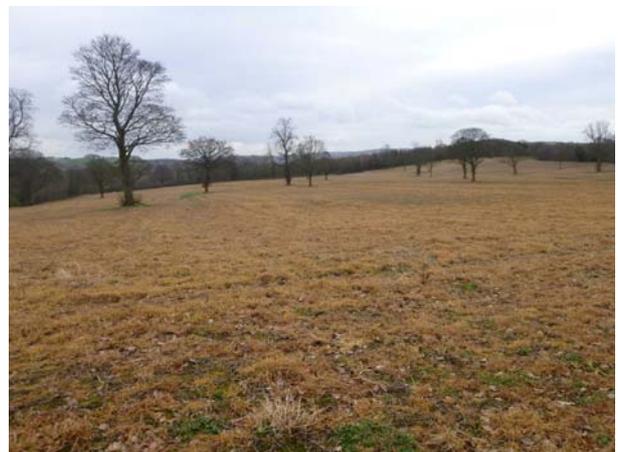
**Plate 29** View from the area in front of Kirklees Hall, looking southeast

Views from the area in front of Kirklees Hall (O) extend to the southeast, towards the tree belts that cross the parkland and which screen or filter more long distance views (Plate 29). Originally, these may have been more extensive. Key views towards the hall are achieved within the parkland from the rising ground north of Castle Hill (O) (Plate 30).

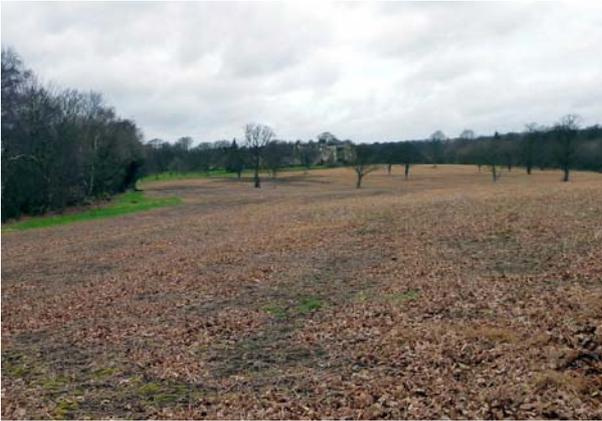
**Plate 30** View of Kirklees Hall from the south

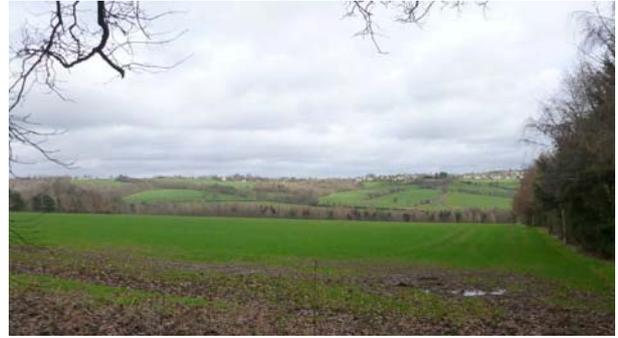
**Plate 31** View across the parkland towards Hartshead, framed by the two tree belts

The intended long distance views from the 20th-century formal gardens on Castle Hill are now lost due to vegetation (including Rhododendron that may represent relict planting), but from this area at the top of Nun Bank, the topography affords commanding views of the agricultural landscape towards Hartshead, framed by the tree belts across the park (Plate 31). The historic maps suggest that the watchtower formed a vantage point with views extending out in four directions – to Hartshead in the east, towards the Hall to the north, across the wider Calder Valley to the west and south (Plate 32). The field boundaries now represented by the tree belts were in existence at this date. Although later developments, the tree belts now serve to screen views of modern development, and also frame views from the parkland out to the east.

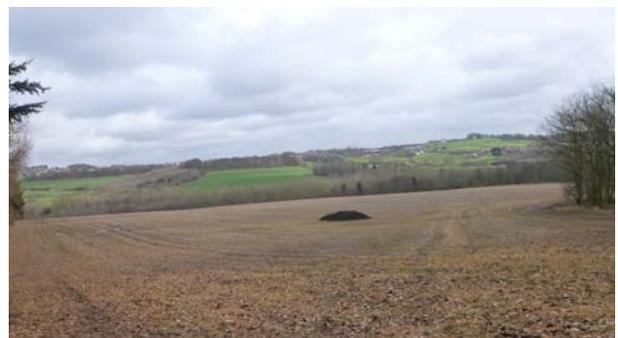
**Plate 33** View from the area of Robin Hood's Grave. The proposed allocation occupies the green field beyond the first treeline

While views from Robin Hood's Grave are screened by vegetation, extensive views are afforded from the open area close to the monument (Q), including towards the proposed allocation (Plate 33). The historic maps do not indicate that views from Robin Hood's grave were ever intended; the monument is shown in a small clearing, connected to the network of paths.

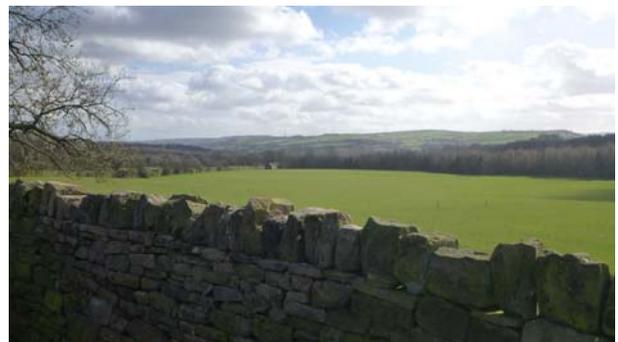
**Plate 34** View of the eastern part of the park, from the north boundary wall

There are also views across the eastern area of parkland from its northern boundary (S), which includes views of the deer shelter and the boundary, contained to the west by planting along Nun Brook (Plate 34).

The proposed allocation lies beyond the park boundary in views across area S. Currently, the allocation and trees within it combine in the view with other wooded areas beyond the park boundary (see Plate 34; allocation lies in trees to the left).

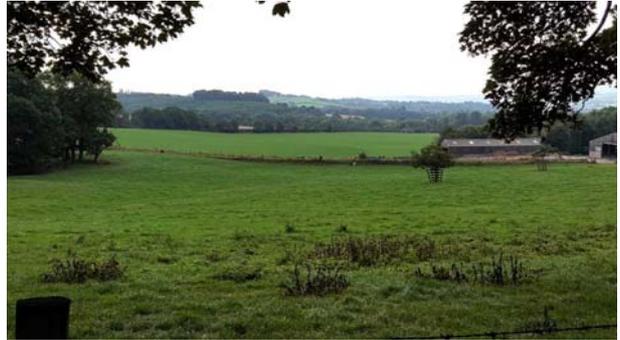
**Plate 35** View from the north drive to the southeast (Home Farm to the right)

Much of the northern part of the park (T) has a more enclosed feel, although there are occasional views across the park from the drive leading from the northern entrance towards Home Farm (Plate 35).

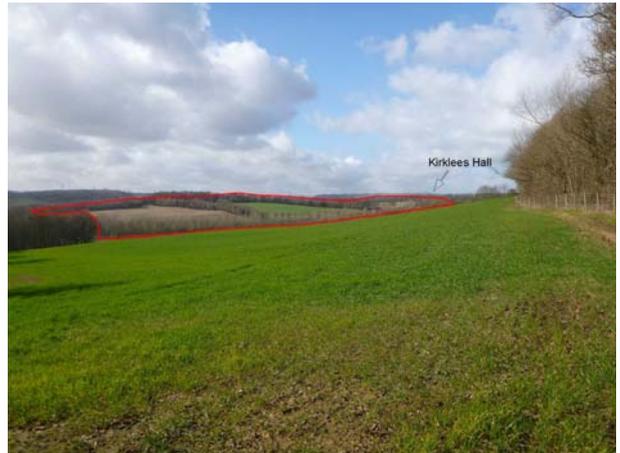
**Plate 36** View of the park (red outline) from the eastern boundary of the allocation, with glimpsed views of Kirklees Hall

From rising ground to the east, much of the park is visible, in particular the southwestern closes of the parkland with the dividing tree belts (P and Q, G and H); these views allow the form and extent of the park to be appreciated, at least in part (Plate 36). The majority of the heritage assets within the parkland are not visible from this direction; Home Farm is not visible due to topography and vegetation. Kirklees Hall is often hidden from view by vegetation, but there are glimpsed views, including from the proposed allocation (see Plate 36).

Views of the park itself can be achieved from within the boundary of the proposed allocation (see Plate 36), therefore contributing to ability to appreciate its extent and layout from the surrounding area.

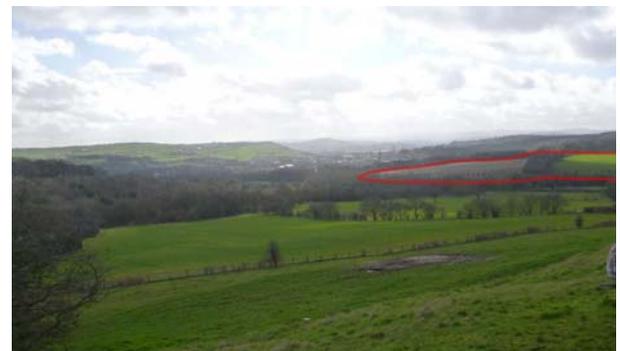
**Plate 37** View of the southern park (red outline) from the rising ground towards Hartshead, looking south

From rising ground towards Hartshead, the southern part of the park can be viewed against the industrial character of the Calder valley (Plate 37).

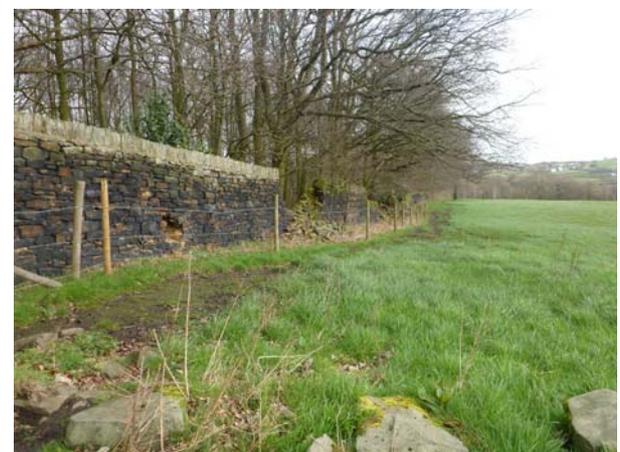
**Plate 38** Southern boundary of the park

More immediate views towards the park are afforded from the open ground to the south (V), where the open pasture allows views towards the park boundary wall (Plate 38). None of the parkland within is visible from this direction.

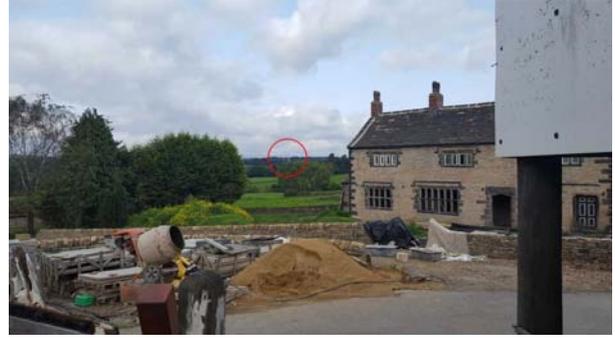
**Plate 39** Glimpsed view of the Hall beyond Mock Hall

Kirklees Hall appears nestled in the wooded valley from some areas of the Leeds Road; these are infrequent views, glimpsed between properties and hedges as one travels along the road. These include views past Mock Hall (HA 32) and from the end of Far Common Lane (Plate 39).

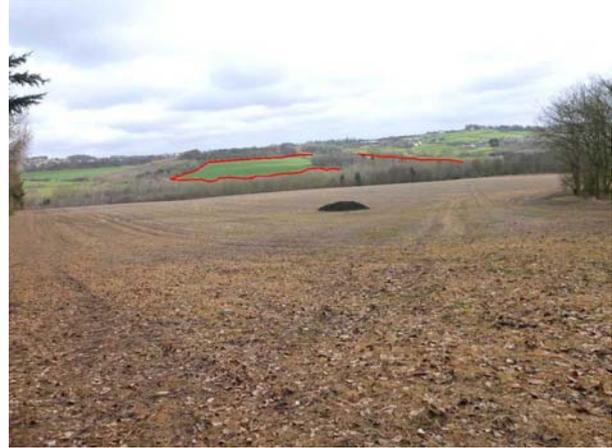
**Plate 40** View of the proposed allocation from area Q

The proposed allocation site is visible from the elevated land at the western side of area Q, and as such makes a significant contribution to this view. In particular, the rising ground in the northern part of the proposed allocation features in views from this area; the lower lying part of the allocation is screened by vegetation (Plate 40).
