# **Heritage Overview Report**

Cooper Bridge Strategic Employment Site

January 2018

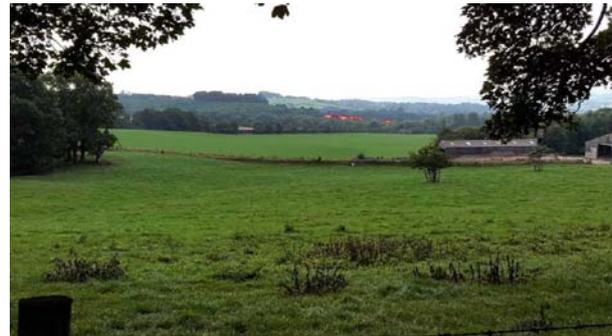
**Plate 41** View of the proposed allocation from area T

The proposed allocation is screened from much of area T by the falling topography and vegetation, but there are glimpsed views of the site from the drive; this makes some limited contribution to the character of this area, which is generally more enclosed (Plate 41).
