## **GEOENVIRONMENTAL DESK STUDY REPORT**

**Ferrand Lane  
Gomersal  
BD19 4SB**

**MT/DS/4730.v3**

**December 2015**

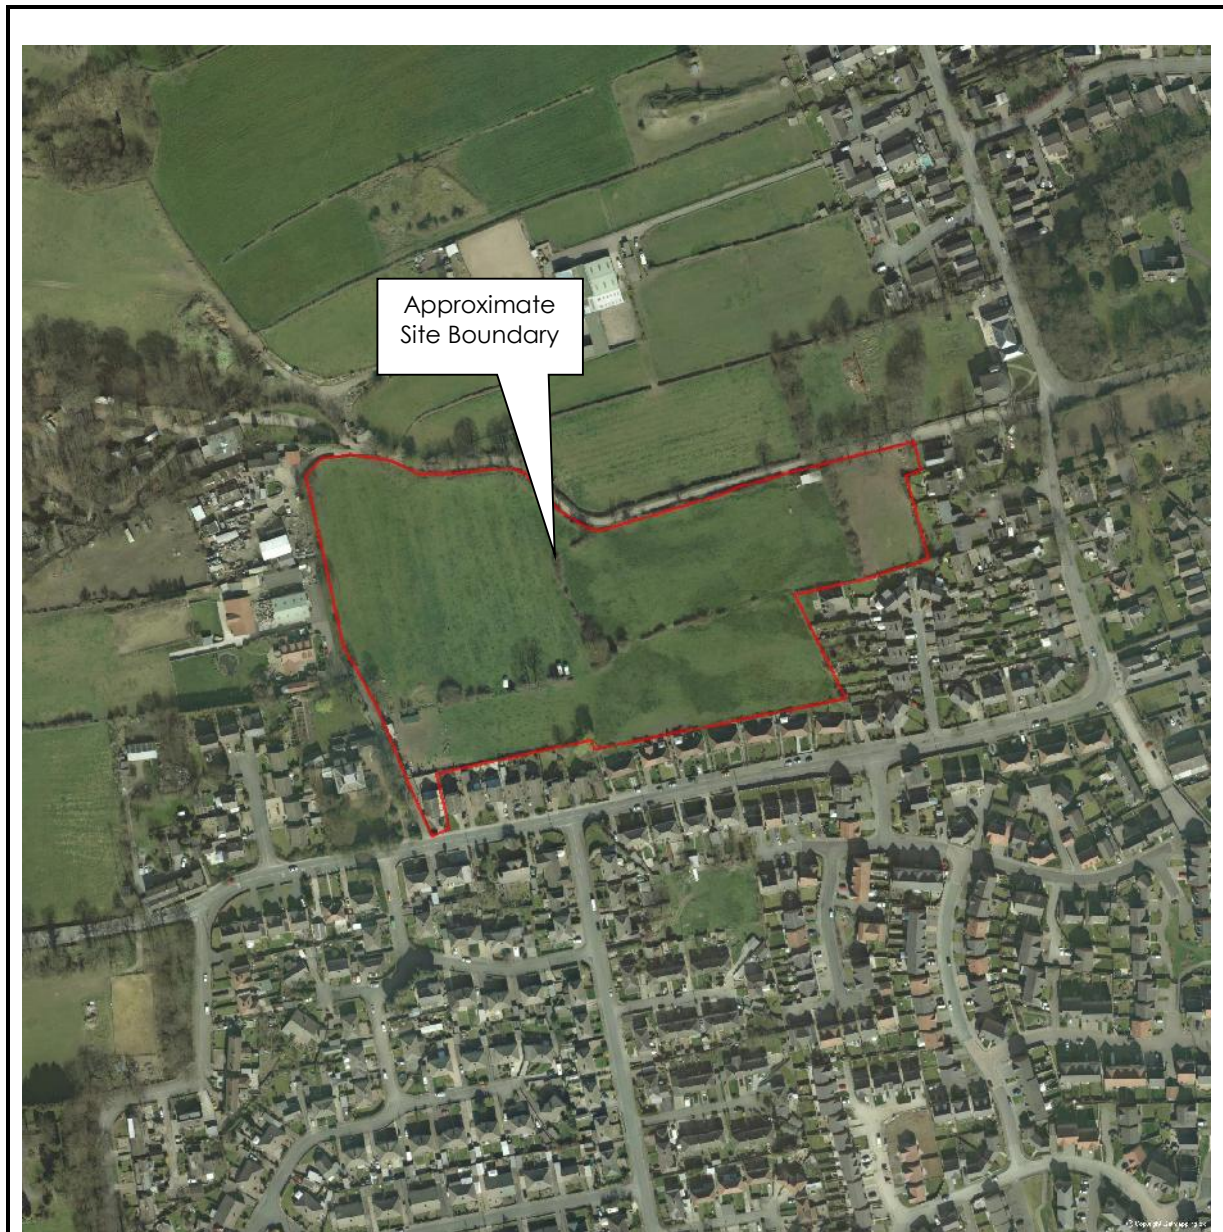
**Figure 2 – Aerial Photograph**

An aerial photograph of the site is presented as Figure 2 and selected photographs of the site are presented in Appendix B.

The site had an undulating and locally hummocked profile, which was most prominent in the south and east and generally sloped down to the north west. The site was at a higher elevation to Ferrand Lane at several points and a shallow ditch ran along much of the northern boundary.

Most of the site has a cover of short grass with mature trees and bushes along the field boundaries. Throstle Nest Farm was present at the north west corner of the site which was utilised by commercial plant vehicles. An above ground fuel tank was noted in the field at the north western boundary, along with some agricultural equipment.

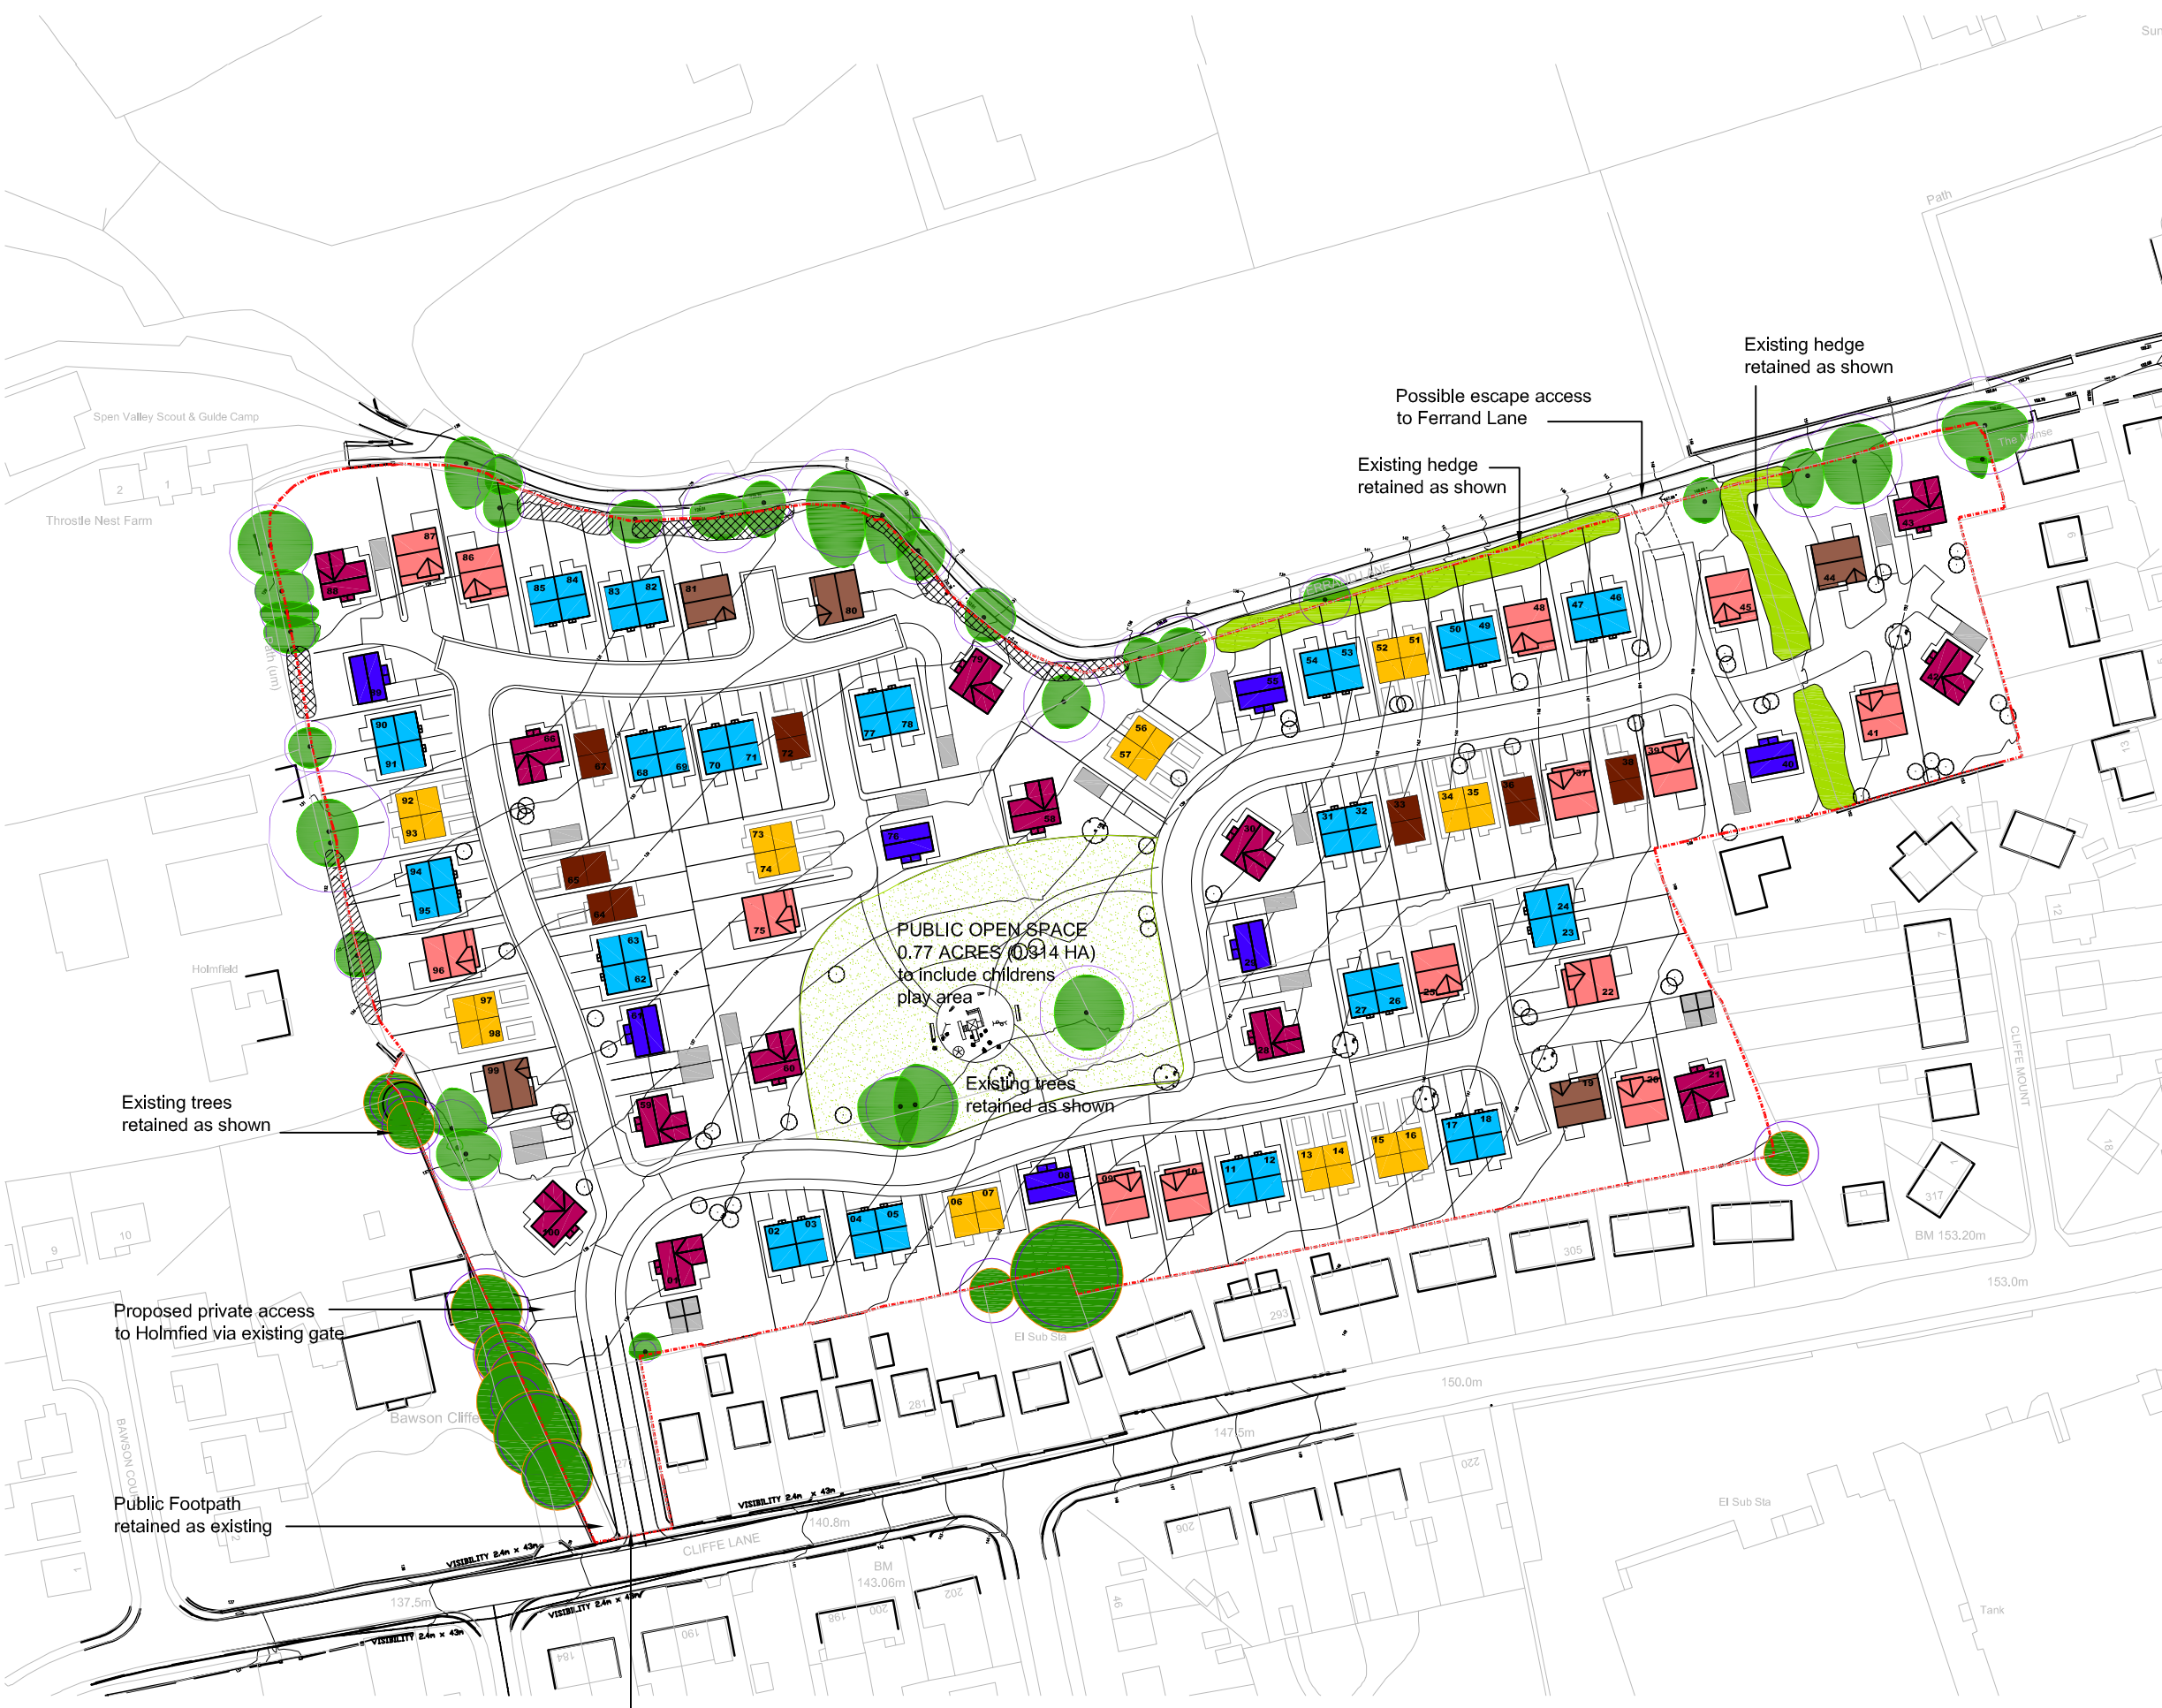
Site layout subject to detailed level and topographical review

A proposed site layout plan has been provided. This is referenced below and a copy is presented in Appendix A.

- Ellis Healey Architecture. May 2014. Proposed Development Land at Ferrand Lane Gomersal. Proposed Site Plan. Drawing no. 1332 SK 02 A.

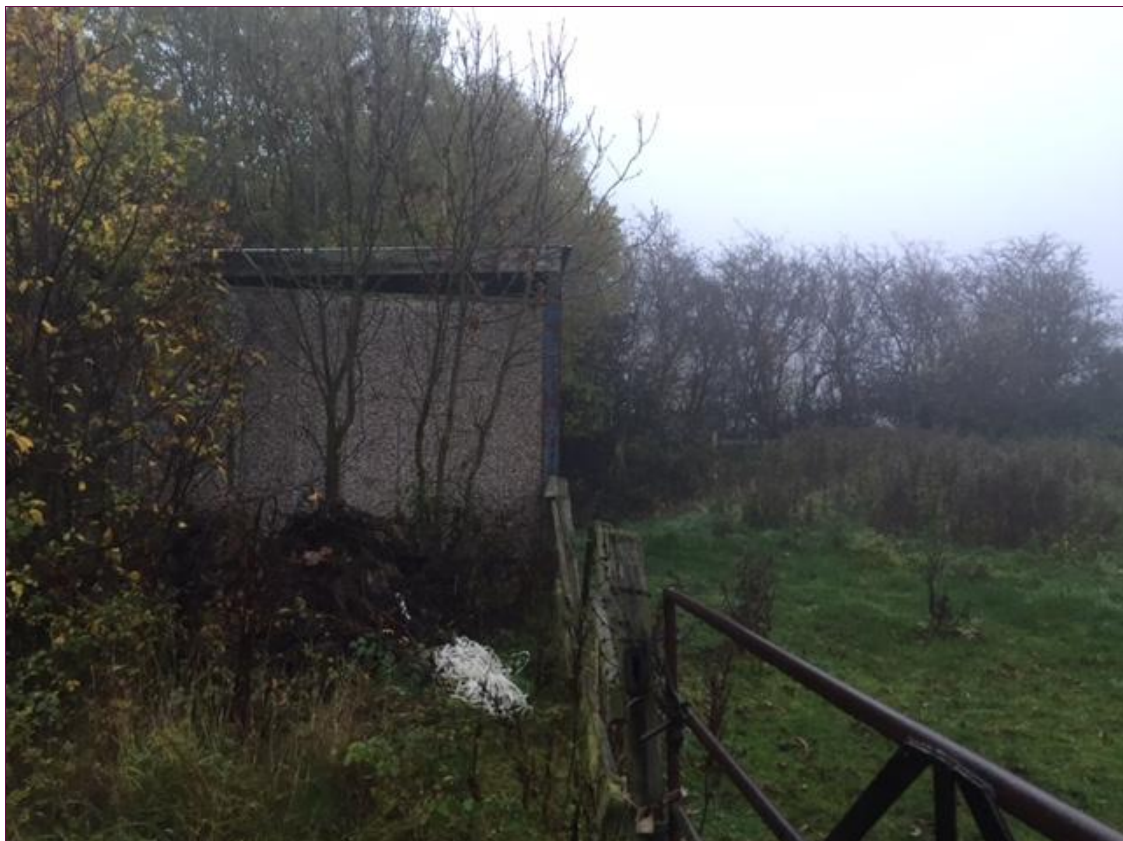
**Photograph 2: View east showing outbuilding at north eastern site boundary**

The site is currently grazing land for horses comprising four separate fields and bounded by residential properties to the south and east and agricultural fields to the north and west. In the north eastern field includes stables for the horses.

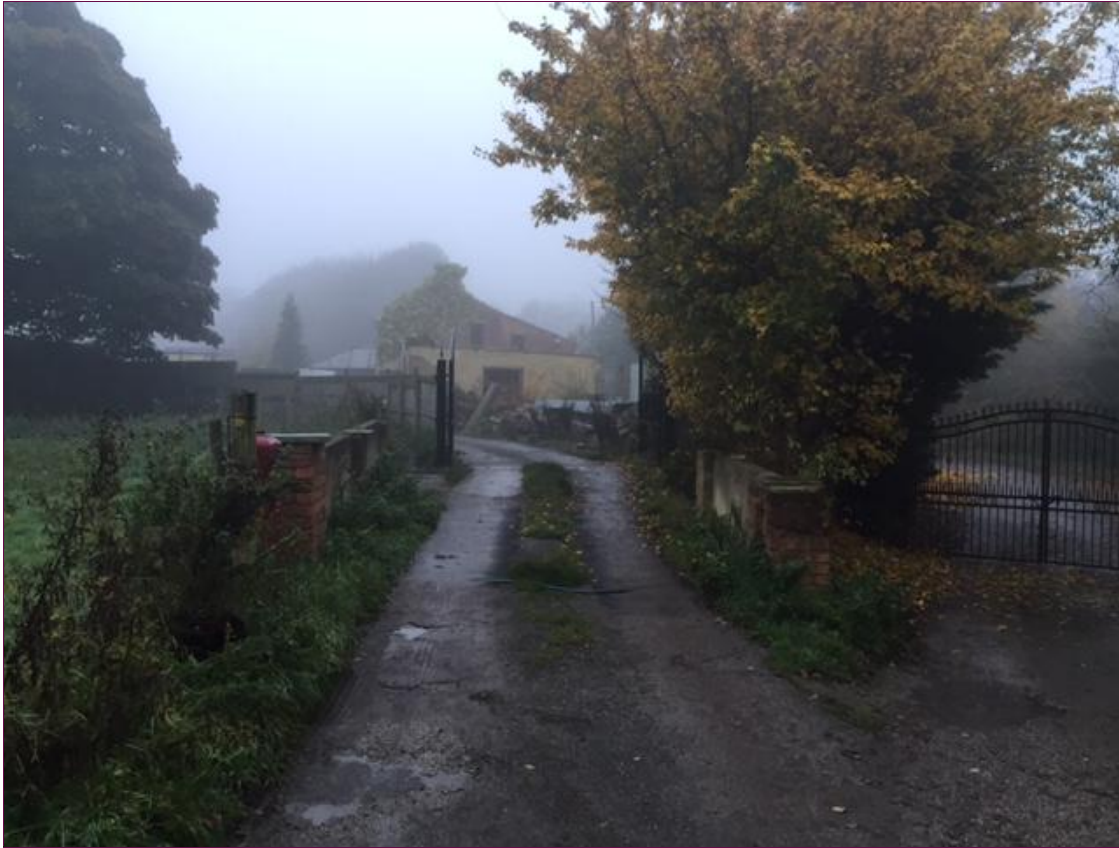
**Photograph 5: View towards Throstle Nest Farm**

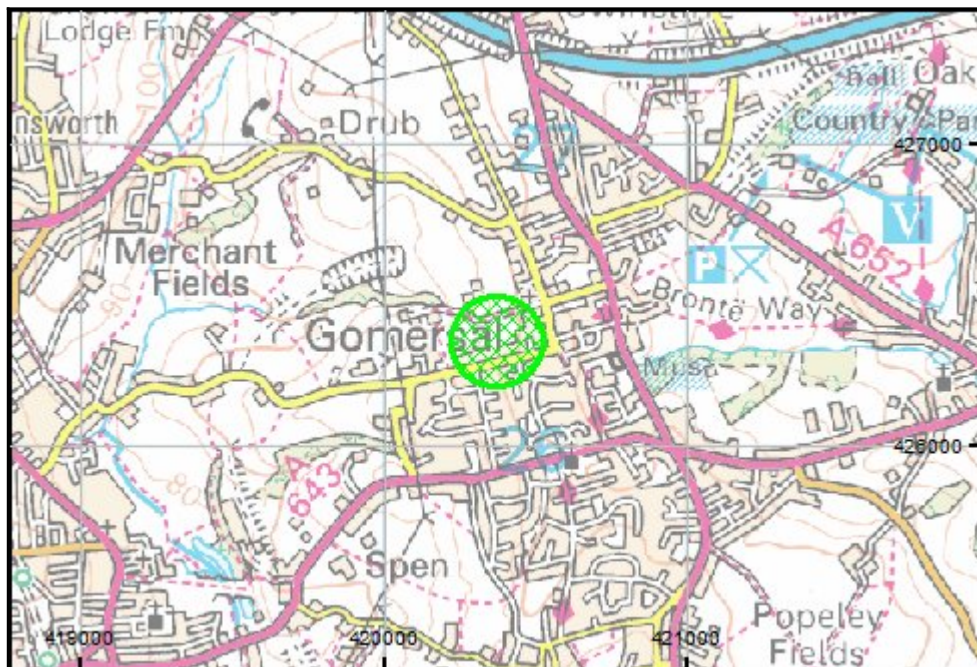
## Location map

This plan shows the approximate location of the disused mine entry / entries referred to in the attached mining report. For reasons of clarity, mine entry symbols may not be drawn to the same scale as the plan.

The shaft reference 420426-003 was probably the former West Lane Colliery. The Coal Authority report states that this was searched for by drilling in 1983, but was not found and they have no record of any treatment.

Shaft/adit:	Shaft
Reference:	420426-003
Source:	1st and 3rd Ed. 1/2500 O.S. 2nd Ed. Geological. Ab plans 4115 NE793
Colliery name:	Unknown
Entry name:	West Lane
Date abandoned:	Unknown
Depth of superficial deposits (m):	Unknown
Depth of shaft (m):	91.4
Diameter of shaft (m):	Unknown
Probable adit azimuth:	Not Applicable
Treatment details:	was searched for by drilling in 1983 but was not found. We have no record of what steps if any have been taken to treat this shaft
Conveyance:	Not Applicable
Easting:	420475
Northing:	426389
Other information:	None
