HUDDERSFIELD TOWN CENTRE AUDIT 2002

FACT SHEET 6: ENVIRONMENTAL QUALITY

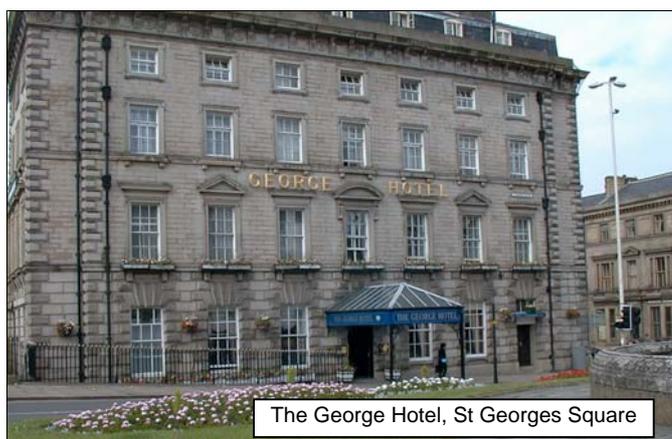
The town has a fine architectural heritage, particularly in the area around John William Street and St Georges Square. In this location there are a number of fine buildings including the Grade I listed railway station, the George Hotel, the Yorkshire Bank and Lion Chambers. There are a substantial number of listed buildings within this northern area of the town and the

The George Hotel, St Georges Square

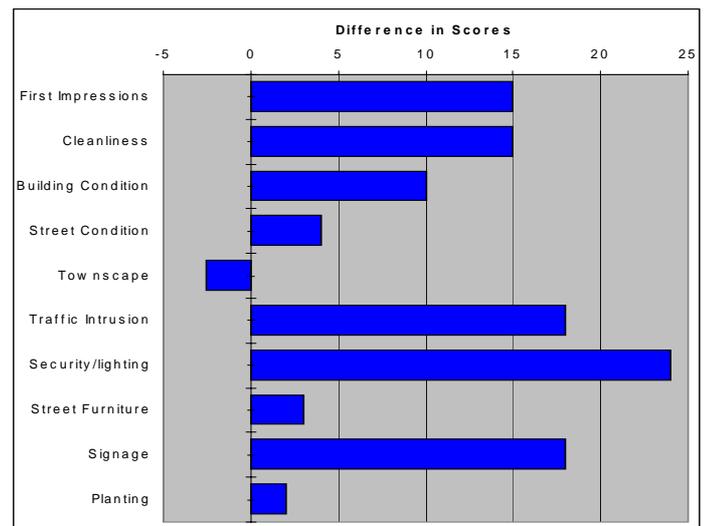
Figure 1: Changes in indicator scores 1998-2001

Figure 1 shows the general changes in the scores achieved for each environmental indicator between the 1998 and 2001 assessments.

Of the 10 indicators of environmental quality, only townscape has failed to show an improvement. However, this was largely to do with improvement works at John William Court. This frontage was screened by scaffolding and tarpaulin at the time of the assessment. All other indicators have improved, with some showing significant improvement since the previous assessment, such as lighting/security.
