Kirklees Council Flood Investigation

(3-5 Spinners Way, Scholes, Cleckheaton)

Flood Management and Drainage Team
Kirklees Council
9/26/2014

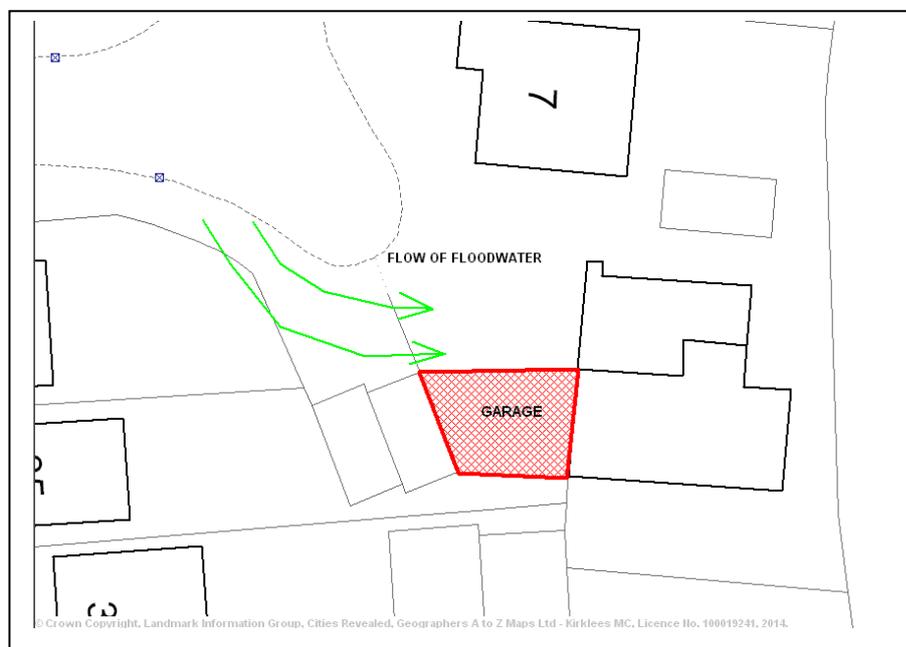
It was subsequently described by the resident as a build up of water in the road network that overtopped the driveways threshold and flowed towards and entered the property situated at a lower level, causing significant damage.

A survey shows the back of pavement levels adjacent to number 1 and neighbouring double garages are lower than that of the driveway of the flooded property. Water will spill into neighbouring property before working its way to number 3-5.

It is likely that the flooding will reoccur if similar extreme conditions arise in the future. The owners are advised to look at a way of passing water to the rear of the property.

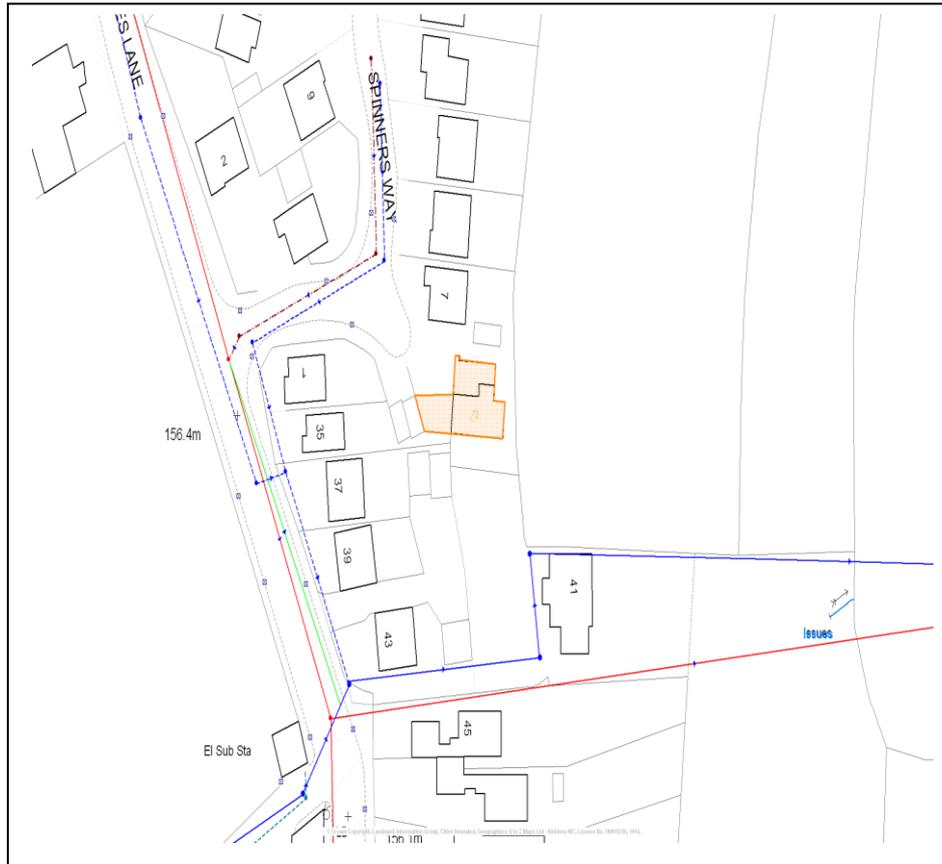
Yorkshire Water Drainage Systems – The plan above shows the recorded extent of the public sewer network in the area. The thicker red lines are the main combined (foul and surface water) public sewers. The dotted blue lines are surface water public sewers. The dotted brown line is a foul public sewer. The solid green line is an abandoned public sewer overflow.

Kirklees Council Drainage – The council is responsible for the road gullies in the public highway (indicated with small blue squares on the plan) and their piped connections to the public sewer system. The council has records of a culverted watercourse to the south of the property, no details are held on record as to the construction of this watercourse. The council has no records of separate highway carrier drains in the vicinity.

Private Drainage - Connections from individual properties to the shared drainage remain the responsibility of the individual owners. These single property connections are generally unrecorded and are not shown on the plan. Watercourses passing through private land are the responsibility of said land owners (riparian ownership)

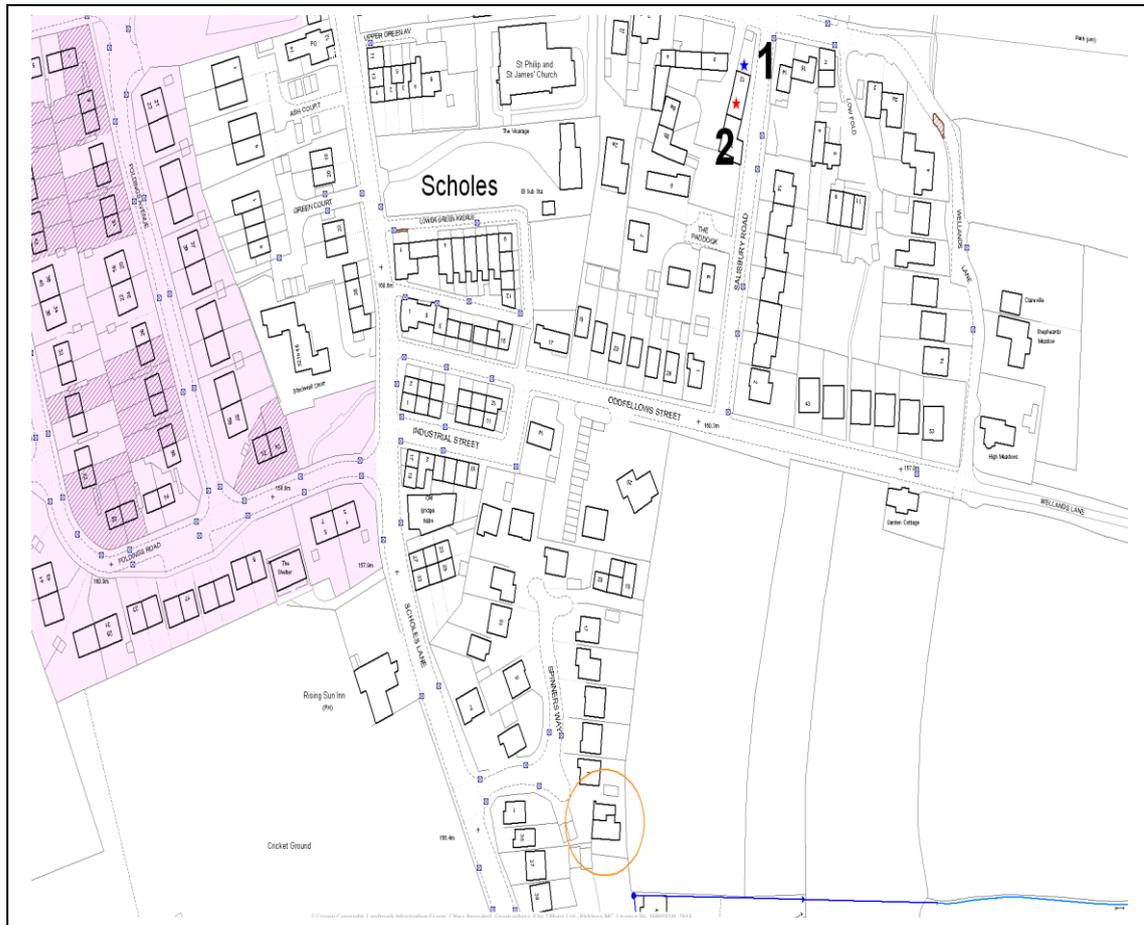
Location of Council recorded flood incidents near to 3-5 Spinners Way

Incident 1 – Cellar flooding, April 2012

Incident 2 – Cellar flooding, November 2012

In summary, there is little recorded history of flooding in the area, either to properties or overland surface flooding.
