Bat Survey Report
Spafield Mill
Batley

June 2015

Oatlands Ecology was commissioned by Tom W Beaumont Ltd to carry out an ecology survey at Spafield Mill Complex, Batley prior to the submission of an outline planning application for a change of use from industrial to residential.

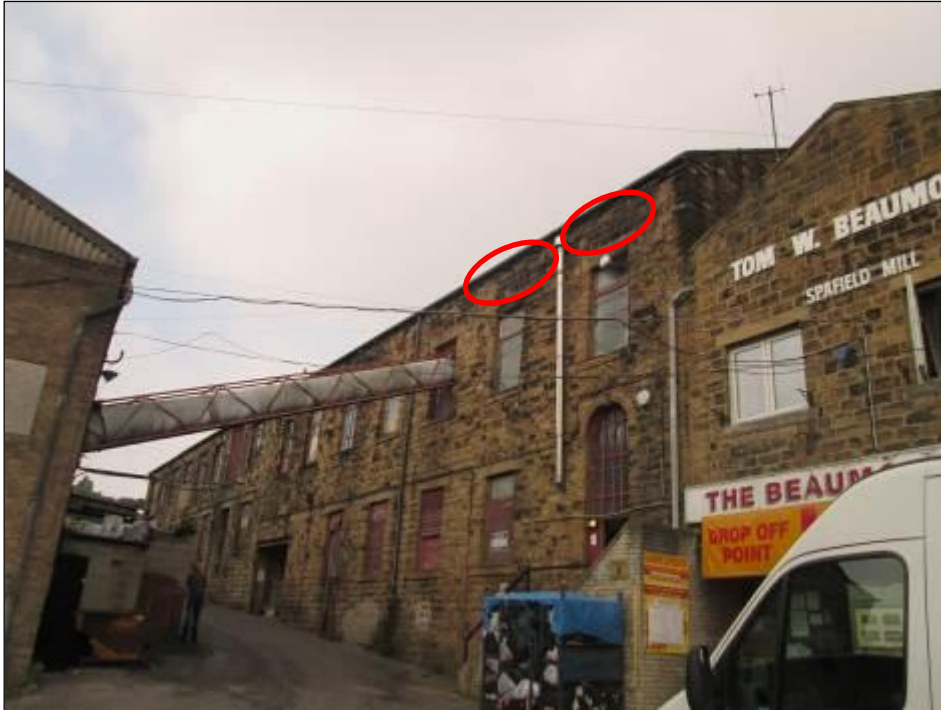
Photo A: Location of roost Unit 2

Photo B Location of roost Unit 2

Appropriate mitigation may include seasonal constraints, pre-works supervision and the inclusion of integrated cavity bat roosts within the new development.

The bats were observed emerging on two (of three) surveys from behind the wooden fascia supporting the guttering on the front (south) elevation and the roost is most likely to be either directly behind the fascia or within a wall crevice behind.

No large accumulations of droppings were observed during any survey which may be indicative of a large maternity roost. and this roost is considered to be a small non breeding day roost used by individual males or non-breeding female.

The survey results indicate the bats move to different (but very close) locations behind the fascia as environmental conditions dictate.

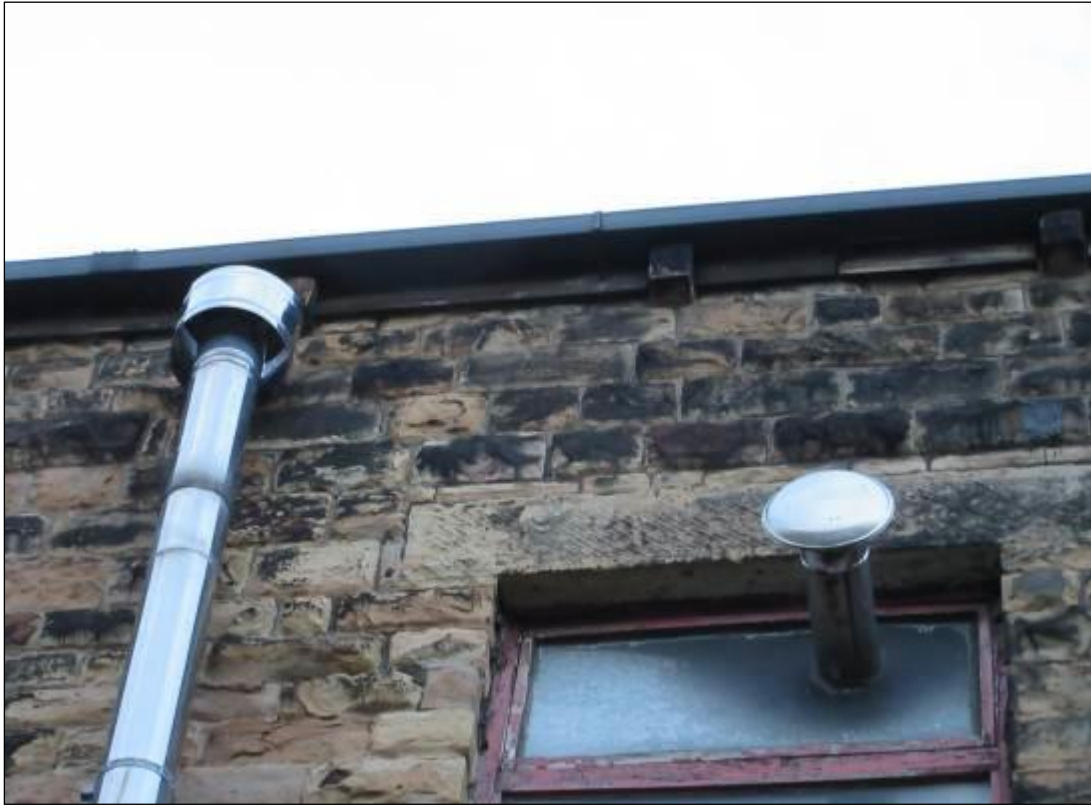
Photo C Close up of Facia

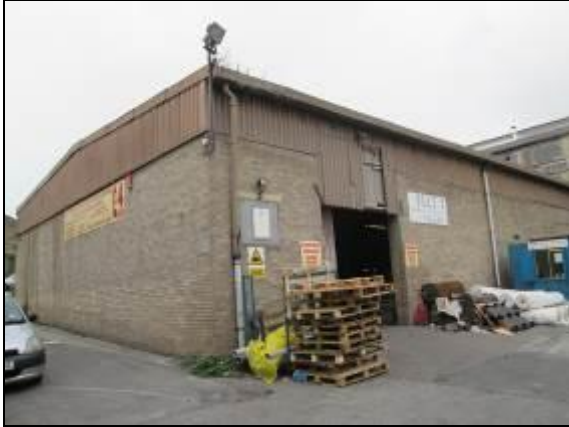
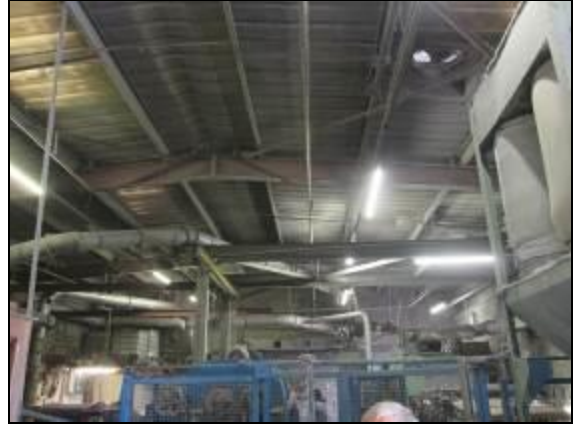
A large building constructed in the 1980s, it is an active industrial unit constructed of brick, corrugated steel panels and corrugated plastic roof panels supported on an internal steel frame. There are high levels of noise and vibrations throughout the day and late into the night.

Photo 1a: Unit 1 Front Mill - exterior

Photo 1b: Unit 1 Front Mill - interior

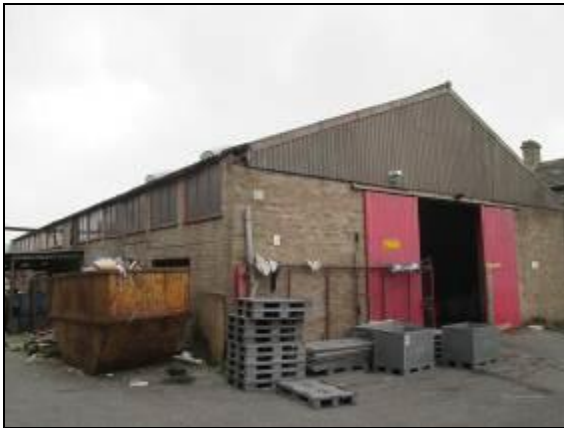
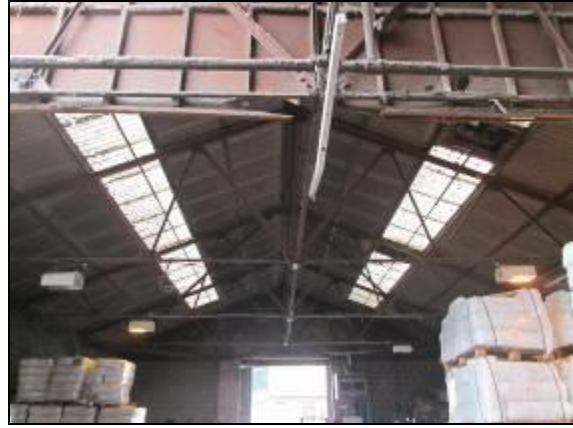
A similar, although somewhat larger and possibly older, building than Unit 1, it is constructed of brick, corrugated steel panels and corrugated plastic roof panels supported on an internal steel frame. There is a lower basement used as storage and the main upper section is open to the roof – as opposed to being divided into several stories.

Photo 2a: Unit 2 New Mill - exterior

Photo 2b: Unit 2 New Mill - interior

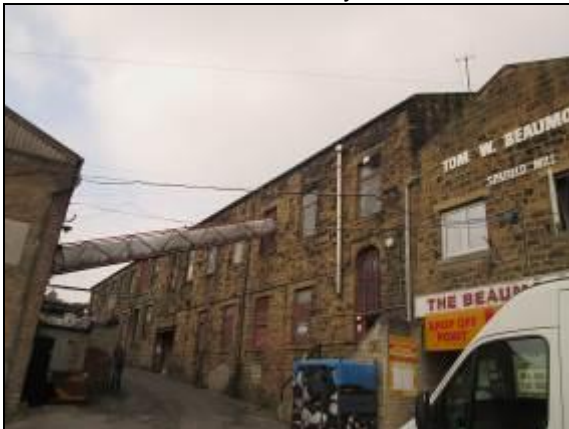
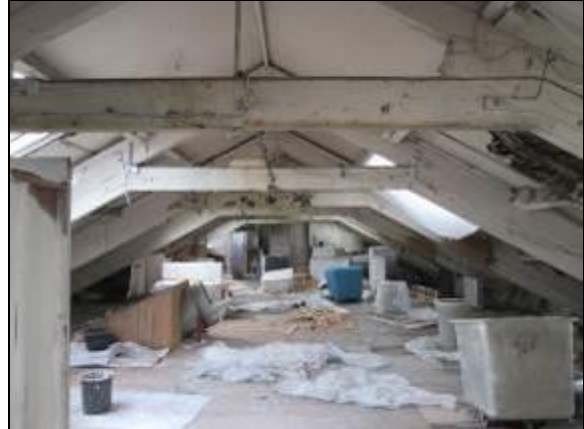
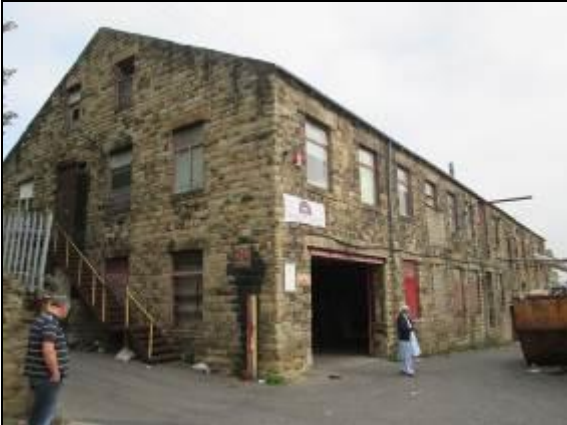
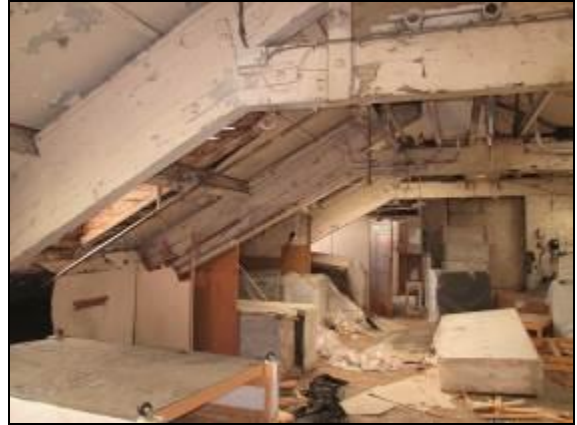
This is the oldest and largest building on the site. It is two joined buildings – the eastern half constructed in 1856 (Unit 3) and the western half (Unit 3) some years later in the early 1900's. Although designated as two distinct units for site administration purposes it is easier to describe as one unit for the purposes of this report.

The building is in a poor state of disrepair with many sections, including the upper floor almost derelict with collapsing ceilings; broken windows displaced masonry and pointing.

Gaps are present along the bottom of the exterior boards supporting the gutters, with further areas of missing mortar behind these boards, providing potentially suitable roosting features for bats and / or potentially leading into the cavity walls and internal roof structure.

Although no evidence of bats was observed, given the high number of potential roosting features present this building is considered to have a high potential to support bats.

Photo 3a: Unit 3: Three Story Mill - exterior

Photo 3b: Unit 3: Three Story Mill - loft

Photo 4a: Unit 4: Three Story Mill - exterior

Photo 4b: Unit 4: Three Story Mill - loft

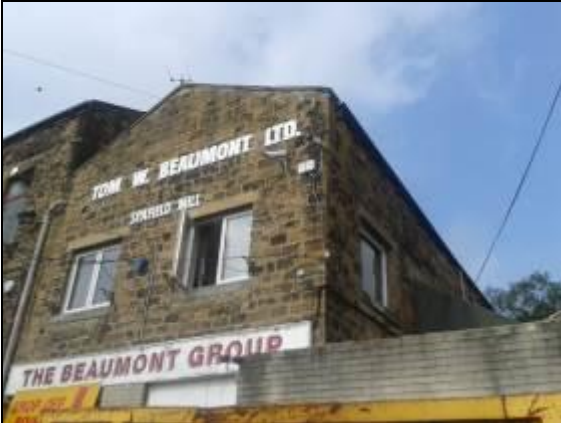
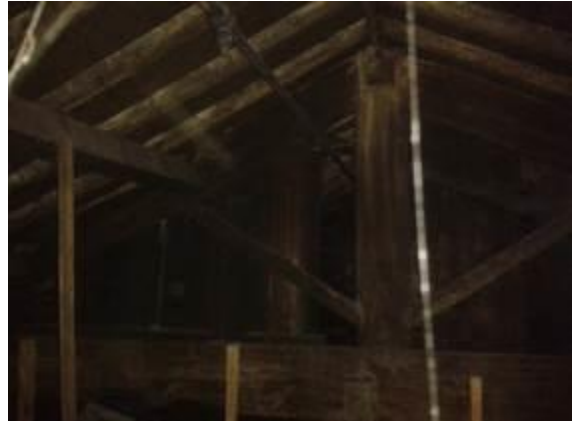
This is a small, two story building with a toilet / bathroom on the ground floor, offices on the first floor and a roof void, it is joined to Unit 3 (the eastern end of Three Story Mill) but is a more recent.

Unit 5: Offices is a stone structure abutting Units 3 & 4: Three Story Mill. All brick work and pointing was intact with no potential access points for bats observed. Although the roof void was lined, all roof tiles and ridge tiles were tight with no lifted or displaced tiles and no cavities or gaps behind the exterior boards supporting the gutters were observed.

Photo 5a: Unit 5: Offices - exterior

Photo 5b: Unit 5: Offices – roof void

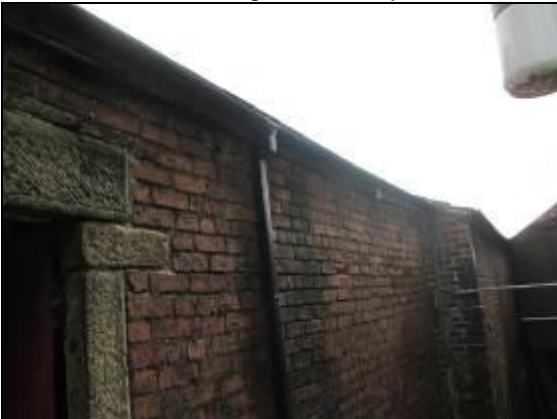
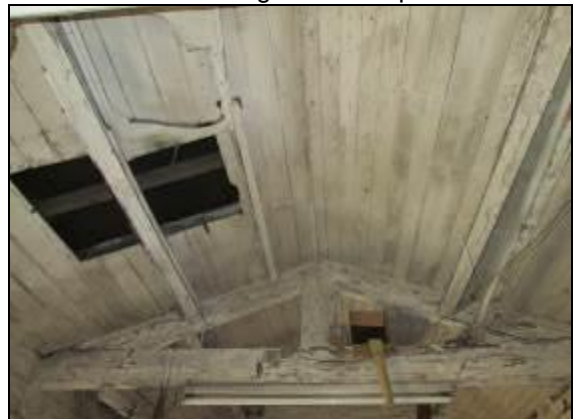
A small red brick building once used as an engineer's shop but now used to store a variety of equipment. It is a brick structure with a till roof supported by a wooded roof frame.

Unit 6: Engineers Shop is a low building constructed of red brick with no cavity wall. All brick work and pointing was intact with no potential access points for bats observed. There were no cavities or gaps behind the exterior boards supporting the gutters and all roof tiles were tight with no lifted or displaced tiles observed.

Photo 6a: Unit 6: Engineers Shop - exterior

Photo 6b: Unit 6: Engineers Shop - interior

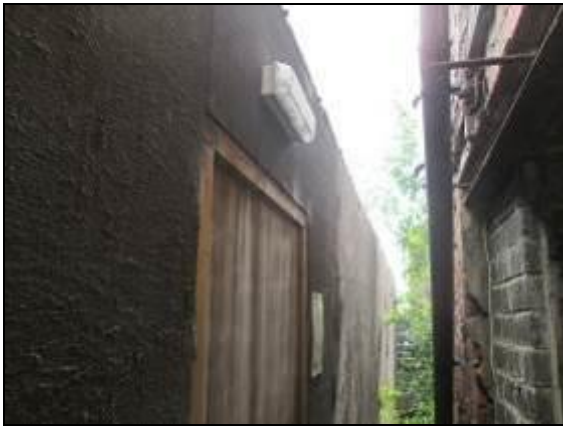
A painted plywood prefabricated building with a tin roof. It was once used as the staff canteen and is now disused.

Unit 8: Canteen is a disused single story prefabricated structure constructed from plywood and a tin roof. The exterior panels, windows and roof are all intact and the structure is painted and sealed. No potential access points for bats were observed.

Photo 8a: Unit 8: Canteen - exterior

Photo 8b: Unit 8: Canteen - exterior

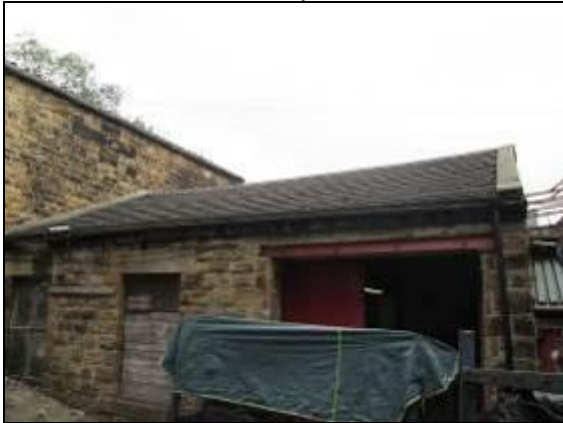
A small building connected to both Units 10 (Old Mill) and Unit 7 (Boiler House). It is an old sandstone building (age unknown) with a tiled roof supported by a wooden roof frame. The internal roof is open to the ceiling (as opposed to being divided into several floors) with the roofing felt visible from the inside.

Once used as the mill laundry is it now used to store and sort large quantities' of second hand textiles.

Photo 9a: Unit 9: Laundry - exterior

Photo 9b: Unit 9: Laundry - interior

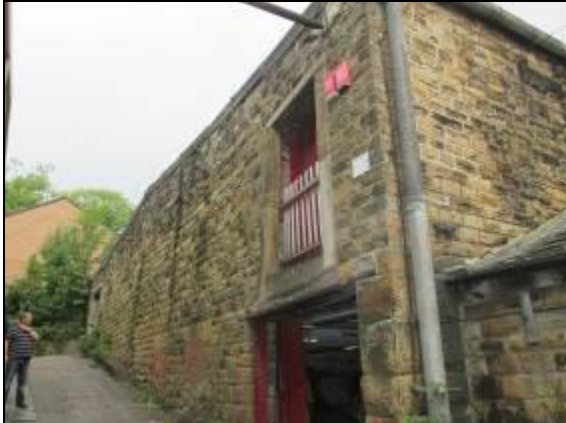
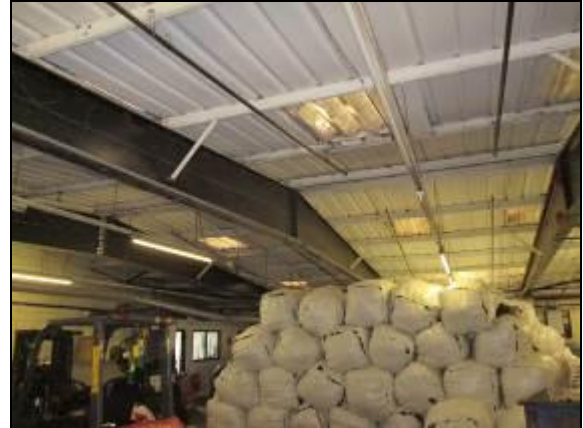
Although once an older building this was rebuilt in the 1960s after a fire. Although the original stone exterior has been retained the majority of the structure, including the roof, is constructed of corrugated steel panels supported by an internal steel frame.

Photo 10a: Unit 10: Old Mill - exterior

Photo 10b: Unit 10: Old Mill - interior

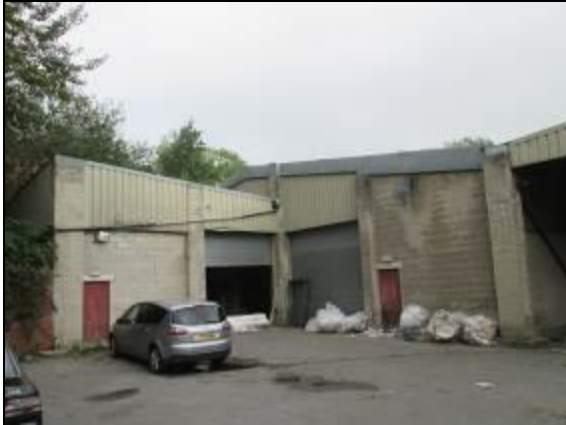
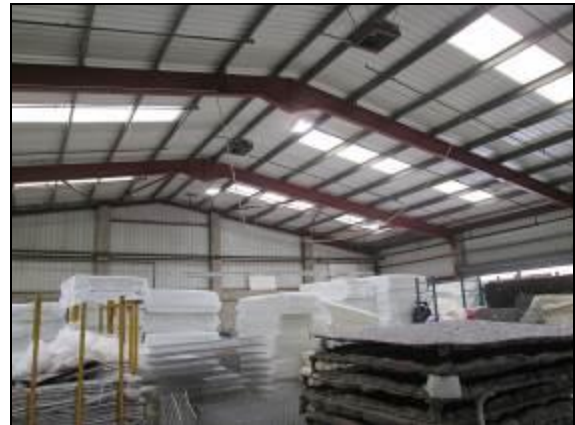
A large building constructed in the 1980s, it is constructed of brick and corrugated steel panels, including the roof, supported by an internal steel frame. There are high levels of noise and vibrations through the day and late into the night.

Photo 11a: Unit 11: New Rear Shed - exterior

Photo 11b: Unit 11: New Rear Shed - interior

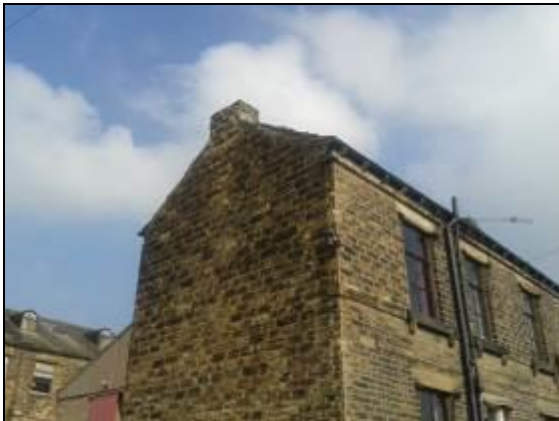
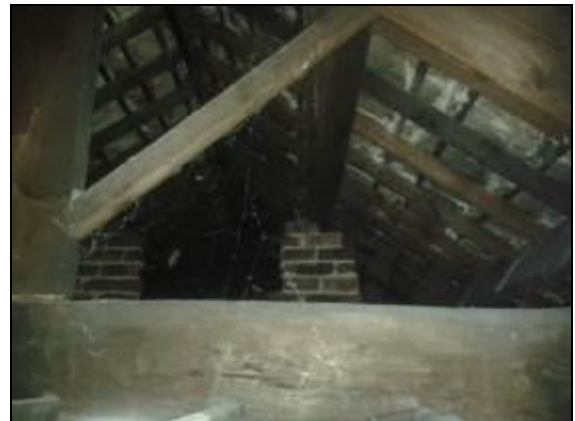
A two story, 3 bedroom house constructed in the 1800's set in own grounds and divided from the main mill complex by a fence surrounding a small garden.

This is a two story, three bedroom house located in its own grounds within the mill complex. The exterior walls were easily surveyed and all brick work and pointing appeared to be in good condition with few potential access points for bats observed.

Photo 12a: House - exterior

Photo 12b: House – roof void
