QUEENSGATE, HUDDERSFIELD.

BAT SURVEY.

Ref No:- 131219.

Date: 21st December 2013.

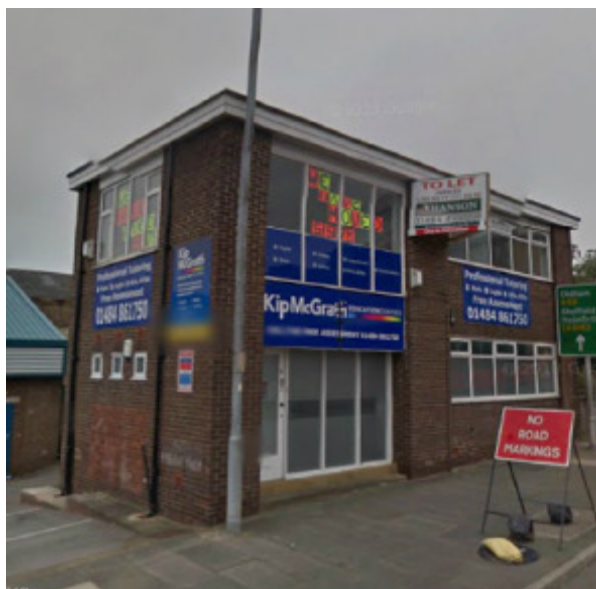
3.3.1. Building A.

3.3.1.1. Building A is a two storey shop unit constructed with brick cavity walls and a flat felt roof, as shown below.

3.3.1.2. The walls are in good condition with no cracks or crevices, the window and door frames are tight fitting and the flat roof unsuitable for roosting bats.

3.3.1.5. The building is assessed as having no potential for roosting bats.

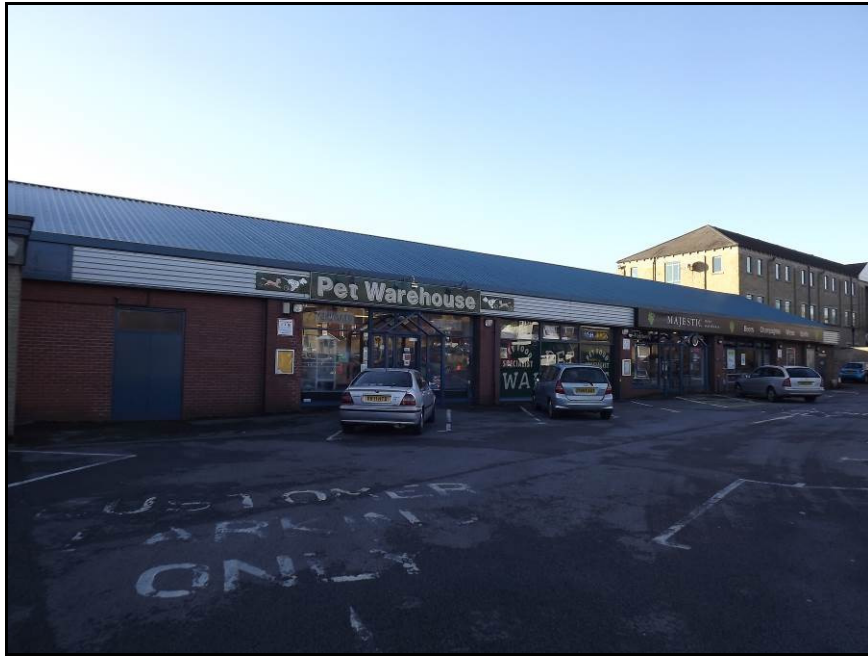
3.3.2. Building B.

3.3.2.1. This is a long building, single story on the northern frontage and two storeys at the rear. The walls are constructed from brick although the front walls are all concealed behind decorative shop fascias. The pitched roof is covered with tin sheeting that appears to be fairly new.

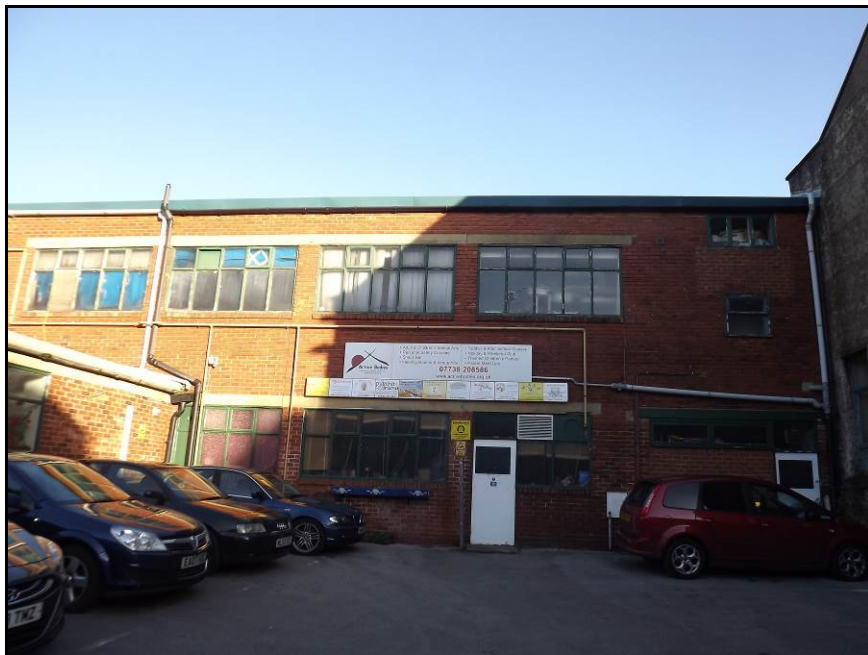
3.3.2.2. To the rear, the brick cavity walls are exposed, as shown below. The walls are in good condition with no visible cracks or crevices, the windows are all tight fitting and the eaves well sealed.

3.3.2.4. No bat field signs were identified around this building and the building is assessed to have no potential for roosting bats.

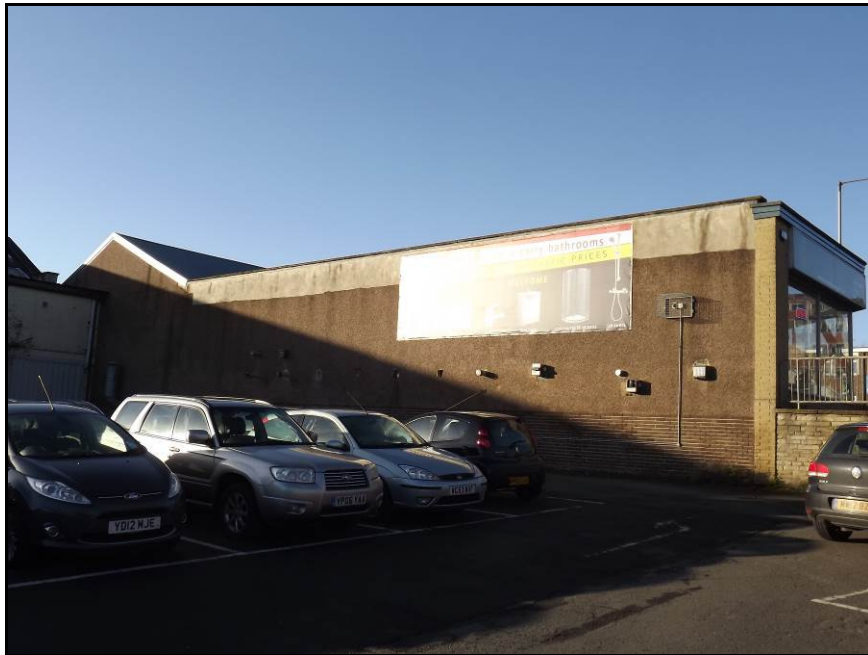
3.3.3. Building C.

3.3.3.1. Building C is a flat roofed extension of Building B with the single frontage used as a retail outlet. The western end wall is exposed and is rendered throughout, as shown in the photograph below.

3.3.3.3. No bat field signs were identified around this building and the building is assessed to have no potential for roosting bats.

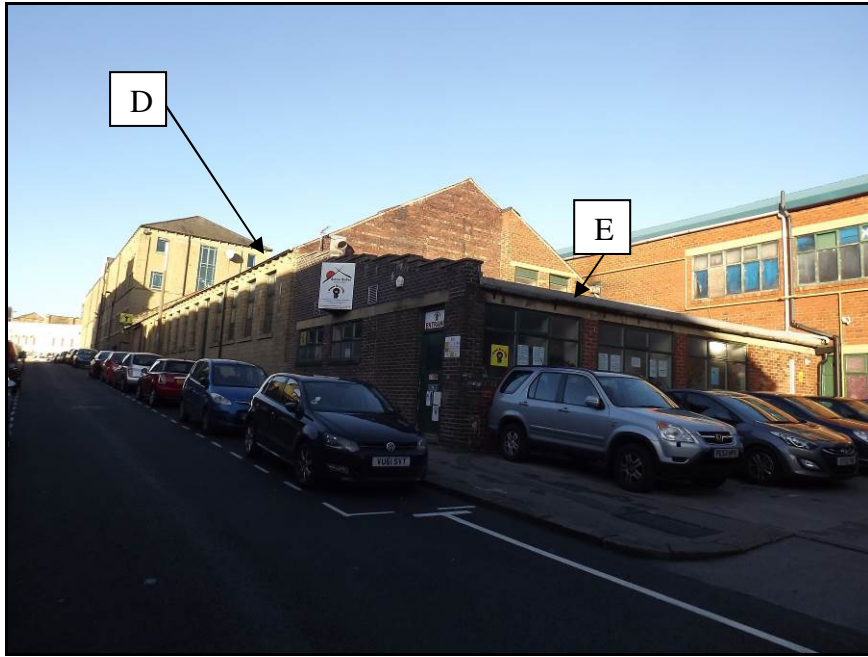
3.3.4. Building D.

3.3.4.1. Building D is a single storey building with walls of cut and coursed stone except for the eastern gable end wall and that is built with brick. The roof is a pitched roof, part covered with Welsh slate, part skylights and part corrugated sheets.

3.3.4.2. The walls are well pointed with no cracks or crevices to provide opportunities for roosting bats. There is a timber fascia board along the southern elevation that is close fitting and there are well pointed coping stones on top of both gable walls.

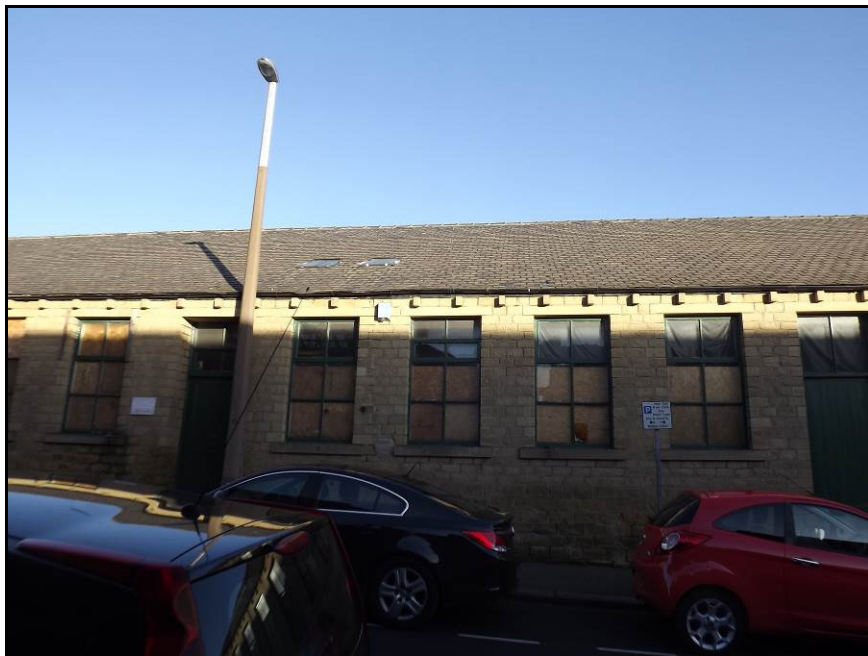
3.3.4.3. The south elevation of the roof is covered with Welsh slates throughout. These are generally in good condition although there are some slipped and missing slates. The ridge tiles are all in place and generally well pointed although there are a couple of small areas of missing pointing.

3.3.4.6. No bat field signs were found in or around this building and the building is assessed to have a very low potential for roosting bats, confined to the opportunity for a small number of crevice dwelling bats beneath the slipped roof slates.

5.2. As a precautionary measure, it is recommended that a further dusk emergence survey be carried out to determine whether there are bats roosting in the roof of Building D before demolition works commence on this building. The survey should be carried out between May and August.

5.3. If bats are found to be roosting in Building D, a Natural England licence application would need to be obtained before works commence on this building. The application for that licence would need to contain full details of the timings of the works and the way in which bats would be maintained at their existing conservation status. This would include the provision of replacement roost opportunities in the new buildings.

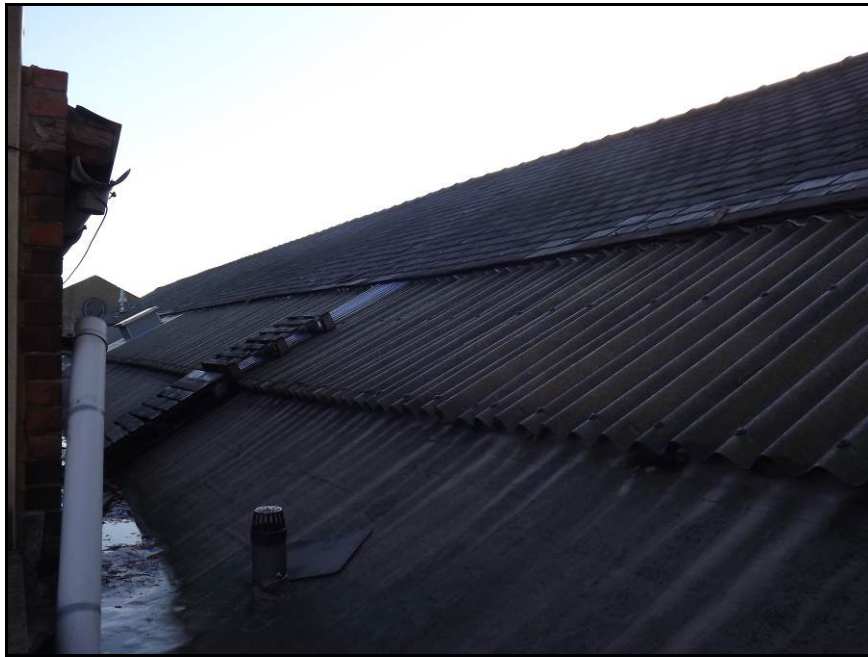
3.3.4.4. The northern elevation of the roof is covered with Welsh slate with a strip of corrugated plastic sheeting below that and then a strip covered with felt along the bottom, as shown in the photograph below. There are a few missing and slipped slates but otherwise the roof is generally in good condition.

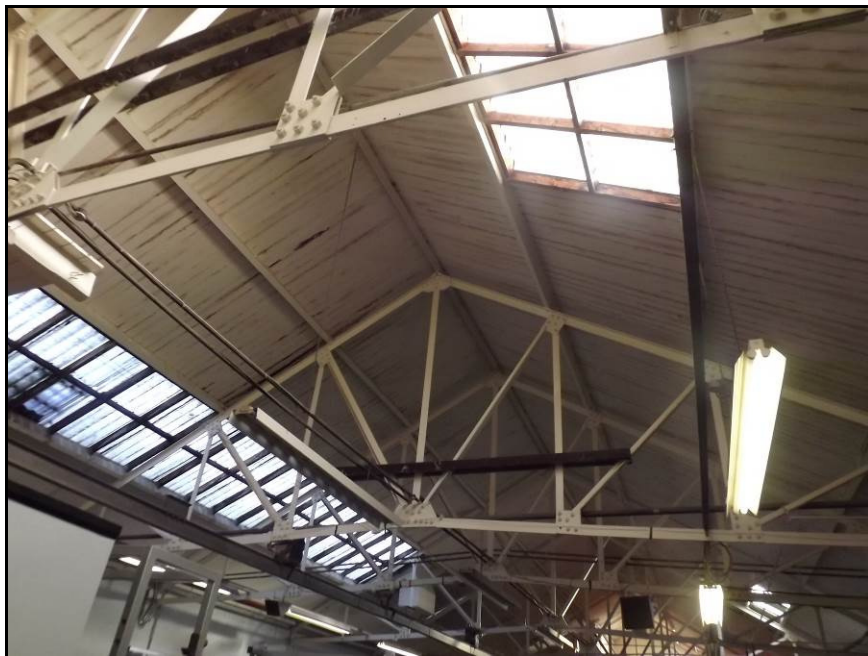
3.3.4.5. Internally this building is used as a gymnasium and is open to the underside of the roof. The roof is supported on a metal frame and is underdrawn with timber. The timber is intact but there are signs of damp along many of the joints.

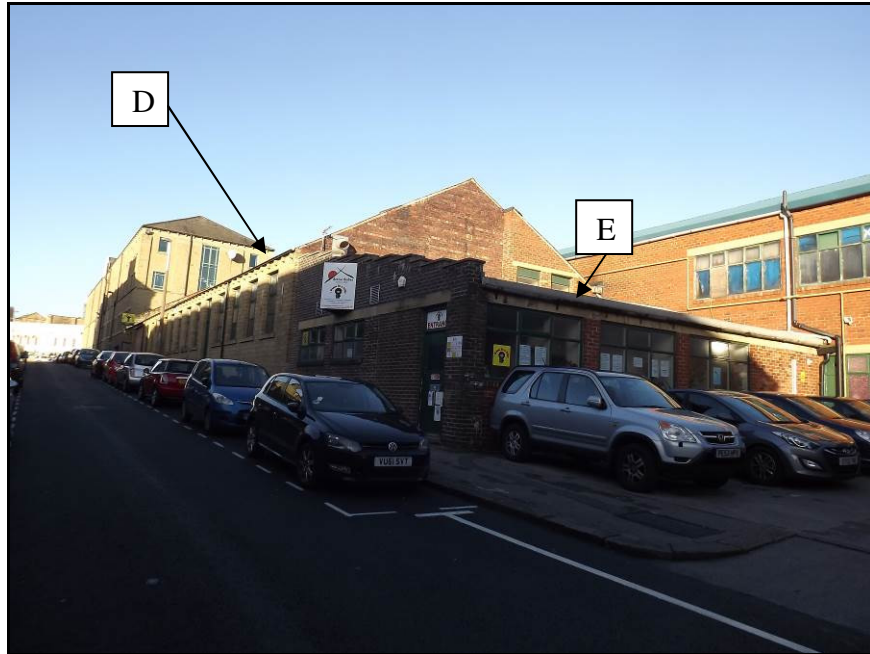
3.3.5. Building E.

3.3.5.1. Building E is a lean-to, single storey extension on the eastern end of Building D. The building has brick walls with coping stones along the southern end of the gable and is joined to Building B at its northern end.

3.3.5.2. The walls are all in good condition with no cracks or crevices and the eaves are well sealed.

3.3.5.5. No bat field signs were identified and this building has no potential for roosting bats.
