**PHASE 1 & PHASE 2 GEOTECHNICAL AND
GEO-ENVIRONMENTAL SITE INVESTIGATION**

**LAND AT NEW MILL ROAD,
HOLMFIRTH**

PROSPECT ESTATES

39141-001

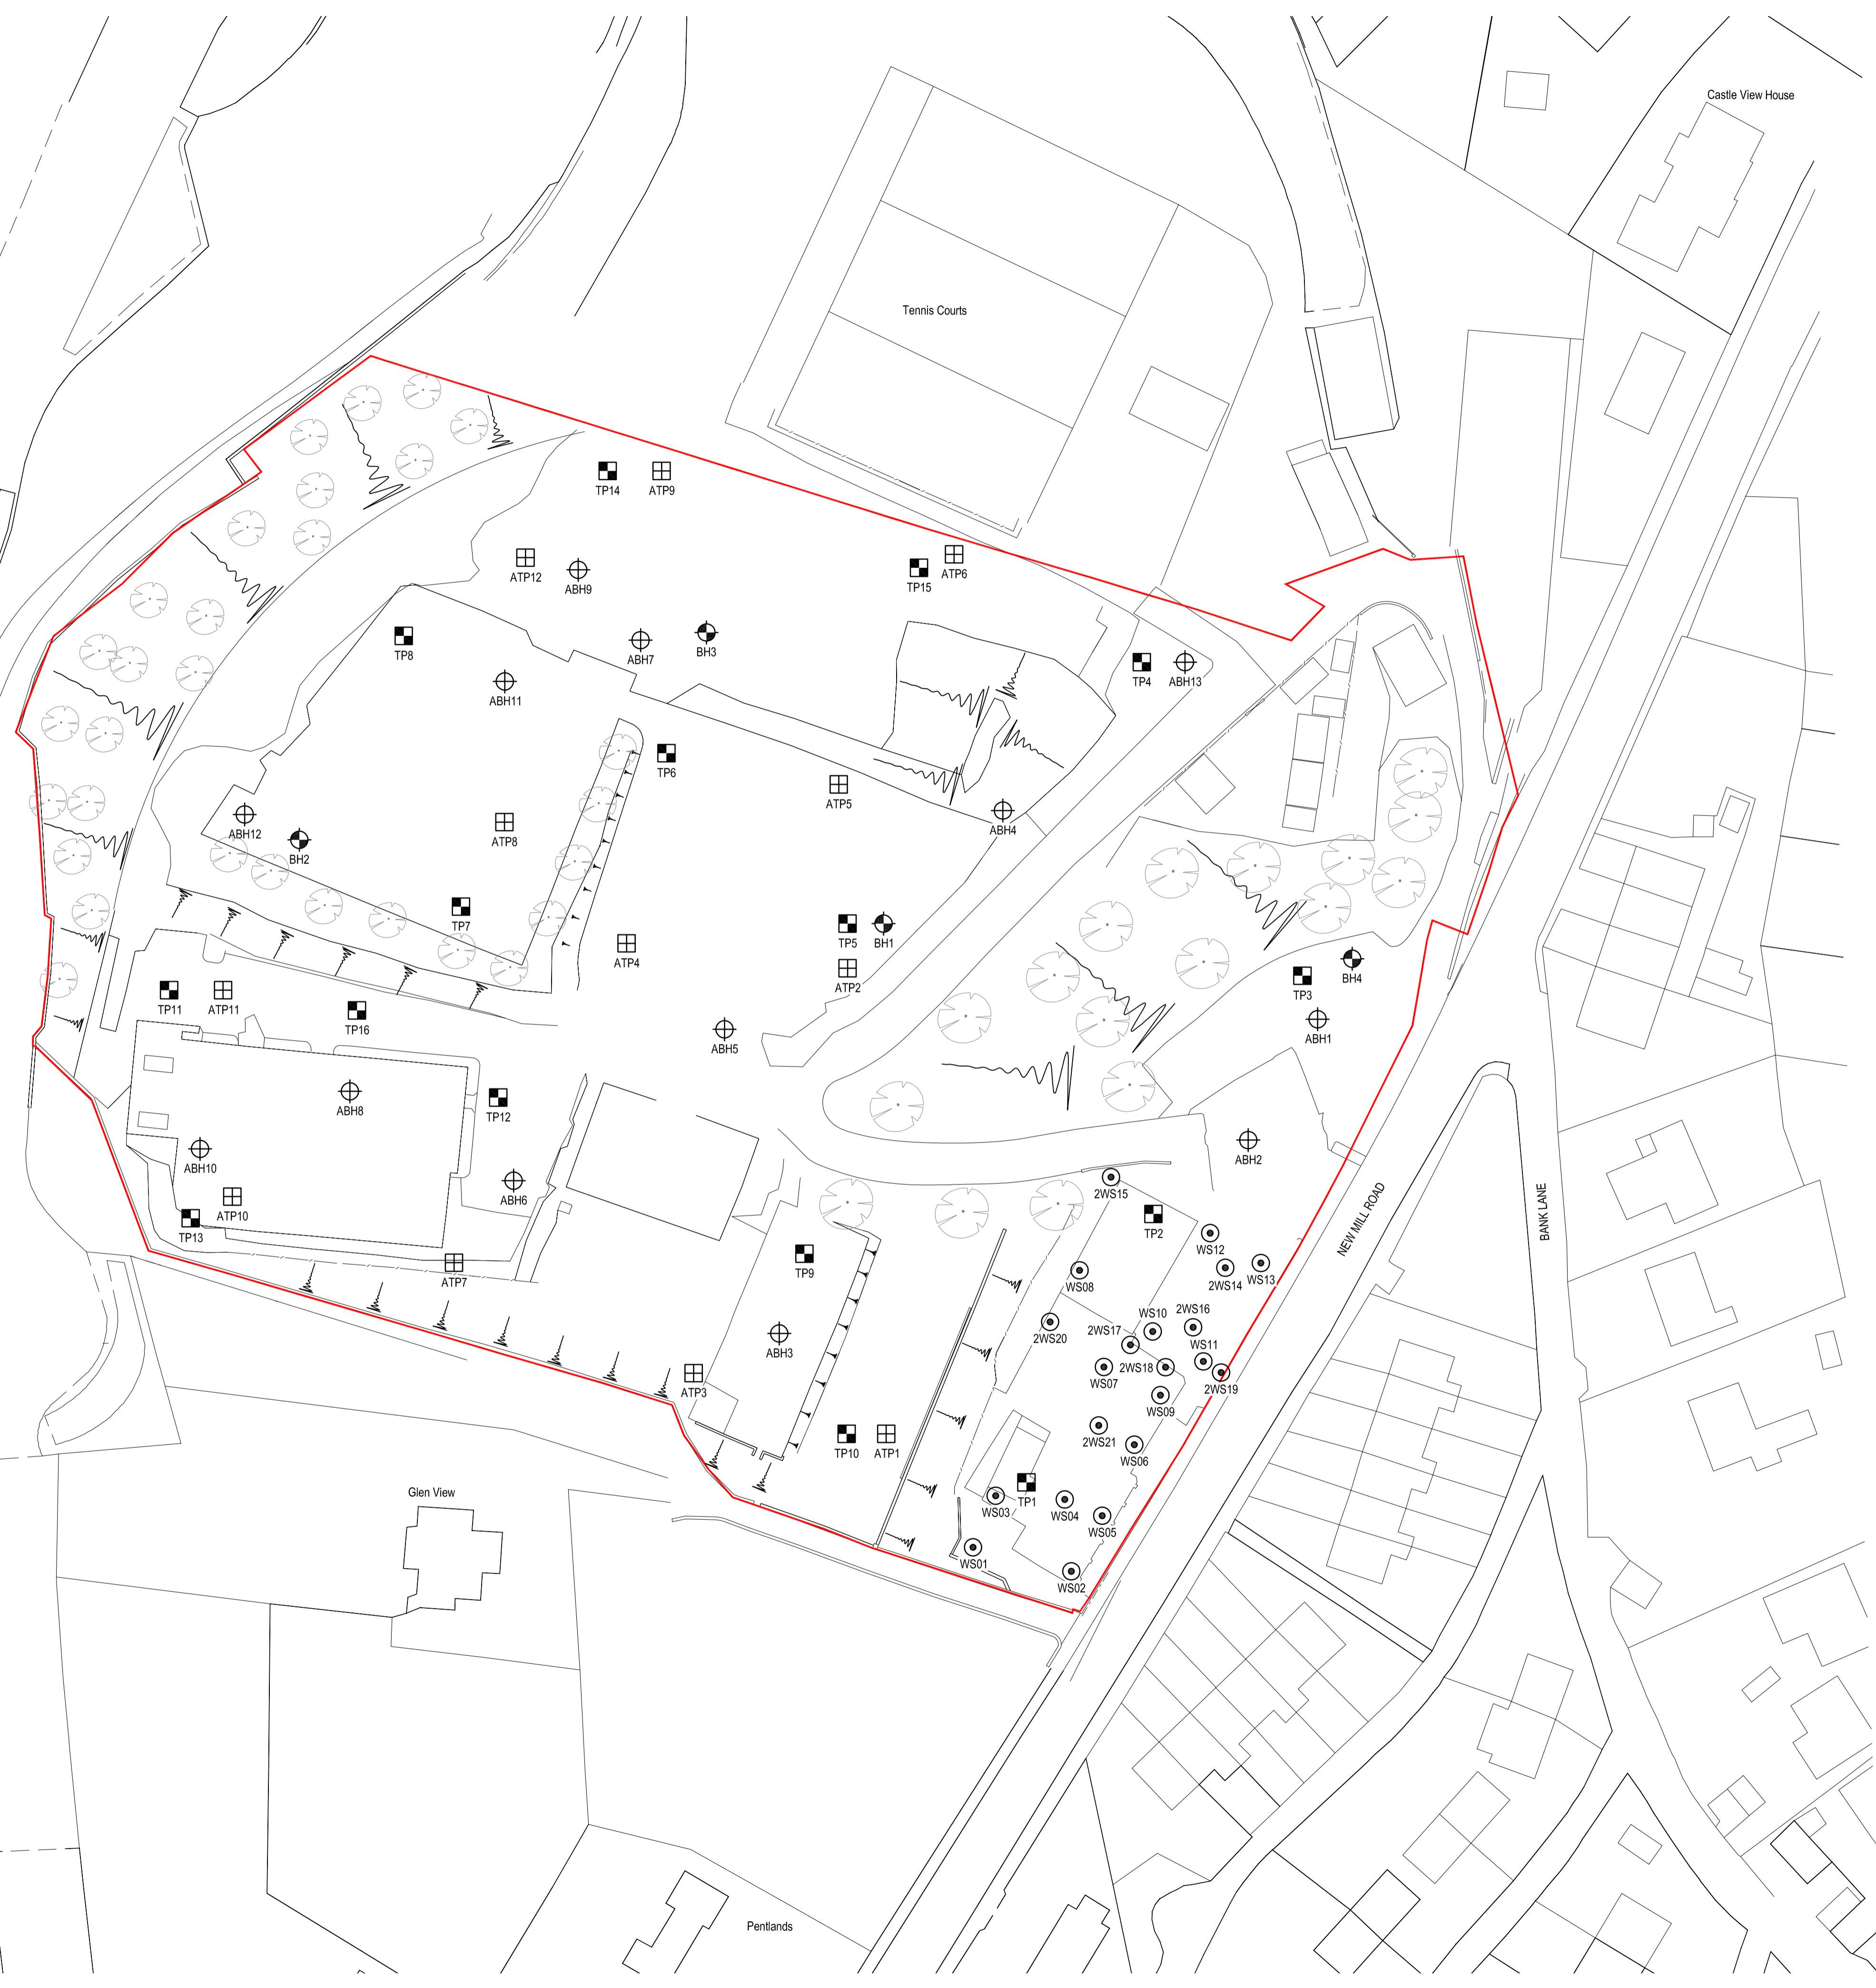
- Site Boundary.
- Approximate position of trial pit excavated by Eastwood & Partners on 28.10.15 and 29.10.15.
- Approximate position of cable percussion borehole drilled by Eastwood & Partners on 04.11.15 to 09.11.15.
- Approximate location of trial pit by Ian Farmer Associates in 2008.
- Approximate location of cable percussion borehole by Ian Farmer Associates in 2008.
- Approximate location of window sample by Ian Farmer Associates in 2008.

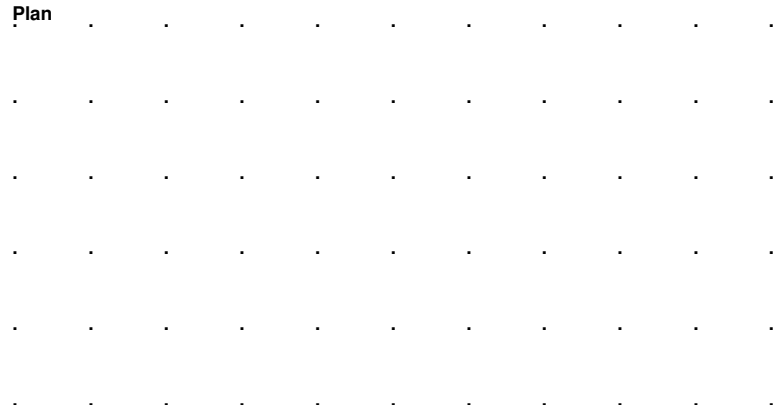
Remarks Trial pit remained dry throughout excavation. Major spalling between 0.00m and 0.50m.		
	Scale (approx) 1:50	Logged By GP	Figure No. 40349.TP02

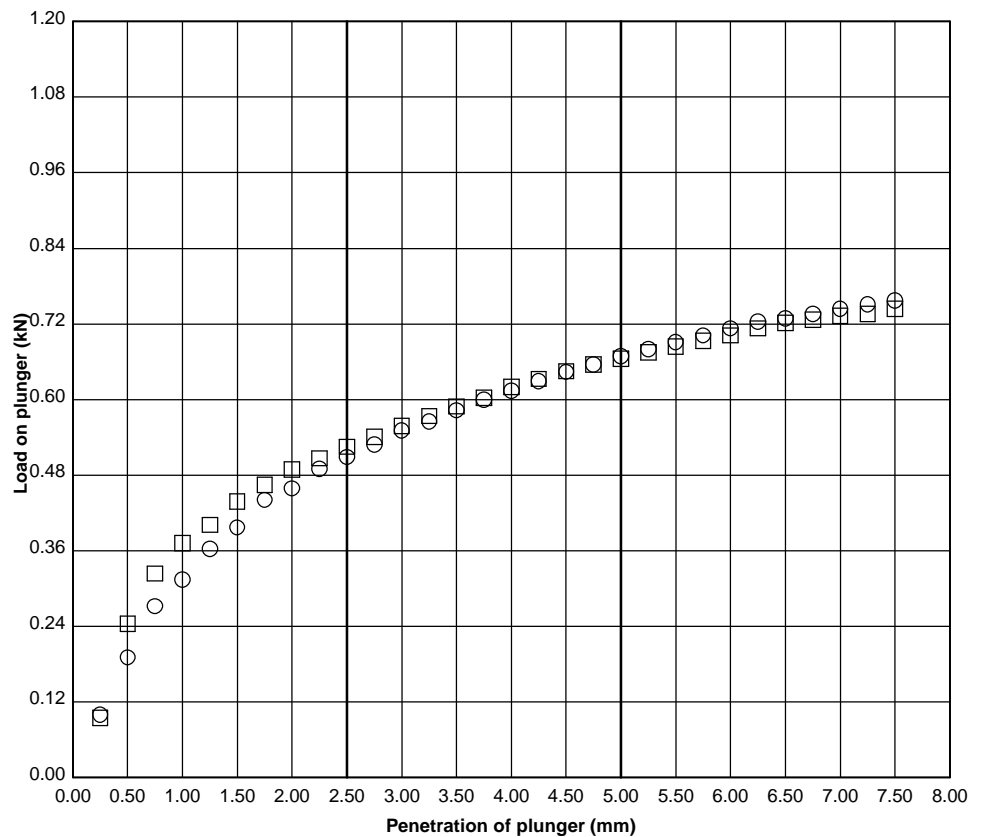
Test on	TOP	BOTTOM
Reported CBR %	4.0	3.9
Mean CBR %	4.0

Method of Preparation : The specimen was prepared by Dynamic compression using a 4.5 kg Rammer
BS 1377:PART 1:1990:7.6.1 General 1990:7.6.5 California bearing ratio test BS 1377:PART 4:1990:7.2 Preparation of test sample

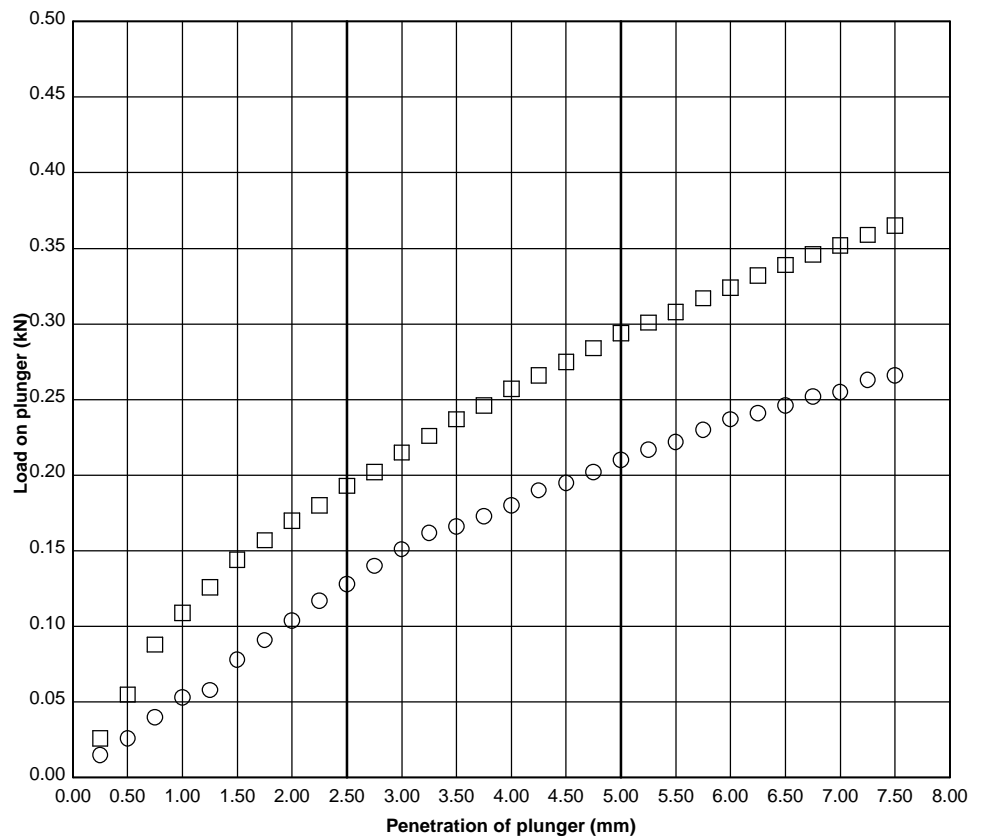
Test on	TOP	BOTTOM
Reported CBR %	1.5	1.0

Method of Preparation : The specimen was prepared by Dynamic compression using a 4.5 kg Rammer
 BS 1377:PART 1:1990:7.6.1 General 1990:7.6.5 California bearing ratio test BS 1377:PART 4:1990:7.2 Preparation of test sample

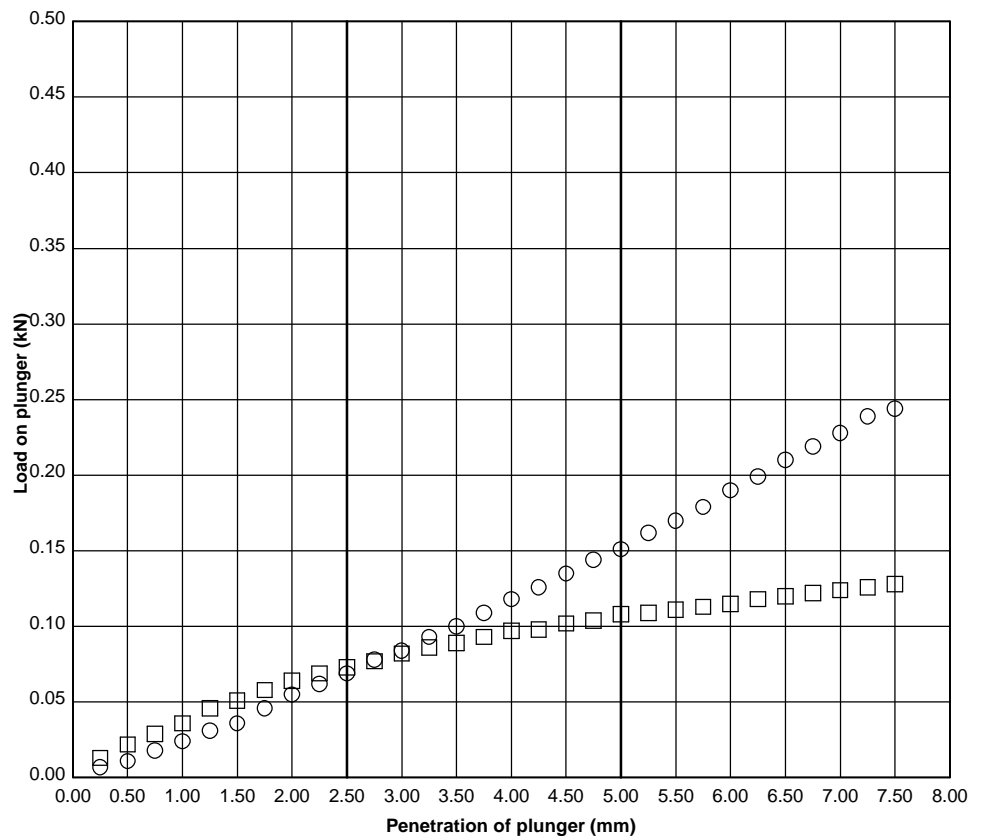
Test on	TOP	BOTTOM
Reported CBR %	0.55	0.76

Method of Preparation : The specimen was prepared by Dynamic compression using a 4.5 kg Rammer
 BS 1377:PART 1:1990:7.6.1 General 1990:7.6.5 California bearing ratio test BS 1377:PART 4:1990:7.2 Preparation of test sample

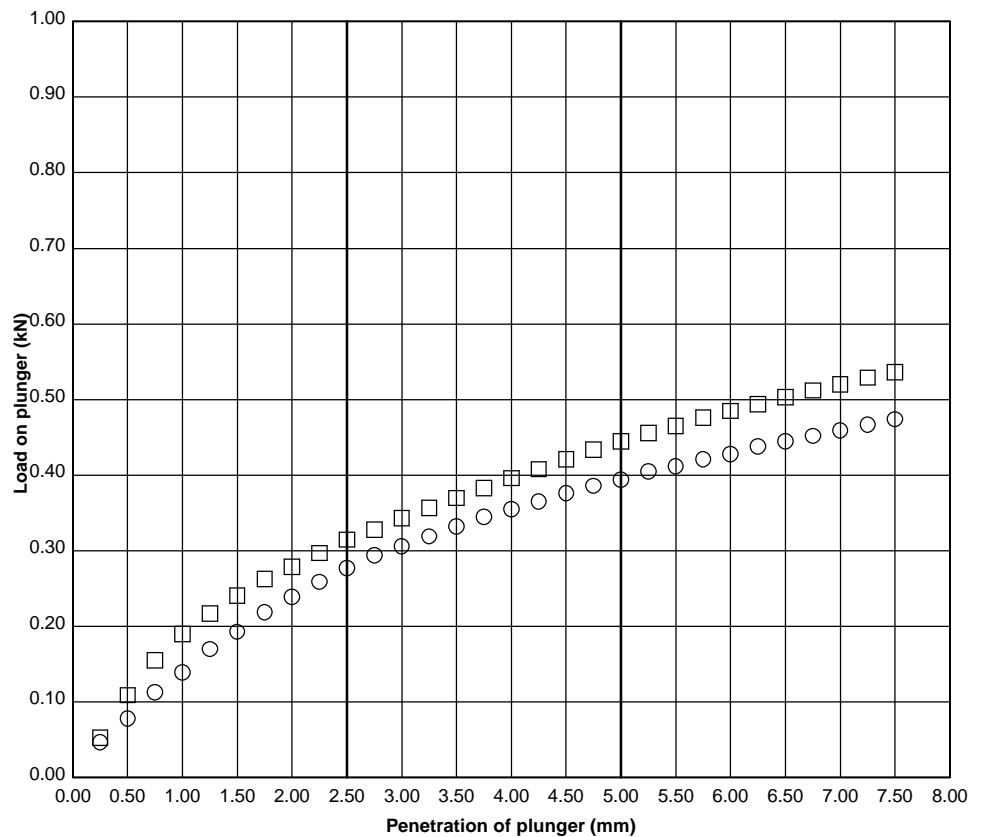
Test on	TOP	BOTTOM
Reported CBR %	2.4	2.1
Mean CBR %	2.2

Method of Preparation : The specimen was prepared by Dynamic compression using a 4.5 kg Rammer
 BS 1377:PART 1:1990:7.6.1 General 1990:7.6.5 California bearing ratio test BS 1377:PART 4:1990:7.2 Preparation of test sample

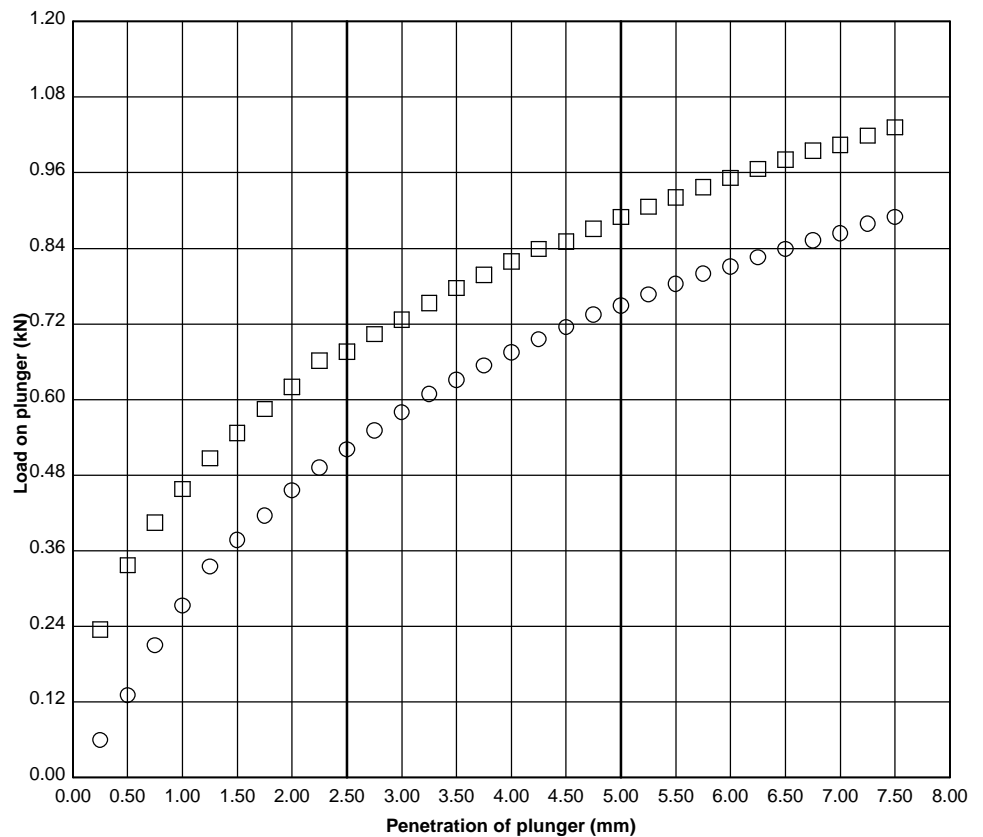
Test on	TOP	BOTTOM
Reported CBR %	5.1	4.0

Method of Preparation : The specimen was prepared by Dynamic compression using a 4.5 kg Rammer
BS 1377:PART 1:1990:7.6.1 General 1990:7.6.5 California bearing ratio test BS 1377:PART 4:1990:7.2 Preparation of test sample

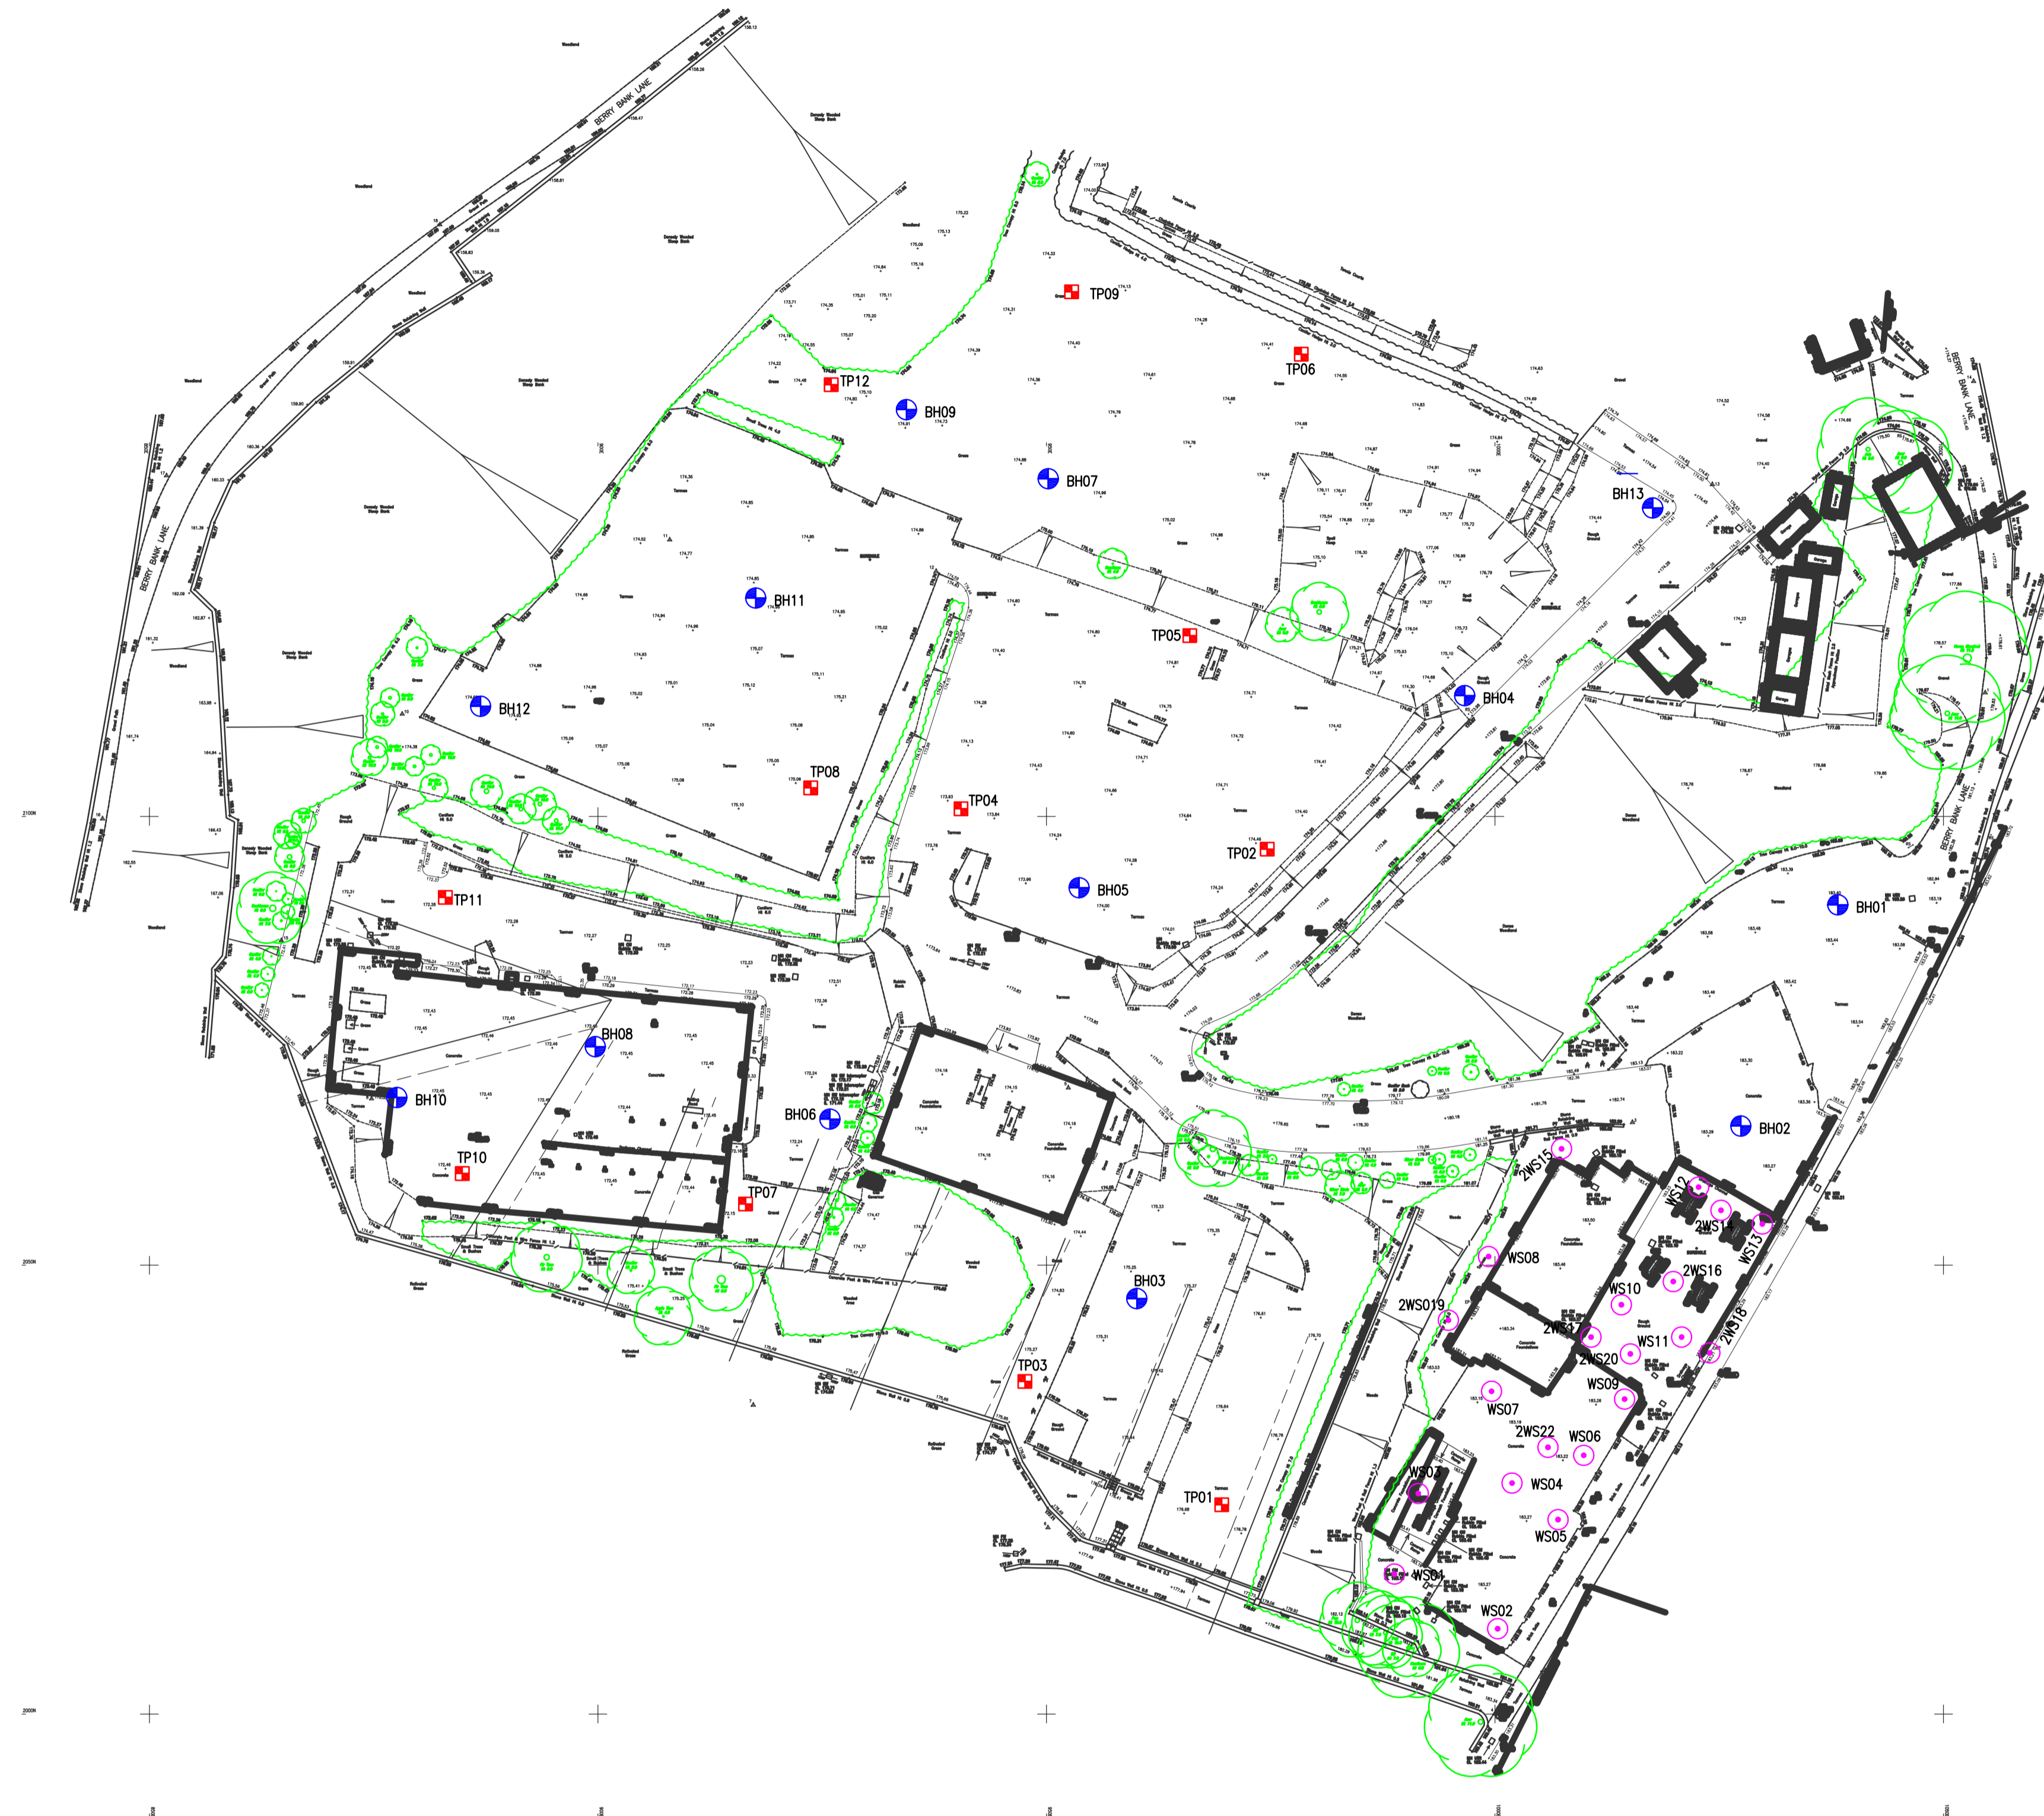
KEY	
	BH : CABLE PERCUSSION BOREHOLES
	WS : WINDOW SAMPLE BOREHOLES
	TP : TRIAL PIT
