# Conservation Management Plan Stage 1 - Conservation Statement

Huddersfield Grammar School,  
Royds Mount, Luck Lane, Huddersfield.

Our Ref: 10-036

Revised 26<sup>th</sup> February 2013

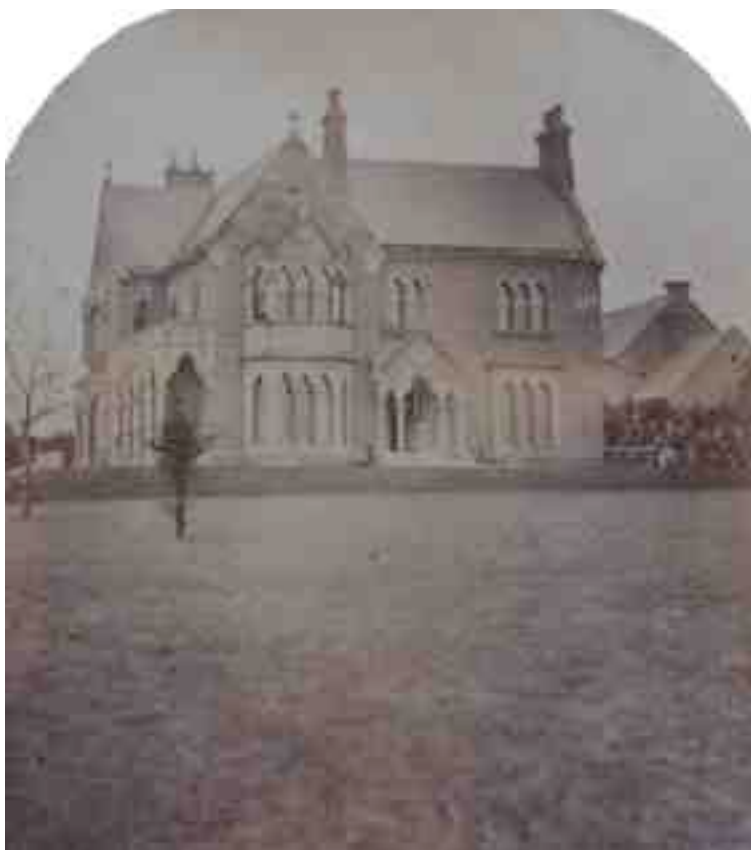
*Fig. 2. Royds Mount taken 1867. Note stable block to the right of the picture.  
(Source: Mrs Hughes)*

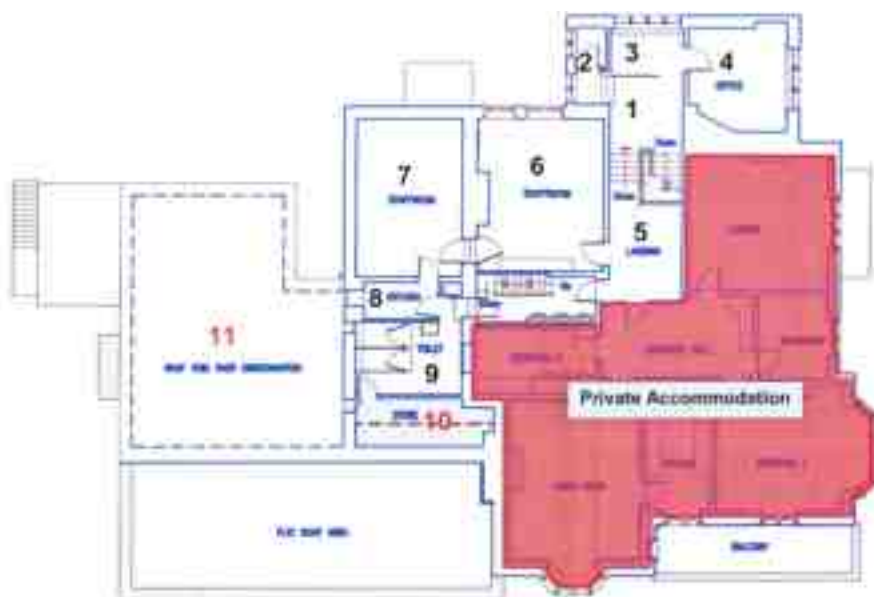
*Fig. 4. Mrs Wilson's private accommodation located on the first floor.  
(Source: Drawing from CARD Geotechnics)*

When Mrs Wilson retired, she continued to reside in her private accommodation within the house. This accommodation was partitioned off from the remaining house which continued to be used for the school. The private accommodation has now been integrated into the school.

The first floor originally comprised of bedrooms and bathrooms and then became a mixture of school facilities and living accommodation for Mrs Wilson (see fig 4) however this floor is now used by the teaching and administration staff.

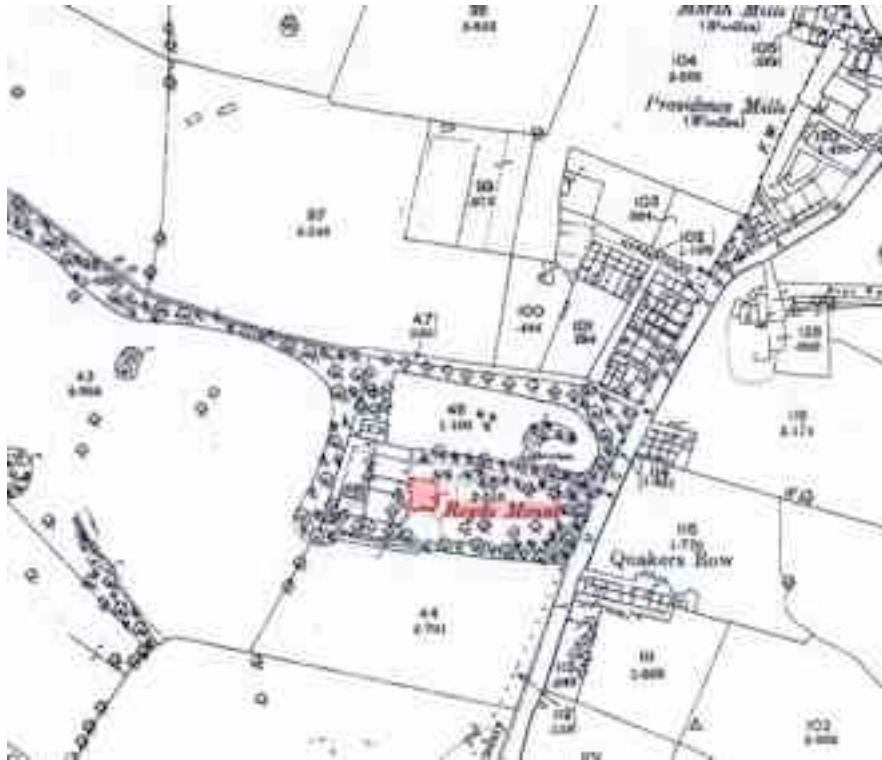
*Fig. ? 1893 Ordnance Survey map. The morphology of the house has altered.  
(Source: Huddersfield Reference Library)*

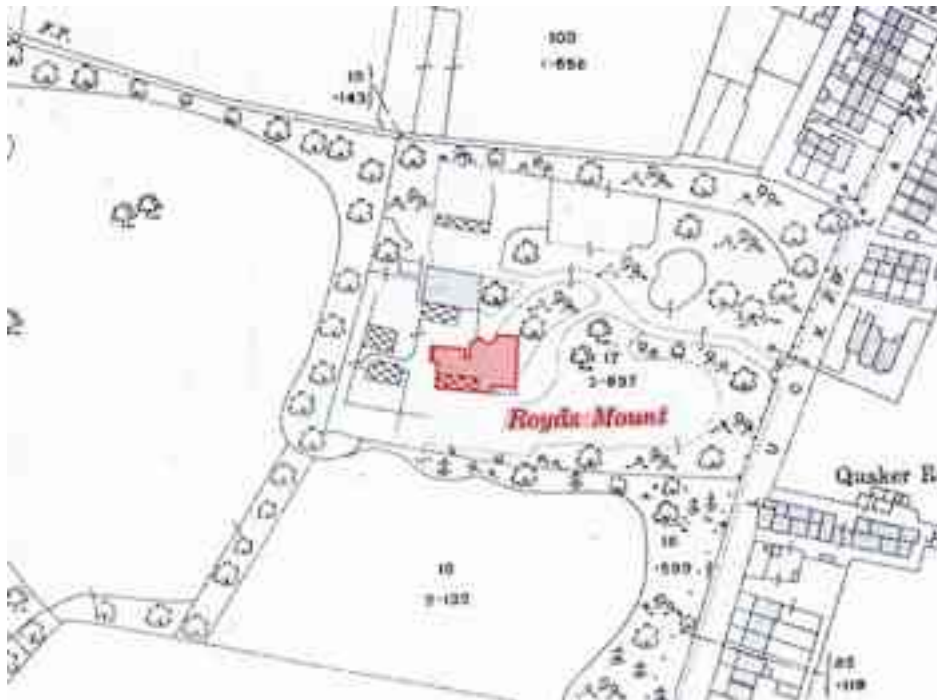
*Fig. 13. 1918 Ordnance Survey map. With this map we can clearly see the house has been extended. With a glass roof to the conservatory and the coach house being enlarged by the addition of the canopy and an extension to the rear.  
(Source: Huddersfield Reference Library)*

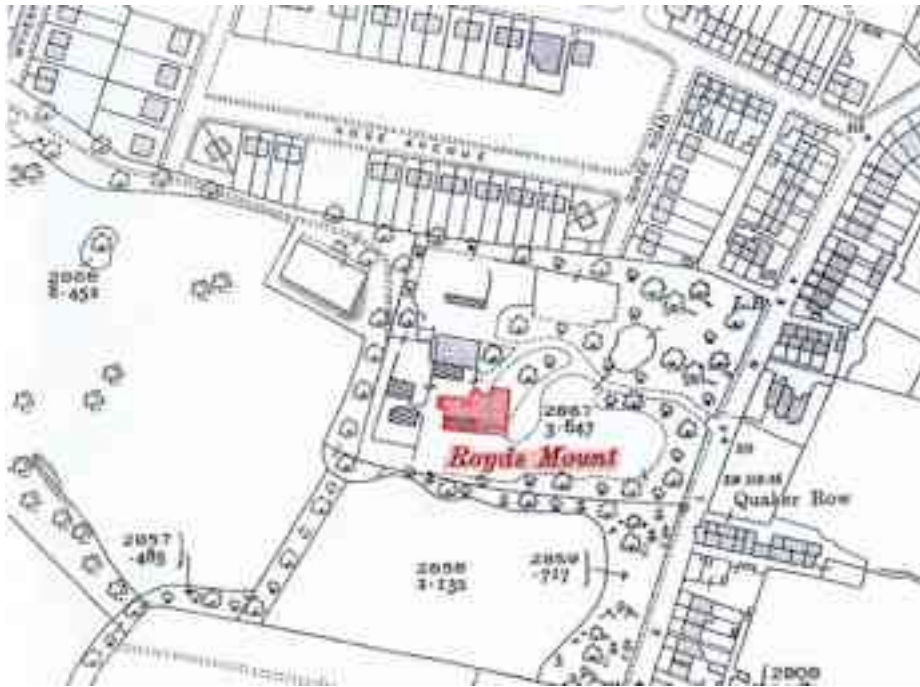
*Fig. 14. 1932 Ordnance Survey map. The house in terms of additions has remained the same when contrasted with the 1918 OS map however the areas which surround the grounds have started to be developed.*

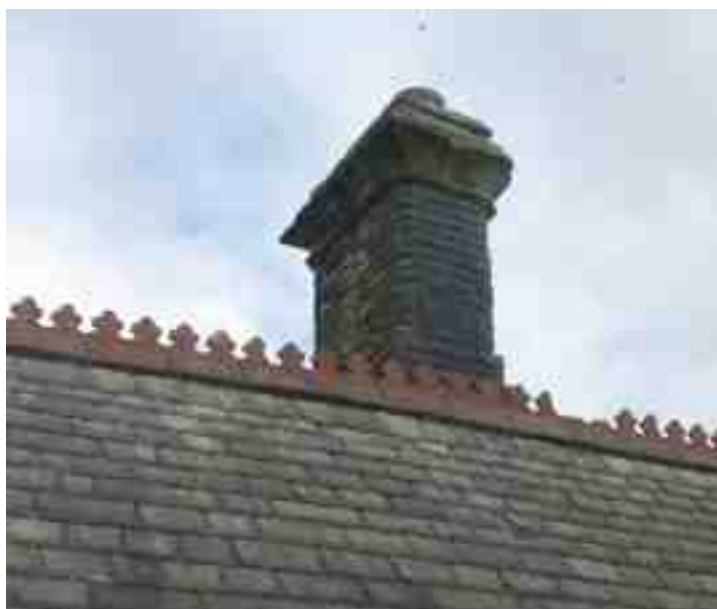
*Fig. 16. Terracotta ridge tiles and chimney stack with a later pot.*

Other embellishment on the building included two cats on the gable of the porch however these were stolen together with the porch leadwork several years ago.

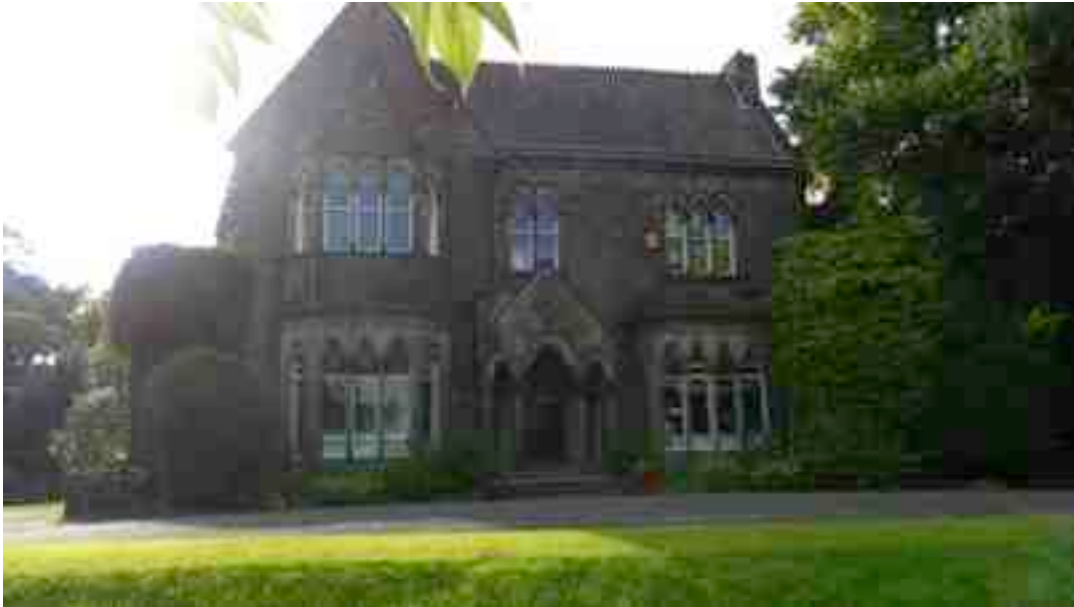
*Fig. 17. The imposing main entrance - east elevation.*

The original building is a good example of domestic Gothic architecture with trefoil windows, carved leaf capitals and a quatrefoil banding detail to the bay window on the entrance façade (east elevation). The south elevation is equally splendid in detail and includes a balcony which incorporates an ashlar stone quatrefoil balustrade. The balcony also forms part of the verandah of four arched bays all constructed from local sandstone with the work undertaken probably by local contractors.

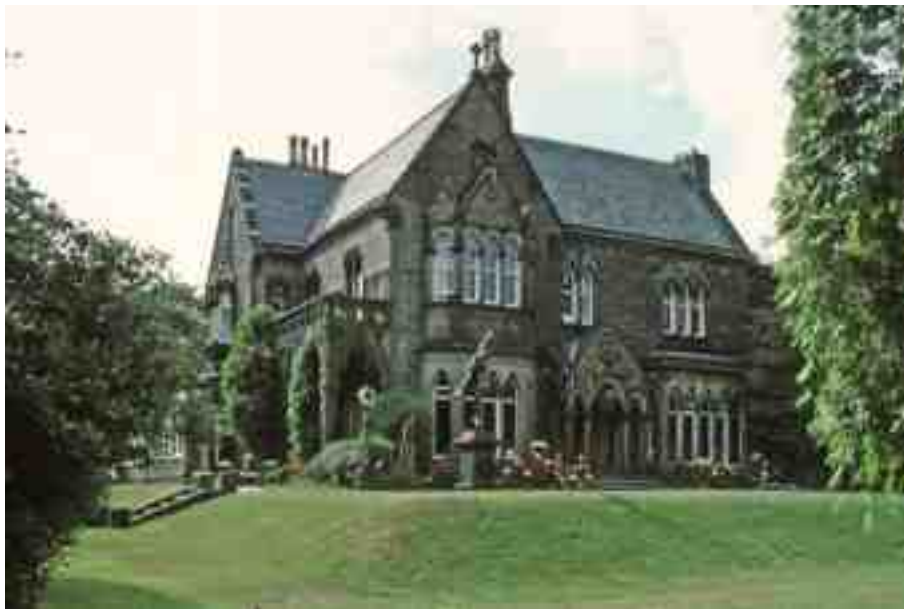
*Fig. 18. Royds Mounts in 1977. Note statue on the plinth and globe light both now gone.  
(Source: Anthony Lunn)*

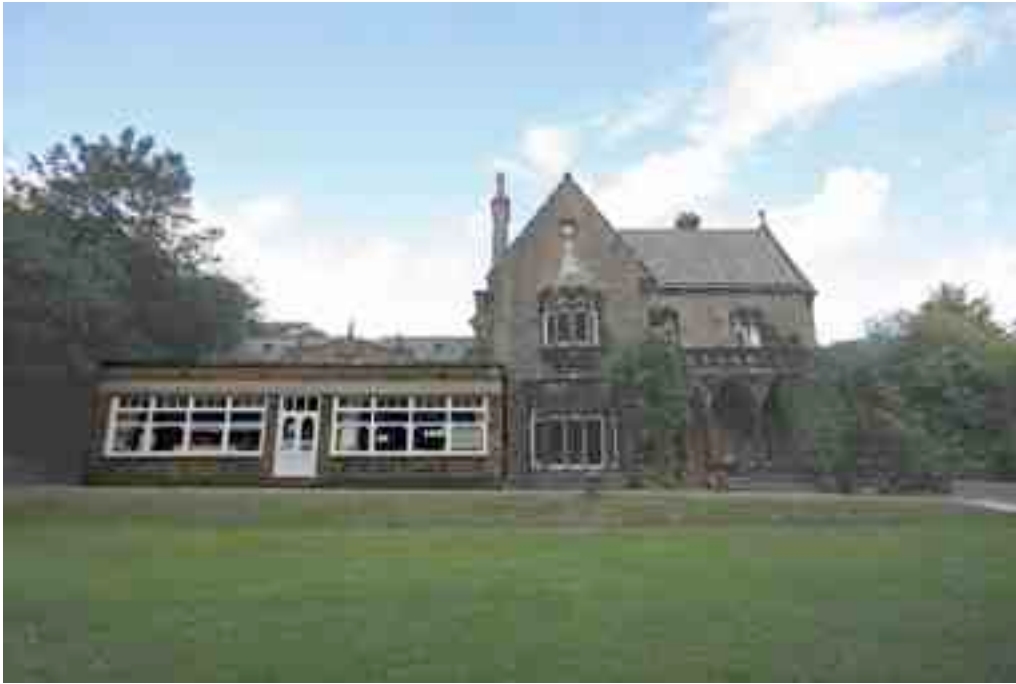
*Fig. 19. 20th Century addition. Also note veranda and balcony to the main house.*

Where the house has been extended it has largely been carried out sympathetically thus giving the impression of a single building phase. The exception of the single storey façade to the east elevation. This section of the building replaced an earlier conservatory and is heavy in its detailing, obscuring an earlier gable, partly visible over the roofline.

The verandah is a feature predominantly found on Victorian houses such as Royds Mount or country villas of the same period. It is an architectural feature which originated in India. The verandah allowed the occupants to relax when the weather was warm whilst giving shade from the sun and it was viewed as an outside living room. The verandah's roof is also used for a balcony.

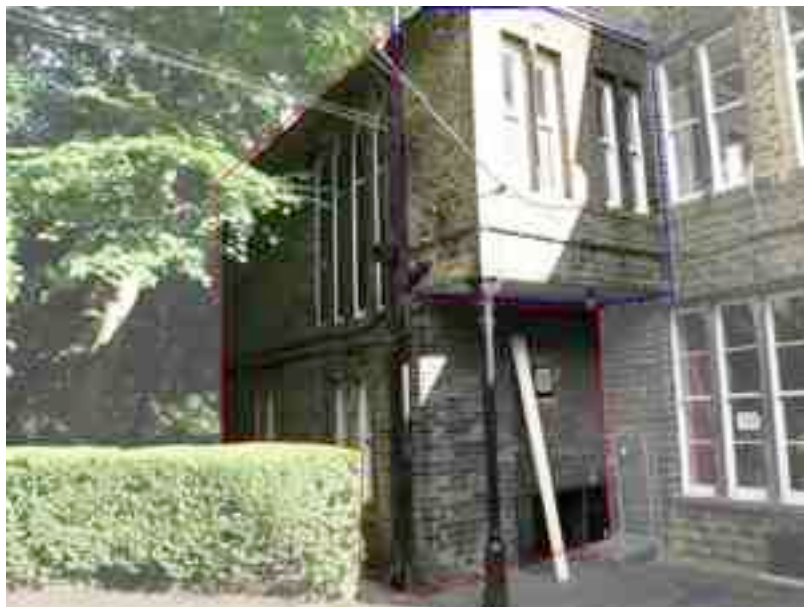
*Fig. 20. Additions to the north elevation - c.1893 addition bordered in red and 1903 WC addition bordered in blue.*

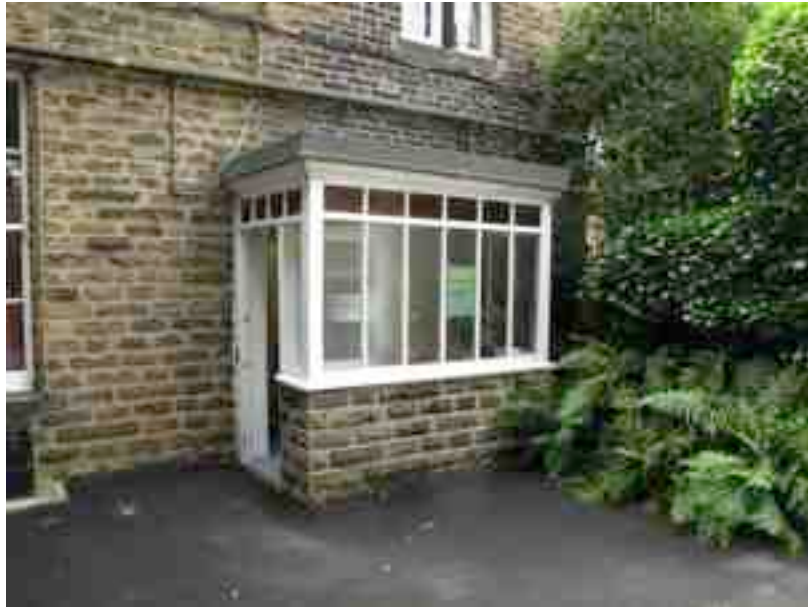
*Fig. 21. Modern Porch to the the rear (servants/trade) entrance*

Room 011 was probably the kitchen for the house now a cloakroom. From here staircase for the servants use leads to first and attic floors. Original cupboards have been retained in situ. From here is access to the basement and a former external doorway to the 1903 addition leading to the tradesman entrance which now incorporates a modern porch.

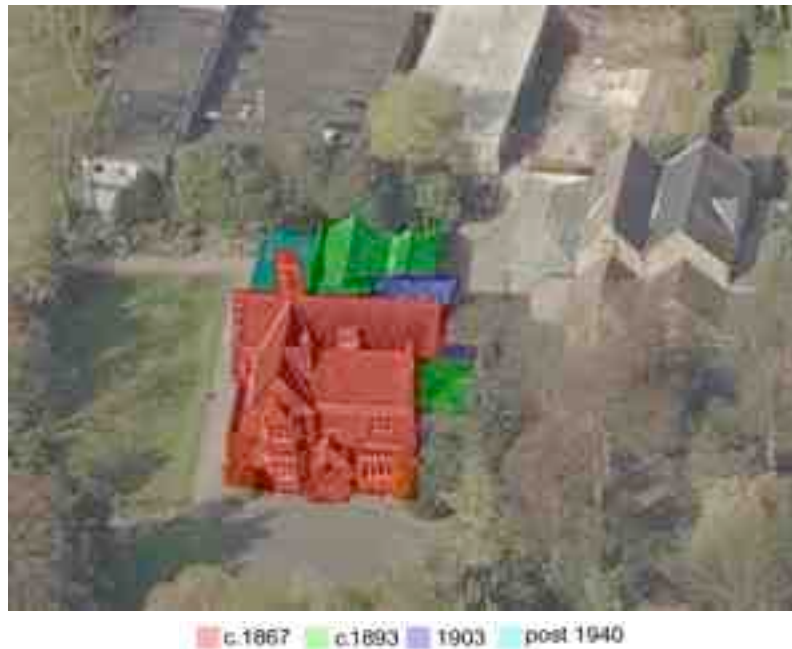
*Fig. 22. Development stages, looking west.  
(Source: Adapted from [www.bing.com/maps](http://www.bing.com/maps))*

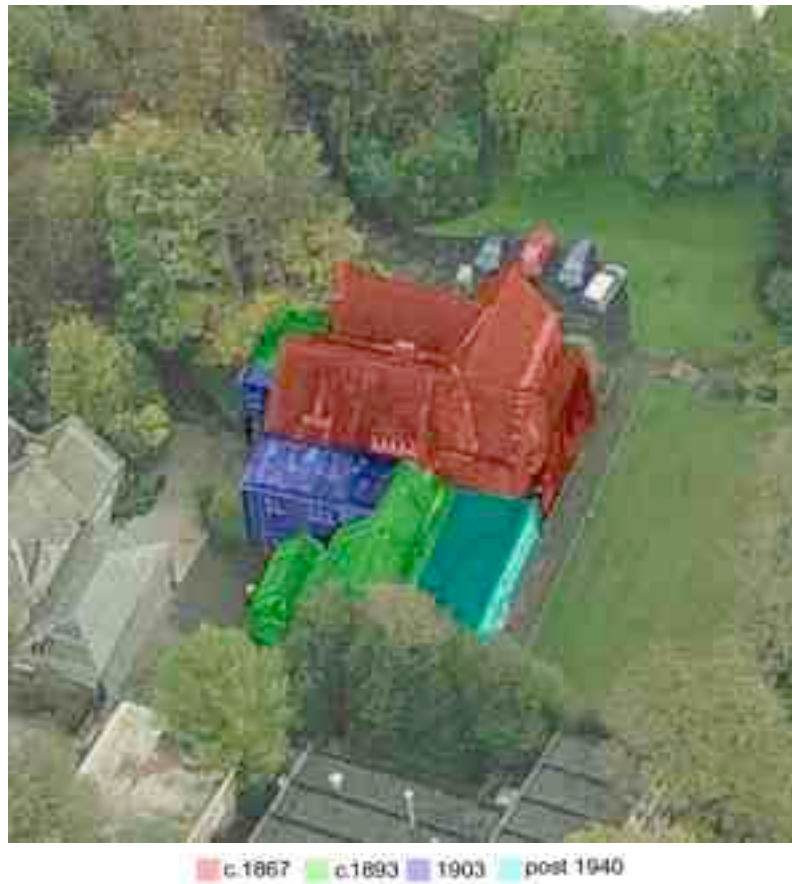
*Fig. 23. Development stages, looking east.  
(Source: Adapted from [www.bing.com/maps](http://www.bing.com/maps))*

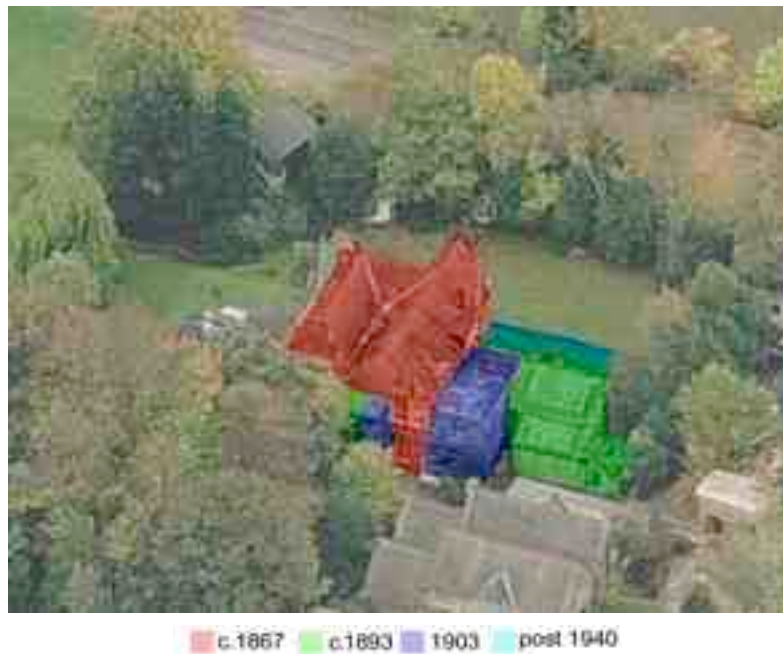
*Fig. 24. Development stages, looking south.  
(Source: Adapted from [www.bing.com/maps](http://www.bing.com/maps))*

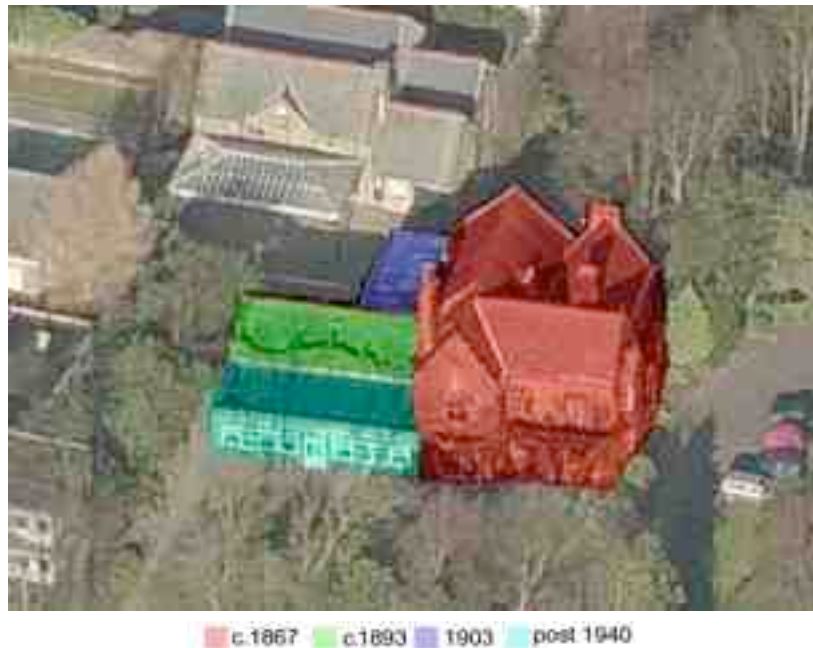
*Fig. 25. Development stages, looking north.  
(Source: Adapted from [www.bing.com/maps](http://www.bing.com/maps))*

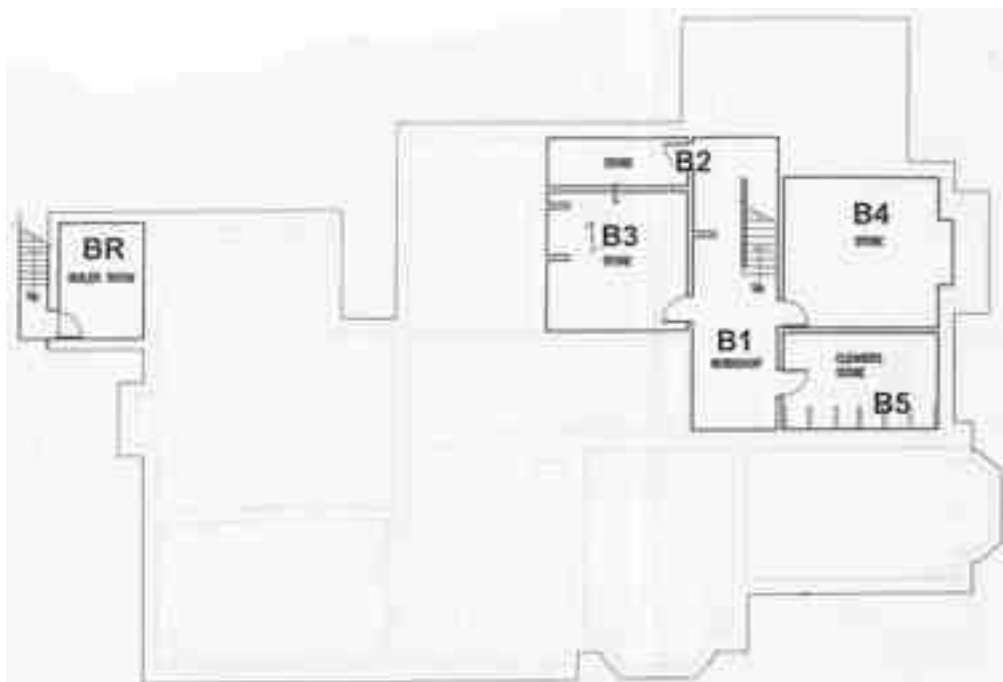
*Fig. 26. Basement Plan.  
(Source: CARD Geotechnics)*

Basements made excellent areas for storing food and drink stock as they retain a static cool temperature throughout the year.

This area is now used for storage and workshops for the schools maintenance department.

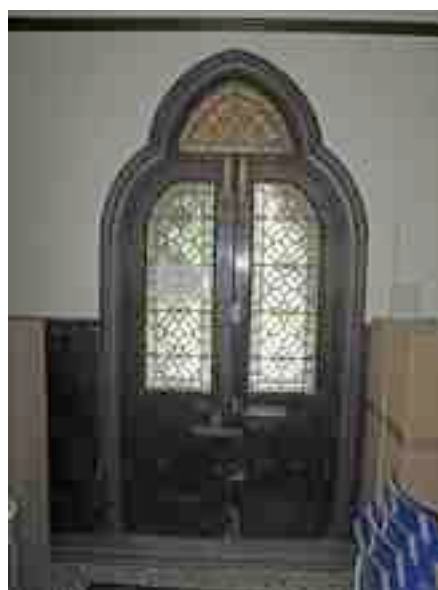
*Fig. 28. Main door within a Gothic arch.  
Stained glass panels was to allow daylight into the hallway/porch.*

The main entrance to the house is enhanced as a visual statement by a porch. The porch also give the visitor protection again the weather. Porches were popular features on Victorian houses and became by the mid 1870's incorporated into the main building as a recess by the front door.

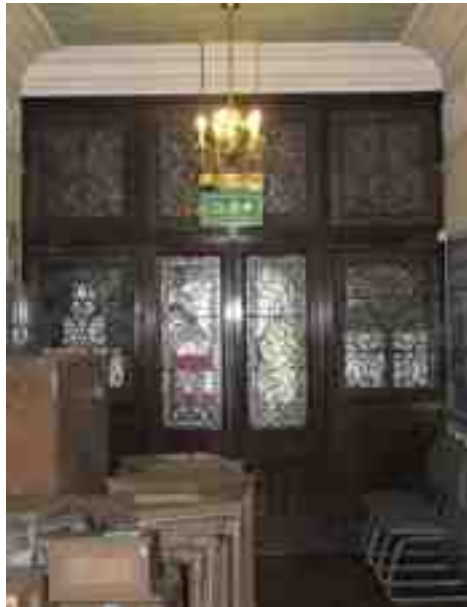
*Fig. 29. View of the stained glass and timber frame separating the lobby and hallway. This panel may of been a later addition as the flow of the stained glass detail is more Art Nouveau than Gothic Revival.*

The lobby also give protection to the house from from draughts. At Royds Mount it is partitioned from the hallway (002) by a hardwood timber and stained glass panel screen, this is a common feature used in Gothic revival houses.

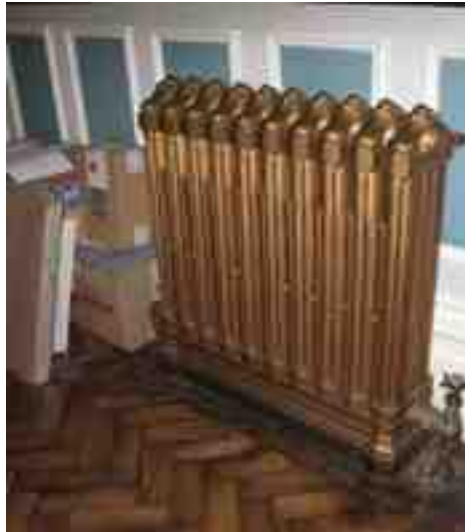
*Fig. 30. Wainscot panels now painted.  
The radiator is a later addition the hall.*

The hallway would of been heated by a fire originally until the development of cast iron radiators towards the end of the nineteenth century. The radiator in the hallway appears to be a Jobson radiator which are now rare and would be difficult to source and replace.

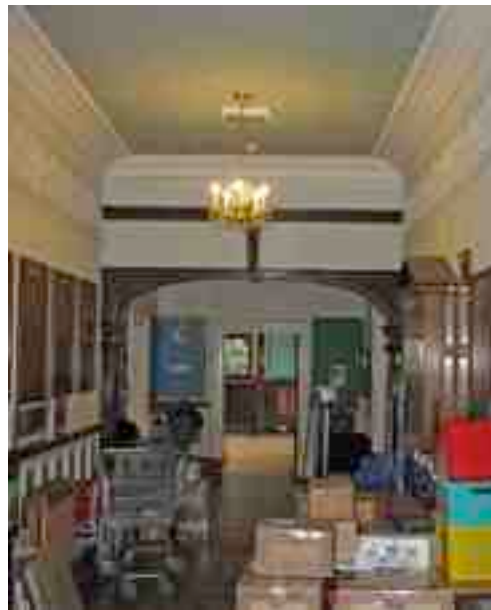
*Fig. 31. Three centred arch between the original hallway and extension.*

At the opposite end of the hall is an arch which is probably a later addition. Dating from when the house was extended as the arch is classical in detail as opposed to Gothic.

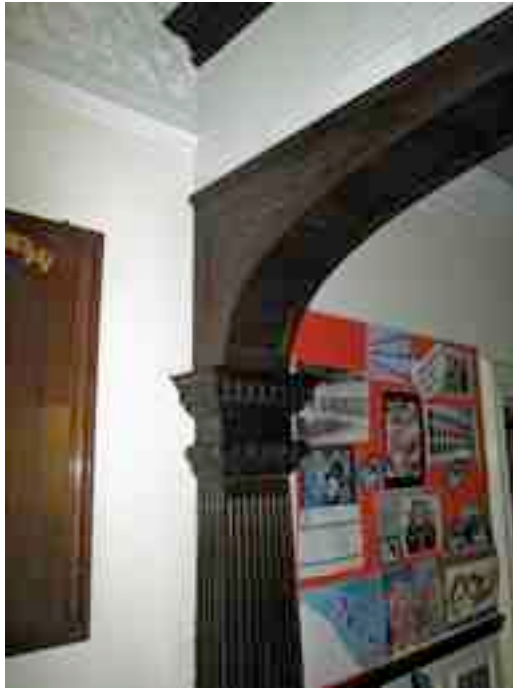
*Fig. 32. Egg and dart, and dentil detail to the fluted pilaster.*

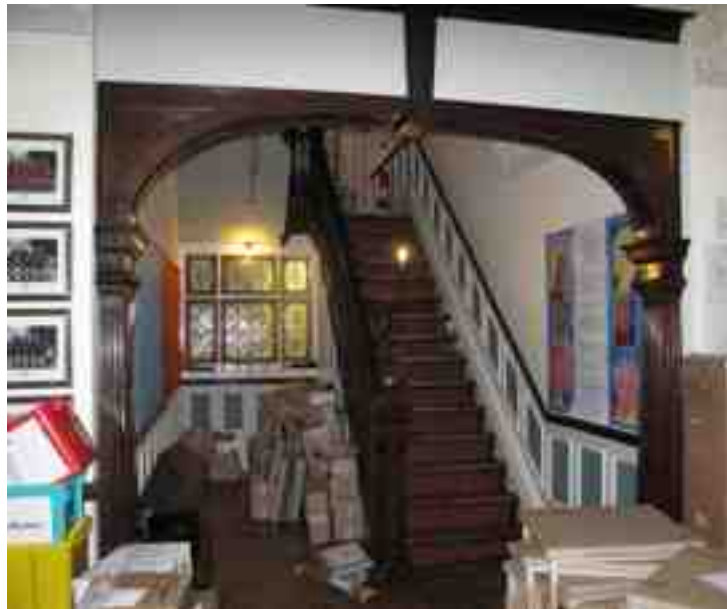
*Fig. 33. Staircase and archway. The archway is a later addition to the original house.*

The stairs are timber with an oak timber barley twist balustrade and handrail. The torchère probably dates from when the house was converted to electric light.

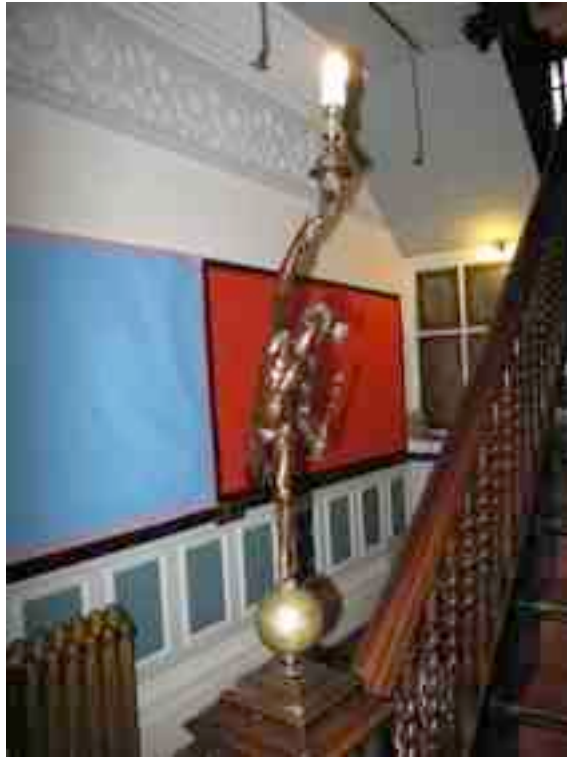
*Fig. 34 The brass torchère is identical to the statute that has since disappeared.*

A statue is also visible on the 1977 photograph and has subsequently vanished. The figure was identical to the torchère found on the ground floor newel post.

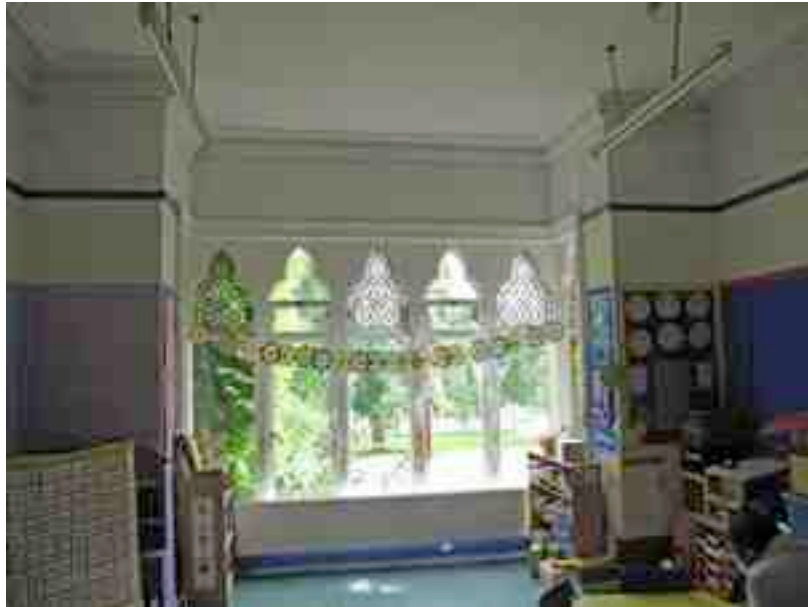
*Fig. 35 Bay window to the classroom (003) which was probably the original dining room when the building was a house. Two of the windows have been adapted by the addition of casement lights.*

Room 003 which is now a classroom may of been the front room prior to the school. This may have originally been the dining room when the house was constructed for James Crowther c.1867 due to its proximity to the kitchen.

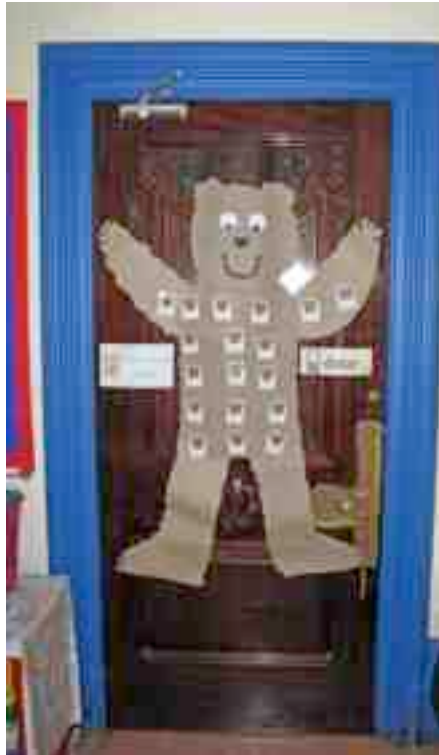
*Fig. 37. Door to room 3 is probably later as it is Art Nouveau in style, in particular the door plate.*

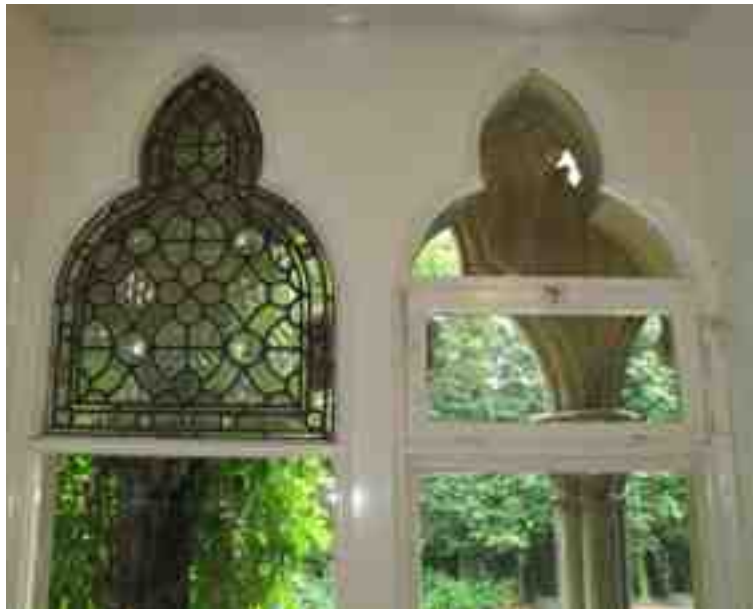
*Fig. 40. Windows over looking the verandah from the admin office.  
Note the right hand window has been altered.*

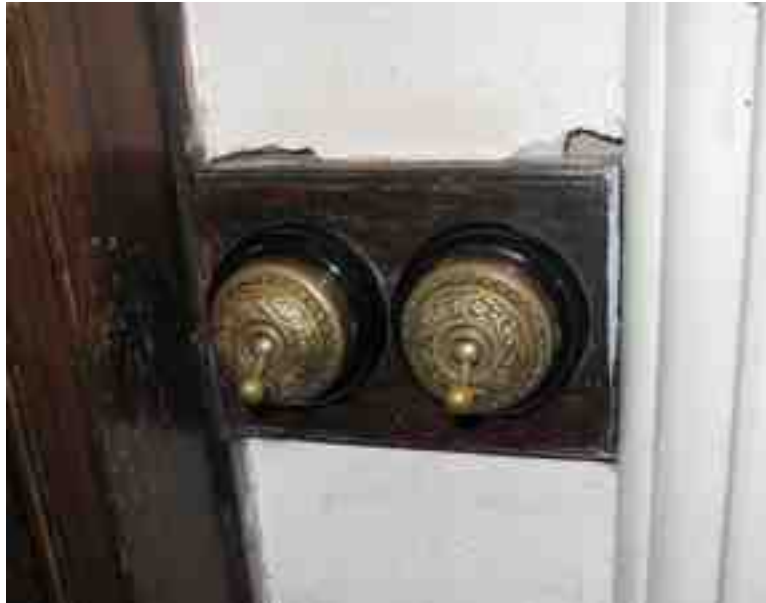
*Fig. 41. Original light switch from when the house was converted to electricity and are still in used today.*

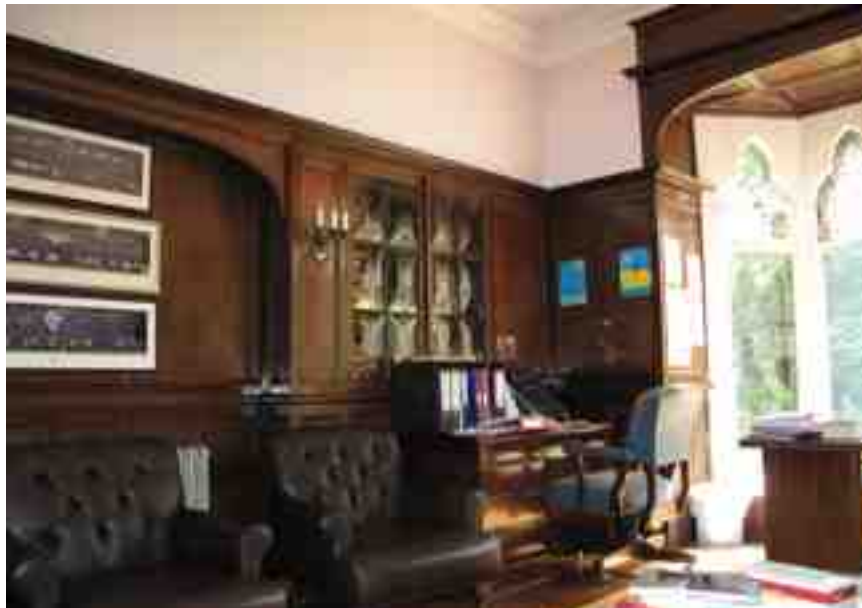
*Fig. 42. Wood panelling, note above the photographs is an arch which has similar detail to the arch found in the hallway.*

Room 005, now the heads study may of been the drawing room. Bookcases and panelling are later in date, and made to match the existing fire surround. The drawing room was for special occasions and entraining.

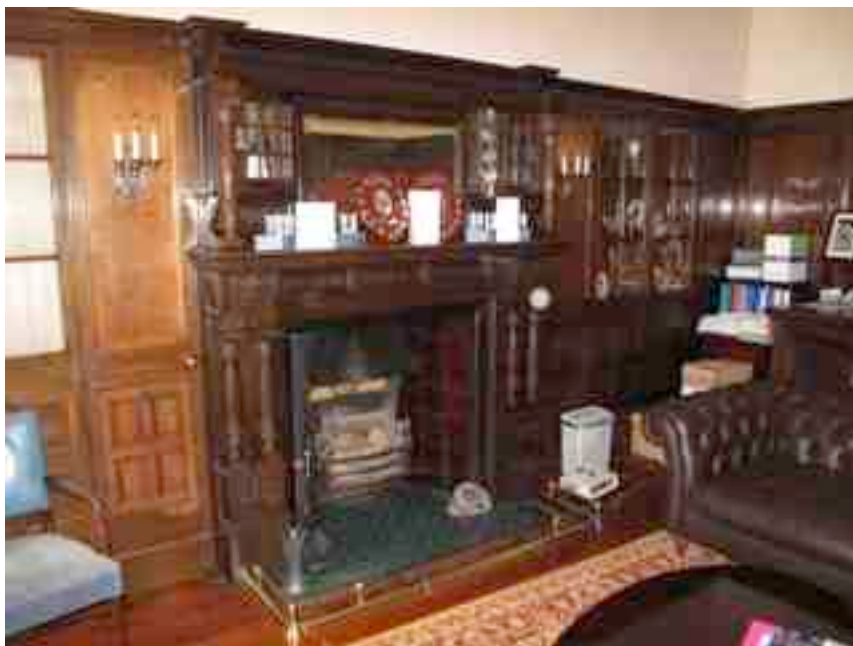
*Fig. 43. The panelling to the Head's study is of a later date, but made to match the earlier fireplace.*

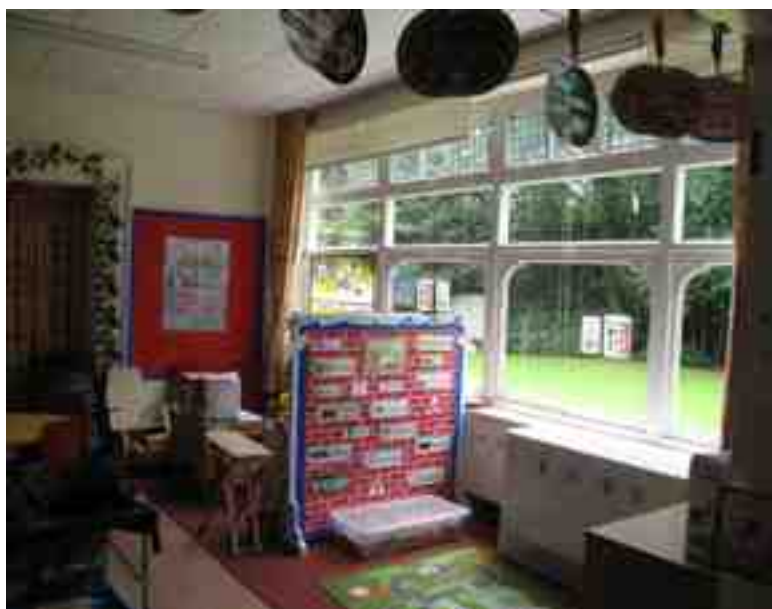
*Fig. 44. Internal decor of the building which replaced the conservatory.*

The house had a conservatory constructed sometime between 1893 and 1918, this has subsequently been replaced by a stone building probably after the house became a school.

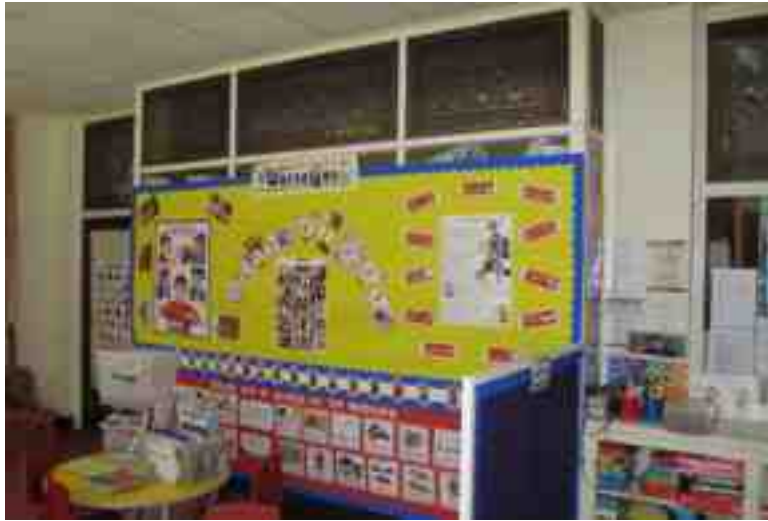
*Fig. 45. Stained glass window between the classroom and former billiard room.*

Within this modern room now used for classrooms (006) the quarry glass panels to the windows are retained in the now internal wall to the former billiard room. These date from when the house was extended in 1903. A stone pediment can be seen externally in line with the wall above this window.

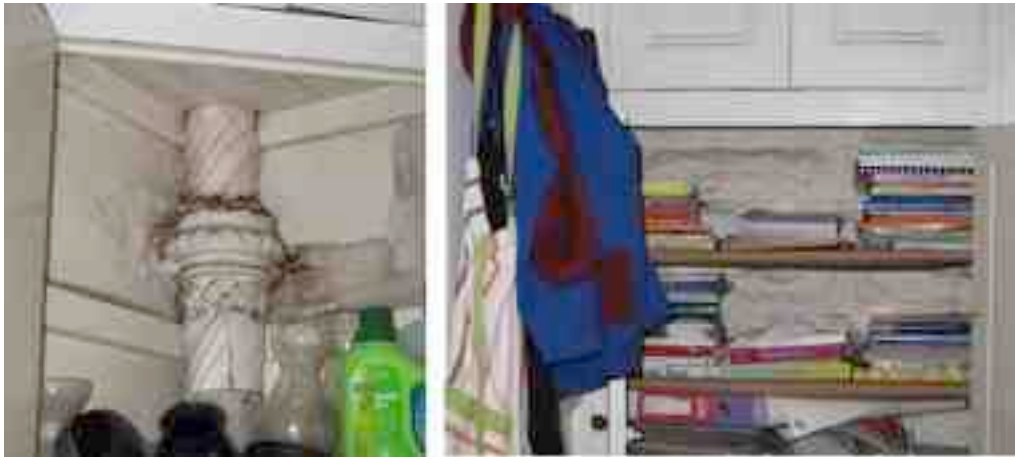
*Fig. 46. Original fabric now hidden enclosed within two cupboards.*

Within room 006 elements of the original fabric of the main house can be seen within two cupboards. These include a barley twist cast iron pipe and the external wall of the heads office, both of which date from the first construction phase of the house.

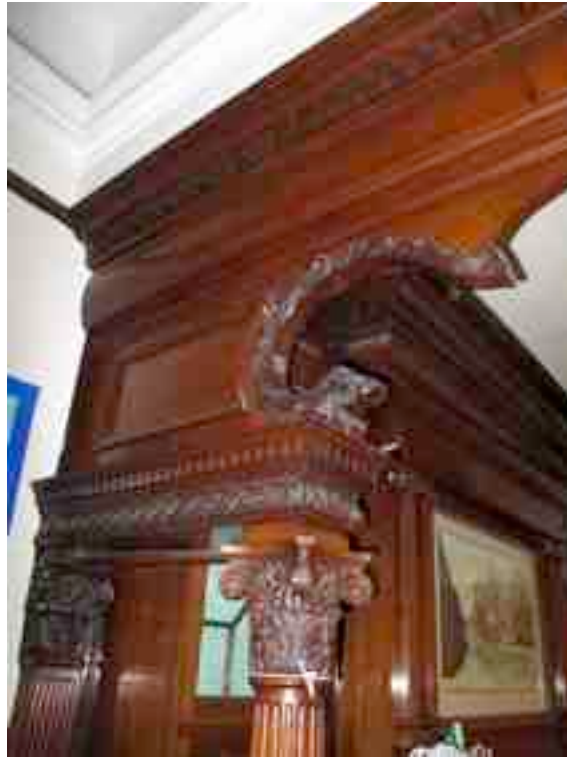
*Fig. 47. Woodwork dividing the billiard room is in a classically based freestyle, with fluted columns and corinthian capitals embellished with Chinese lions to the frieze above.*

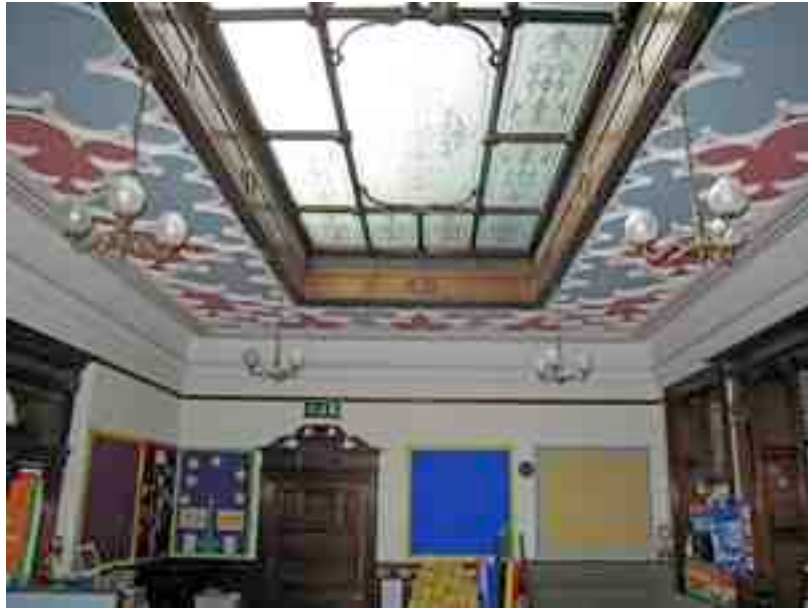
*Fig. 49. Borrowed light once give light over the billiard table.  
The reason why the glass is etched is to allow maximum light and disguise the window above.*

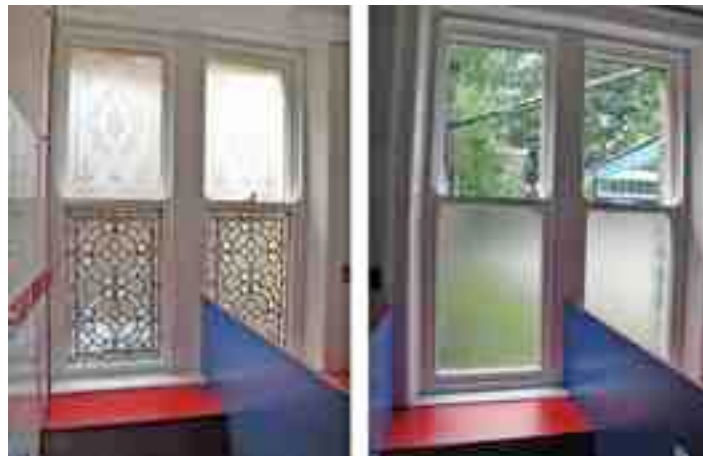
*Fig. 50. Modern toilets in the 1903 addition. The sash window frames are original  
and the glass in the left hand window part of the historic fabric but the glass  
in the right hand window has Georgian wired glass.*

This area (008, 009 & 010)is now forms part of a corridor and toilets, the only historical fabric identifiable is the sliding sash window frames with one pair of windows retaining quarry glass panels. It should be noted that the quarry glass panels are very similar to those found in the front door.

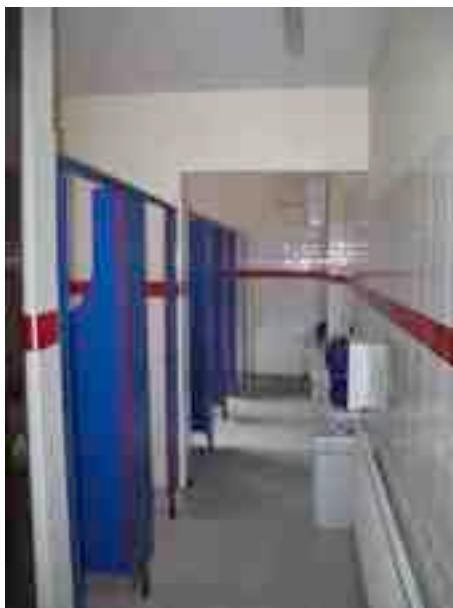
*Fig. 51. Modern toilets in part of the Lunn's 1903 addition.*

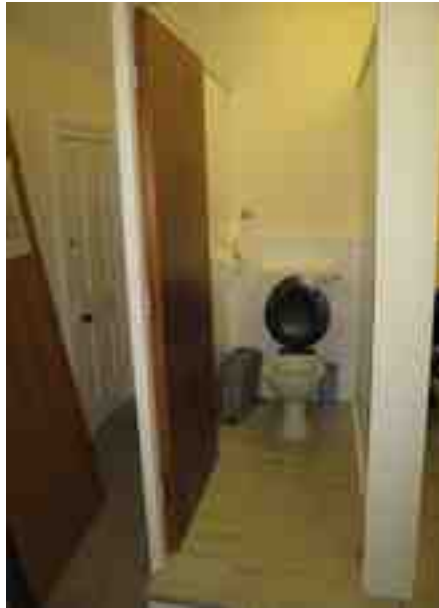
*Fig. 53. Toilets in the area identified as a dark room on Lunn's 1903 architectural plan.*

The dark room and linen cupboard now form the toilet and store (rooms 108 and 109)

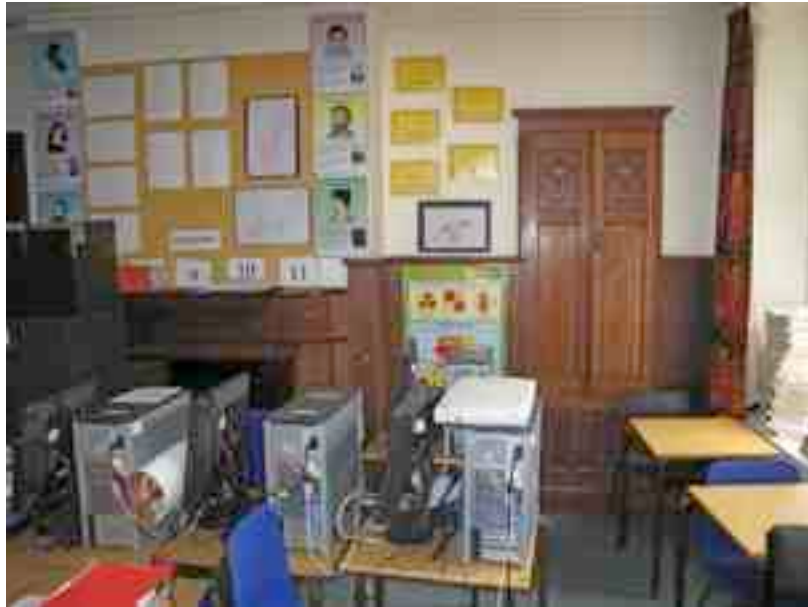
*Fig. 58. Room 6, part of the original house. The room as identical decor as room 7.  
Note bell push to the right of the fire.*

Room 107 according to Lunn's architectural plans was a bedroom. The decor is identical to room 106, both rooms are linked via a door. It is probable that room 106 was a bed room and room 107 was a dressing room. Room 106 was therefore the Oak bedroom

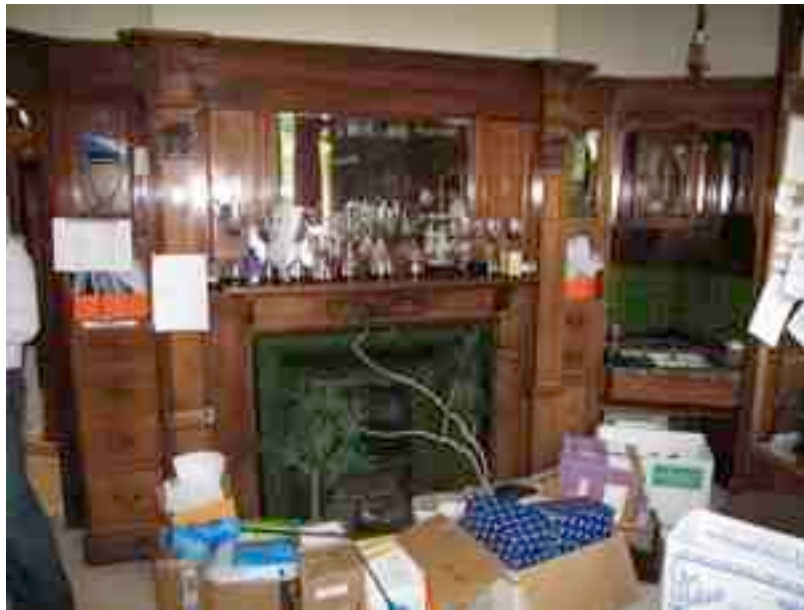
*Fig. 61 Fire place and wash basin (room 115).*

Room 115 is the grandest room on this floor with its fittings retained. The fittings to these two room are not part of the houses original fabric but are latter, probably dating from John Edward Crowther's ownership. However they are still significant architecturally and historically, providing an insight to the fit out of a late Victorian or early Edwardian bedroom.

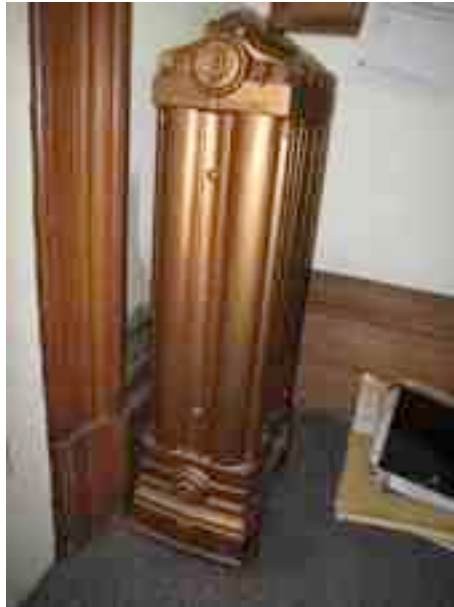
*Fig. 64. Jobsons radiator located in the Bursar's office in the c.1893 addition to the north elevation.*

Room 103, now an office (also noted as a bedroom on Lunn's plan) was part of an extension which pre-dates Lunn's 1903 work. The room retains not only its fire but a Jobsons' radiator identical to the two located in the hallway.

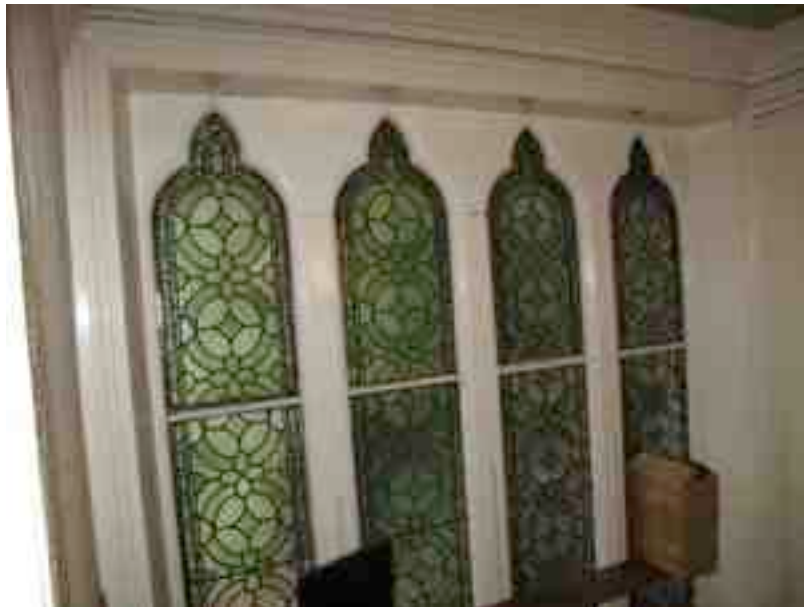
*Fig. 65. Quarry glass windows with identical pattern found in the ground floor WC's (room 9 ground floor).*

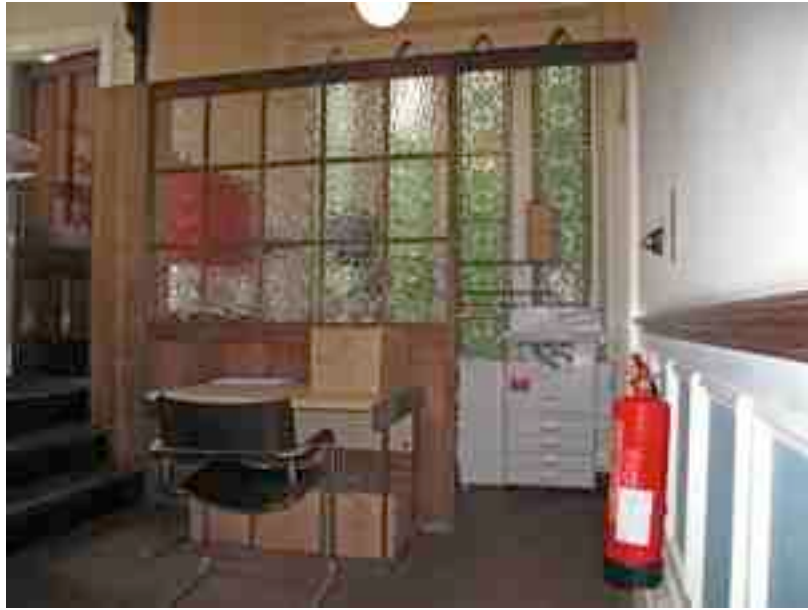
*Fig. 66. Robert Thompson screen.*
