# Conservation Management Plan Stage 1 - Conservation Statement

Huddersfield Grammar School,  
Royds Mount, Luck Lane, Huddersfield.

Our Ref: 10-036

Revised 26<sup>th</sup> February 2013

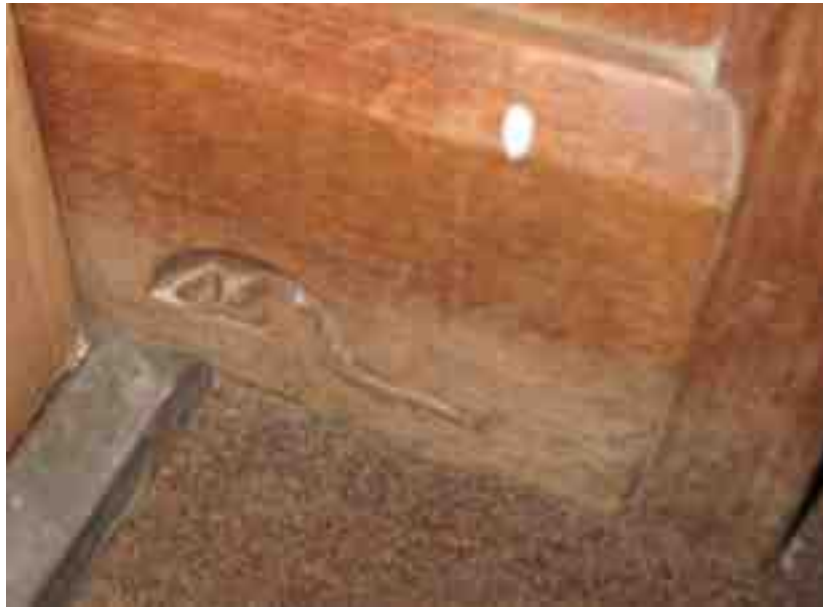
*Fig. 67. Carved mouse, Robert Thompson's trademark.*

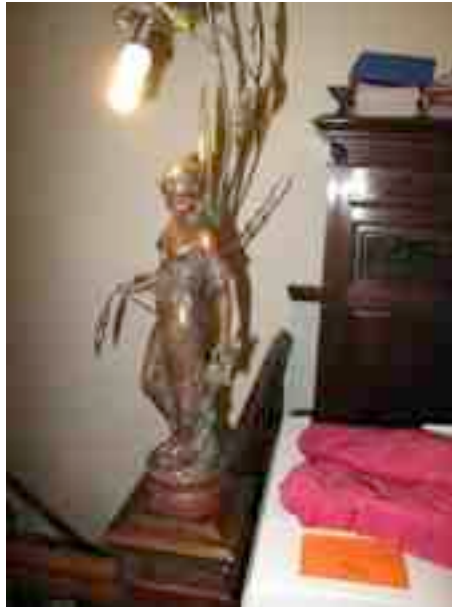
*Fig. 68. Torchère on the first floor newel.*

A statue is also visible on the 1977 photograph and has subsequently vanished. The figure was identical to the torchère found on the ground floor newel post.

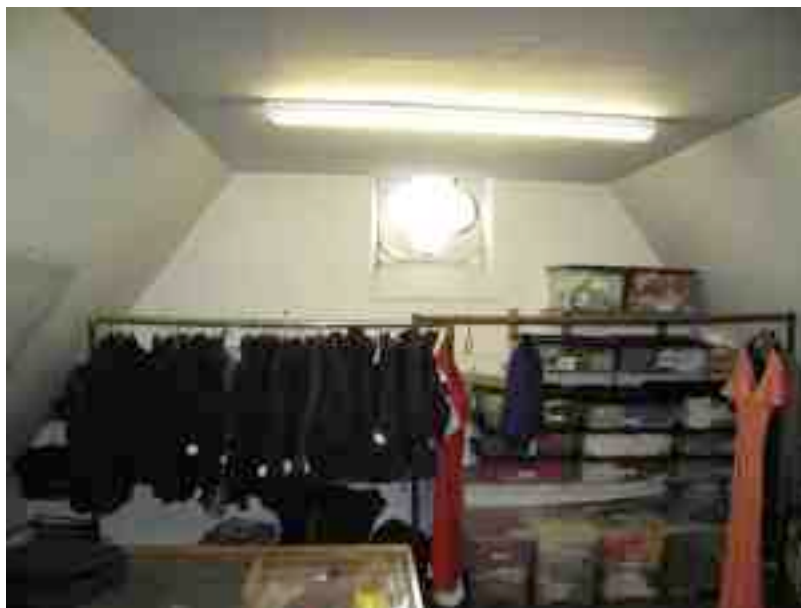
*Fig. 70. Former servants room now used for the school shop.*

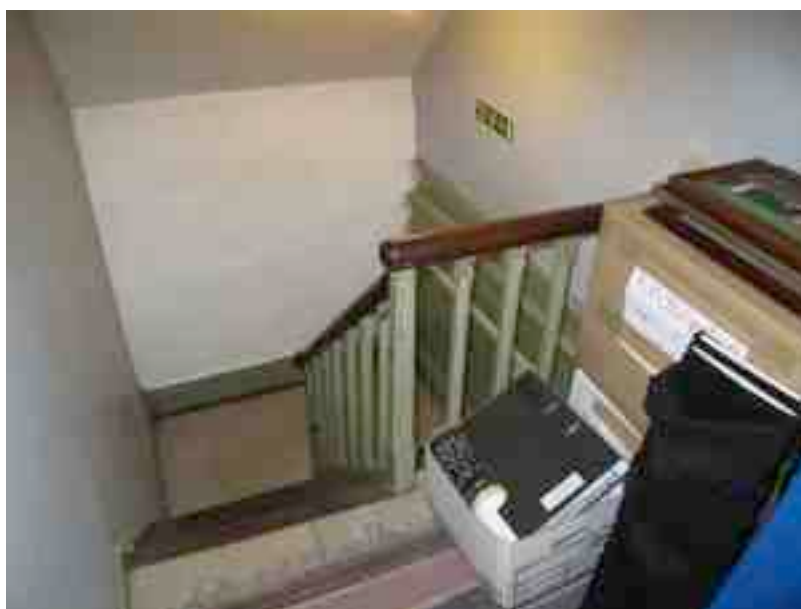
*Fig 71. Staircase to attic.*

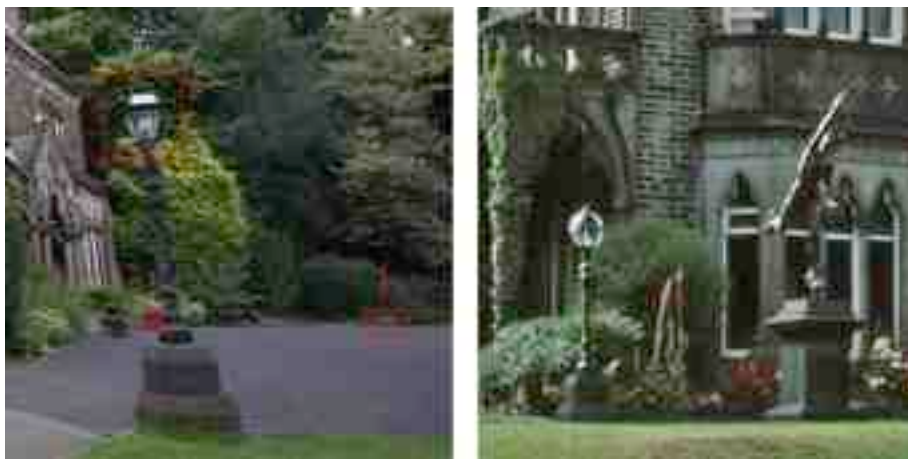
*Fig. 72. Left hand picture show the lamp post as current and the right hand picture dates from 1977. Also note the statue, now gone.  
(Source: Anthony Lunn)*

The area to the front of the main elevation (east) has also changed between 1977 and the present day. Only one lamp post has been retained and the base for another is still in situ. The retained lamp post has been altered, the glass globe seen on a 1977 photograph has been replaced with a lantern. The lamp post is not visible on the 1867 photograph of the house however it is probable such a feature would of been implemented soon after.

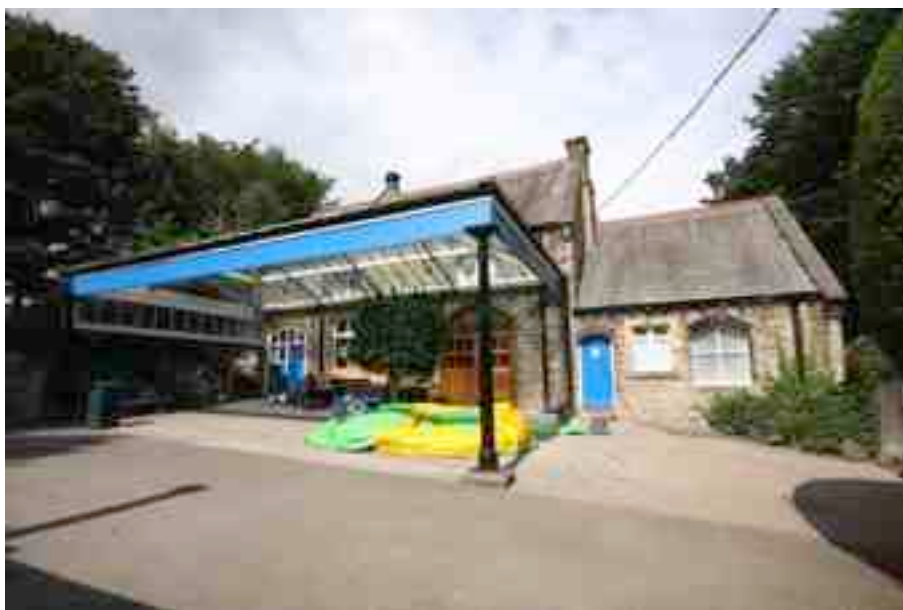
*Fig. 73. Former stable block and canopy. The building is now used for classrooms*

To the north of the house, separated from the house by a small service yard is the former stables and coachhouse. The stable block was probably constructed together with the house and is typical of those dating from this period. It has been extended over time, first with a matching range to the rear and latter with various single storey additions. The glass canopy is a later addition, probably added following the purchase of a motor car in the early twentieth century.

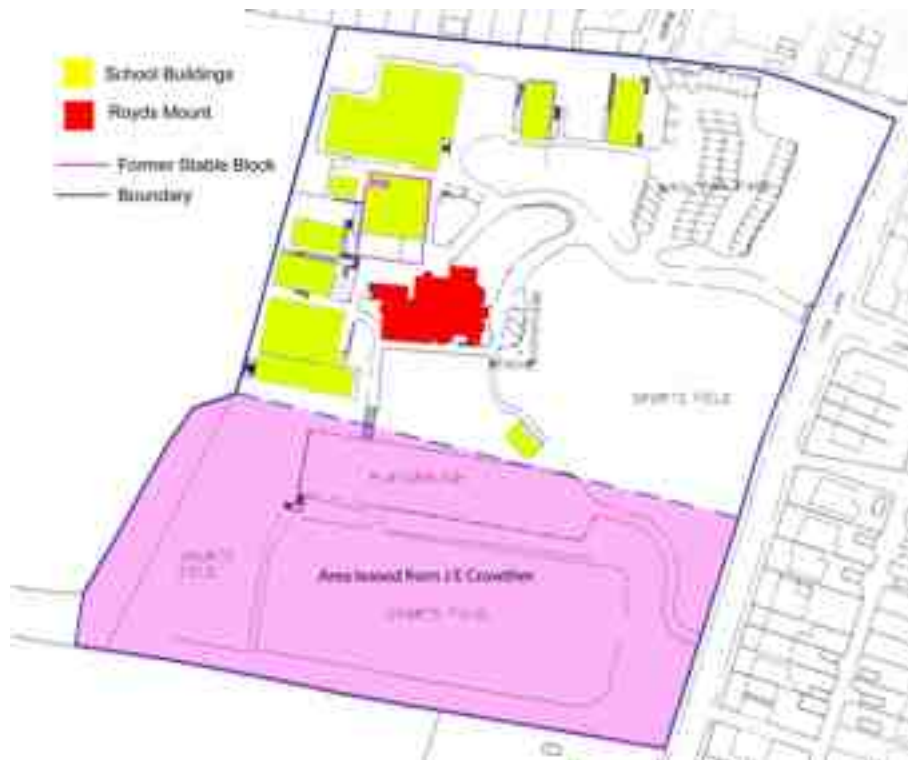
*Fig. 74. Site plan showing location of ancillary buildings in relation to Royds Mounts*

Since the house has become a school there have been various buildings erected in the grounds. Of these the laboratory and gym block is the major, permanent addition, the others being prefabricated buildings of a more temporary construction. These have no conservation significance, but affect the setting of the house and stable block.

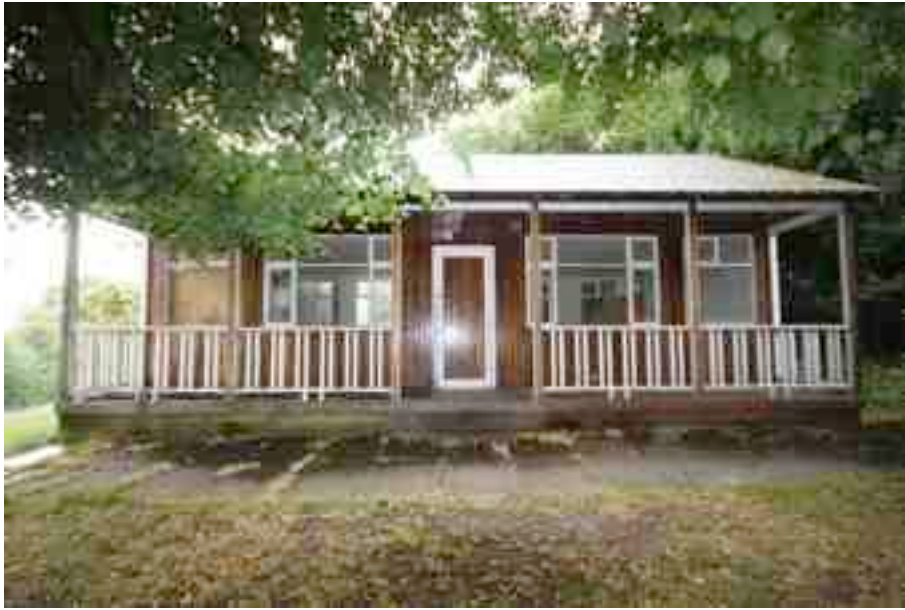
*Fig. 76. Pavilion now used for a classroom.*

A small timber prefabricated pavilion, with a verandah. Possibly dating from the 1950's, in style and appearance it is typical of many found on small sports pitches throughout the country. Now almost completely shielded from the school and all play areas by planting, it is of no particular evidential, historical and aesthetic value, but may be of social significance through association with past school sports events. It is provisionally considered to be of **Low significance**.
