**Bat Survey Report**  
**Hepworth Sports Club, Hepworth.**  
3<sup>rd</sup> July 2015

**Middleton Ecological Consultancy, 33 Wilthorpe Road, Barnsley S75 1JA**

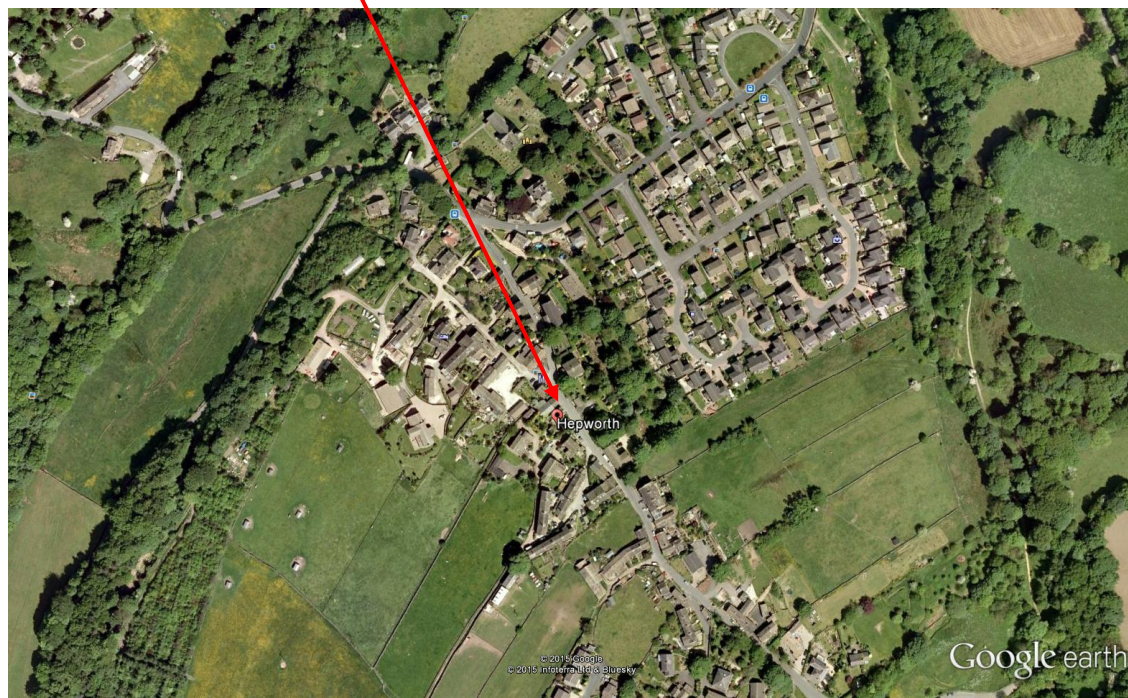
**Plate 1**                      **Hepworth Sports Club**

- 3.2.1 The surrounding area is predominantly a mixture of residential and farm buildings together with grassland. The surrounding habitat provides good habitat for bats therefore all of the locally occurring species are likely to be in the area. Table 1 outlines the habitats present, adjacent to and further afield to Hepworth Sports Club (see plate 1).

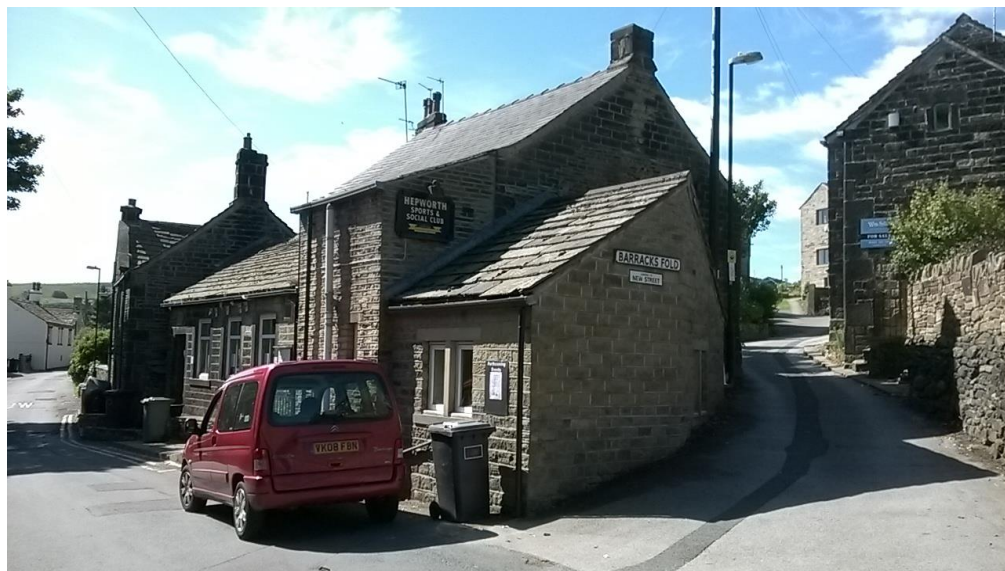
**Plate 2** The Sports Club on Towngate

- 3.1 The site consists of a relatively old (1852) both single and two story building formerly built as a school but presently used as a sports club. The small complex of buildings are built of stone and are situated on Towngate at Hepworth (see plate 2). The two storey part of the building has a single ridge and gables with a roof covering of welsh slate whilst the single storey section that is sandwiched between the two story building and number 58 Towngate has a single ridge and a roof covering of York stone slates. Additionally, there is a single story annex on the north elevation with a sloping roof and York stone slates (see plate 2).

- 5.3.1 The walls of the buildings have been well maintained and consequently there are no features within the stonework on all elevations. The welsh slate roof has several features allowing potential access to the roof-space but the feature with the most potential is the single storey roof that has York stone slates. As with all such roofs, when there is a membrane beneath the slates it provides the perfect roost for crevice dwelling bats.
