**Bat Survey Report**  
**Springhead Farm, Scholes Moor Road.**  
**27<sup>th</sup> Sept 2015.**

**Middleton Ecological Consultancy, 33 Wilthorpe Road, Barnsley S75 1JA**

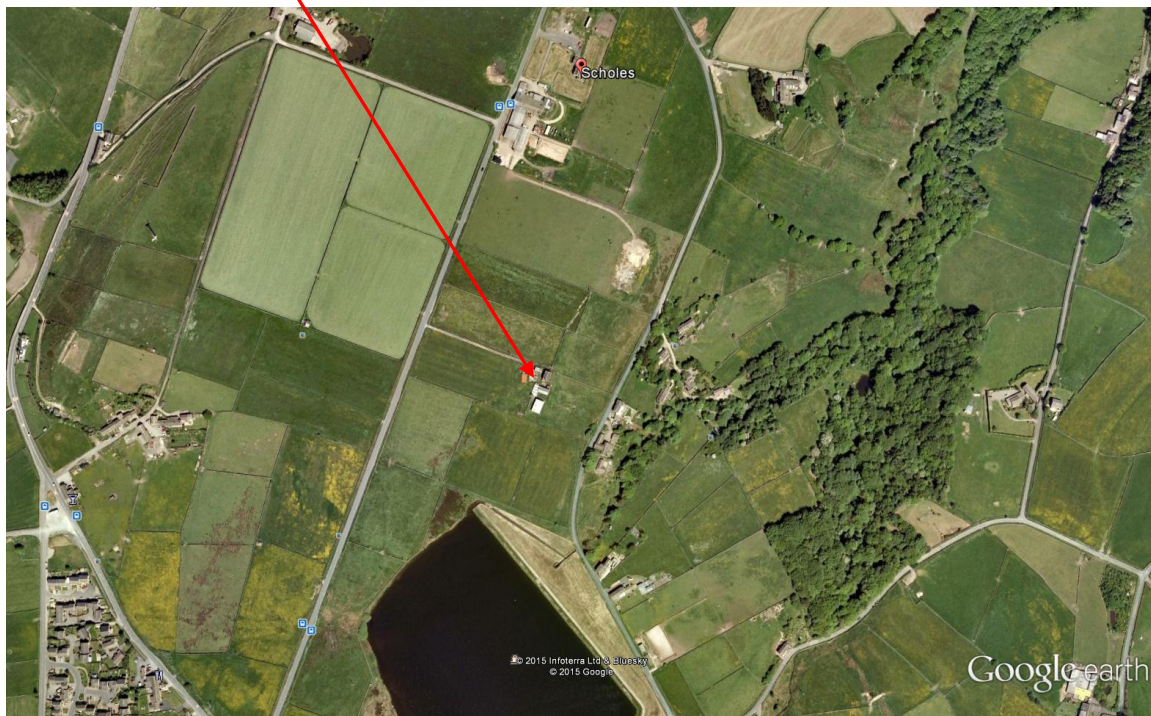
Plate 1 The site

- 3.2.1 The site is 303m above sea level and the surrounding area is predominantly grassland together with a reservoir and a tree lined brook. (See plate 1). Table 1 summarises the habitats present, adjacent to and further afield to 1 Springfield Farm on Scholes Moor Road.

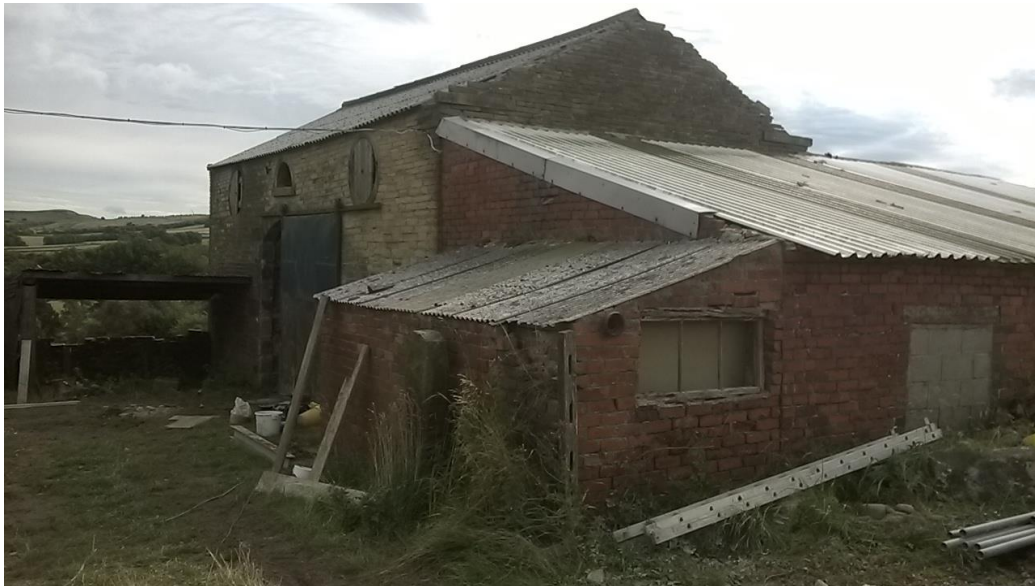
**Plate 2** west and north elevations

- 3.1 The site consists of a rectangular stone built barn with hay-loft and adjoining single storey lean-to. The barn has a corrugated asbestos cement sheet roof with ridge and gables and the lean-to has a sloping sheet metal roof with transparent fibreglass roof lights (see plates 2, 3 & 4).

- 5.4.1 There are some large holes on the external walls which are not normally used by bats plus some more suitable holes and gaps in mortar joints mostly near the wall tops on the east gable and the south facing wall. The northern elevation does not appear to have any suitable features (see plates 2 & 3).

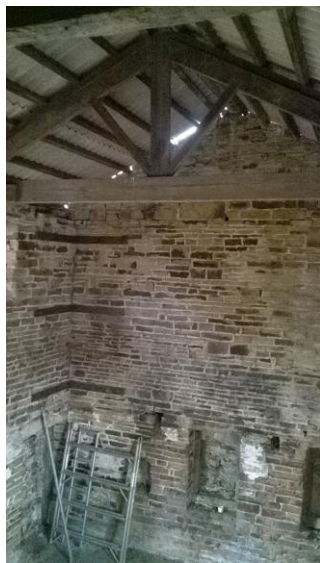
**Plate 4**

- 5.3.1 The building has king post roof timbers and the internal space is open to the underside of the asbestos sheets. There is no ridge board and the apex is considered unsuitable for Brown long-eared bats. Also, the asbestos sheets fall short of covering the wall top on the east gable (see plate 4). However, the walls have many holes giving potential access to the rubble filled core. The ground floor beneath the hay-loft is very ‘cobwebby’ around joists and walls. The only potential within the lean-to is within holes in mortar joints in the gable wall of the main barn (see plate 5). No signs of bats were found.

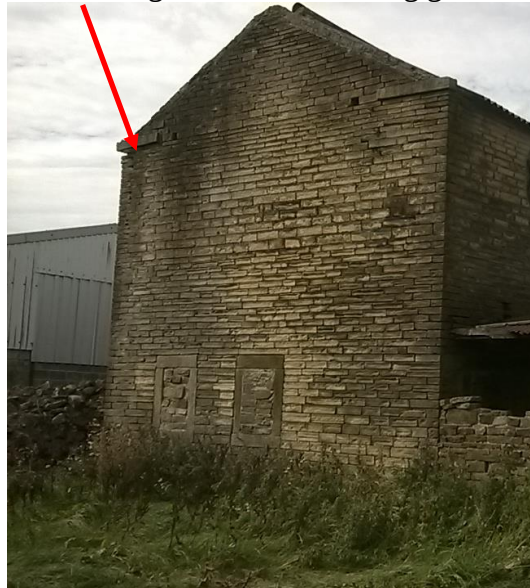
**Plate 6**

Bat tube high on this east facing gable

- 7.1 No bats were recorded roosting on site during the survey works and consequently there is no compulsory requirement for mitigation. However, in order to enhance the ecological value of the site and in accordance with the aims of planning policy NPPF: 11, it is suggested that the developer integrates bat roosting features into the building. It is therefore advisable to use a F1 bitumen felt membrane beneath the tiles when re-roofing and install a bat tube high on the east gable where some of the stonework will have to be rebuilt (see plate 6). For further information on appropriate bat roosting features please contact Middleton Ecological Consultancy.
