Dene Bottom Works, Kirkburton

Bat Roost Assessment

January 2014

QUANTS environmental Ltd

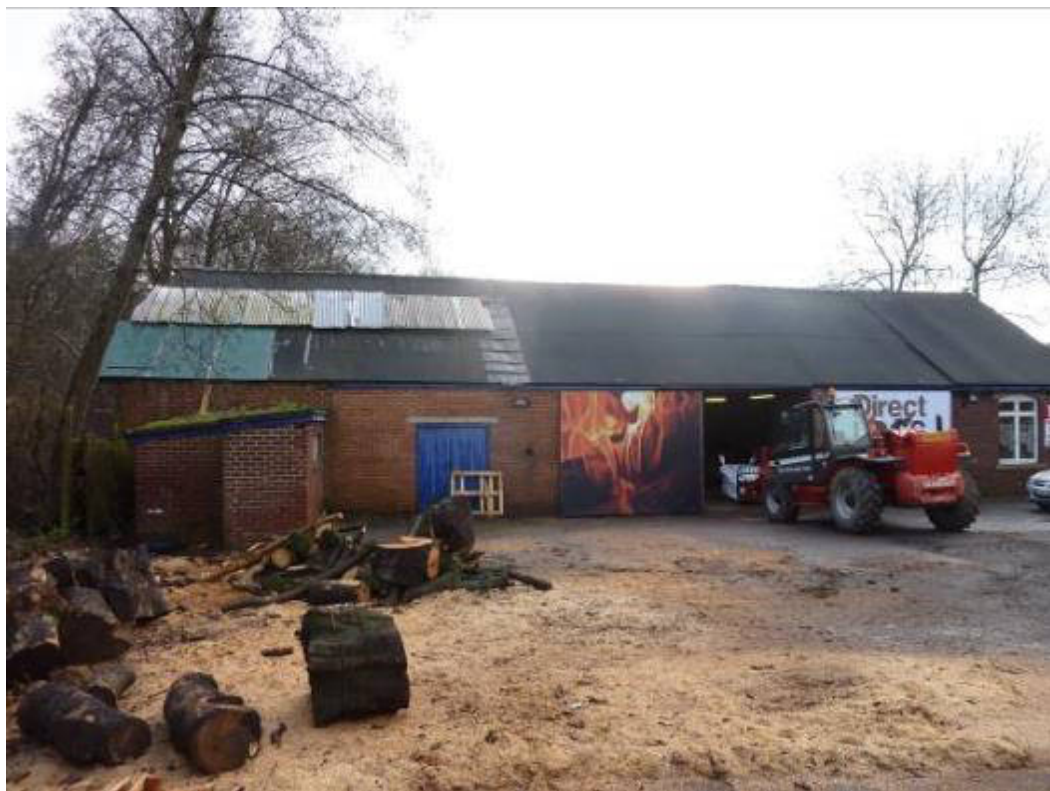
The building is a single-skinned brickwork construction; therefore, there are no wall cavities. To the north-west of the ridge, the roof has a bitumen roof felt over timber; to the south-east of the ridge, the roof is of slate tiles with no lining. The south-eastern elevation of the building comprises a rendered block wall. External suitable roost opportunities for bats are largely absent; limited to one or two suboptimal places in which the felt lining was slightly raised on the south-western gable end.

Photo 2: North-east elevation of Building 1

It is extremely difficult to provide conclusive evidence of absence of bats outside of the emergence survey season (May to September), particularly with regards to smaller roosts (1-2 bats) of crevice dwelling species. However, based on the evidence, the use of Building 1 and Building 3 as a bat roost is considered unlikely and further survey works to confirm presence / absence of bats are not considered necessary.

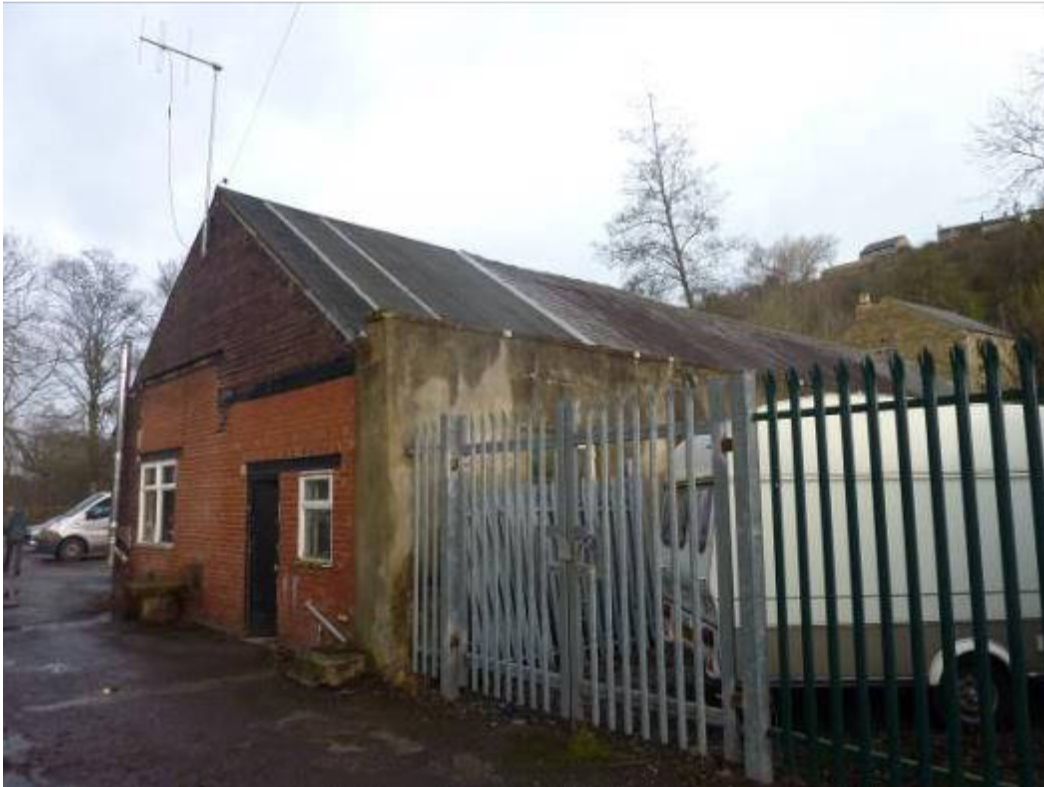
Building 1: With consideration of the limited number of bat roost features (e.g., lifted bitumen roof lining) and high disturbance factors, Building 1 is considered to have **negligible to low** potential for use as a bat roost.

Photo 3: Building 1 viewed from the south

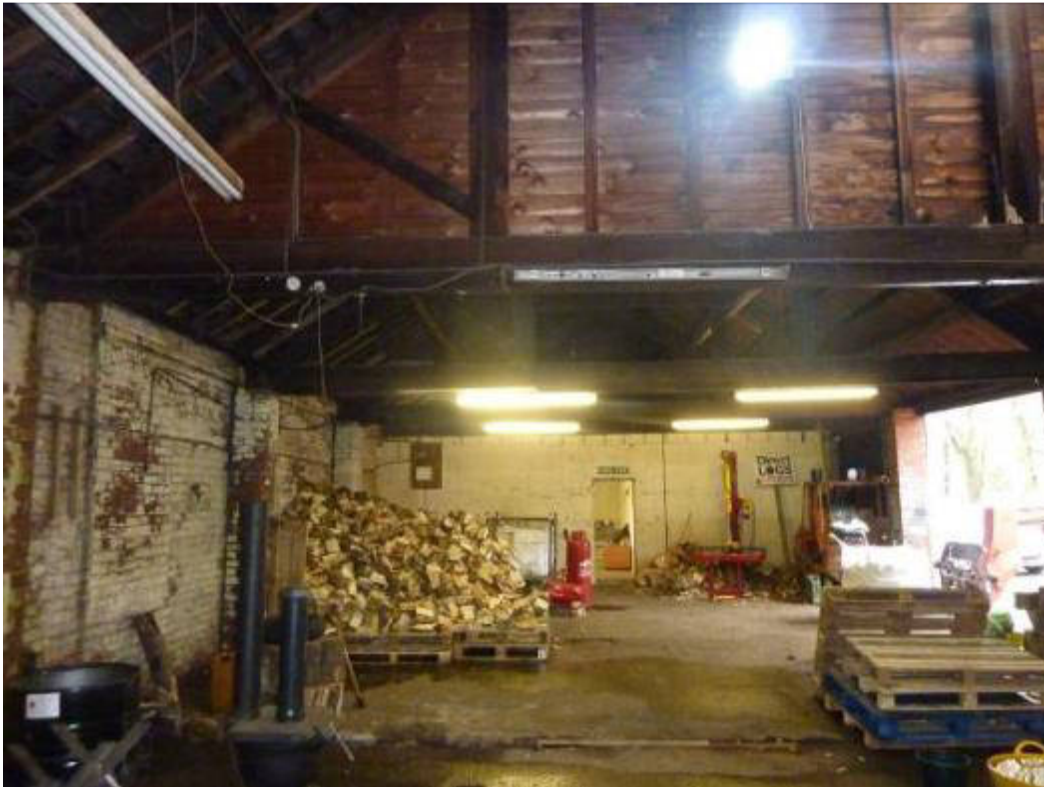
Internally, the building is an open structure with no roof void. In the majority, the roof is unlined; on the south-western part there are several areas where bitumen felt has been lain directly over timbers slats. Based on the absence of external access features, the timber lining is considered unlikely to provide suitable crevices for use by roosting bats.

Photo 4: Internal of Building 1

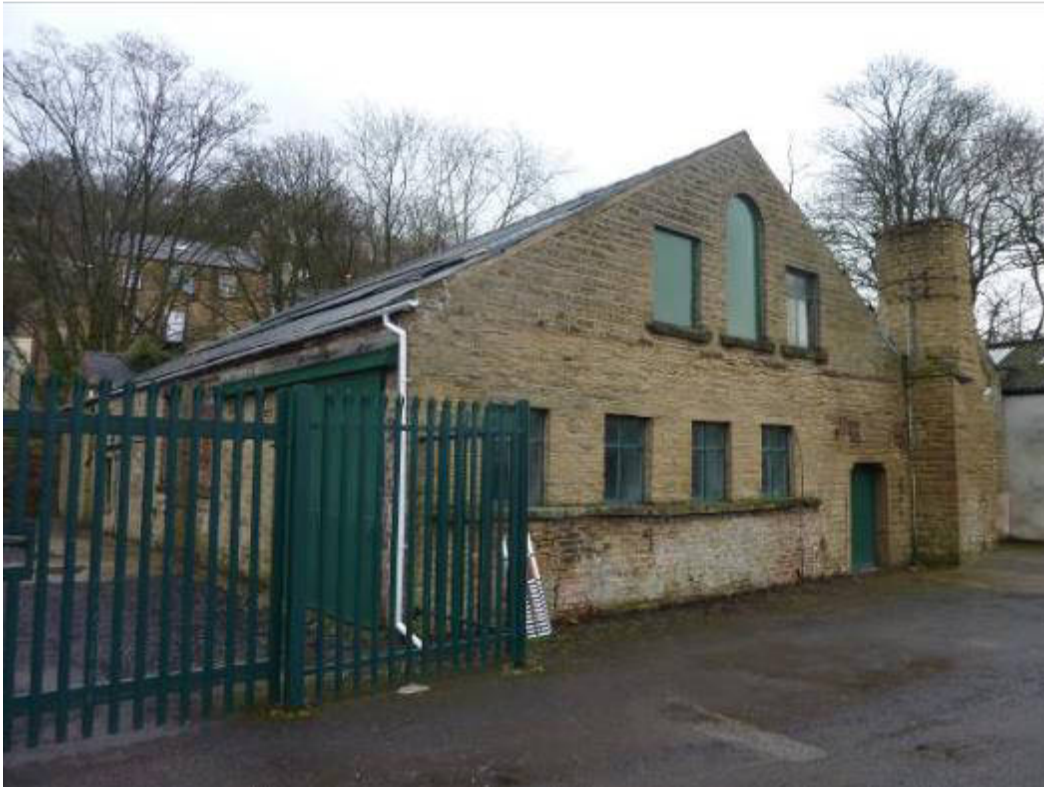
Building 2 is a disused, stone-built industrial unit which is attached to a brick-built industrial unit used for storage (Building 3). The unit has two pitched roofs with a slate tile roof covering. Externally, most features of suitability to bats were observed: a) within the stonework on the north elevation; and b) on the east elevations adjacent to the watercourse. There are several gaps within the stonework, particularly towards the midsection of the north elevation (Photo 7). These gaps lead to extensive cavities within the stonework. There are also several suitable gaps / crevices underneath the eaves board on the north elevation and to a lesser extent, the east elevations. It should be noted that no bat droppings were observed within these cavities.

Photo 5: Building 2 viewed from the north-west

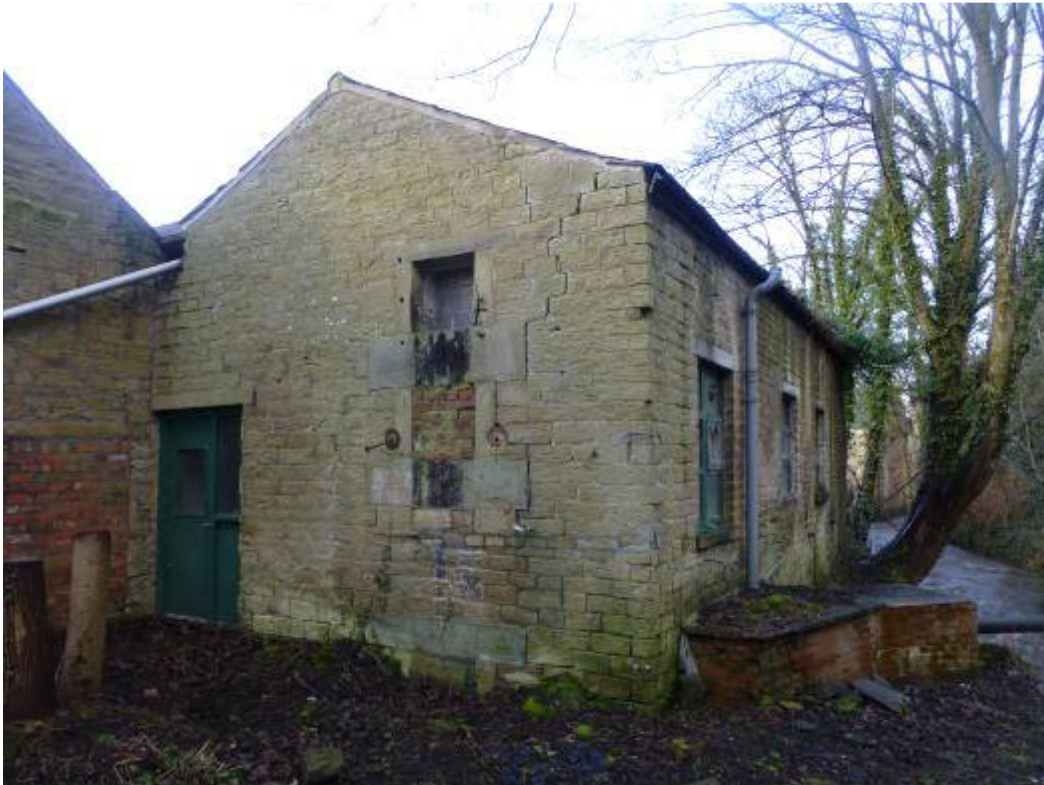
The site and immediate surroundings are largely hard standing and bat activity within the site is likely to be low. However, all units are located directly adjacent to the watercourse of Thunder Bridge Dike which provides a suitable foraging and connective flyway for bats. Bat activity within the site is expected to be largely associated with this watercourse and bat activity is expected to decline at increasing distances from the watercourse.

Photo 6: Building 2 viewed from the south-east (watercourse visible on right)

It is recommended that impacts to the watercourse which flows south-north adjacent to the east of the site are avoided as far as possible. If impacts such as lighting or bankside disturbance are unavoidable, further surveys for bats and otters may be required and measures may be required to mitigate any impacts.

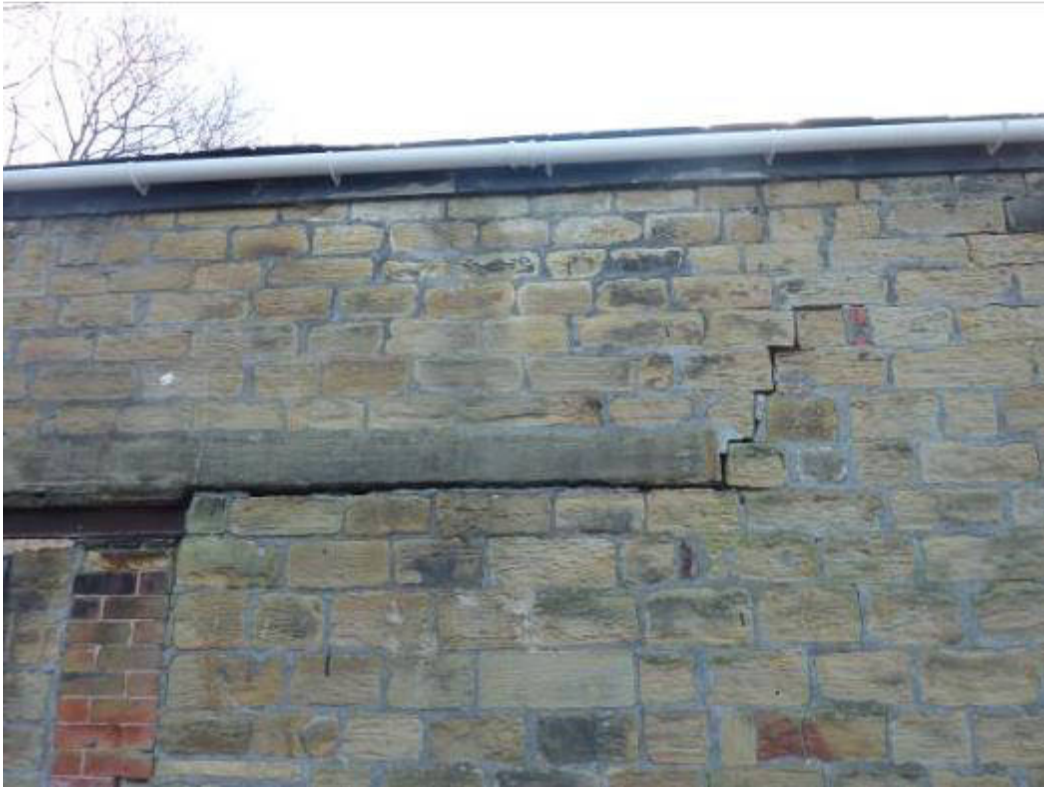
Building 2: Suitable features for bats are located within the stonework and eaves boards on the north elevations and to a lesser extent, the eastern elevations. Therefore, Building 2 is considered to have **moderate** potential for use as a roost by bats.

Bird nesting material was observed in two locations within the wall cavities of Building 2 (northern elevation). The wall cavities are therefore likely to provide a suitable nest site for birds during the breeding season (March to August).

Photo 7: Gaps within stonework (& behind eaves board) on north elevation of Building 2

Building 2 contains several features of suitability of use by bats (e.g., cavities within stonework) and consequently there is a sufficient element of risk of impacts to bats to trigger further survey effort. Therefore, it is recommended that dusk emergence and / or dawn re-entry surveys are undertaken during the bats main activity period (May to September) to provide more comprehensive information on the presence / absence of bats from this building.

All wild birds in the UK are protected under Section 1 of the Wildlife and Countryside Act 1981 (as amended) which makes it an offence to intentionally kill, injure or take any wild bird or take, damage or destroy the nest (whilst being built or in use) or its eggs. Bird nesting material was identified within Building 2. Any works to the building are therefore recommended to be undertaken outside the main breeding bird season (March to August). Any work which could affect active bird nests should be supervised by a suitably experienced ecologist and any active nests must be retained in situ undisturbed until the nests are no longer active.

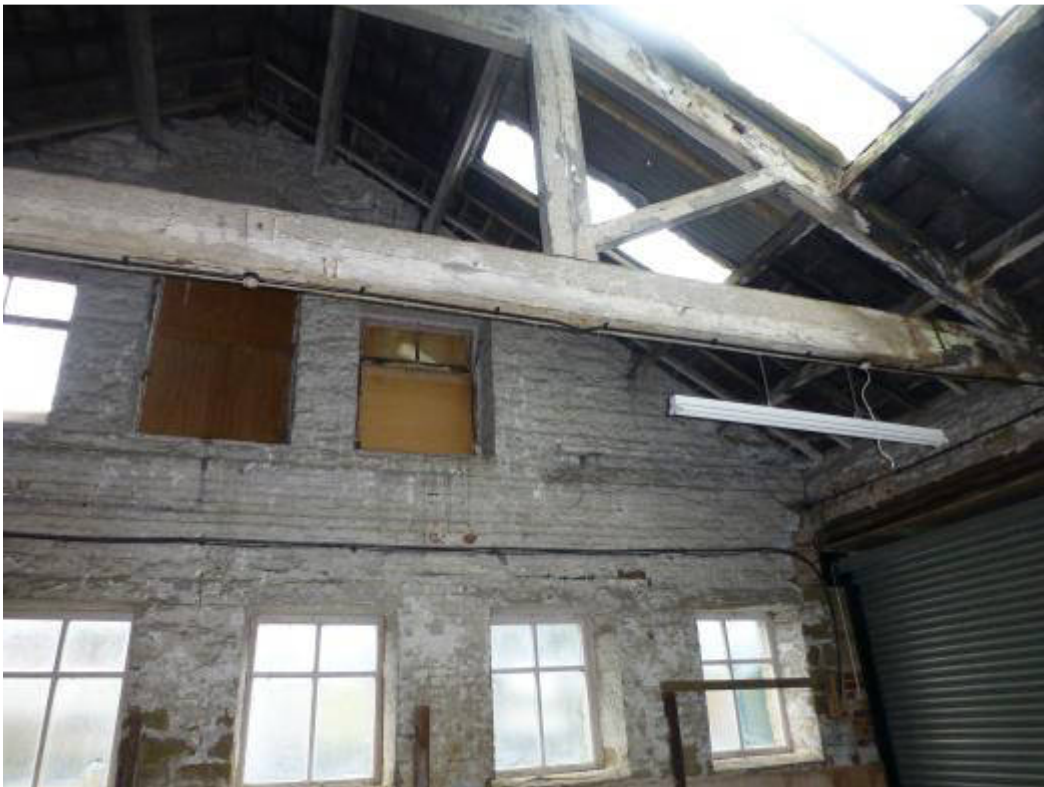
The roof structure is in very poor repair; extensive water ingress was observed in numerous places including walls & flooring throughout the building. This wetness will reduce the suitability of these parts of the building for use by bats. The ceiling of the building is largely collapsed. The roof is unlined and there are no true-roof voids. There is also extensive light ingress due to a number of skylights throughout the roof.

Photo 7: Internal roof structure of Building 2

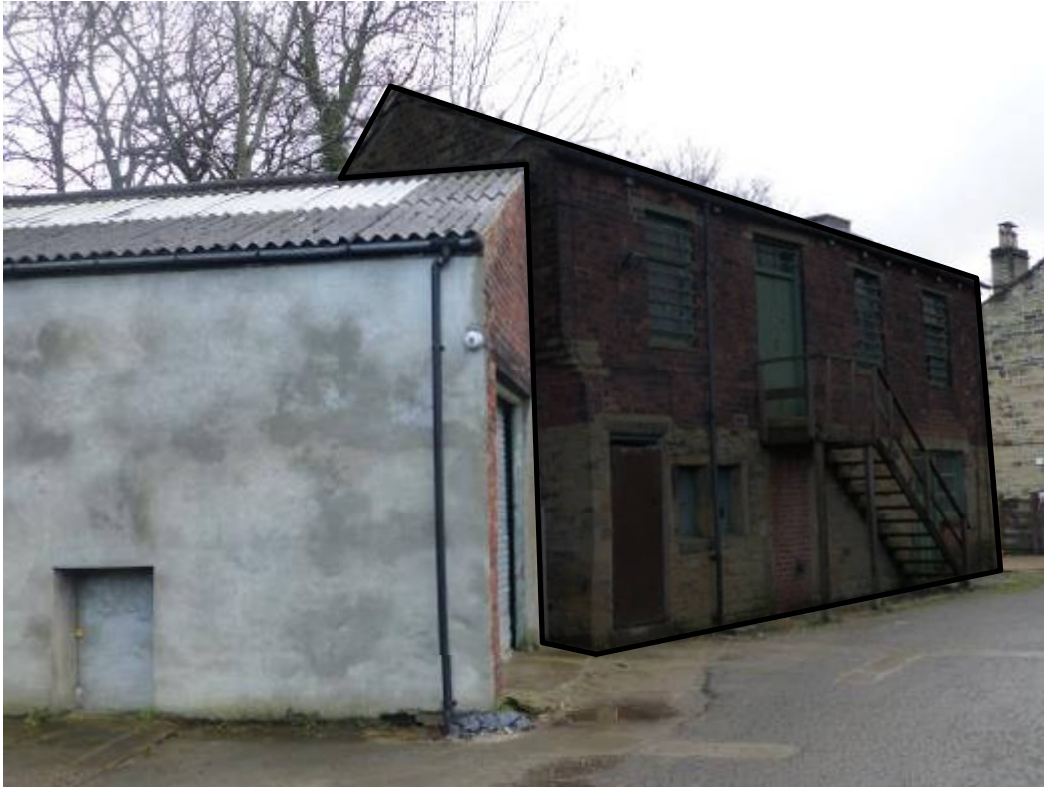
Building 3 is a brick-built, single industrial unit attached to Building 2 and currently used for storage. The building has a corrugated sheet roof which is unlined. Internally, the building is an open structure with no roof void. Externally, roost opportunities for bats are limited to crevices underneath the roof covering where it overlaps the wall on the east elevation adjacent to a watercourse.

Photo 8: Building 3 (left of picture) viewed from the north

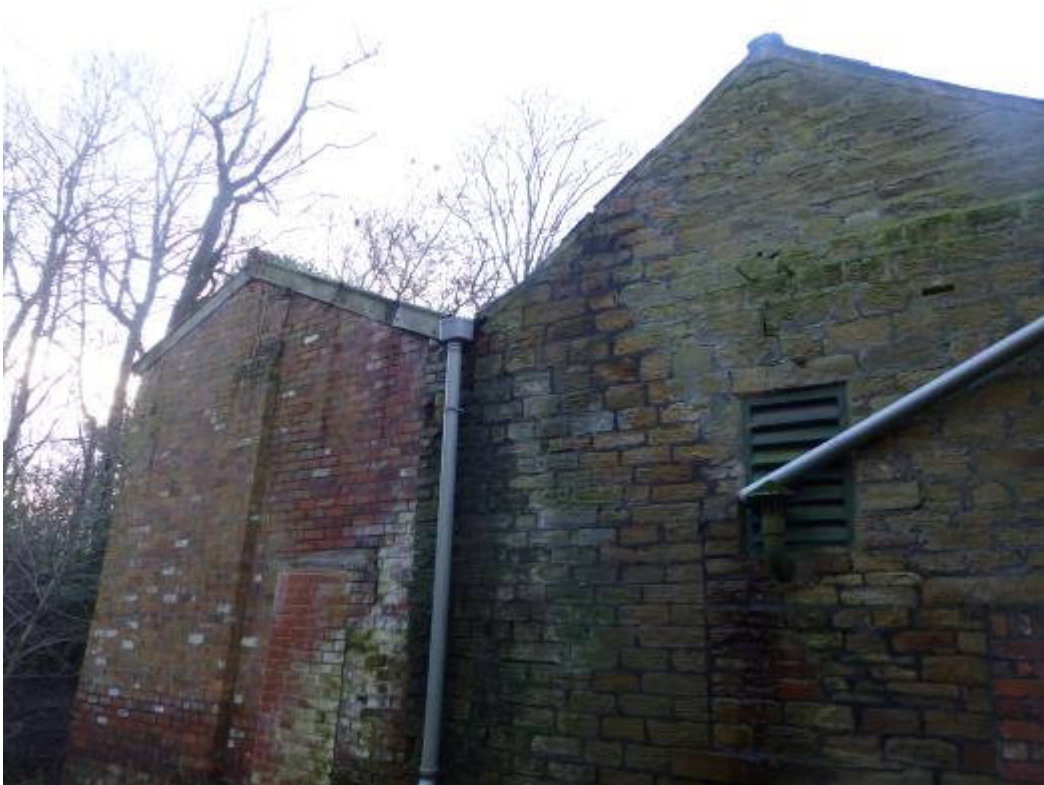
Building 3: With consideration of the limited number of bat roost features (e.g., crevices beneath roof sheet overlap), Building 3 is considered to have **negligible to low** potential for use as a bat roost.

Photo 9: East elevations of Building 3 (left of picture) and Building 2 (right of picture)
