# Geoenvironmental Appraisal

## Land at Flockton Working Men's Club For Barratt and David Wilson Homes Yorkshire West

Report no: 2211/1

Date: October 2015

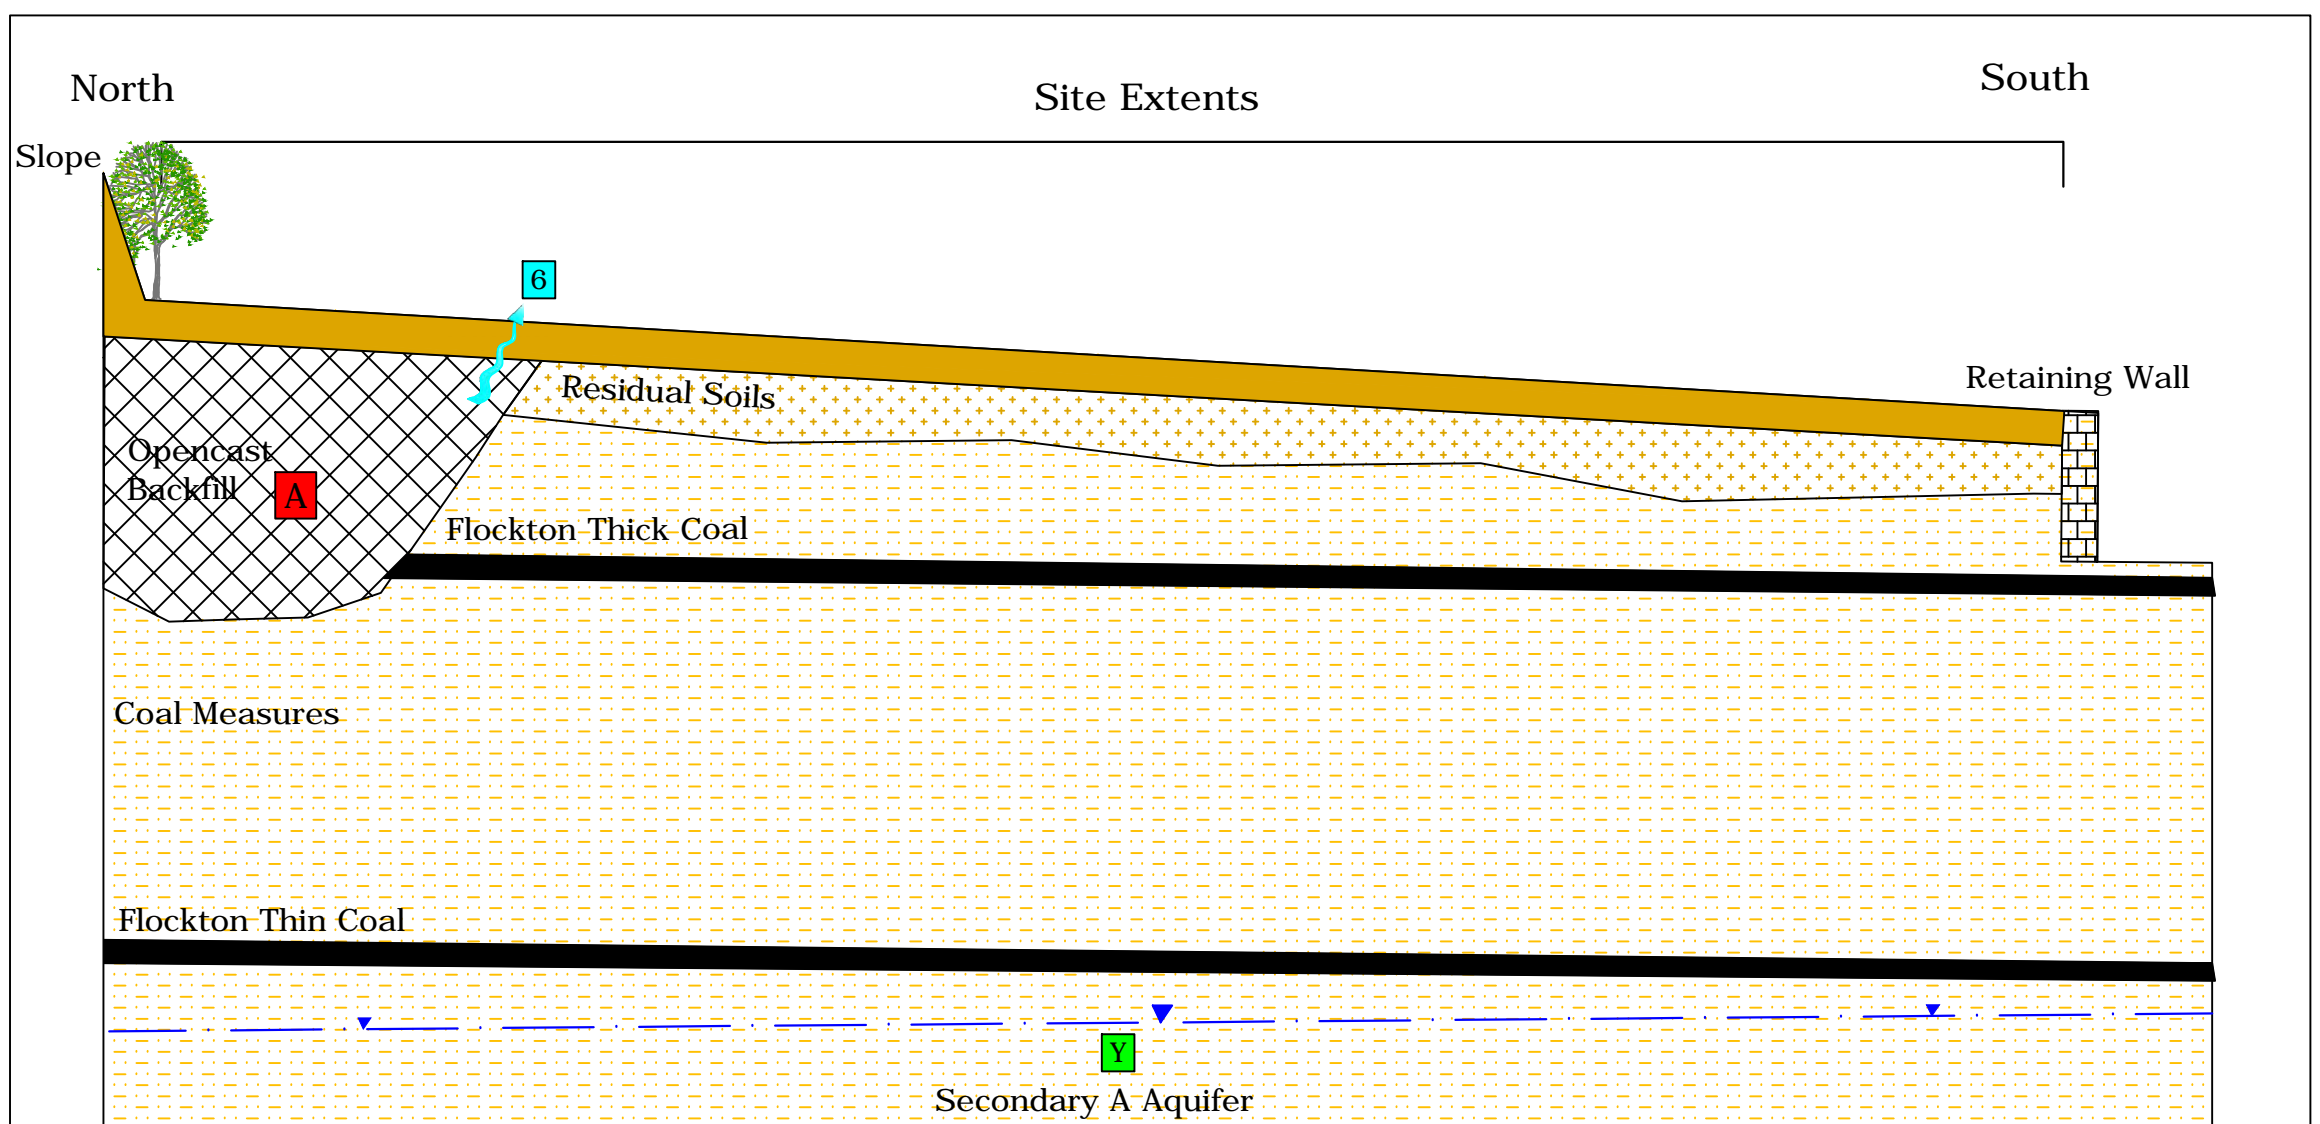
**REVISED CONCEPTUAL SITE MODEL**

SOURCES	
B	MADE GROUND

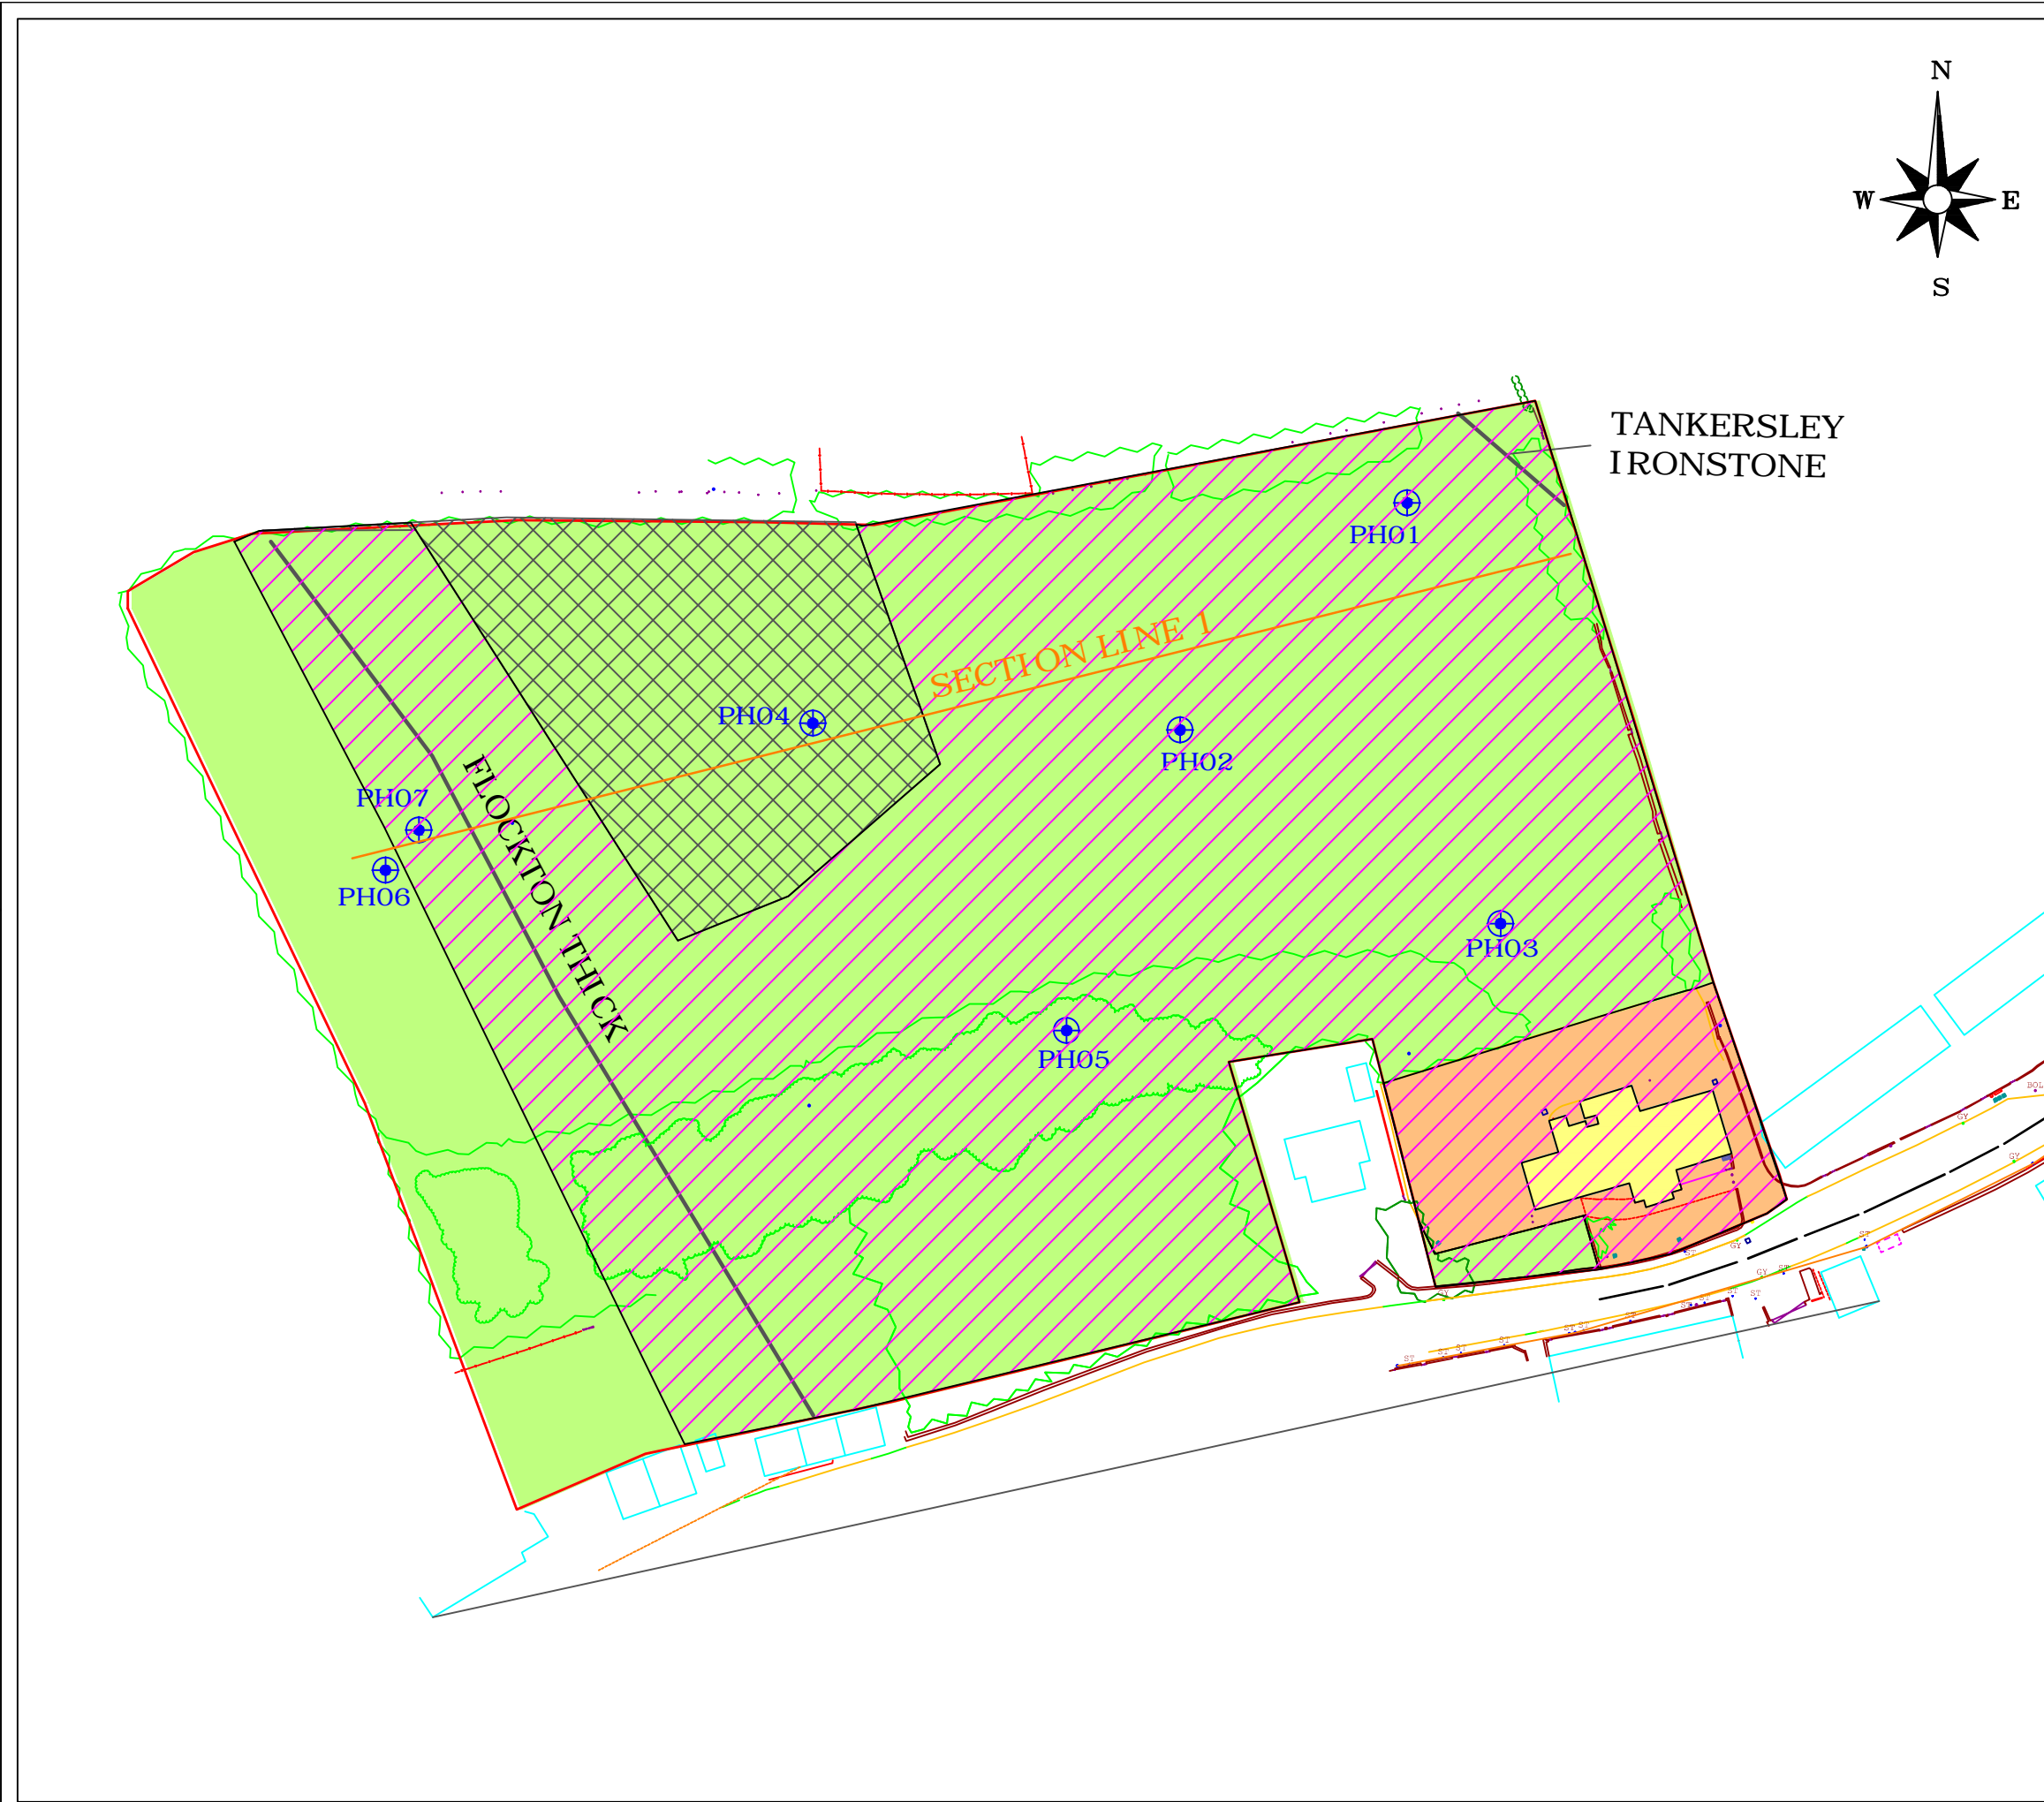
- NOTES**
- PROBEHOLE LOCATION
  - AREA LIKELY TO REQUIRE MITIGATION MEASURES FOR WORKINGS IN FLOCKTON THICK SEAM
  - FORMER OPENCAST
  - APPROXIMATE COAL SEAM OUTCROP
  - CROSS SECTION LINE
  - APPROXIMATE SITE BOUNDARY
