**Bat Roost Potential Survey  
The New Wharf, Huddersfield**

Report reference: R-1574-01  
August 2013

### Summary Statement

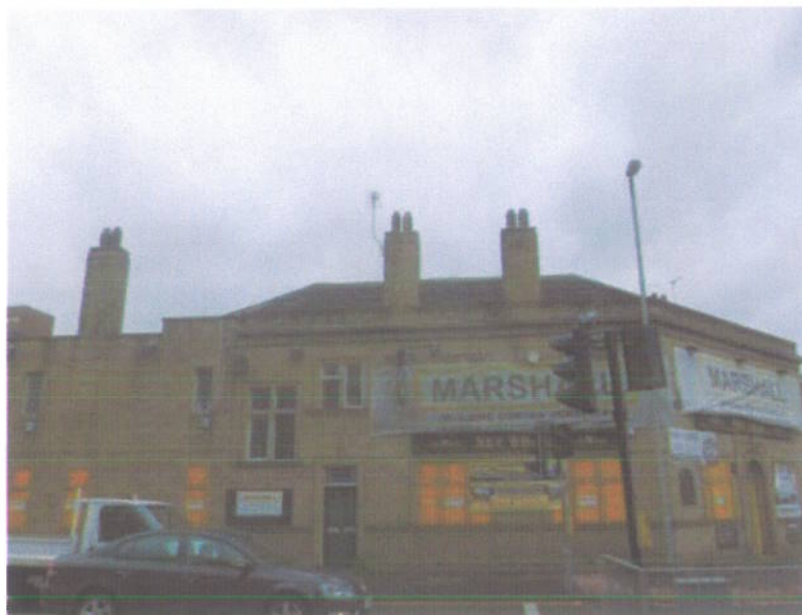
**Figure 2** General view of the site viewed from the east.

8. The application site is located on a main road, surrounded by built environment. Although the immediate area seems to provide little in terms of suitable bat habitat, the site is located between the Huddersfield Broad Canal (60m to the west) and the River Colne (120m east) both of which would provide good foraging for bats and link the site with additional habitat such as the wooded areas of Ashley Hirst Plantation some 240m to the south east.
9. The building has two storeys, occupying a corner plot and is attached to retail units on the north western elevation.

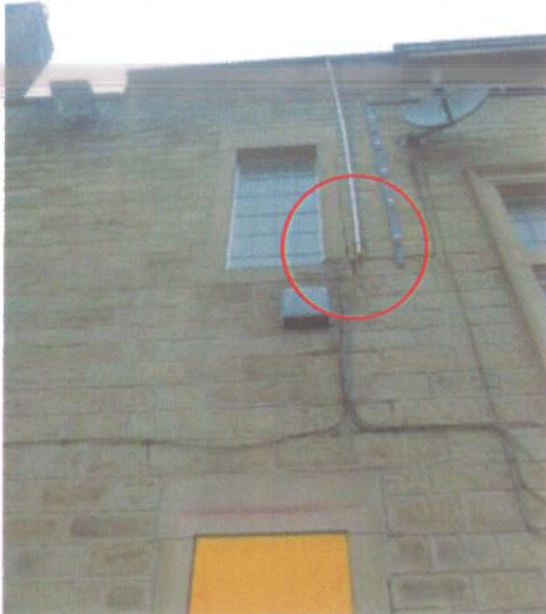
**Figure 3**

10. The wall are constructed from brick and lined with local stone, being in the most part in a sound condition, although there are a few gaps where pointing is missing creating gaps that could give bats access to potential roosting space within the walls. These features are largely limited to areas around the stone lintels at the south and eastern elevations of the building. A search was made for any droppings which would suggest roosting, but none were found.

Gaps around stone frames of windows on the south eastern wall.

17. The building occupies an area likely to be attractive to bats and this will increase the possibility of its use as a roost.
18. Emergence surveys will need to be carried out during bat's active period (May to September) by a suitably qualified ecologist to prove the absence of roosting prior to works commencing on the building.

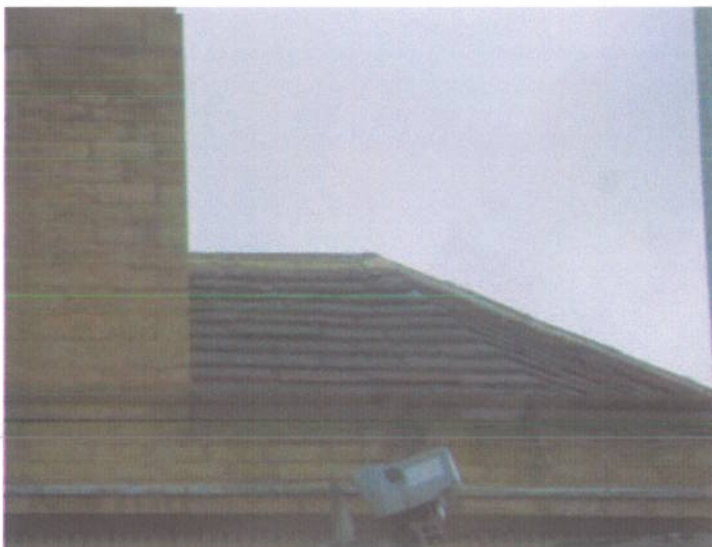
**Figure 4**

11. The hipped roof features a small parapet wall which runs along the pitched sections of the building, effectively sealing the eaves and providing no access points for bats.

View of parapet wall which adjoins all pitched roof sections.

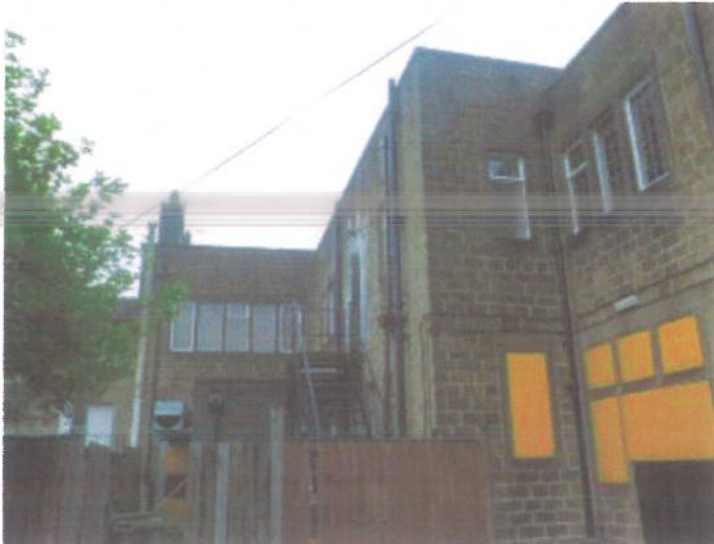
**Figure 5**

12. A number of flat roofed areas are found to the rear of the building facing south: these have well sealed bitumen roofs with a small coping stone along the edges and offer very little in terms of roosting potential.

Rear of the building showing arrangements of flat roofed sections.

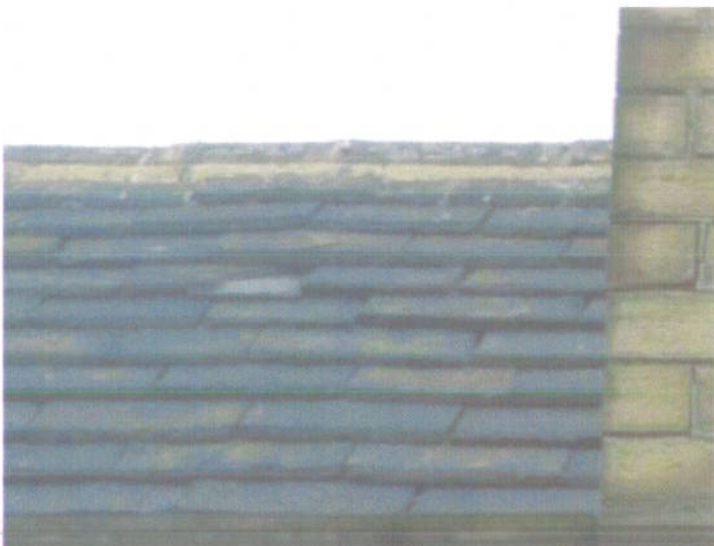
**Figure 6**

13. The slate roof is in a variable state of repair and although the ridge appears well sealed, there are a number of slipped or missing slates which have created gaps visible on the south and eastern elevations. It was difficult to gain a clear view of other elevations due to adjoining buildings. These gaps could offer roosting spaces for a small number of bats or potentially give access to the roof void.

Missing slates along south eastern section of roof.

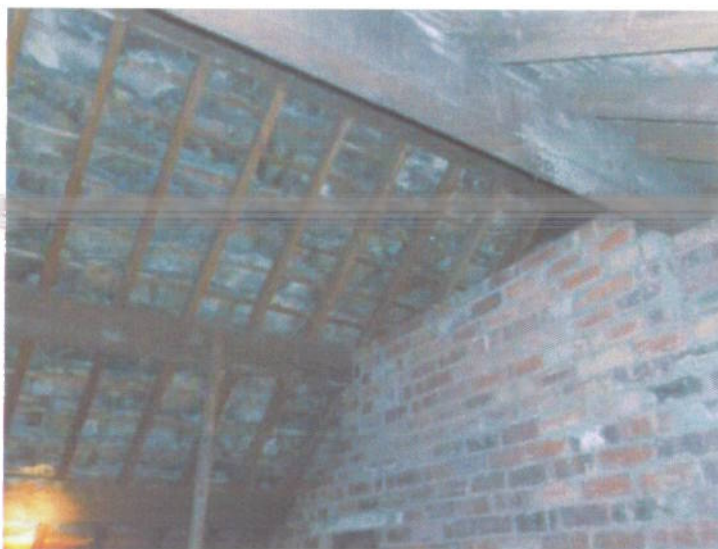
**Figure 7**

14. An internal inspection of the loft revealed sound timbers, well sealed wall tops and an unlined roof, while the space was unlit with some limited draughts from small gaps within the slates. A detailed inspection was made of most of the southern section of the loft although it was not possible to gain safe access to all areas. No droppings were found within the viewed sections, though the floor was covered with a thick layer of dirt and mortar from the roof, so small amounts of droppings would have been difficult to detect.

Internal view of loft space showing unlined slates.
