Bat Survey Report
11 Olney Street
Slaithwaite
West Yorkshire
HD7 5EG

September 2016

Oatlands Ecology was commissioned to carry out an Initial Scoping Survey (Bats) at 11 Olney Street, Slaithwaite as part of a planning application for a first floor front extension.

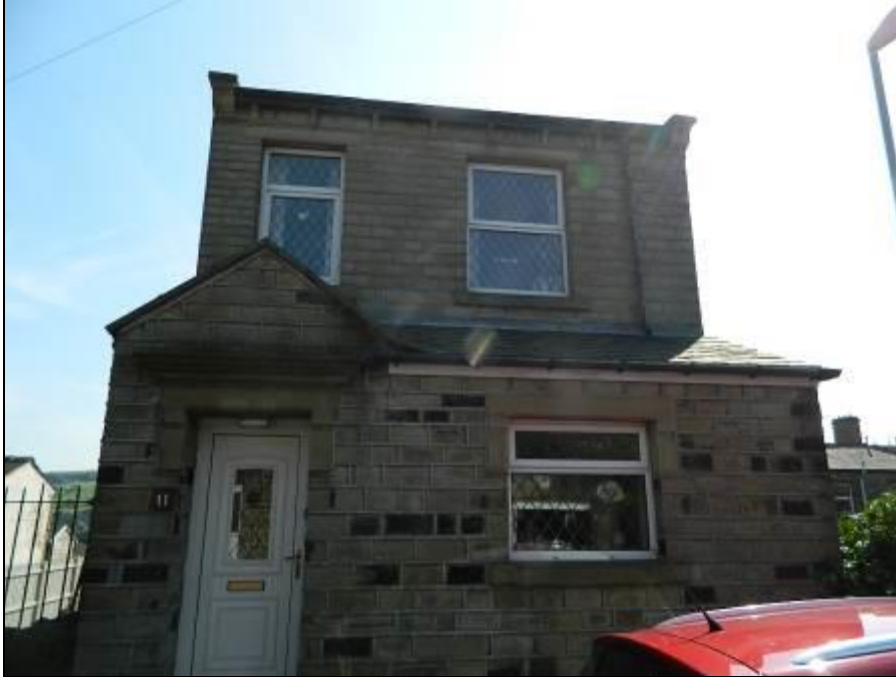
Photo 1: Front elevation – showing location of 1st floor extension

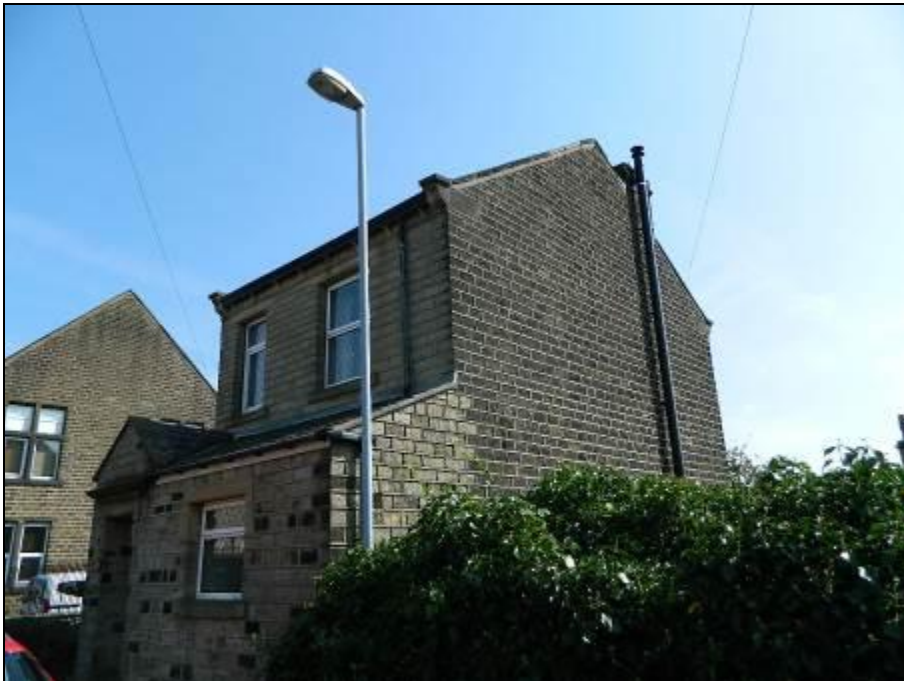
Photo 2: Side (west) and front elevation

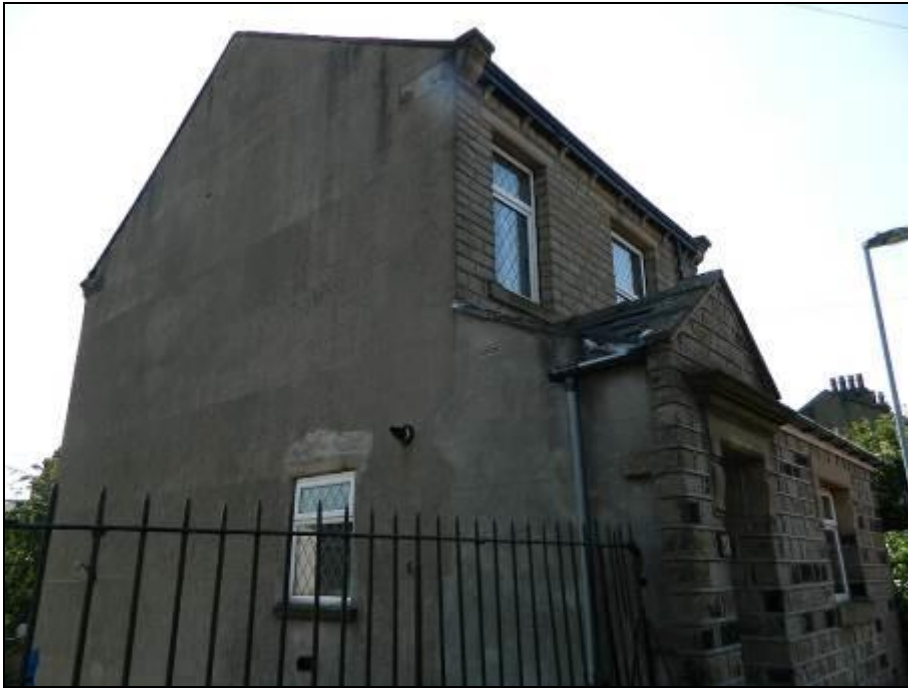
- All exterior pointing was in very good condition with the eastern side extension rendered with concrete. No gaps suitable for bats were observed.
- All windows and frames were in good condition, sealed with no suitable features for bats observed.

Photo 3: Side (east) and front elevation – showing rendered side elevation.

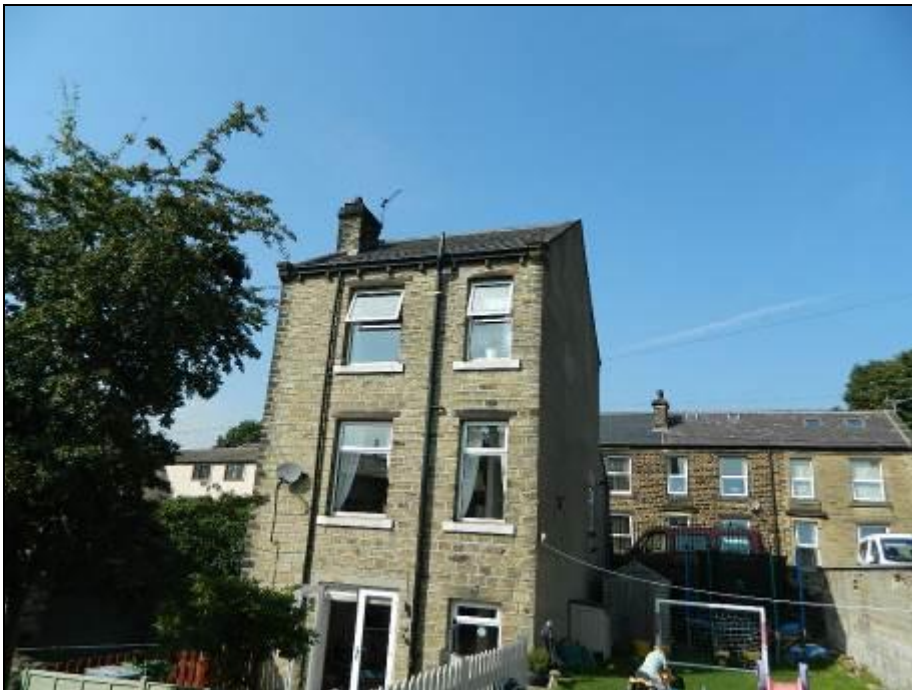
- There was a small gap running along the length of the rear guttering which may have some limited potential to support a very a small, occasional roost of individual bats. However, despite a thorough search of the exterior wall , windows and ground at the foot of the walls no droppings were observed.

There was a small gap running along the length of the rear guttering (between the back of the guttering and the wall). However, despite a thorough search of the exterior wall immediately beneath this guttering and further down, the rear windows, the ground at the foot of the walls and the tops of all garden furniture no bat droppings were observed.

Photo 4: Rear elevation

- The rear guttering and the gap behind it should remain *in situ* during the works.
- Should bats, or evidence of bats, be observed during the works, all work should cease and either of the following contacted for advice:
 - The Local Authority Biodiversity Officer at Calderdale Council
 - The Bat Conservation Trust: 0345 1300 228.

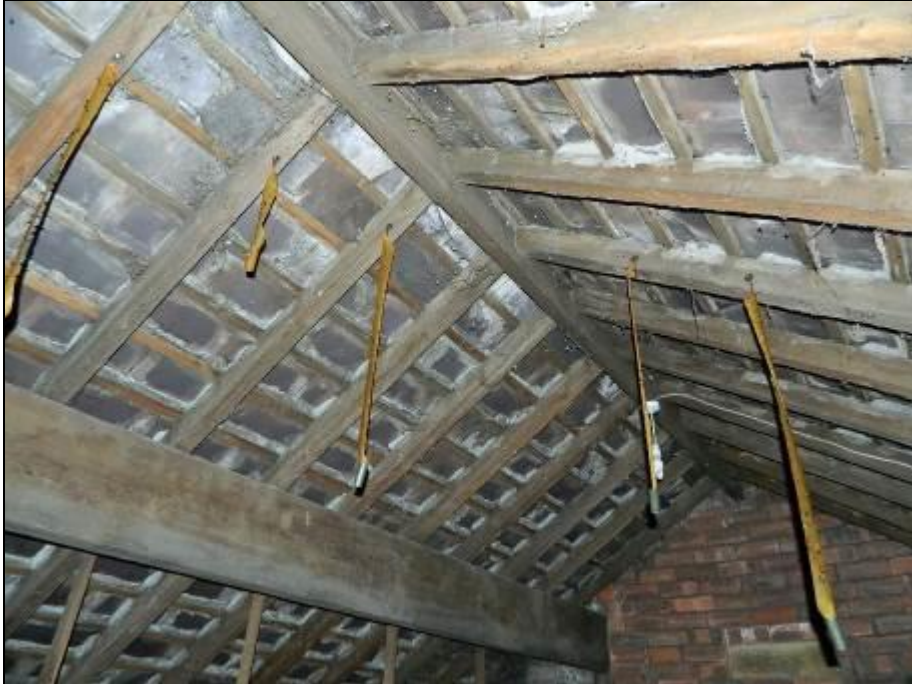
- The roof void was unconverted and the tiles un-lined and back pointed. The internal pointing (at the internal gable ends) was in very good condition and all roof timbers were tight with no gaps, crevices or cavities with the potential to support bats observed.
- Large accumulations of dust and webs were present across the entire roof frame and floor and walls of the loft– indicating bats are not using these areas and the floors and walls of the roof void.

Photo 5: Roof void – showing unlined back-pointed tiles

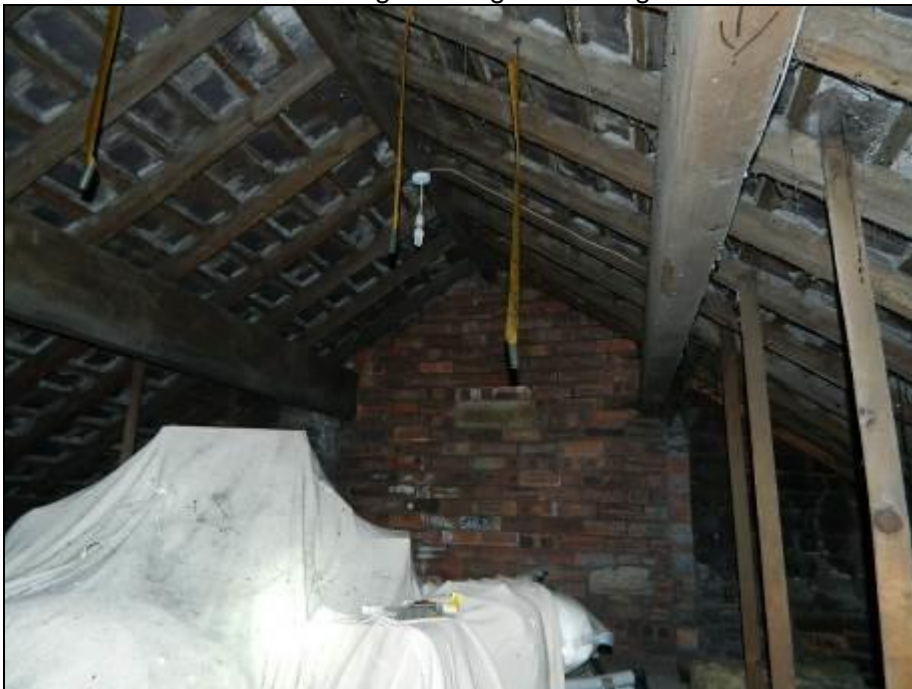
Photo 6: Roof void – showing stored goods and gable end wall.
