333 Drub Lane,
Cleckheaton, BD19 4BX

Bat Scoping Survey

February 2016

QUANTS environmental Ltd

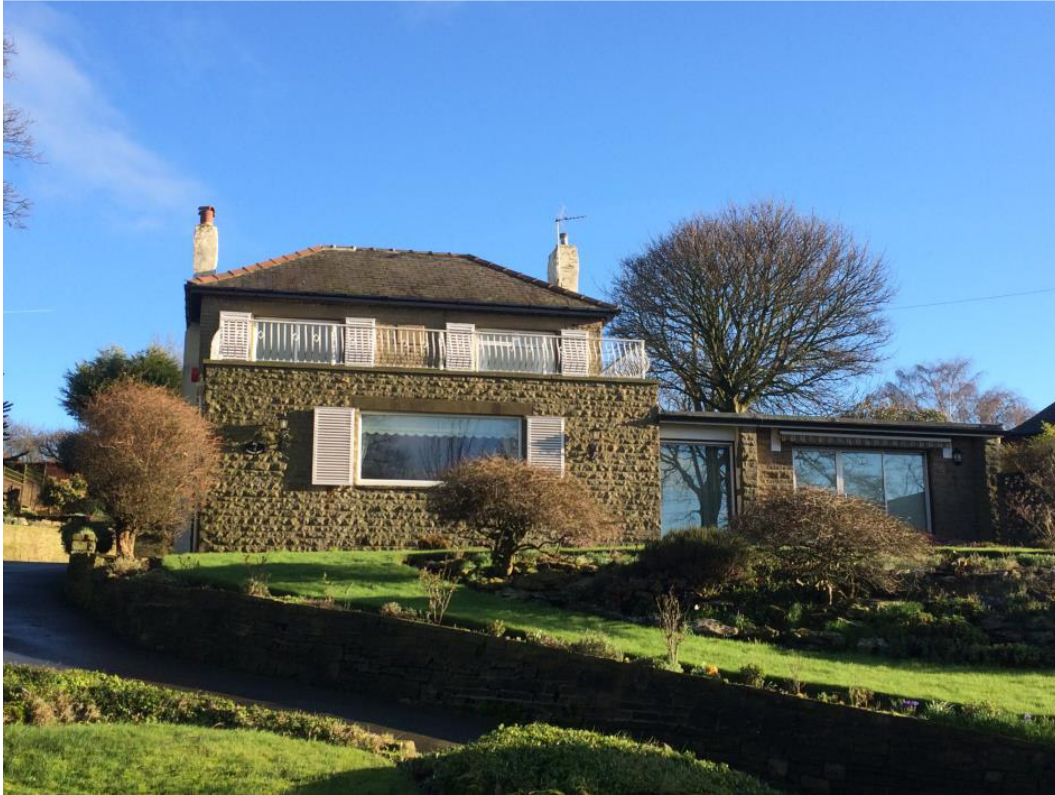
See photos at Appendix 2. The house on the site is recently disused but appears to be in a generally very good state of repair. It appears to be constructed of brick with stone facing and is part rendered. A date stone on the south elevation reads 'Fairfield House 1927'. The house comprises a two-storey section with a hipped-gable roof covered in Welsh-style slates and a large flat-roof single-storey section.

Photo 1. 333 Drub Lane viewed from south-west (front)

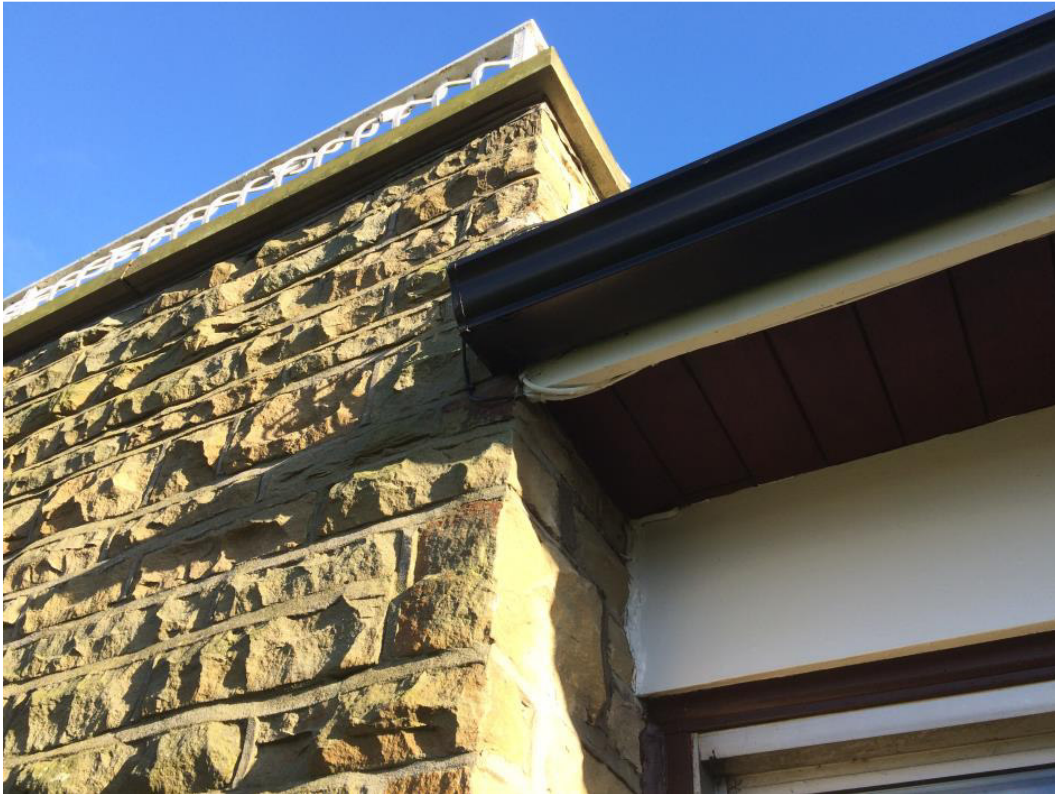
Photo 3. Detail on south-west elevation showing flush soffits and roof verges

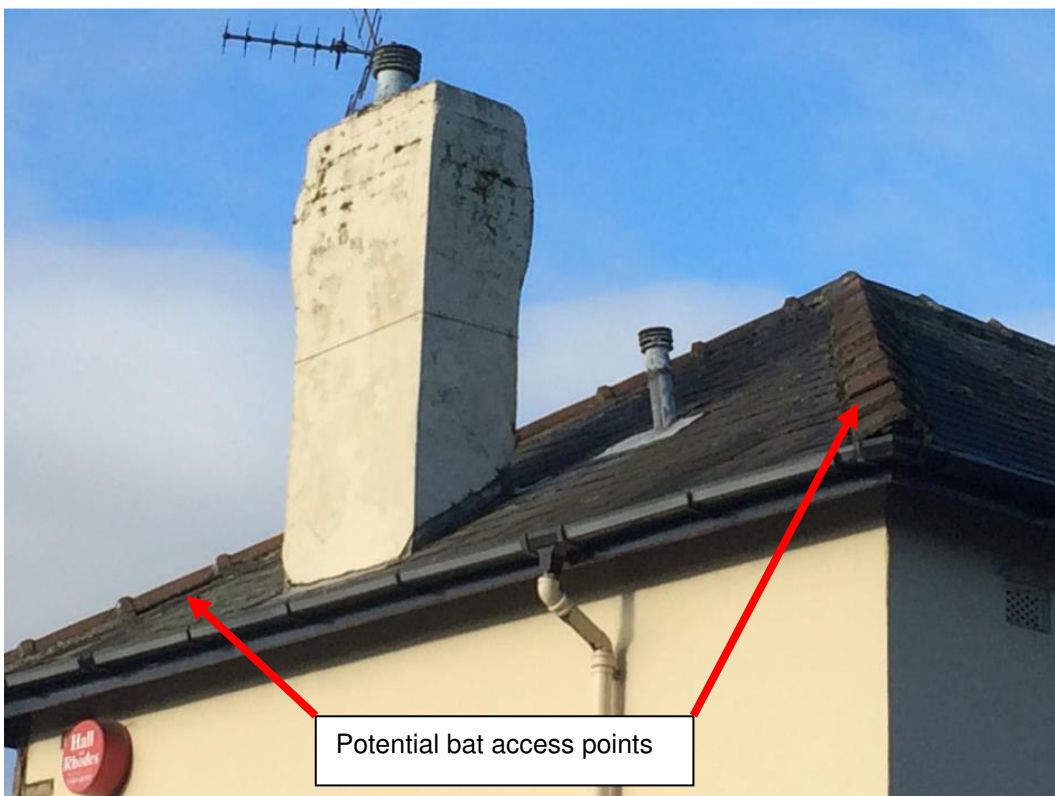
Photo 6. South-east facing hipped-gable viewed from east

1. Raised ridge tile on east side of roof (see Photo 6, Appendix 2).
2. Raised ridge tile on south side of roof (see Photo 6, Appendix 2).

Both of the above listed raised ridge tiles provide potentially suitable bat access points.

No signs of bats were found during the scoping survey and it is considered that the building has low bat roost potential. The only identified features with potential to support bat roosts were two gaps beneath ridge tiles as shown on Photo 6 (Appendix 2). However, as described under Limitations in Section 2.4, it is noted that the survey was conducted outside the optimal season for bat surveys and the interior of the building was not accessible.

In accordance with current West Yorkshire guidance, due to the survey limitations and the presence of two gaps beneath ridge tiles on the surveyed building, it is recommended that further work is required, as described below. Two options could be progressed:

1. If full internal access to the loft spaces can be obtained, the loft spaces should be surveyed (this can be undertaken at any time of the year). If no signs of bats are recorded during the internal inspection, it will be recommended that the demolition works can proceed under a precautionary method statement (i.e. ecological supervision of removal of the ridge tiles).
2. If full internal access to the loft spaces cannot be obtained, it will be necessary to undertake a minimum of one bat activity survey during May-August. Due to the position of the potential roost sites, one surveyor will be sufficient to survey the house adequately.

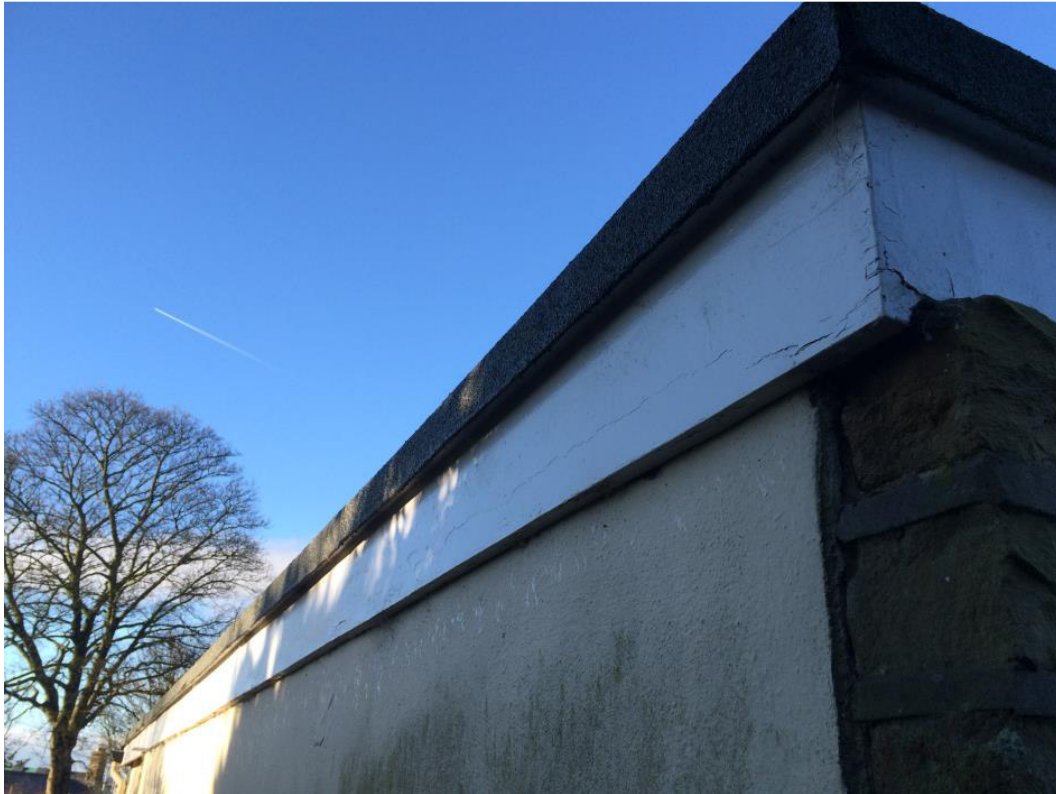
Photo 7. South-east elevation of house showing eaves boards in good condition and flush with wall providing no potential bat access points
