# Poplar Farm Briestfield, Dewsbury

## **Bat Survey**

July 2014

**QUANTS** environmental Ltd

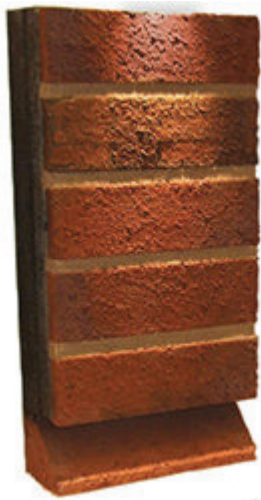
**Figure 3: Illustration of Habibat bat box design - Dimensions: 215 mm wide x 440 mm high x 102 mm deep**

It is recommended that an integrated bat box is built into each house during construction using designs such as the Bat Conservation Trust approved integrated custom brick facing design by Habibat ([www.habibat.co.uk/](http://www.habibat.co.uk/)). Habibat is a large, solid bat box made of concrete with an internal roost space, which has been designed to be incorporated into the fabric of a building as it is built. It can be manufactured to suit any existing brick or stonework finish (other suitable bat bricks are available from different manufacturers, e.g. Schwegler 1FR bat tubes). The fixed position for bat boxes should be located underneath the eaves of each dwelling, preferably on the south elevation and have a clear 1-2m drop from the entrance point. The bat box should also be located away from windows and excessive light spill. An illustration of the design is presented in Figure 3. The integration of bat boxes should offer potential ecology accreditation within a housing scheme such as Code for Sustainable Homes.

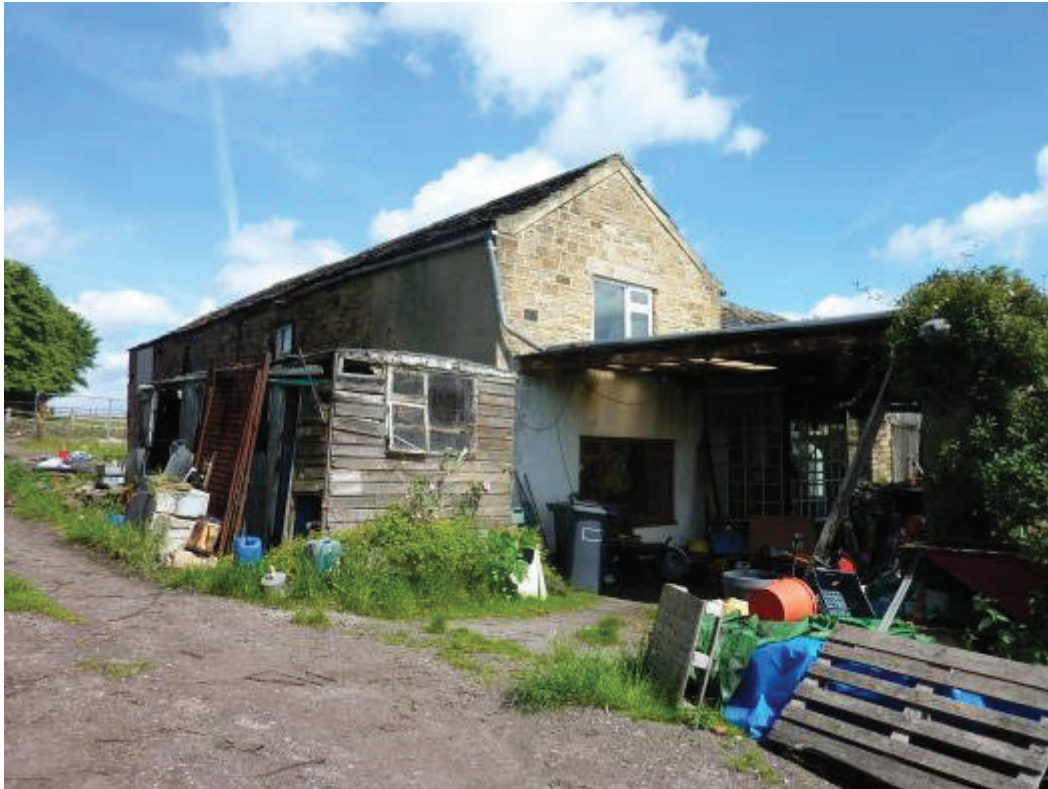
**Photo 1: Southeast elevation of farmhouse.**

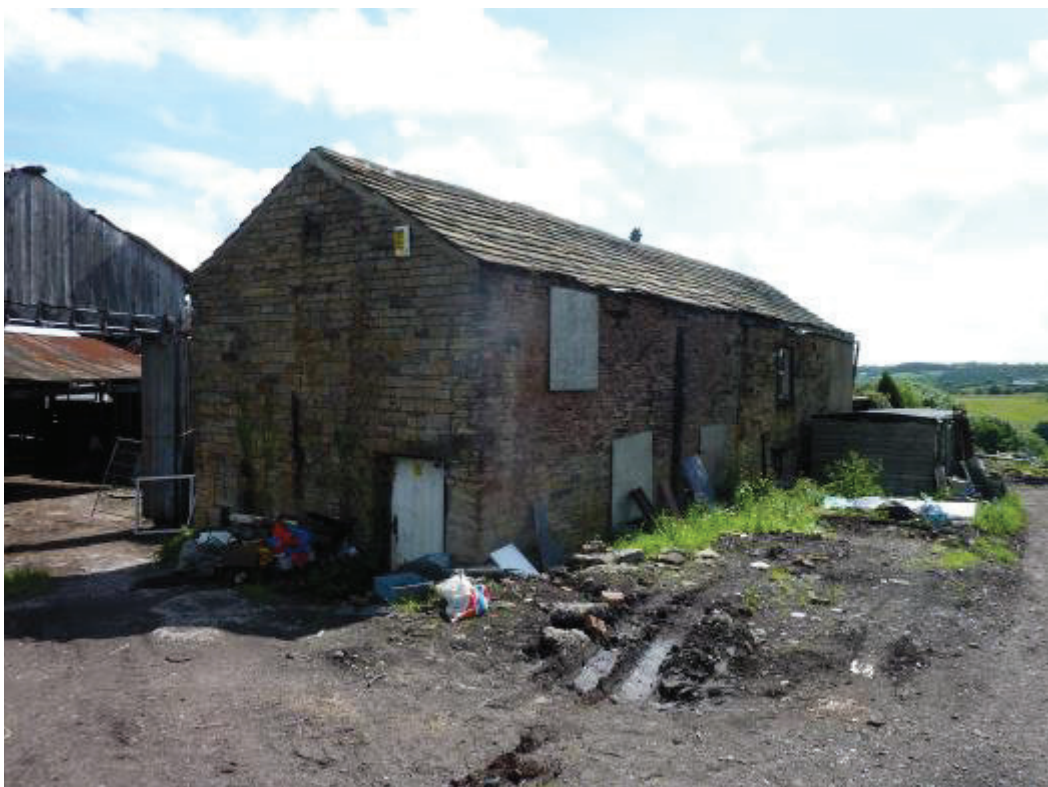
**Photo 2: Northwest elevations of farmhouse.**

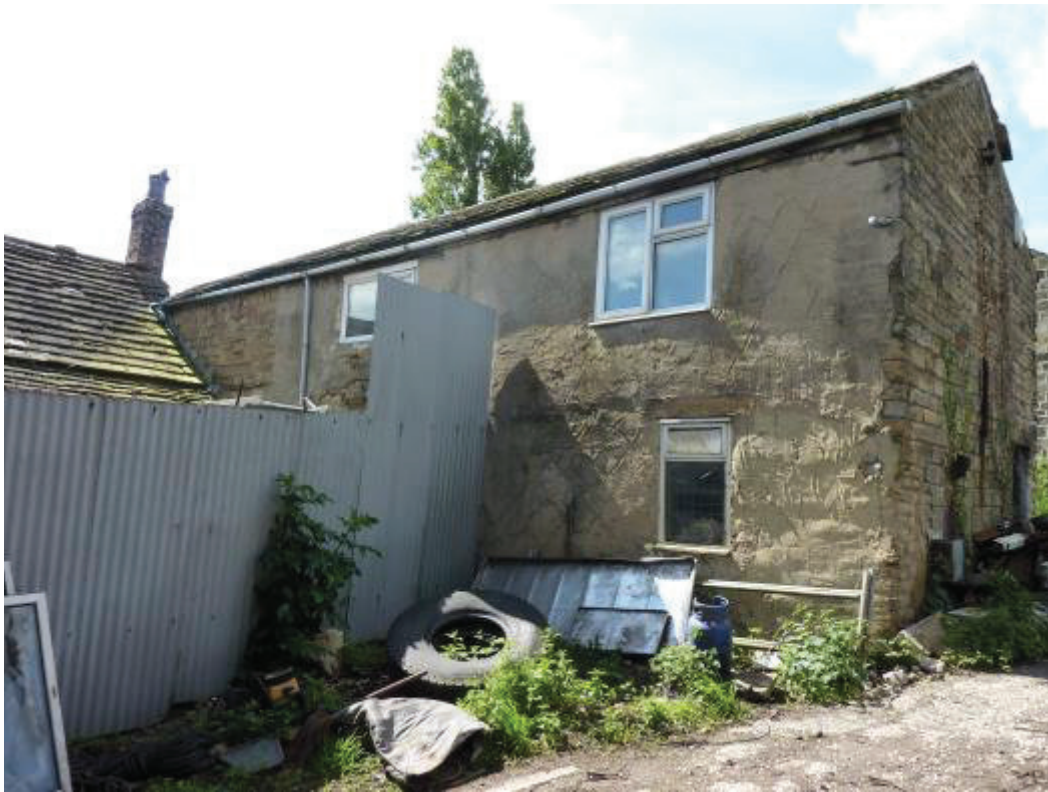
**Photo 3: East elevations of farmhouse (stone barn to left of photo).**

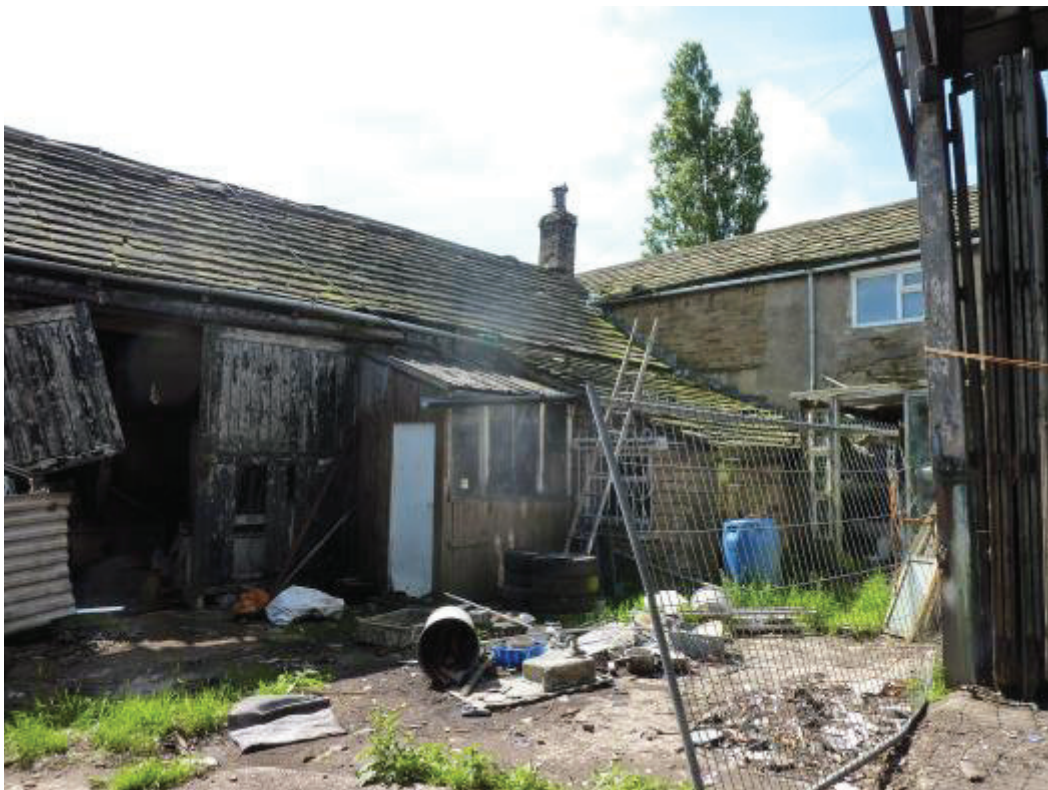
A stone barn is attached to the farmhouse on the lower east elevation. The barn has a stone slate covering. The barn is in a highly noticeable poor state of repair; sections of the walls appear to have moved and/or collapsed; many ridge tiles and roof slates were missing resulting in a high amount of rain egress and many roof timbers were rotten. Due to missing roof slates and two large open entrances, the barn was very light throughout. Due to such

**Photo 4: North elevation of stone barn.**

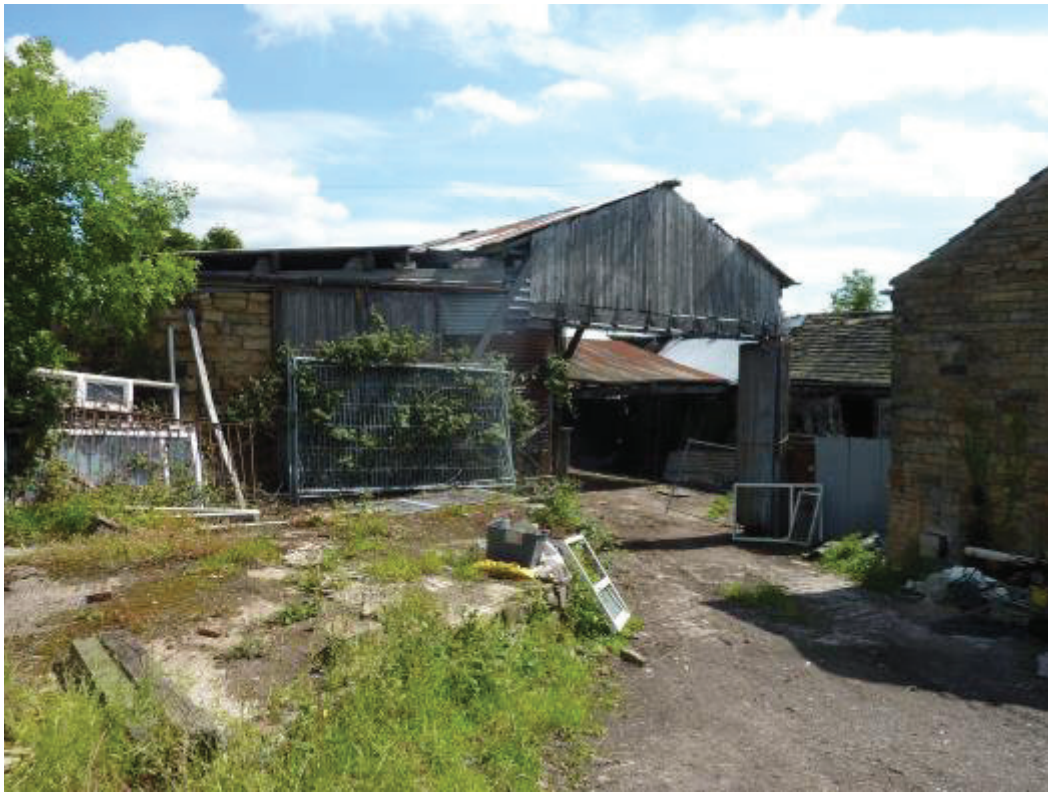
The farm has a large Dutch style open barn which is constructed from use of timber stanchions, corrugated sheets, concrete blocks and stone. Typically, such constructions do not offer features of suitability for use as a bat roost and no readily observable roost features were recorded. The outbuildings including small (collapsed) sheds and lean-to's are not considered to offer any roost potential for bats and are therefore not described in any detail.

**Photo 5: Dutch style barn**

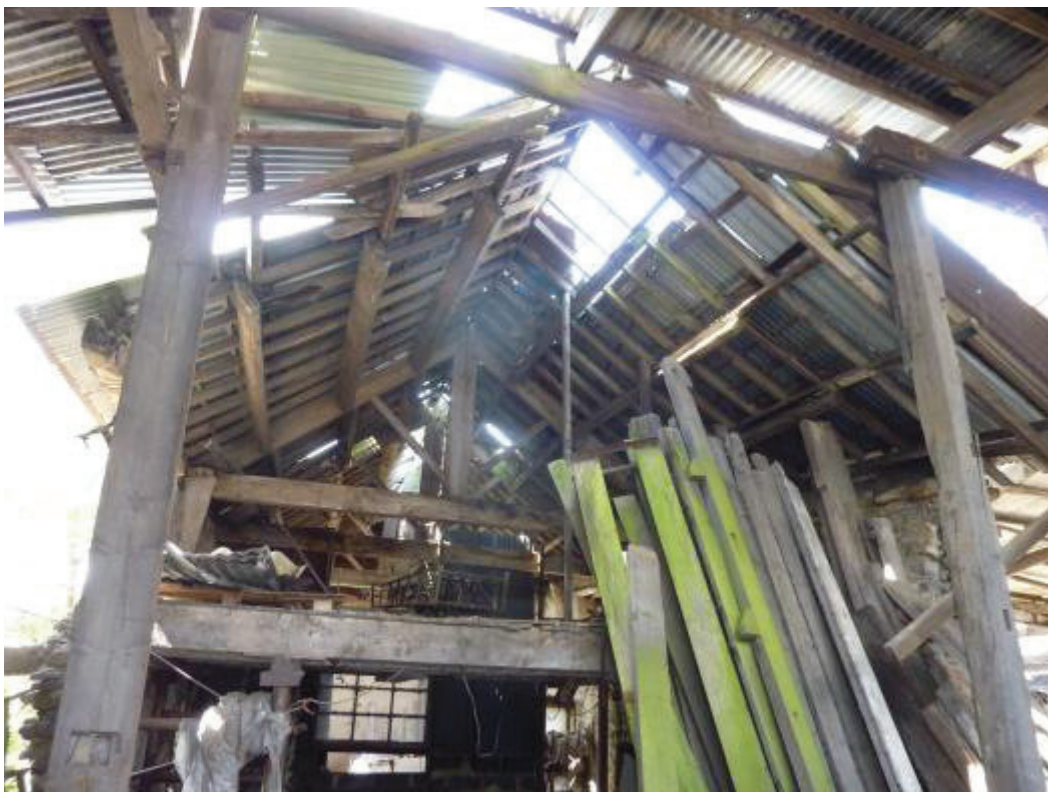
A number of birds' nests were recorded amongst the roof timber of the Dutch style barn. No evidence of nesting birds was observed within the farmhouse or attached stone barn.

**Photo 6: Inside of Dutch barn.**

Birds' nests were recorded within the roof timbers of the Dutch barn. All wild birds in the UK are protected under Section 1 of the Wildlife and Countryside Act 1981 (as amended) which makes it an offence to intentionally kill, injure or take any wild bird or take, damage or destroy the nest (whilst being built or in use) or its eggs. The demolition works must therefore be completed outside of the bird nesting season of March to October.

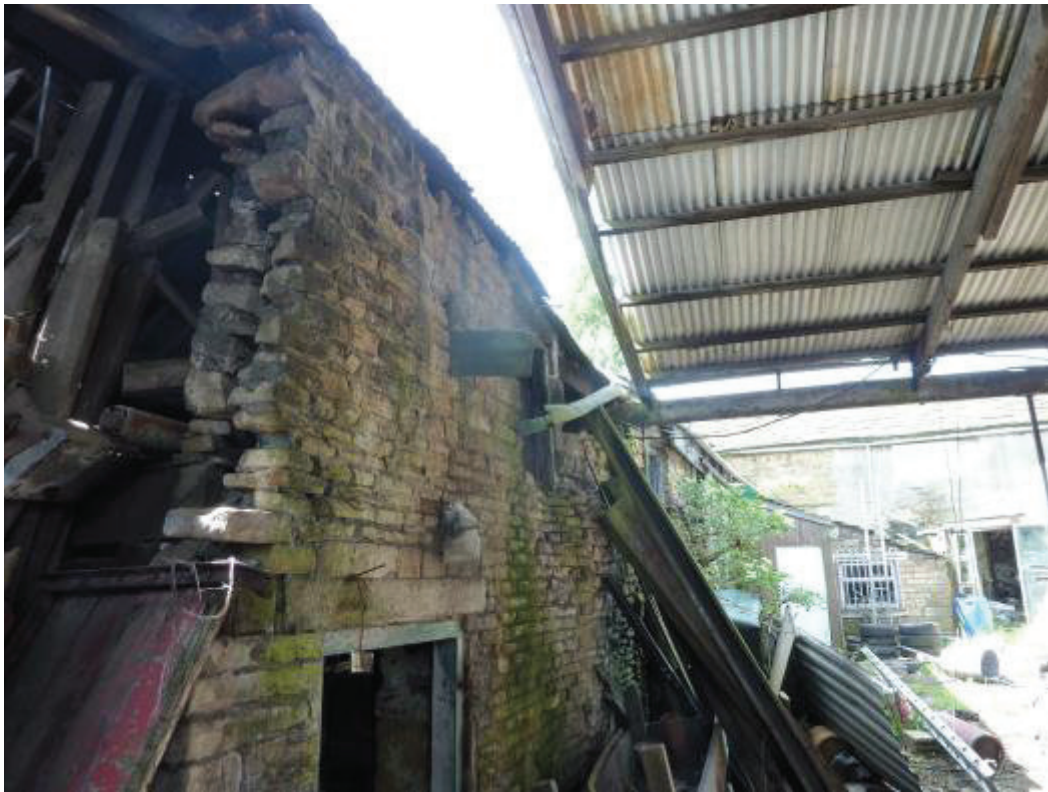
**Photo 7: Stone barn (looking west along north elevation)**

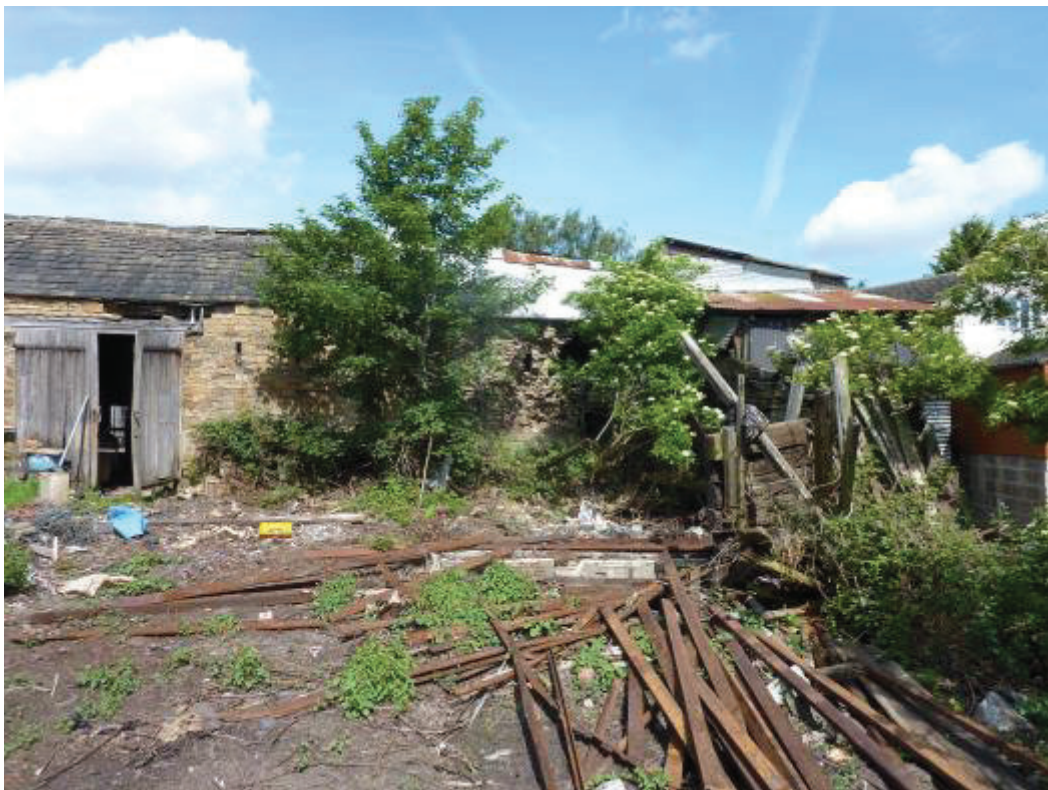
**Photo 8: South elevation of barn & connected sheds**

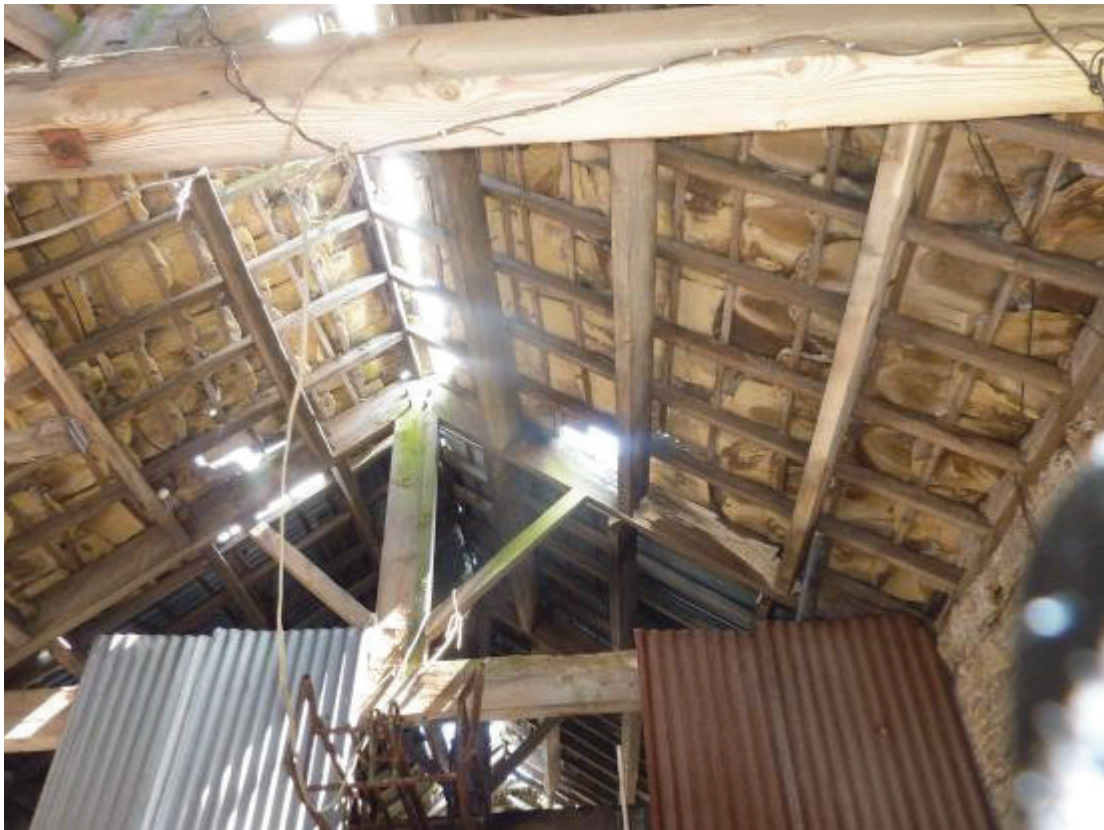
poor structural repair and conditions, potential roost features for bats were limited to possible crevices between roof slates.

**Photo 9: Light levels within Stone barn**

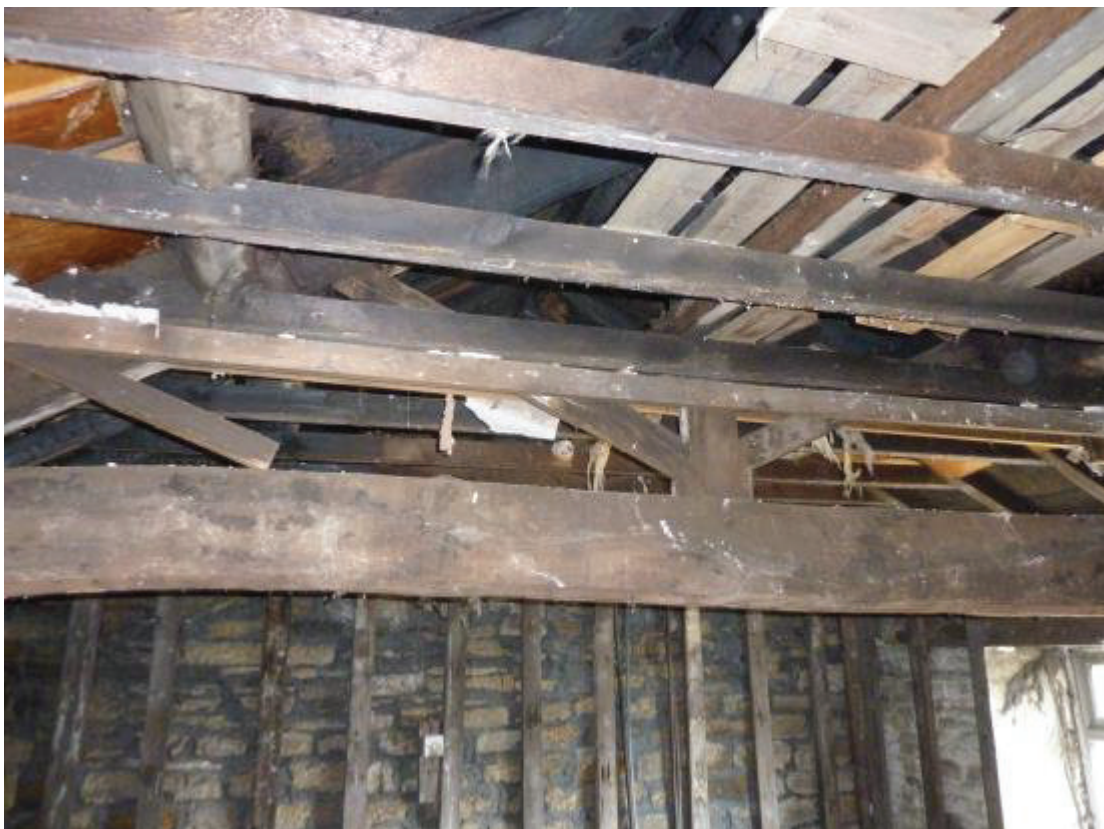
The fire damage was extensive within the roof structure. The northern half of the roof contained no void due to fire damage and many timbers were charred. The southern half contained a very shallow roof void and visible signs of smoke damage were evident.

**Photo 10: View of fire damage within upper floor of farmhouse.**
