Bat Survey to
Oak Mills
Cliff Hollins Lane
Bradford
BD12 7ER

1. Summary

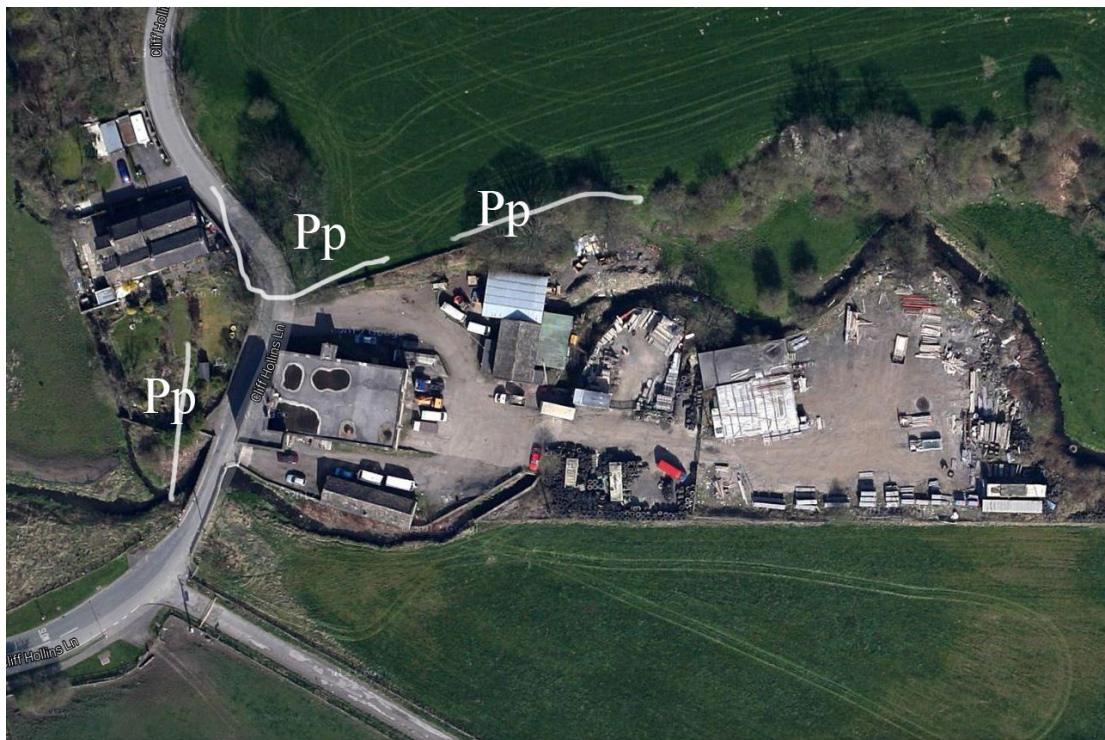
Figure 3. Flight direction of bats and main activity area

No bats were observed emerging from the survey site but small numbers of common pipistrelle (*Pipistrellus pipistrellus*) were recorded feeding and socialising along the north edge of the site around large sycamore trees on the boundary line. Bats were also very active under the tree canopy over Cliff Hollins Lane and in front of the stone cottages on the opposite side of the road to the survey site.

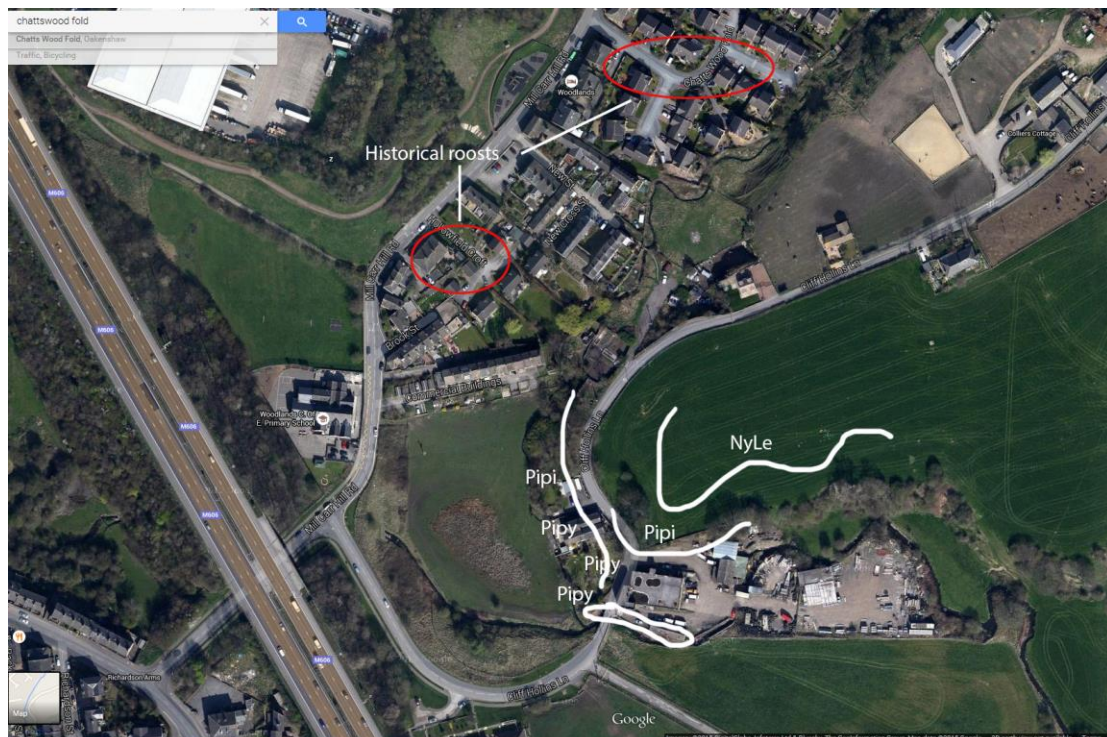
Figure 4. Flight direction of bats and main activity area

As with the first survey, no bats were observed emerging from the survey site but good numbers of bats were recorded, especially around the cottages opposite the survey site. In total, four species of bats were recorded feeding along the north edge of the site, under the tree canopy over Cliff Hollins Lane and in front of the stone cottages on the opposite side of the road to the survey site.
