**Phase 1 Land Contamination  
Risk Assessment**

**Demolition of current building  
and erection of residential  
Dwellings**

**Hardy and Hanson Site, Summit  
Works. Longlands Road,  
Dewsbury. WF13 4AB**

**Date: December 2015**

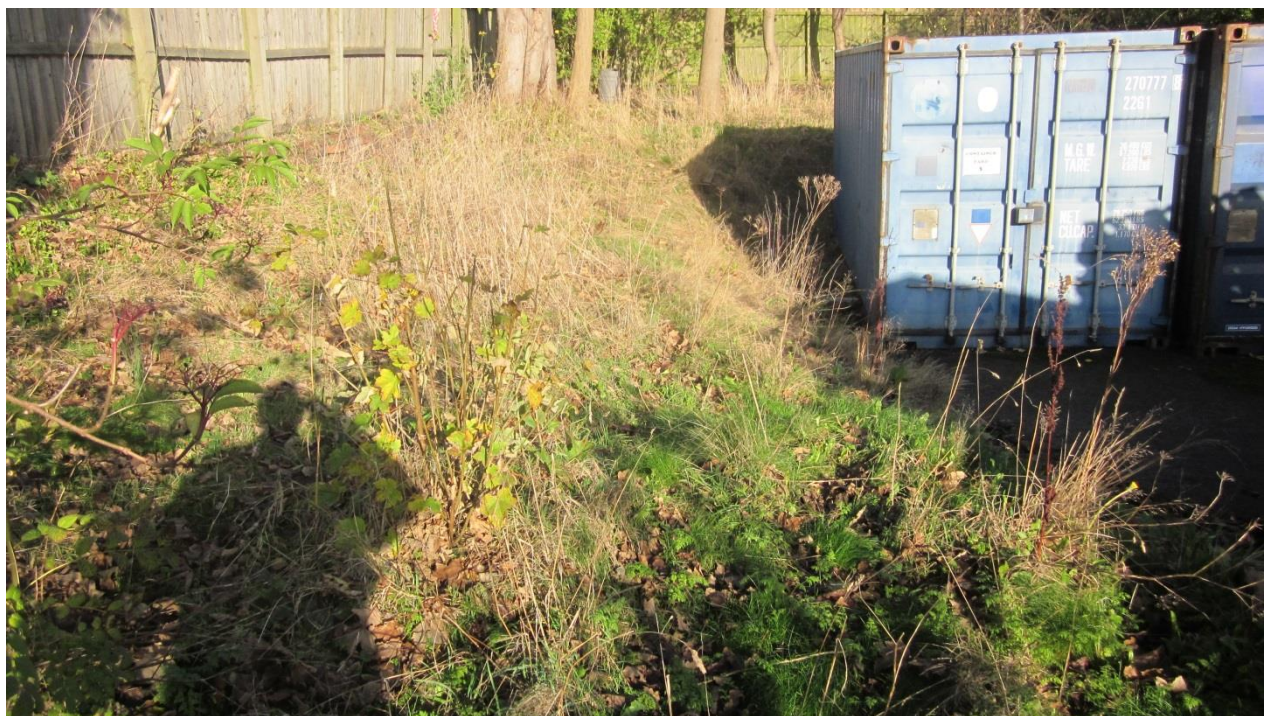
5.

Area to north (pic 7) and east (pic 5) rough grass showing good growth.

Grass at back (5) is elevated about a meter above yard level.
