**34 Daisy Lea Lane, Huddersfield, HD3 3LP**

**Bat Survey - Preliminary Roost Assessment**

27 October 2016

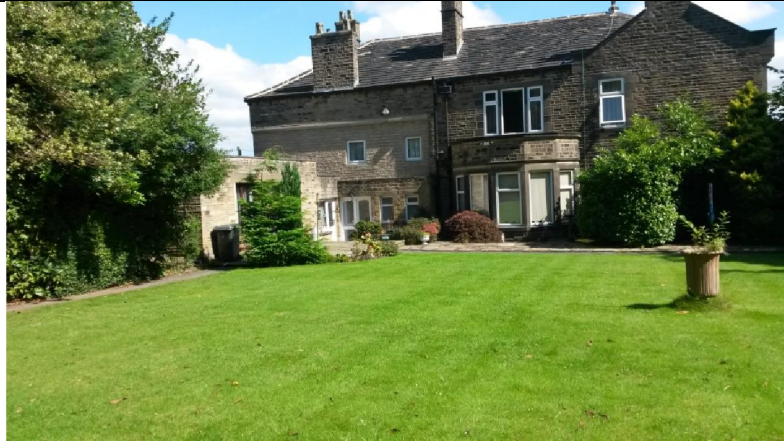
- Two storey brick/stone-built semidetached residential house (refer to photo 1). The roof comprises large heavy slate tiles that have risen in numerous sections (refer to photo 2) to create potential roosting opportunity for crevice dwelling bats species and/or access into the roof space.
- Located on the western elevation of the building is a single storey bay window with a flat roof. The extension appears to be in good condition, providing no suitable roosting opportunity for bat species.
- The eastern elevation of the building comprises the adjacent property.
- Located on the western elevation of the main building is a single storey extension with a flat roof of concrete (refer to photo 3). The building and roof appear to be in good condition, providing no suitable access and/or roosting opportunity for bat species.

Photo 1: B1 western elevation

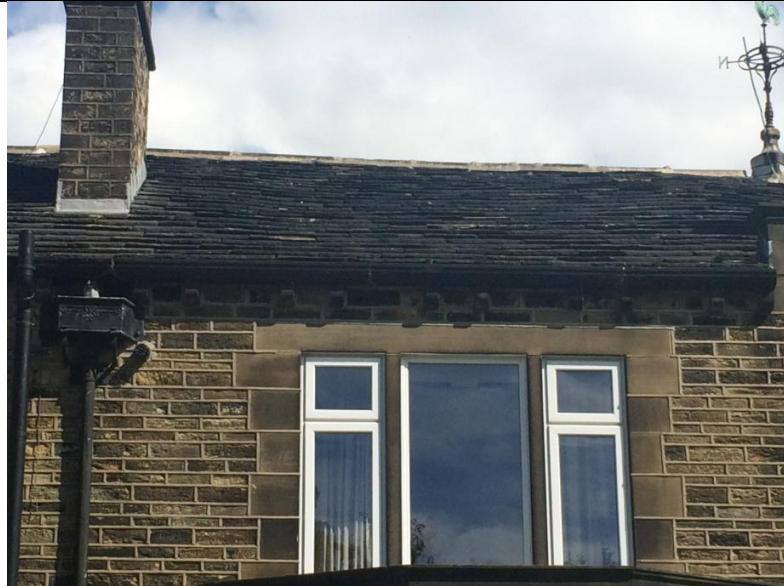
Photo 2: B1 raised tiles western roof pitch

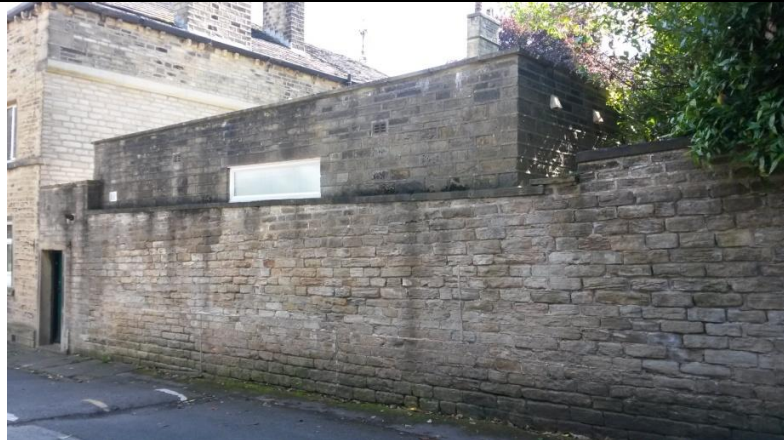
Photo 3: B1 flat roof extension - southern elevation

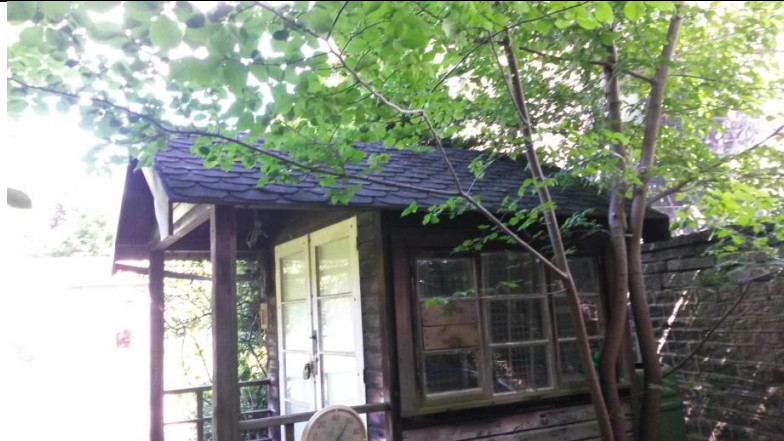
- A single storey wood-built shed with dual pitch roof of felt over wood (refer to photo 4). The structure appears to be in good condition and regularly used by the current land owner.
- Internal inspection showed the shed to be used regularly. The roof had no internal lining and there were large undisturbed cobwebs present hanging from the rafters. Internal conditions at the time of the survey were similar to the external.

Photo 4: B2 northern elevation

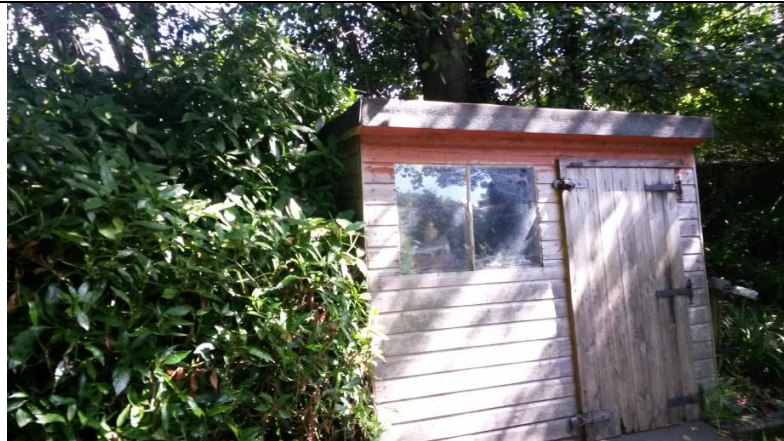
- A single storey wood-built shed with mono-pitched roof of felt (refer to photo 5). The structure appears to be in good condition, however the roof has numerous damaged and raised sections of felt providing potential access and/or roosting opportunity for bat species to utilise.

Photo 5: B3 western elevation

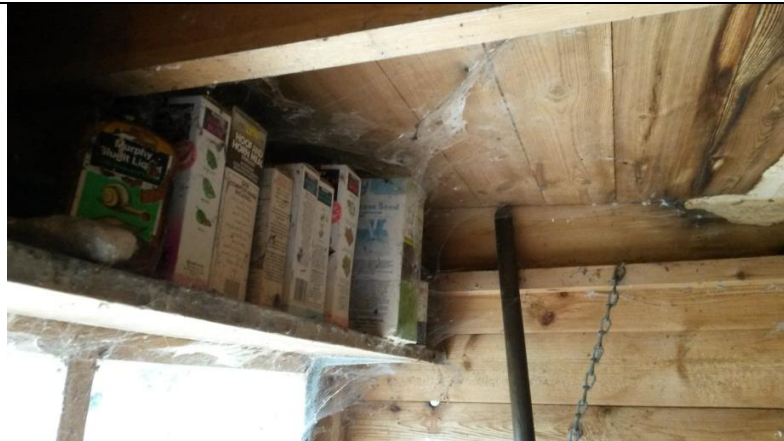
- internal inspection showed there to be water damage on all the walls, causing fungal growth. There were very large cobwebs present throughout (refer to photo 6) the internal of the structure, indicating no recent activity within the structure by bird or bat species.

Photo 6: B3 internal view

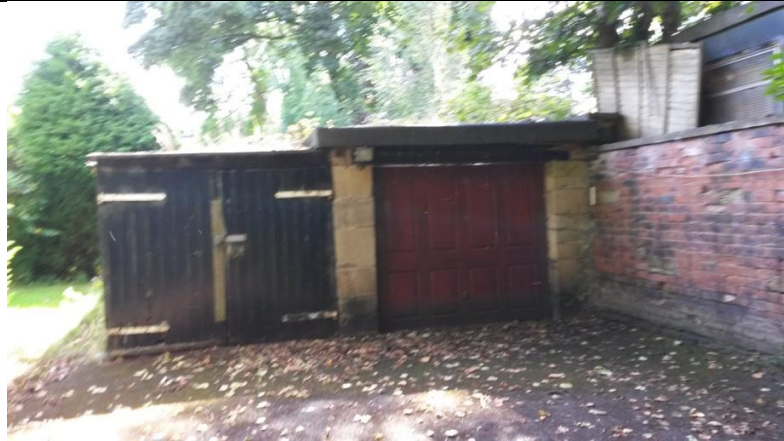
- A single storey brick-built single garage with mono-pitched roof of felt over wood (refer to photo 7). The roof of the structure has collapsed opening the structure to further water damage and the elements.

- The walls of the structure appear to be in need of repair, the brickwork and mortar appear to be crumbling, causing the structure to be unsafe. The missing mortar and/or brick sections provide potential roosting opportunity for crevice dwelling bat species.

- A single storey wood-built garage with mono-pitched roof of felt over wood (refer to photo 7). The building appears to be in dis-repair.
- The wooden slats of the walls of the structure have large holes present due to the wood having warped and pulled away leaving potential roosting opportunity within the cavity for bat species (refer to photo 9).
- The roof appears to be in need of repair, large sections of the felt appear to be torn and are pulling away from the structure, providing potential access and/or roosting opportunity for bat species.
- Internal inspection of the structure shows there to be large holes in the roof allowing potential access for bat species into the building.

Photo 7: B4 & B5 southern elevation

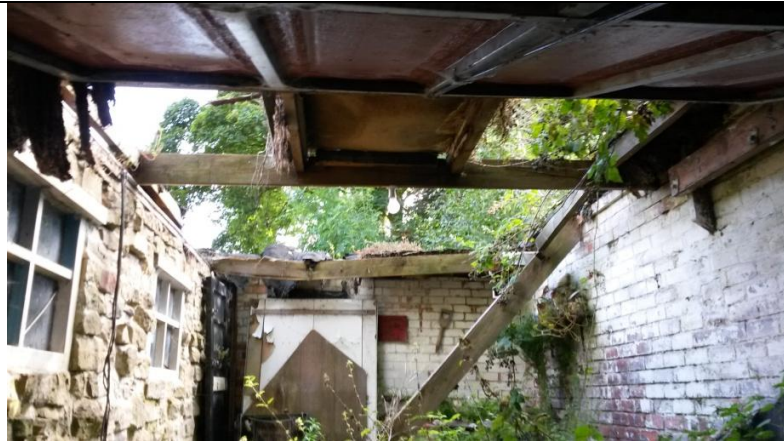
- Internal inspection of the structure showed the roof to have collapsed (refer to photo 8), leaving a large hole providing access into the structure for bird and bat species. The brickwork and mortar at the top of the walls are crumbling, leaving holes for potential roosting opportunity for crevice dwelling bat species.

Photo 8: B4 internal view showing collapsed roof

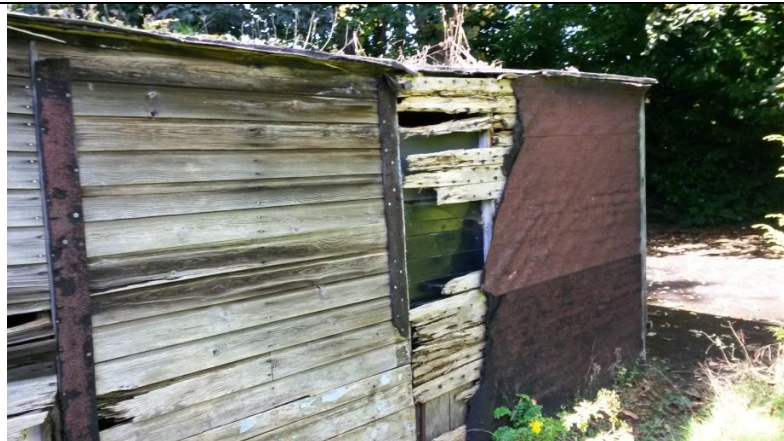
Photo 9: B5 eastern elevation
