Number 5, Two Gates, Slaithwaite  
Results of Preliminary Bat Survey

SLR Consulting Ltd was commissioned by Mrs Dyson to undertake a bat survey of an existing detached property known as Number 5, Two Gates, Slaithwaite, West Yorkshire, HD7 5UG (approximate OS grid reference SE 07235 14252).

Planning permission is being sought to demolish and rebuild a small extension, located on the northern side of the property. The exterior of the main house is also to be repaired, and repointed throughout, with the replacement of windows, and the rebuilding of a section of the eastern wall, which is bowing. The stone roof tiles on the main house are also going to be turned, and the existing bitumen underfelt lining replaced with a breathable roofing membrane, although the roof void itself will be retained.

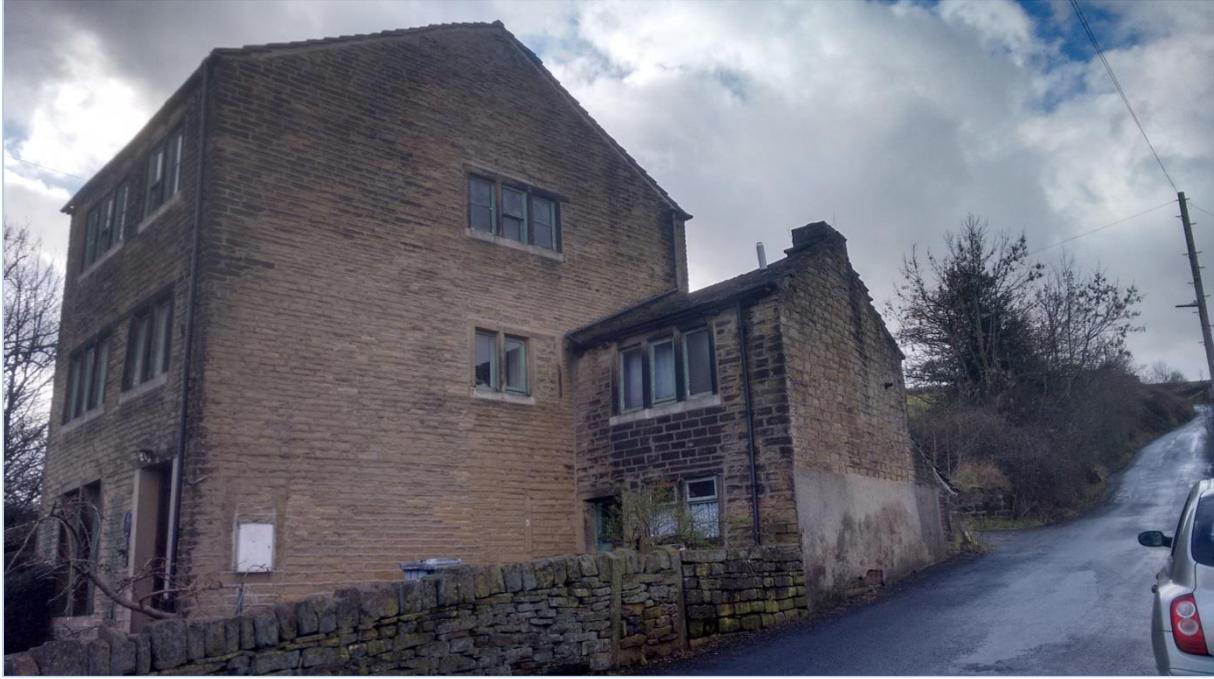
The survey site consisted of a large three storey detached property, and a two storey extension and coal bunker, located to the north/ north-west (Plate 1).

**Plate 1:** View of Number 5, Two Gates, as seen from the north-east.

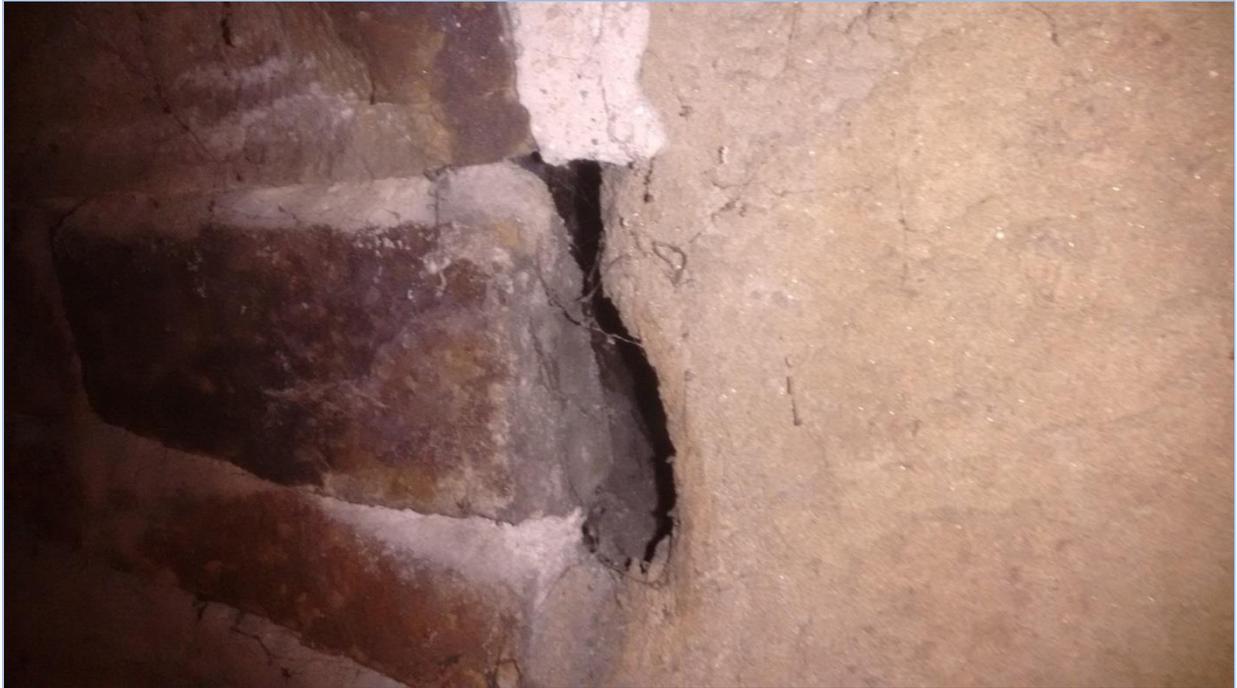
The roof void has been used to store a few planks of wood but is otherwise disused; it is dusty and heavily cobwebbed. Some gaps exist in the stonework on the north-facing gable (Plate 2), which lead into a cavity wall. It is assumed that this cavity will once have had a rubble in-fill, however, over time this has 'settled' towards the bottom of the cavity, leaving the upper section open. This was inspected using a flexi-torch and fibre-optic endoscope, furthermore, approximately 15 sections of roofing felt were cut-away, and examined using a flexi-torch and fibre-optic endoscope (Plate 3).

No bats, or signs of bats, were found on the floor of the roof void, between the cut-away sections of roofing felt and the outer tiles, or in the cavity wall (where visible) on the northern gable end.

**Plate 2:** One of the gaps within the stonework, on the northern gable, as viewed from within the loft void, leading into an open cavity. This, and several other gaps, were inspected using a flexi-torch and fibre-optic endoscope, but no bats or signs of bats (such as droppings) were found.

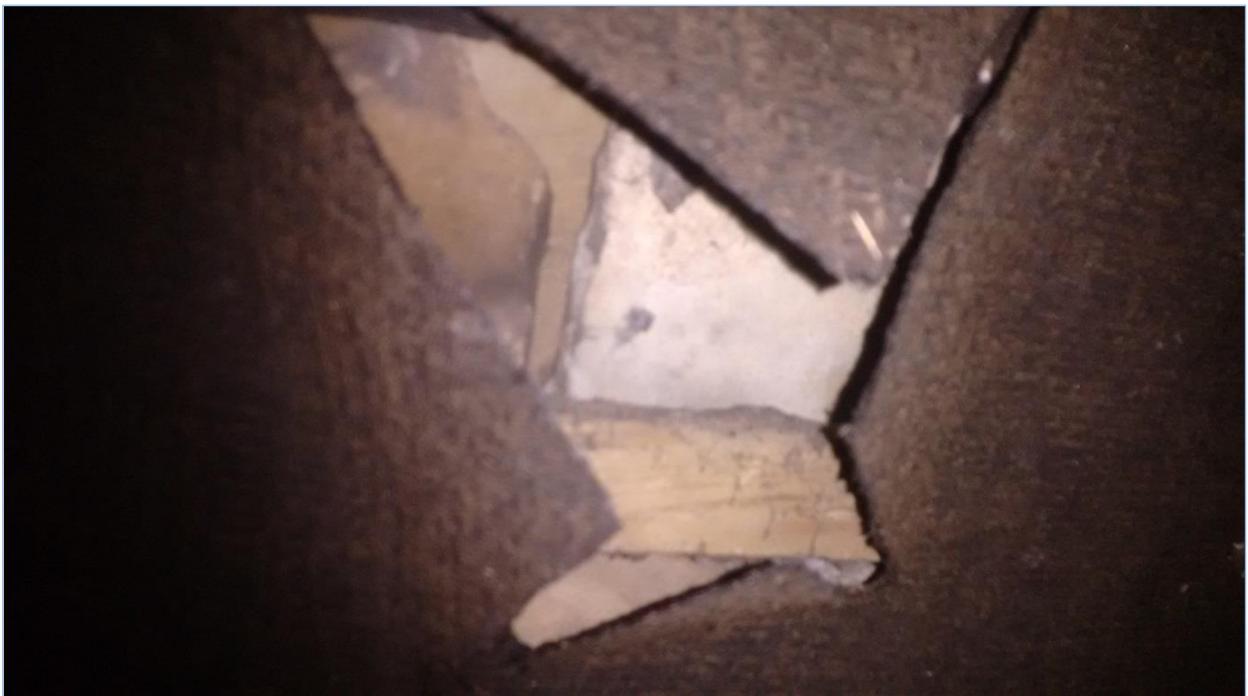
**Plate 3:** One of circa 15 sections of cut roofing felt, close to the ridge, which were examined for bats, and evidence of occupation by bats; none was found.

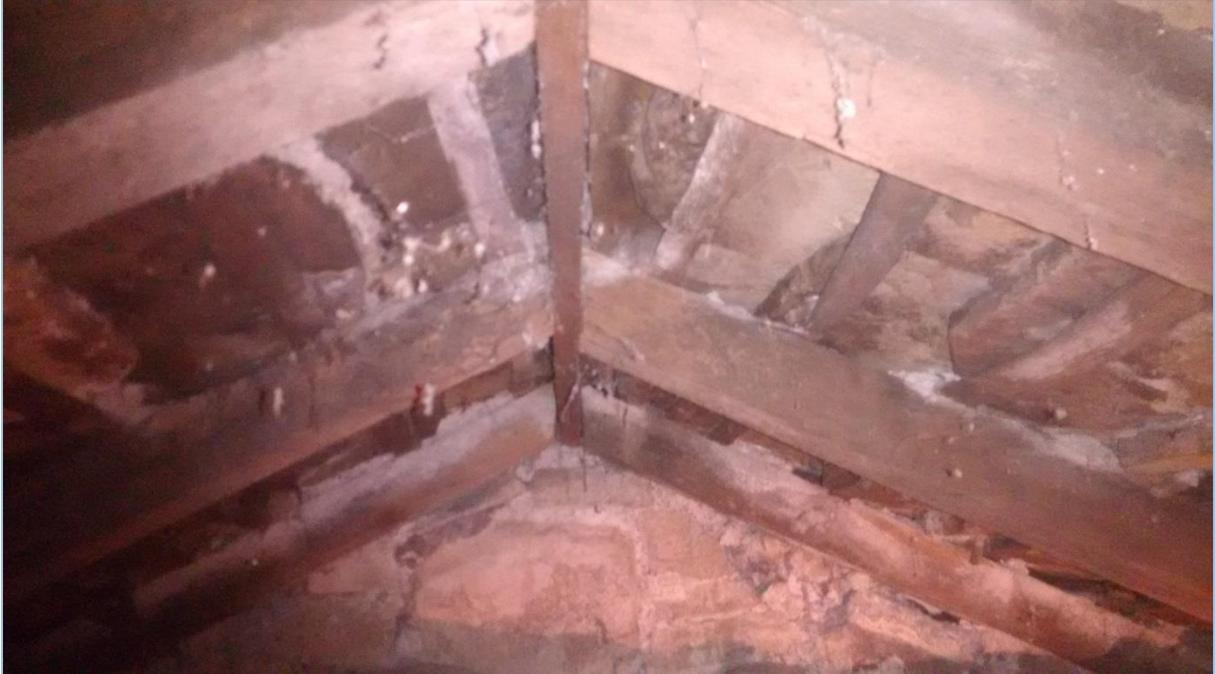
The roof void above the northern extension is relatively small and low, measuring approximately 5 metres x 4 metres and 1 metre in height (maximum). The space is open, and the stone tiles do not have underfelt; it is heavily cob-webbed (Plate 4). It is reported

that the tiles on this roof were not turned when the main roof was turned, around 15 years ago. There are several gaps in the wall, particularly on the eastern side of the extension.

**Plate 4:** Roof Void above two storey extension; no bats or signs of bats were found.

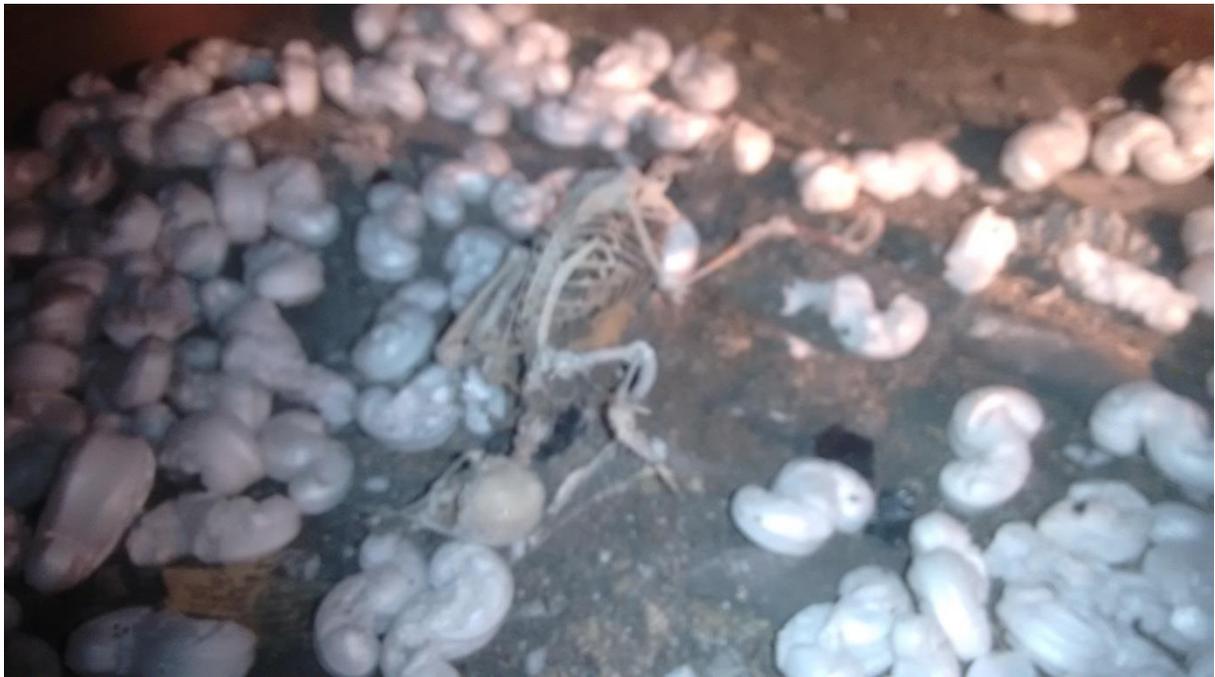
No bats or signs of bats were found in the roof void above the extension, although a bird skeleton, mostly likely a starling (*Sturnus vulgaris*) was found (Plate 5).

**Plate 6:** Skeleton of bird, mostly likely starling, on floor of roof void above two storey extension.

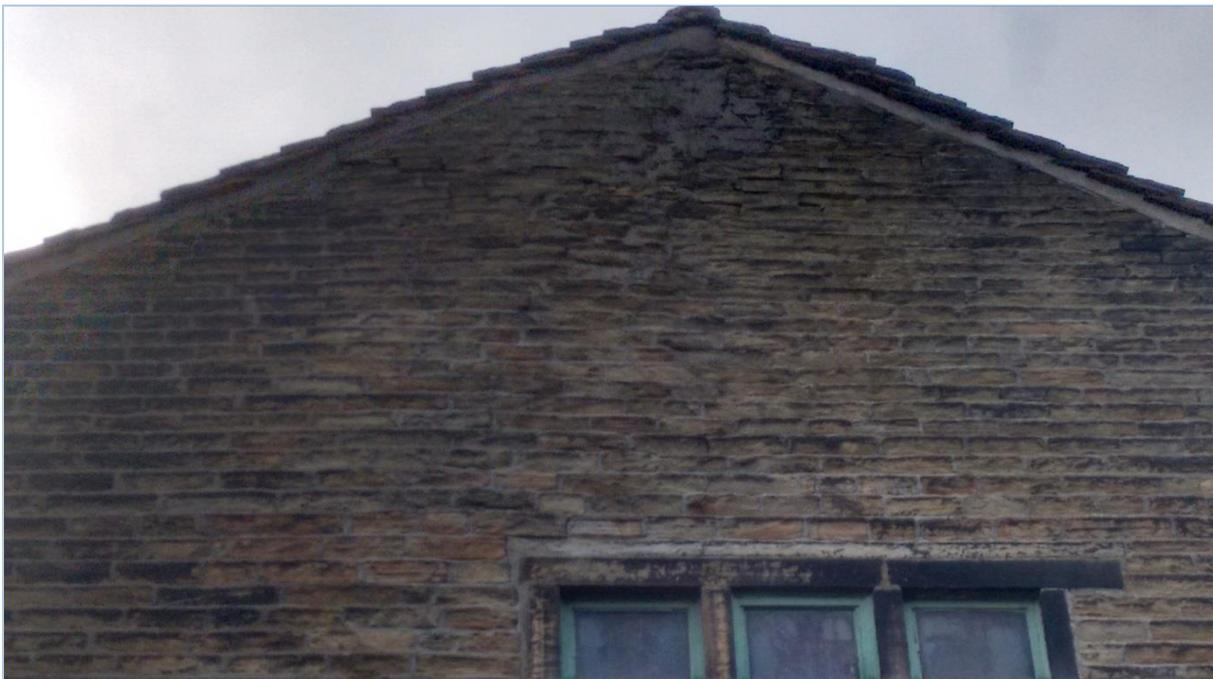
The northern gable end (facing the adjacent road, Holme Lane) is approximately 15 metres tall. There are several gaps along the verge, immediately beneath the tiles, a *circa* 1.5 metre long diagonal subsidence crack in the stonework, to the east of the upper window, as well as several gaps within the stonework on the western side of the gable, 3 metres above the upper window (Plate 7).

**Plate 7:** Northern gable end, with gaps in verge (beneath tiles), 1.5 metre long subsidence crack above and to left of window, and gaps in stonework above and to right of window, offering roosting opportunities for bats.

It is therefore recommended that a dusk/ dawn bat detector survey, to be undertaken within the period mid-May to August inclusive, is conditioned. If bats are found roosting within the property during this survey, a European Protected Species Licence, potentially a Low Impact Class Licence, may need to be obtained from Natural England, in order to allow the development to proceed legally.

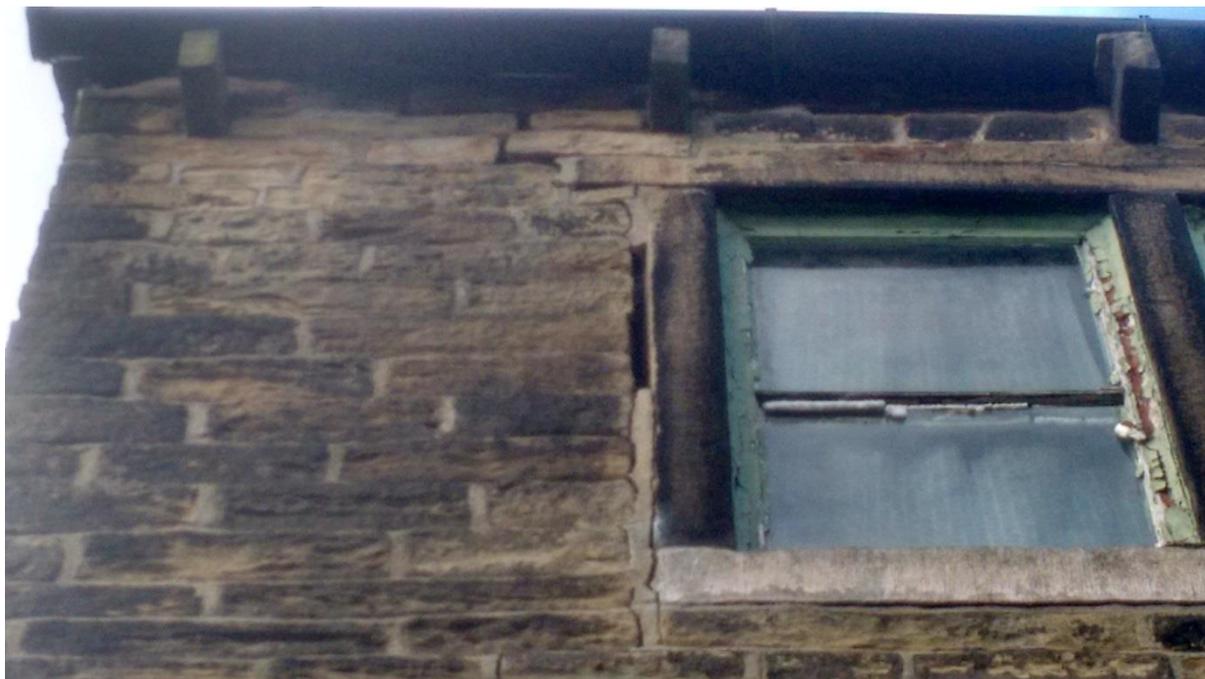
The front (eastern) elevation of main house also contains a number of gaps and crevices, including a vertical gap where mortar has fallen away beside an upstairs window (Plate 8), and between two upright sections of a second floor mullion window (Plate 9). In addition to this, there are several gaps within the upper section of stonework, several of which appear deep enough to offer potential opportunities for roosting bats (an example of which can be seen in Plate 8).

**Plate 8:** Gaps beside and above and to left of upper window, on eastern (i.e. front) elevation, of potential value to roosting bats.

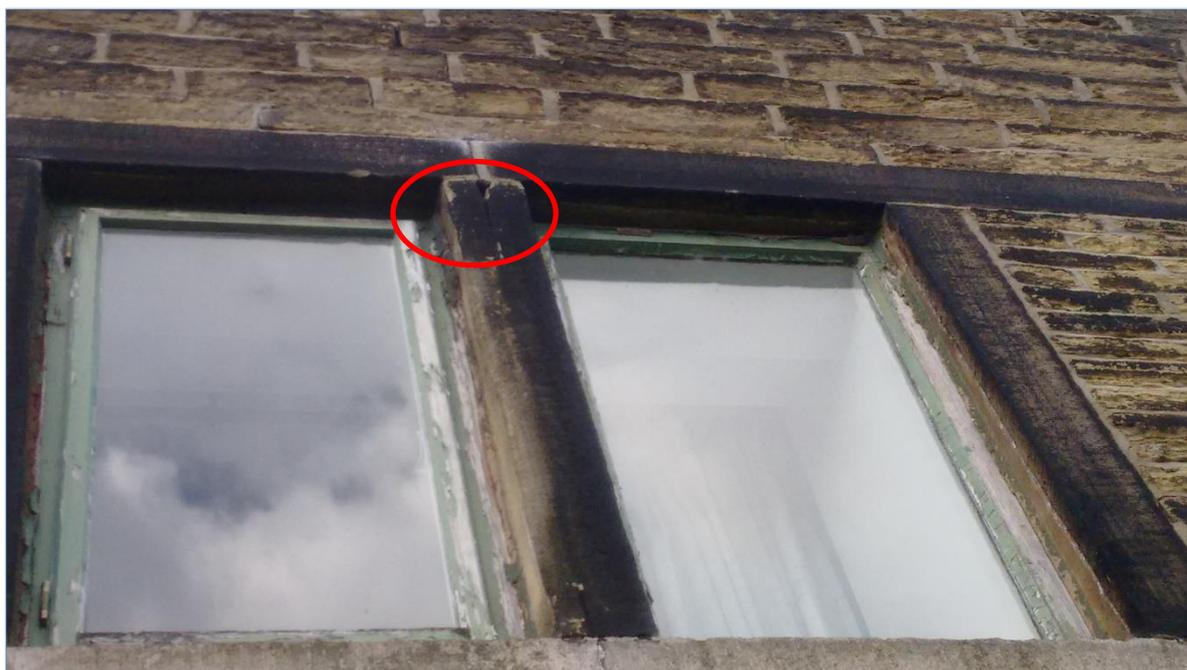
**Plate 9:** Gap between mullion window (circled), on second floor of eastern elevation, of potential value to roosting bats.

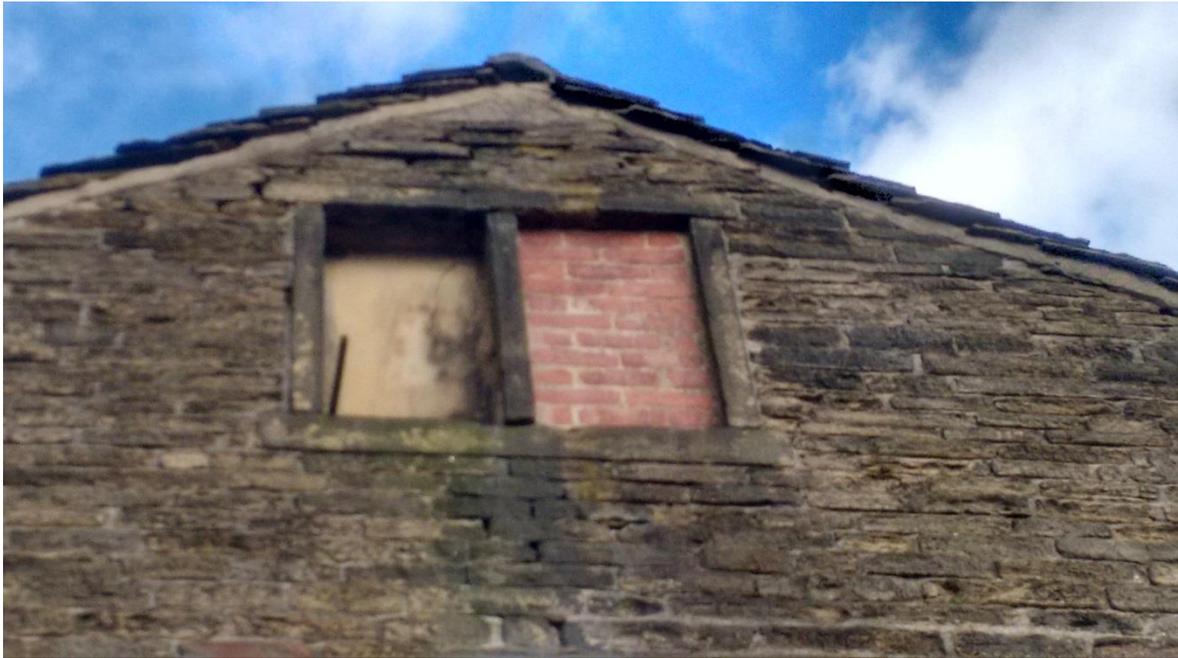
The southern gable end of the main house also contains a number of gaps in the stonework, particularly above and below the upper, blocked-up, window, and in the verge, immediately beneath the tiles (Plate 10).

**Plate 10:** Southern gable end, with many gaps in stonework above and below blocked-up windows, and immediately beneath tiles along the verge, of potential value to roosting bats.

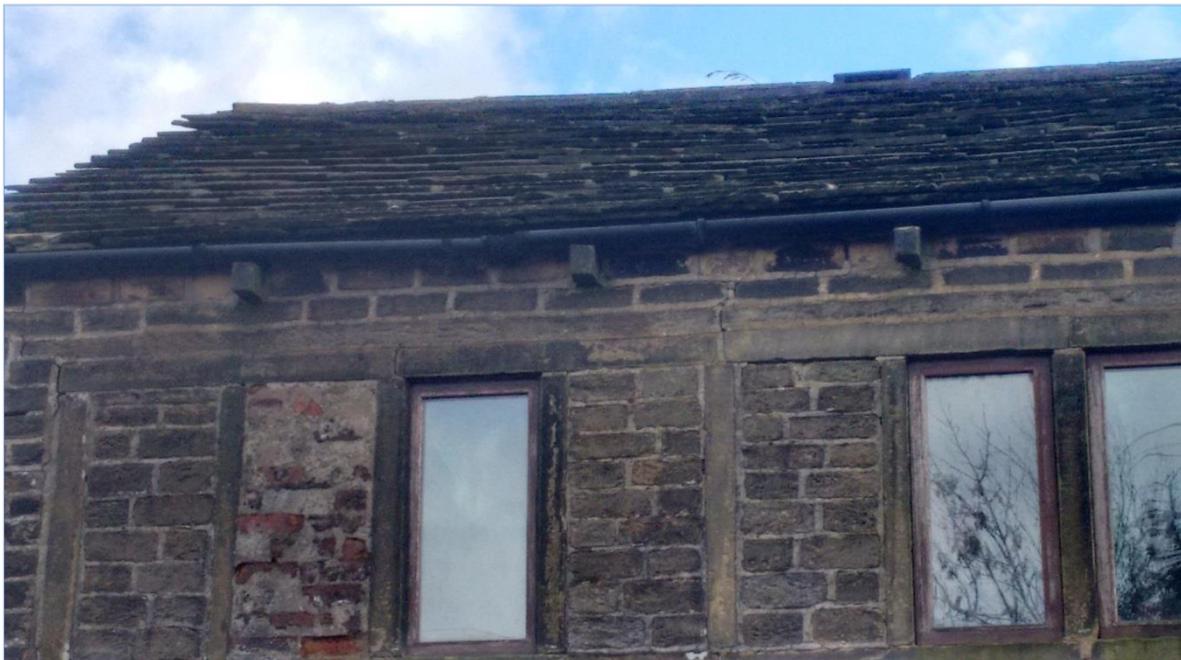
As with the other aspects, there are several gaps in the stonework on the west-facing side of the main house, particularly above the bricked-up window, nearest the road. The roof on the western aspect could be examined from a vantage point high on an adjacent bank, this revealed that many of the tiles are raised, or have gaps beneath them (particularly along the north-facing gable), several of which appear potentially large enough to accommodate roosting bats (Plate 11).

**Plate 11:** Western side of house, including roof, which contains several raised tiles (particularly on left hand side), creating opportunities for roosting bats.

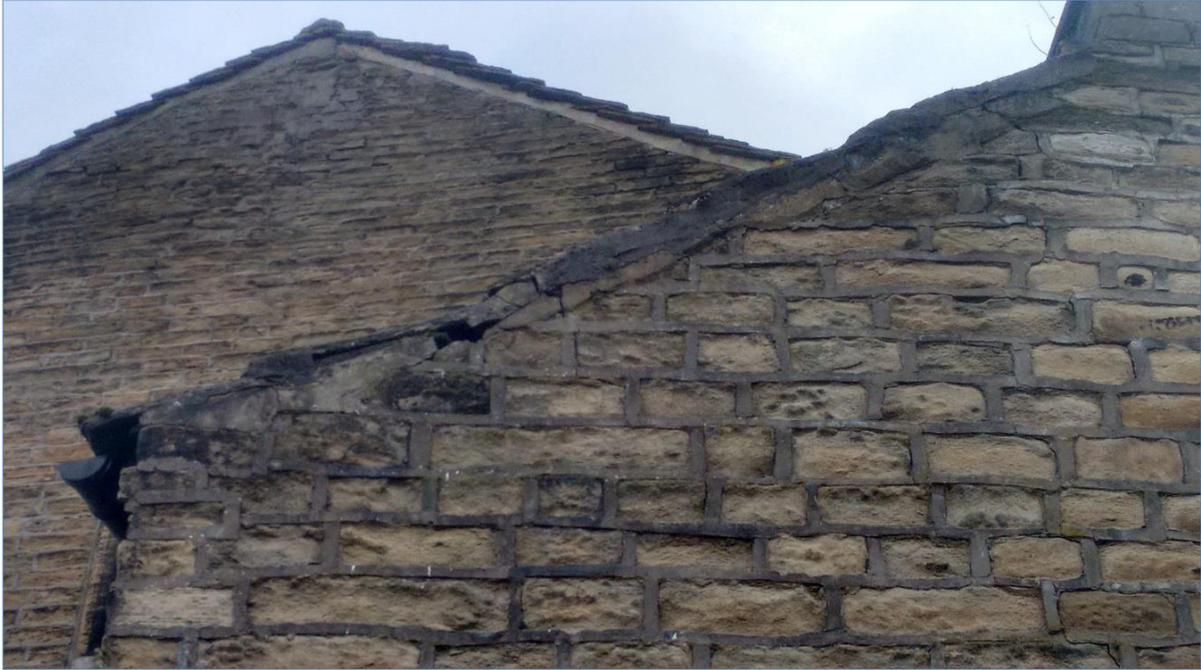
The northern gable end of this extension (immediately adjacent to the road) contains a large section of missing mortar along the verge (Plate 12), and there are several gaps in the

**Plate 12:** Gap in verge along the northern gable of the two storey extension (directly facing onto the road), of potential value to roosting bats.

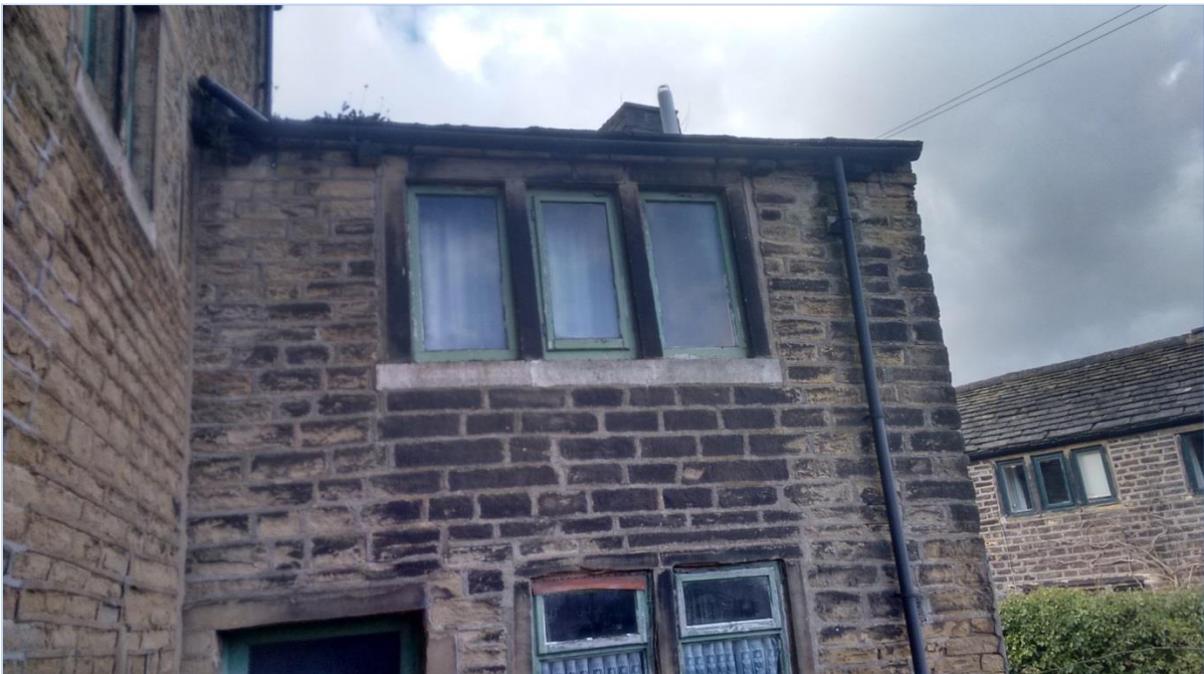
stonework on the eastern elevation (Plate 13). There are also several gaps between the tiles, which appear once to have been coated with bitumen, which has perished (Plate 14).

**Plate 13:** Eastern elevation of two-storey extension; there are several gaps in the stonework beneath the gutter, of potential value to roosting bats.

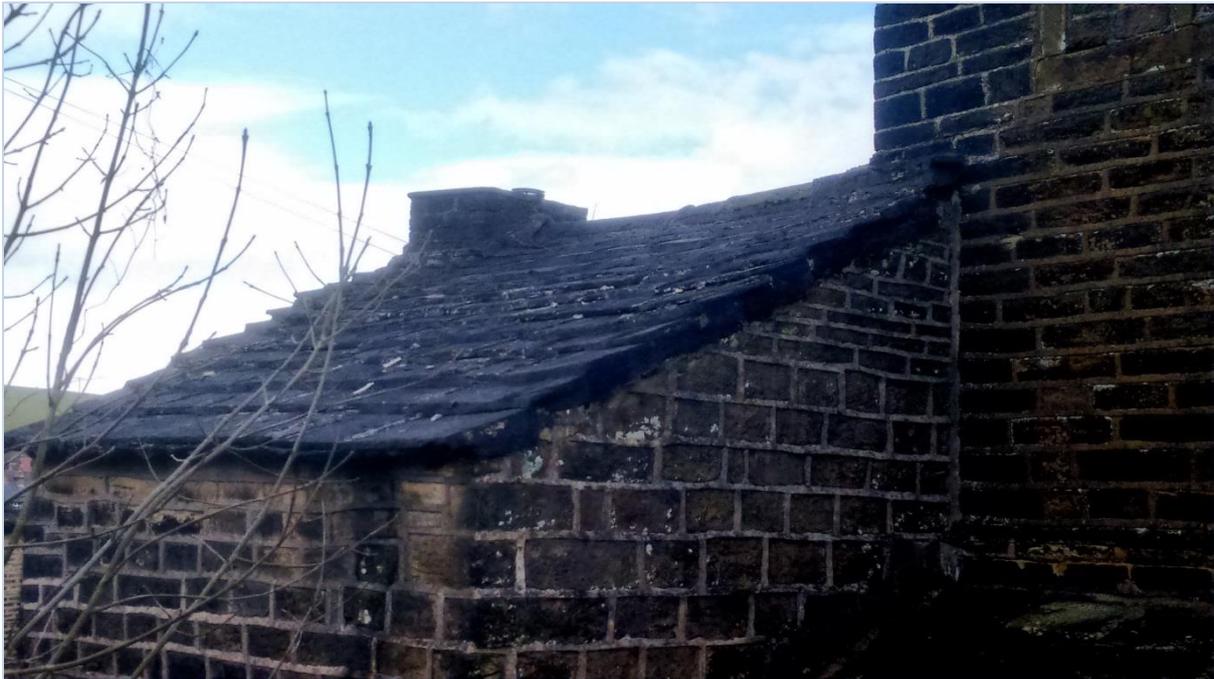
**Plate 14:** View of western aspect of the two storey extension, showing gaps between and beneath some of the stone tiles, offering further potential roosting opportunities for bats.
