PHASE I DESK STUDY

CELLARS CLOUGH MILL MARSDEN, HUDDERSFIELD, HD7 6LY

FOR CELLARS CLOUGH PROPERTIES LTD

REPORT REF: CCP 3225

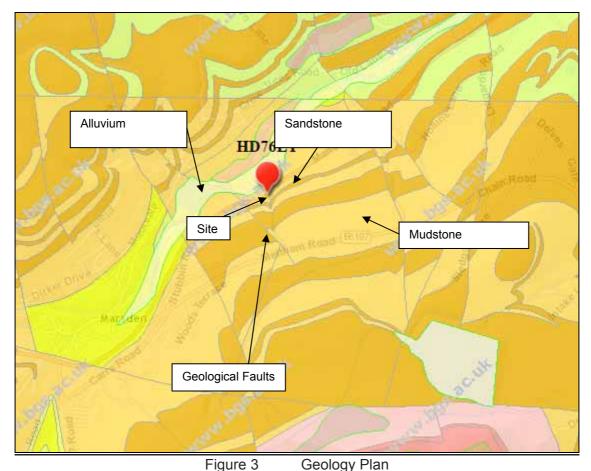
The following published BGS geological map for the site has been examined: 1:50,000 scale (Solid and Drift) Sheet 86 "GI ossop". The map shows the site t o be underlain by Mud stone from the Marsdenian Millstone Grit Series which is Carboniferous in age. It is likely that these Mudstones interbedded with East Carlton Grit and Ready Con Dean Flags Sandstone – both of which are hard coarse grained sandst ones, along with a thin coal seam. There are drift deposits shown to b e overlying the Millstone Grit Serie s in the valley of the River Colne of all uvium – lo ose unconsolidated soils and sediments, these are unlikely to be much thicker than a few meters. The maps i ndicate the mudstone d irectly underlying the site to be dip ping northeast at shallow angle of 5° -8° to the horizontal.

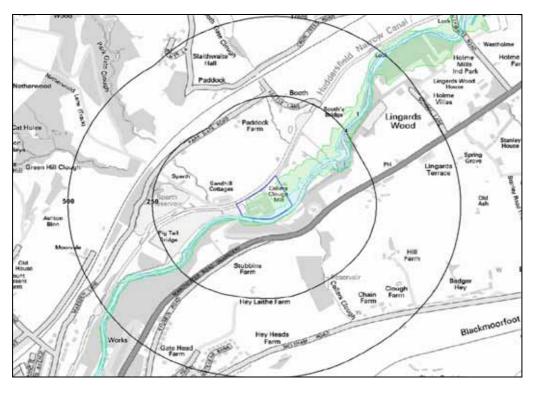
Figure 4 EA Flood Map for Planning (from rivers and the Sea)

Site Outline	Zone 2 Floodplain	Area used for Flood Storage
Search Buffers (m)	Zone 3 Floodplain	Area Benefiting from Flood Defences
	Flood Defences

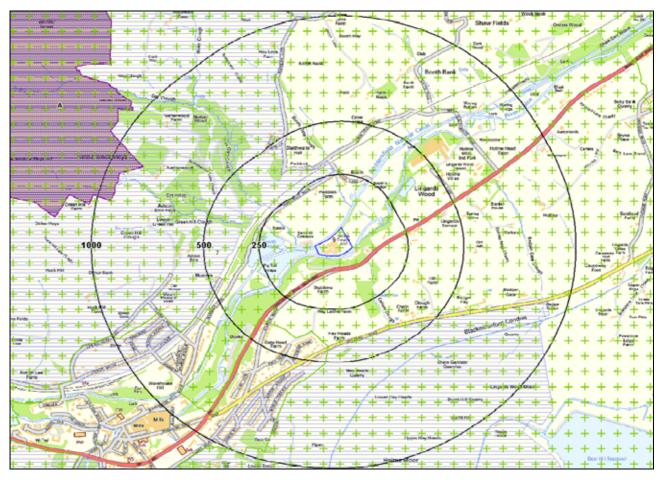
Figure 5 Designated Environmentally Sensitive Sites

There is one designated environmentally sensitive site present within 500m of the site, 237m to the northwest of the site, the North Peak which is an Environmentally Sensitive Area. The site lies within a Nitrate Vulnerable Area. This is unlikely to be detrimentally affected by the proposed development.

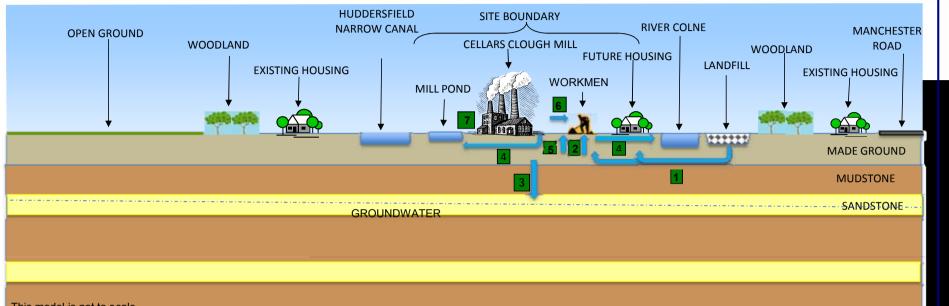
Appendix **D**

This model is not to scale

SOURCES	PATHWAYS	RECEPTORS	RISK	GEOLOGY
HISTORICAL USE AS OPEN LAND	Inhalation of vapours	Workmen / future site users / adjacent land uses	Low/Mod - Landfill within 250m requires monitoring	MADE GROUND
MILL BUILDINGS	Ingestion and or skin contact	Workmen / future site users/ adjacent land uses	Mod - requires soil/water testing & mitigation measures	
CURRENT USE AS DISUSED MILL WITH MILL PONDS	Ingestion of drinking water / leaching to groundwater	Groundwater.	Low - No potable boreholes within 1000m	SANDSTONE
<u>OFF SITE</u> RESIDENTIAL	Leaching to surface water	Surface water/ mill ponds	Low/Mod - due to proximity to surface water and mill pond.	MUDSTONE
RIVER COLNE	Ingestion of plants/animals/veg	Future occupants / adjacent land uses	Low / Moderate - requires ground investigation	
CANAL	Inhalation of dust	Workmen / adjacent land users	Low - assuming good construction practice	
MILL PONDS	Ground subsidence/mill pond failure	Workmen/future site occupants	Low - Risk of damn wall stability	APPENDIX D
