**Wildlife and  
Bat Survey  
Meadowcroft,  
Lower Lark Hill,  
Cleckheaton BD19 6JJ**

**Prepared for: Mr A Fairbotham.**

**Date of Survey: 6th February 2010**

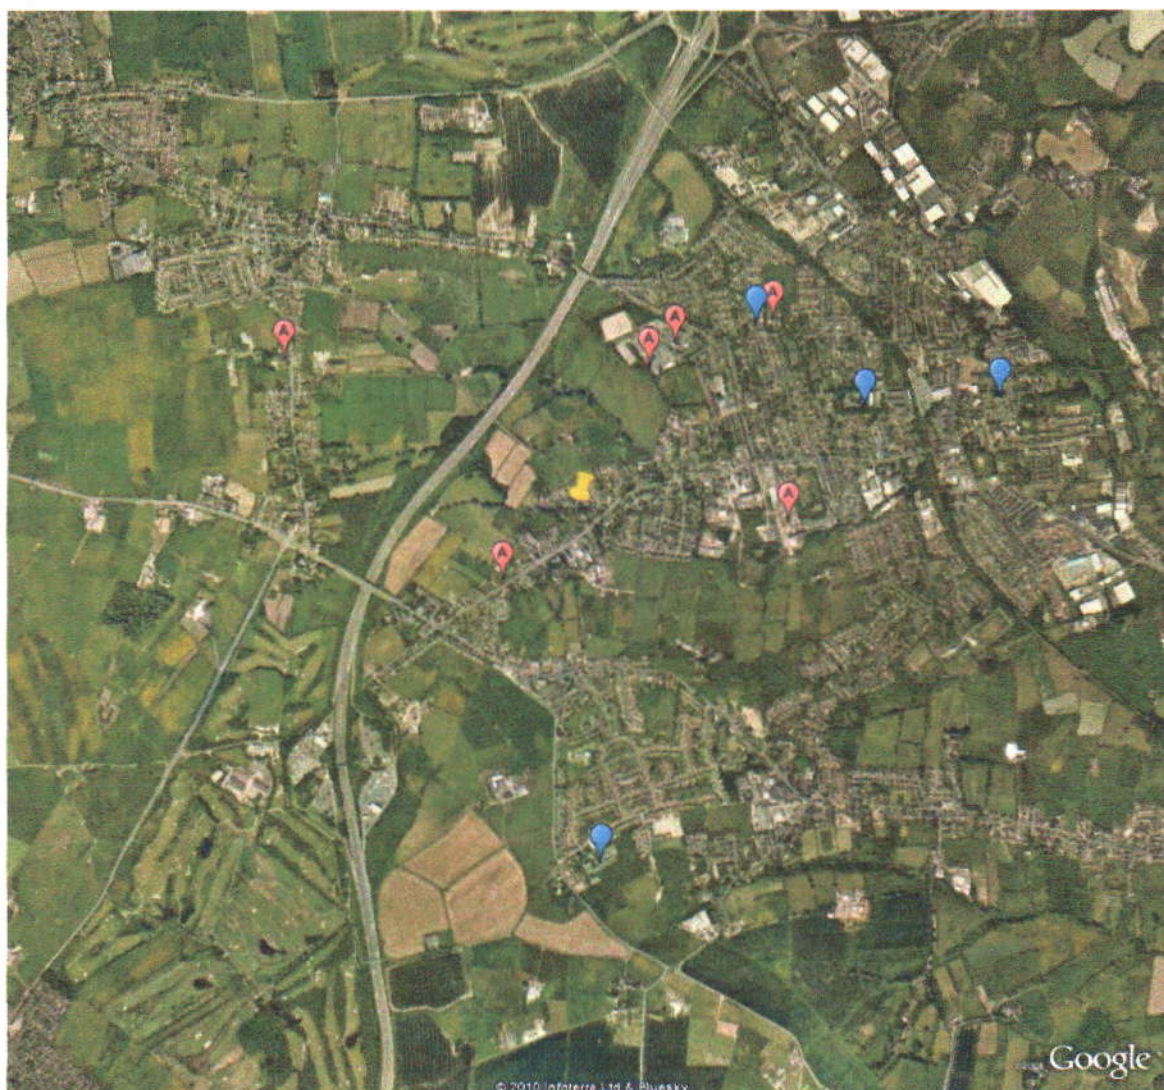
Showing site and bat roosts/observations – 2km radius

Yellow: Site, Meadowcroft, Lower Lark Hill.  
Motorway M62 seen to left of site  
Blue: Recorded field observation  
Red : Recorded Roost

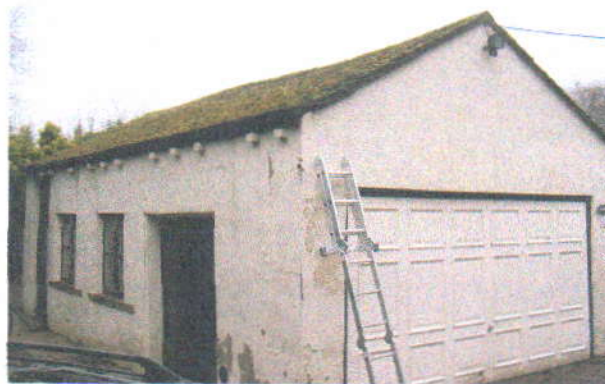
2: South East Corner

The south wall has a doorway to either end with two windows between. The windows were glazed and intact. It is understood all the doors are kept closed and locked when not being used. Also, all windows were non-opening type. No gaps were seen to the wall. Gutter was in place upon a shallow bargeboard. No gaps were seen beneath the bargeboard. The south facing roof was observed from ladder and found completely covered in a growth of very wet green moss. The ridge was also covered from end to end with moss. No gaps were seen in any area due to the dense coverage. This situation would preclude bat use had any gaps been available.

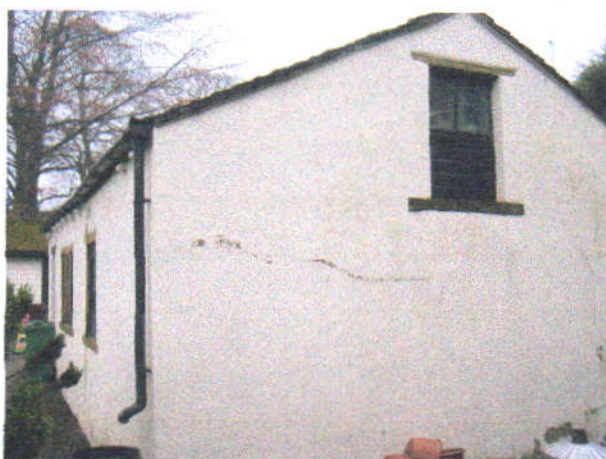
3: North And West Facing Walls

The west rear apex wall was observed and found with all render intact and no gaps. Beneath the apex was a window being half glazed to the upper part with horizontal wood panelling to the lower part. All was seen intact with no gaps.

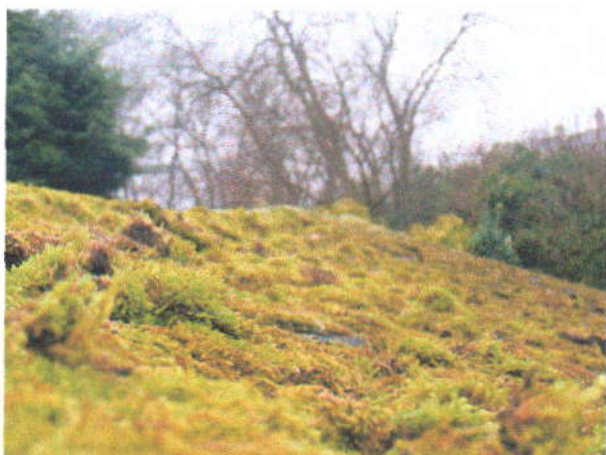
5: Moss Covered Roof

The roof edge was seen moss covered, however two gaps were noted. Ladder access showed water soaked moss and a wet sandy substance immediately beneath the roof edge. A limited amount of travel was noted and use of endoscope was not needed. Wet cobwebs were also seen and these gaps were discounted. No evidence of bat use seen.

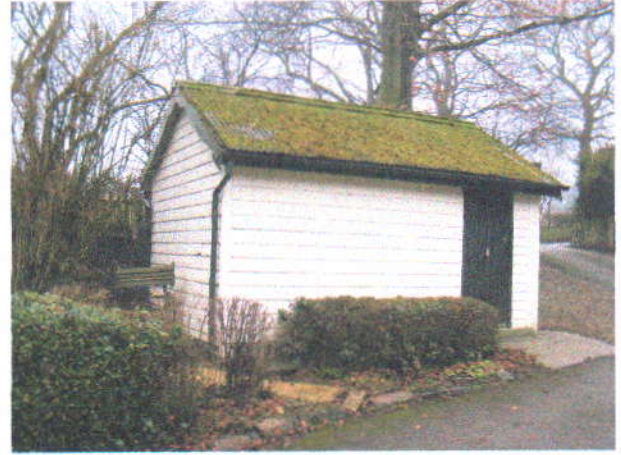
8: Wooden Garage To Be Demolished

To the right side of the driveway entrance and beneath the mature copper beech tree is a single garage. This was constructed of overlapping wood panels fixed vertically to sides and rear. The front had closed double doors also of wood, with horizontal fixed panels to the upper part. The front and rear had a wooden fascia board to the roof edge. No gaps were found beneath, cobwebs were present. The roof had a wooden overhang to both sides with guttering in place. Cobwebs were present beneath the overhanging roof. No gaps were found in any part of the woodwork beneath the overhangs. No gaps were found in any part of the garage walls.

The corrugated apex roof was covered in green moss to both sides and this continued to gutter edge. The overhanging copper beech tree served to create a wholly cluttered environment. The garage was considered unsuitable for bat use. No evidence was found to indicate use by bats had taken place.

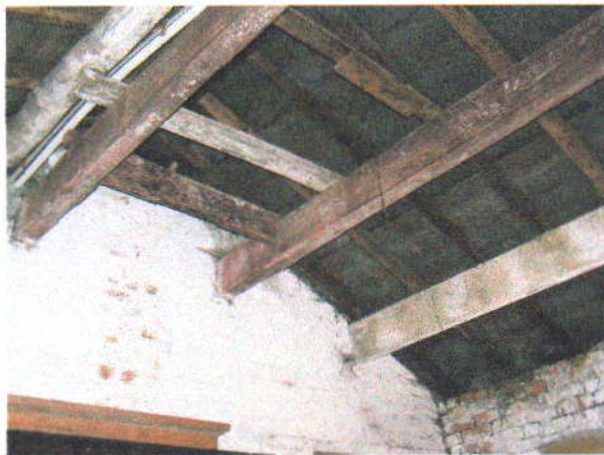
9: Area 1 Beams And Cobwebs

Front south facing was seen to have black older type roofing felt intact to the stone underside. Two main supporting roof beams were to either side from west to east. Two further beams non supporting, were below. The beams and walls had been whitewashed in the past and showed no signs commensurate with bat use. Ladder access showed no droppings or moth wings on the beams or the non- supporting ones beneath. No smooth cleaner areas or darkened spots were seen that would be expected if use by bats had taken place. Hanging cobwebs\* were noted on the beams indicating no disturbance for some considerable time. The purlins were all noted free from signs of bat use. All walls were searched from roof edge down to floor level. Aged and dirty cobwebs were on the walls. Window ledges and surroundings were covered with a thick coating of dusty cobwebs. No evidence of moth wings seen beneath the beams or any other area. A garden table with sundry gardening tools on top was observed for signs of droppings, as was the concreted floor, none were found in any area. No gaps were seen in any area that would allow access from outside.

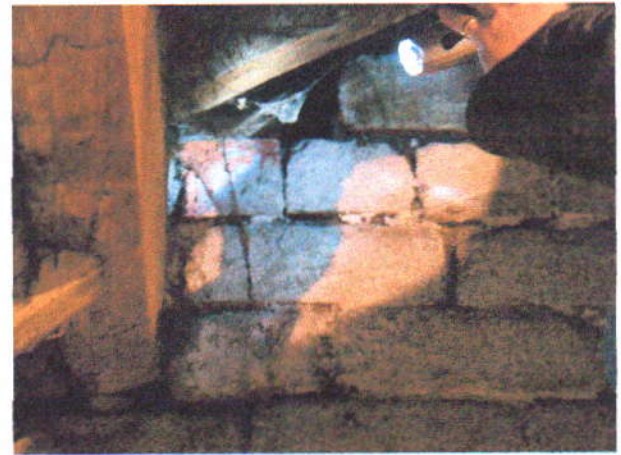
10: Area 2 Cobwebs

This had a wooden mezzanine type floor overhead to almost  $\frac{3}{4}$  width. Below at floor level was a wooden division attached to the east wall. Horses may have been kept here in the past. A single electric light was available with natural light from window. A ladder to the upper floor gave close views of all roof area. Roofing felt was intact. All areas of the roof underside, beams and purlins were fingertip searched. They were uniform in dust coverage with no smooth area or signs of staining. The only gap found was at the top of the south apex wall, beneath the roof edge. Torchlight use was necessary and showed this gap did not offer any access from outside. It was found to be full of black gritty cobwebs and damp, sandy degraded mortar.

The walls were observed to ground level and all areas were seen free from use by bats. Cobwebs were very evident and the windows were thickly coated. The floor was in use as a store for gardening equipment and all surface areas were observed for signs of droppings, none were found. The only gaps seen with daylight through were noted at the top of the door in the south wall. These gaps were all covered with Narrow gauge wire netting and precluded bat access. No evidence of use by bats was found in any area.

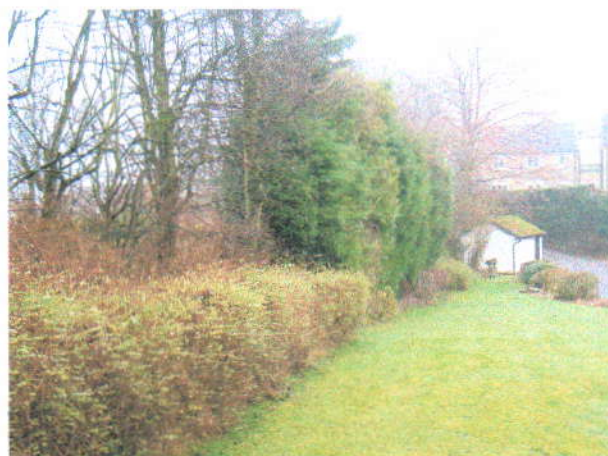
15: Hedge To Be Removed ( on left)

The development of the site requires removal of approx 20m of a further hedge being alongside Lower Lark Hill. This we understand is to create separate access for Meadowcroft, and a service vehicle turning point.

The hedge approx 60m length in total was surveyed and is regarded as an overgrown, stretched to light, domestic hedge consisting of hawthorn with one small section of evergreen cypress. Occasional elderberry and single privet were also seen. The hedge is not a hedgerow under the meaning of the Hedgerow Regulations 1997.

**7:** It is further recommended that the hedge should not be cut or removed during the period 1<sup>st</sup> March to 31<sup>st</sup> July in any year and that the hedge should only be removed or cut between 1<sup>st</sup> August and 28<sup>th</sup> February.
