**Bat Emergence Survey
Dobroyd Mill, Hepworth**

Report reference: R-2513-02

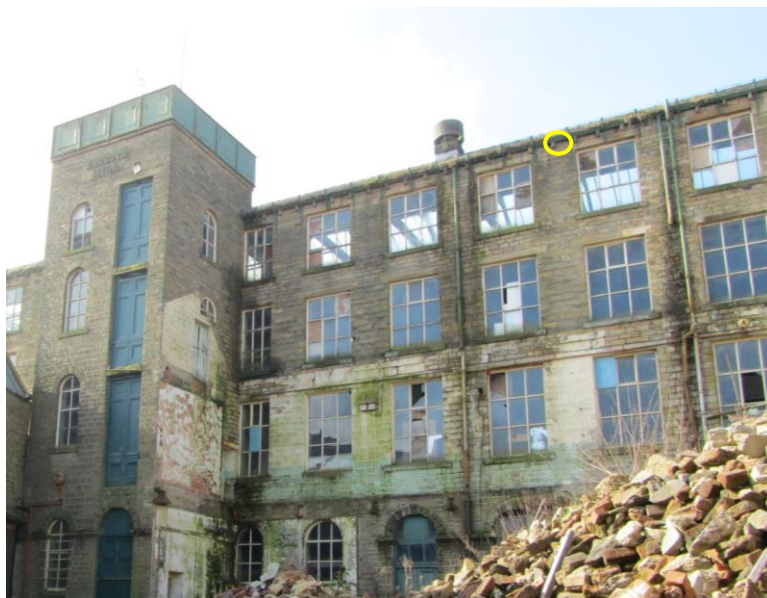
Figure 2

Location of emerging bat seen during 2nd survey

18. A single common pipistrelle bat was seen emerging from below the eaves on the eastern elevation of building three on two out of three surveys. This roost is assessed as being a non-breeding day roost, used by a single bat.

- As the first stage of these works the gutter section and tiles around the roost structure (figure 2) will be removed by the ecologist - safe access will be provided by the developer, or their contractors. The ecologist will confirm the absence of bats, or effect the removal of up to 3 bats to a bat box mounted nearby within the site.

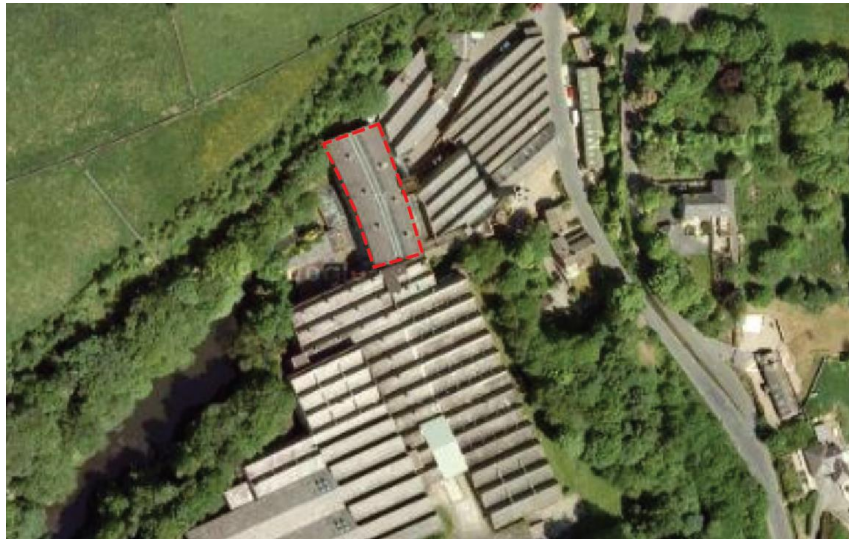
Figure 3

13. With no other roosting suspected around the Site, the final survey was conducted using a small team of surveyors to cover the roost location discovered in the previous survey.
14. A single common pipistrelle was seen to emerge from the same location as discovered on the previous survey, dropping from the eaves of the eastern elevation. This bat left the roost at 21:27, 17 minutes after sunset, moving to forage to the north of this building.

The roost building.

- The roost building (figure 3) should be fenced off prior to any demolition works on site and should be retained as the last building to be worked on. This will encourage the bat to move on of its own accord and avoid the chance of it relocating to other crevices in other buildings on site.

- The new roosts committed to in the site layout will be installed prior to demolition of the roost building.
 - Once, and only once, a license is in place will any works to the identified roost building (figure 3) commence.

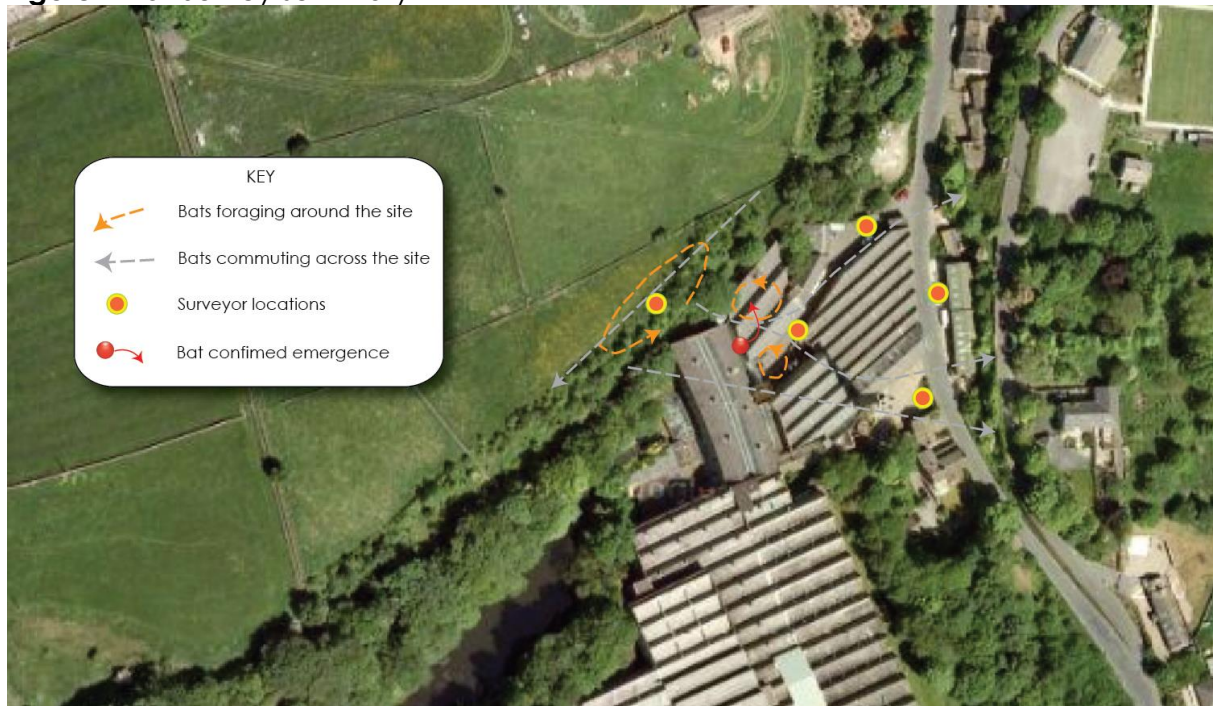
Figure 4 Bat Survey summary

15. Additional bats were seen arriving on Site from the north, as previously observed. Bats foraged intermittently in various locations around the courtyard.
16. Bat activity over the three surveys is summarised in Figure 3 below.
