**Bat Roost Potential Survey
Dewsbury Fire Station,
Huddersfield Road, Dewsbury**

Report reference: R-2145-01
February 2015

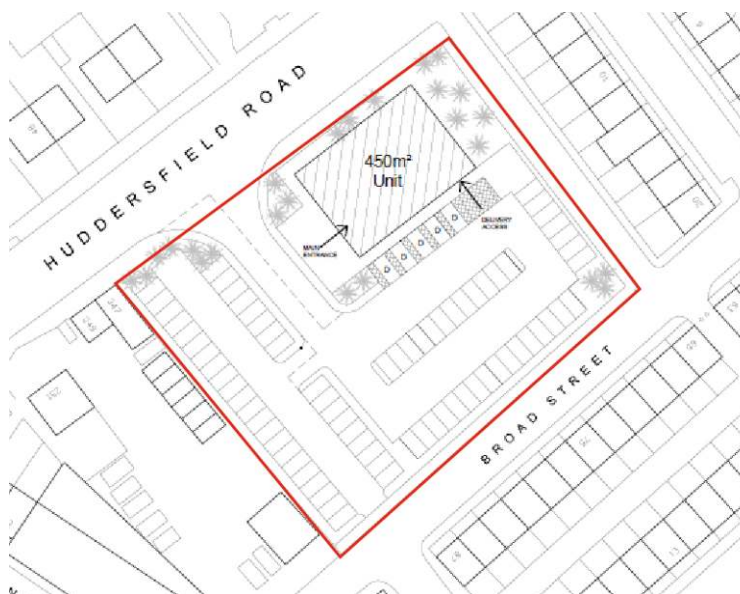
Figure 2

3. It is proposed to demolish the existing fire station building and construct a single commercial unit and associated car parking; see below figure.

Proposals plan – taken from Rance Booth Smith Architects drawing: 4005 101 B

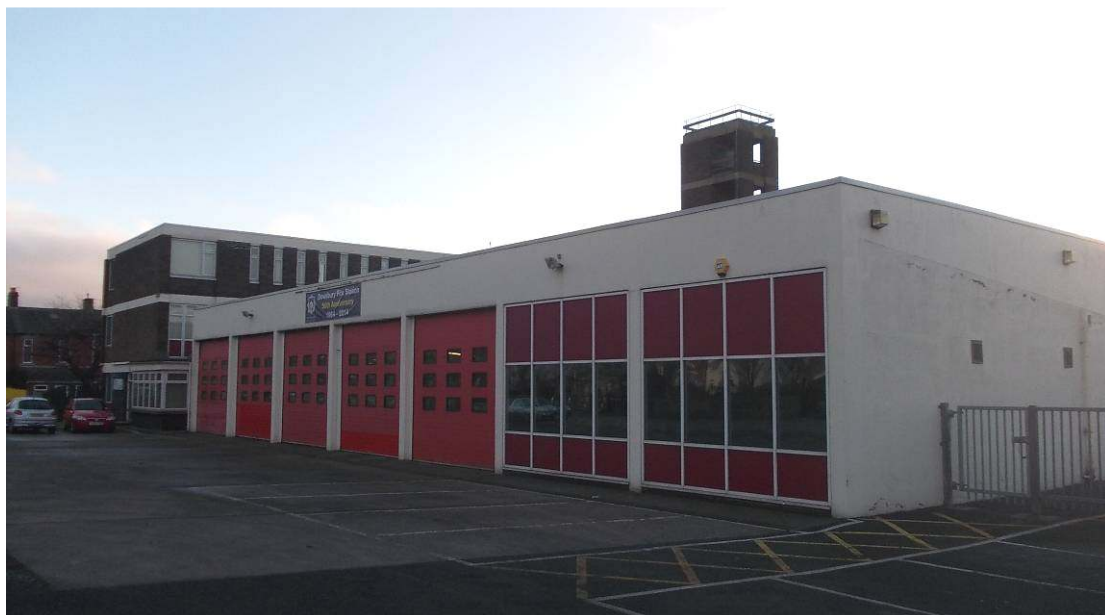
Figure 4 Looking east across the site from the western boundary

14. The application site represents a fairly typical West Yorkshire Fire and Rescue Services property; with a large single-storey garage to the centre, a mix of three and single-storey sections to the northeast used as offices / living quarters and a six storey training tower to the east. A single-storey outbuilding is also found within the southwest corner.

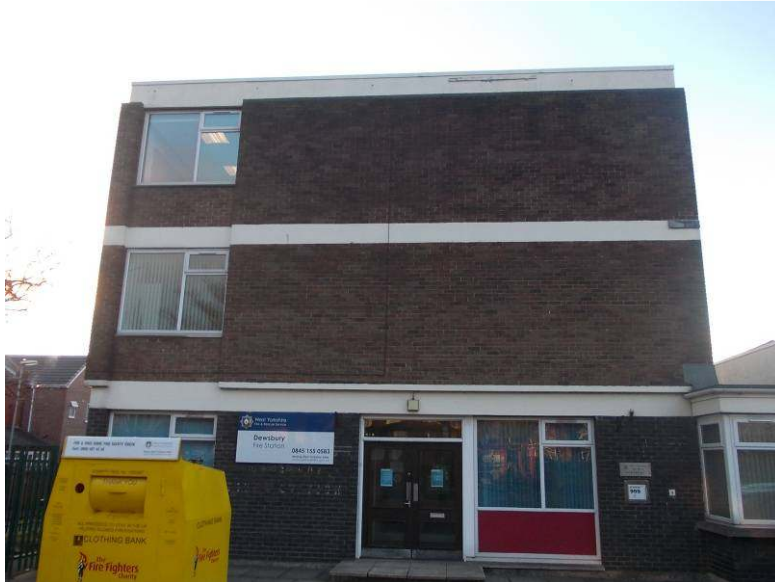
Figure 5

15. All sections of the building, with the exception of the garage, are of a similar construction, with reinforced concrete frame and curtain brick (cavity) curtain walls and flat felt covered roofs. The external brickwork is found to be in an excellent state of repair throughout; with no areas of damage or missing pointing being obvious which could permit bats access into the cavity wall space.

Looking south across the three-storey section.

Note brickwork in excellent condition.

16. The wall tops of the three-storey section are well sealed with the concrete frame as seen in the above figure. The frame similarly runs along the wall tops of single storey sections, but have, uPVC soffit boxing along the eaves. This boxing is found to be well sealed throughout.

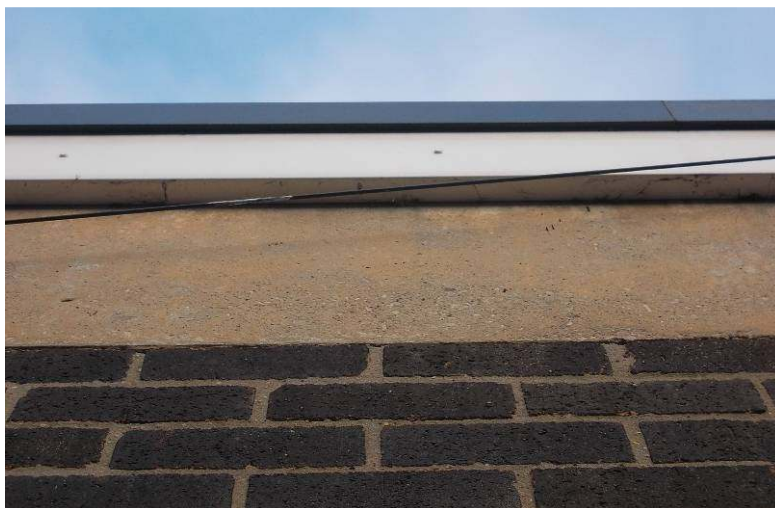
Figure 6

Well sealed uPVC soffit boxing along eaves of single-storey sections.

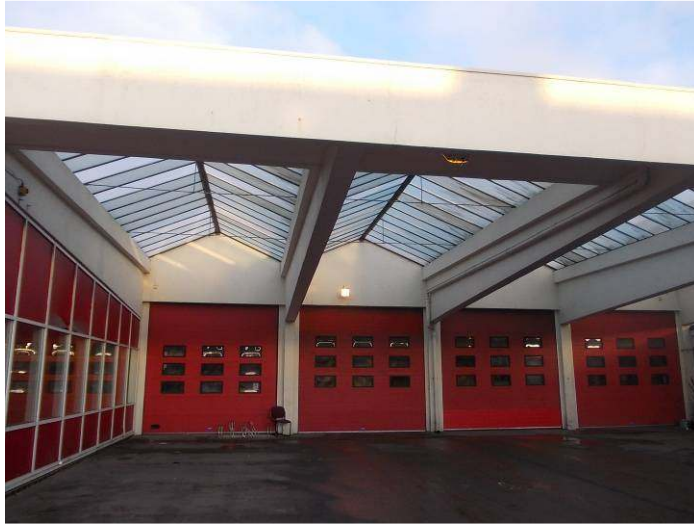
Figure 7

18. Most of the roof is flat built and felt lined, with the exception of a small multiple pitch glass and concrete canopy found to the southeast corner.

Multiple pitch glass and concrete canopy.

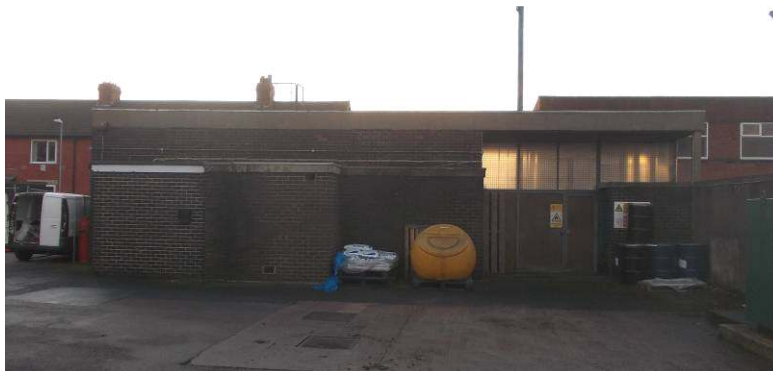
Figure 8

19. The small single-storey outbuilding within the site's southwest corner is of a similar construction to the main fire station building, with blue cavity brick walls topped with a course of concrete frame which extends to form the roof. The brickwork is found to be in an excellent state of repair with no areas of damage or missing pointing being obvious.
20. Several small single-storey extensions adjoin the outbuildings northern elevation. Here, the roofs are flat built and covered with bitumen felt. Wooden barge boards run along the eaves and are well sealed, preventing bats accessing any internal spaces.

Looking south at the small out building.
