**Bat Survey Report**  
**12 Hillhouse Lane, Fartown, Huddersfield.**  
**8<sup>th</sup> Jan 2015**

**Middleton Ecological Consultancy, 33 Wilthorpe Road, Barnsley S75 1JA**

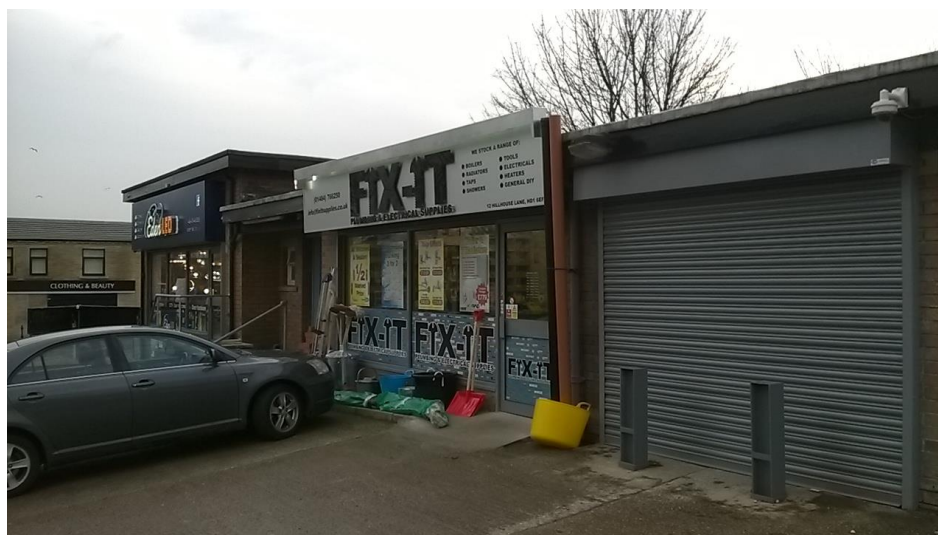
### Plate 2 Shop fronts - North elevation

- 3.1 The site is in the centre of Fartown in Huddersfield adjacent to the A641 Bradford Road. It consists of a modern single storey row of shops. The building(s) are built of brick with flat roofs covered in bitumen felt. The height of one of the shop buildings is higher than the rest and the flat roof overhangs the walls creating a large soffit (see plate 2).

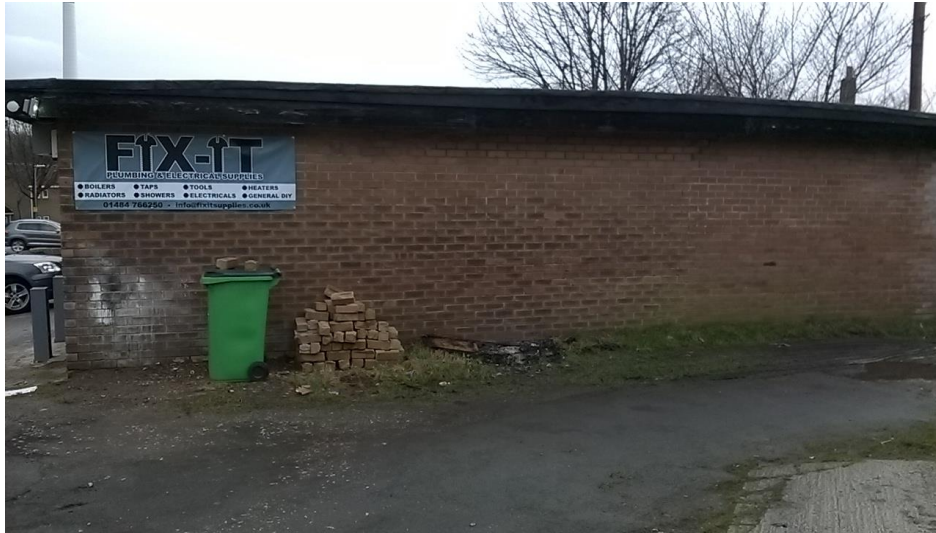
**Plate 3**      **West elevation**

- 5.4.1 The buildings are of a modern construction and the brickwork is consequently mostly devoid of features except for where the west elevation of the building has moved/subsided. The brickwork has a relatively large vertical crack under the soffit and on inspection with the aid of a ladder it was possible to see through the crack to the inside of the building (see plate 4). The crack was mostly cobwebby. The soffits of the building were intact and without any features except for a short

- 8.3 Works should proceed with caution and vigilance for unexpected bat presence, as single bats can roost almost anywhere. Consequently, the initial removing of the roof above the wall of the west elevation should be undertaken under the watching brief of a suitably qualified ecologist in order to that the cavity of the wall can be inspected.

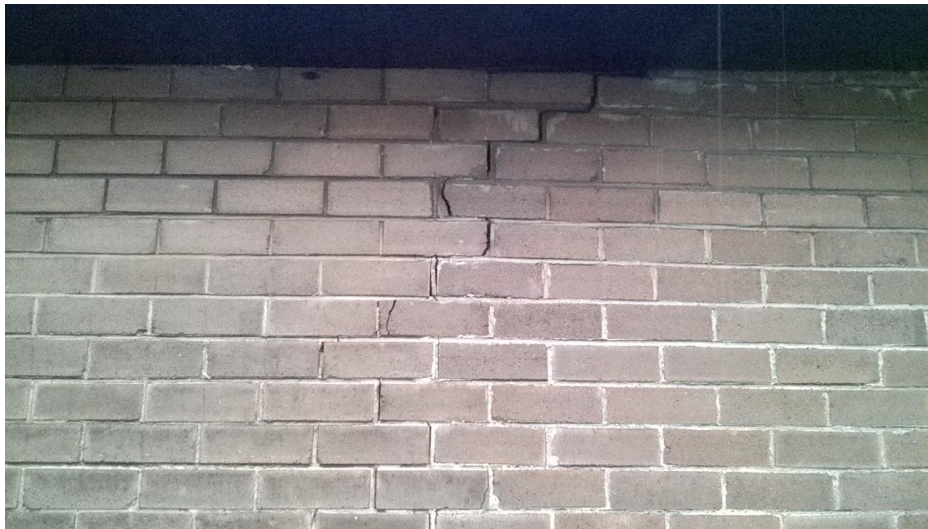
**Plate 4**

- 5.3.1 The buildings have a flat roof therefore there is no roof-space to inspect. The building is therefore unsuitable for Brown long-eared bats *Plecotus auritus*.
