# **Bat, Breeding Bird and Barn Owl Scoping Survey**

**Dry Hill Farm, Lower Denby**

**February 2016**

MAB Environment & Ecology Ltd

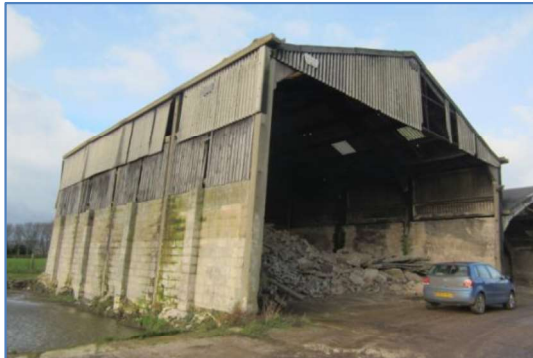
Open-sided. Breezeblock walls with corrugated asbestos sheet roofing on a concrete frame. Corrugated sheet cladding to the walls with some timber Yorkshire boarding. Skylights present. The internal space is filled with rubble and full access was restricted. Open, exposed ridge line, no ridge beam. 1x old bird nest. No potential for barn owl. To the south and west elevation, there are some crevices within the block-work but on closer inspection these areas appear to be very damp and exposed. *Negligible/very low bat roosting potential.*

Photo 1 - Building 1.

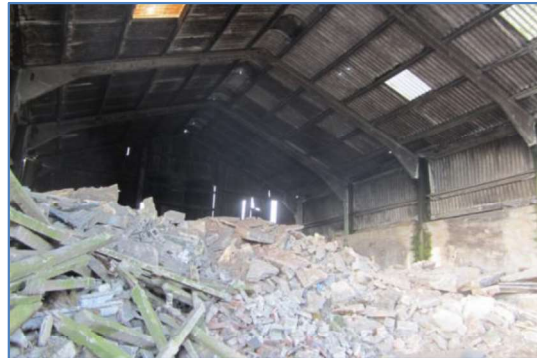
Photo 2 - Interior to building 1.

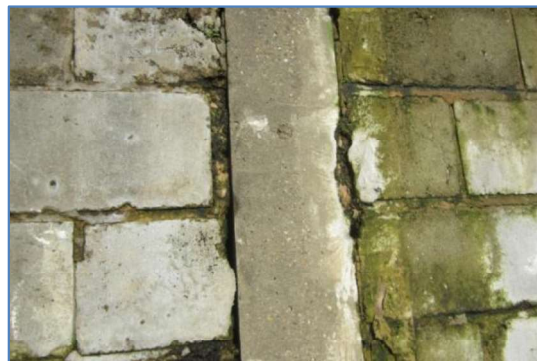
Photo 4 - Crevices within masonry of building 1 south elevation (damp walls).

A number of outbuildings (buildings 1, 4, 5, 11 and 12) offer some minor crevice roosting opportunities due to cracks and crevices in the breezeblock walls, and crevices around timbers. Many of the crevices in the walls (in the case of buildings 1, 11 and 12) were large where the walls had cracked, and lead all the way through to the inside. They do not lead into any enclosed cavities and some areas were visibly damp and exposed/draughty. These areas are unlikely therefore to offer suitable dry, warm and sheltered roosting opportunities, especially for use by high numbers of bat (e.g. by a breeding colony), but there is still a residual risk of use by low numbers or by solitary bats. Crevices between timbers joints and between the roofing sheets and roofing timbers/cladding are features sometimes utilised by small numbers of roosting bats.

To take account of this and the presence of low risk crevice roosting habitat, and as a precaution, it is recommended that an updated visual assessment is carried out during the bat active season and prior to work.

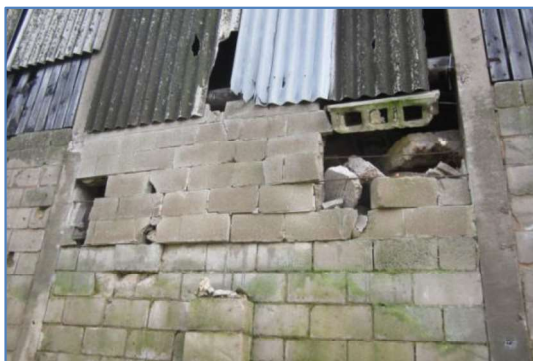
Photo 5 - Block work in poor condition on west elevation to building 1.

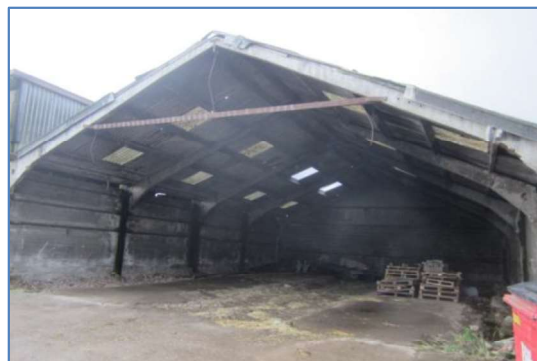
Construction as building 1. Some minor crevices where the building connects with building 1. 2x old bird nests present inside. *Negligible bat roosting potential.*

Photo 6 - Building 2.

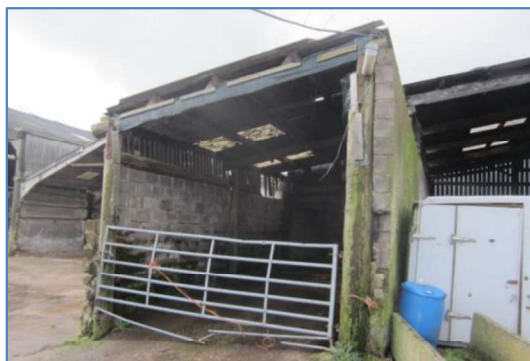
Breezeblock construction with corrugated asbestos roof, timber frame. Mono-pitch roof. Used as a wood store. No access right to the back (internally). 1x old bird nest. Roofing timbers are densely cobwebbed. *Negligible bat roosting potential.*

Photo 8 – Building 3.

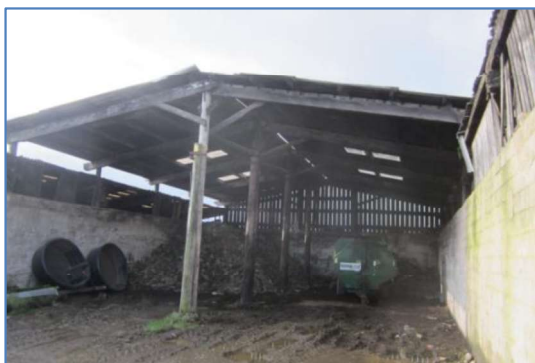
Breezeblock construction with corrugated asbestos roof, supported on a timber frame. The floor internally is very damp. There are some minor crevices and gaps between timbers but these are generally exposed and cobwebby. *Low bat roosting potential.*

Photo 9 – Building 4.

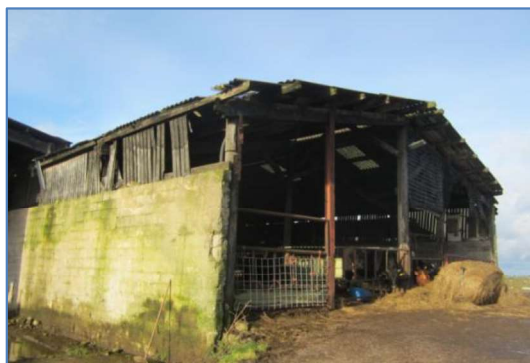
Large cattle shed, similar construction to building 4 but with large roofing timbers, many crossing over and overlapping which may provide crevices and roosting opportunities. These areas are generally densely cobwebbed (see photo 11). The floor is covered in straw and animal dung. Old bird nesting material is present on roofing timbers. *Low bat roosting potential.*

Photo 10 – Building 5.

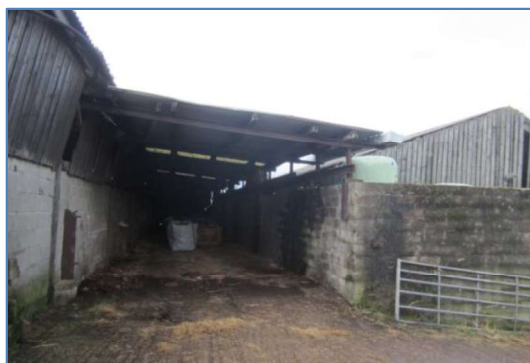
Narrow, mono-pitched lean-to between buildings 5 and 7. Corrugated metal roof on thin timbers. Some timbers overlap, creating small gaps between but these areas are cobwebby and undisturbed. Saw dust covers the floor. The rear (west) wall has some cracks in the block-work but these lead all the way through to the inside and are exposed/draughty. *No/negligible bat roosting potential.*

Photo 12 – Building 6.

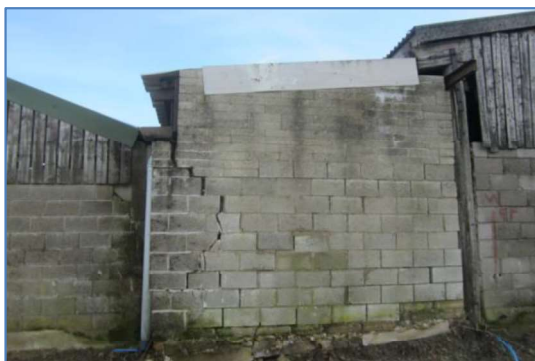
Photo 13 – West elevation of building 6, showing large cracks in rear wall.

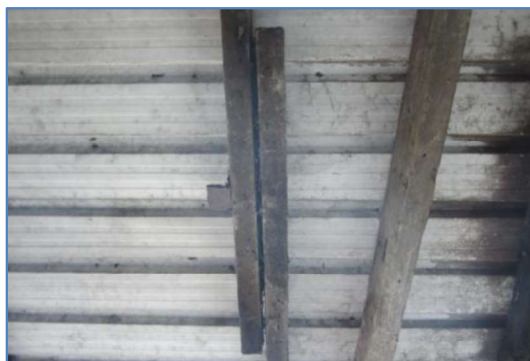
Photo 14 – Overlapping timbers of building 6 with gaps in-between (cobwebby).

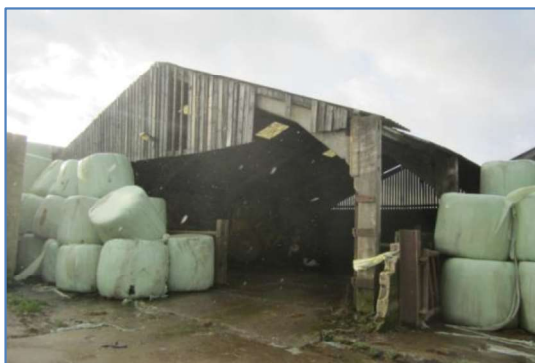
Same construction as buildings 1 and 2 with concrete frame. Open ridge line, no ridge beam. *No bat roosting potential.*

Photo 15 – Building 7.

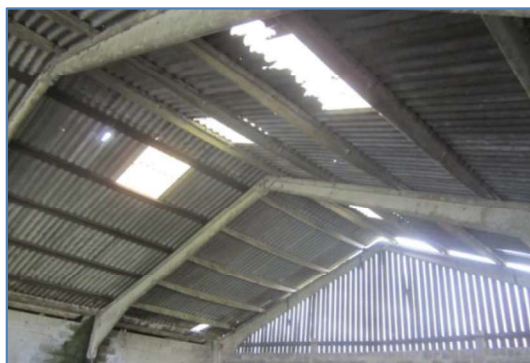
Photo 16 – Interior of building 7.

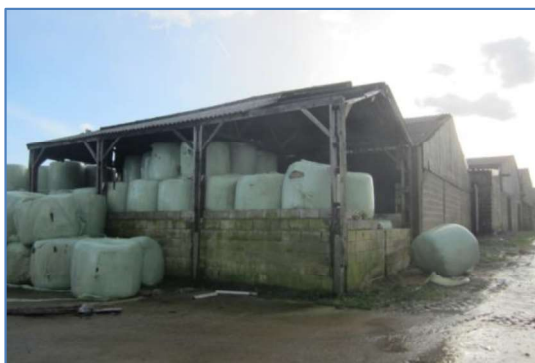
Open-sided, corrugated asbestos roof on a thin timber frame, part of the roof has collapsed. Timbers overlapping and attached together (see photo 18) but there are no obvious crevices and no bat droppings visible on top of hay bales stored below. Old bird nesting material present. *No bat roosting potential.*

Photo 17 – Building 8.

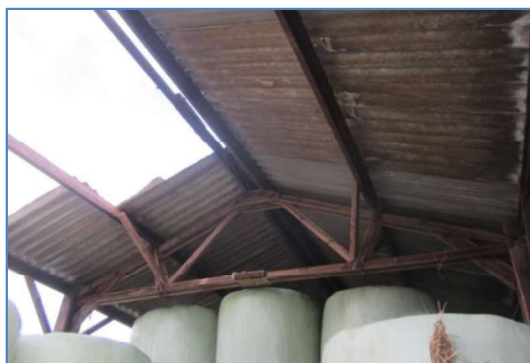
Photo 18 – Partly collapsed/missing roof of building 8, and thin roofing timbers.

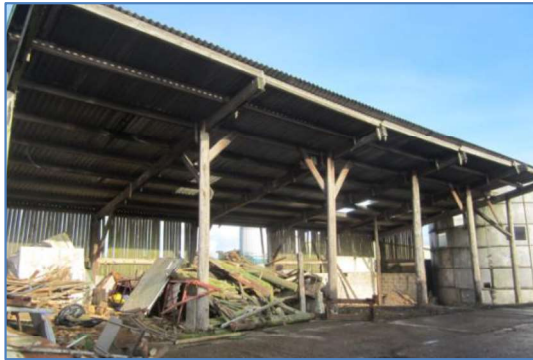
Open-sided lean-to. Corrugated roof on timber frame. The structure has no bat roosting potential. An old wooden crate has been attached to one of the roofing timbers to provide a nest box but no signs of use could be seen. No barn owl pellets were found.

Photo 19 – Building 9.

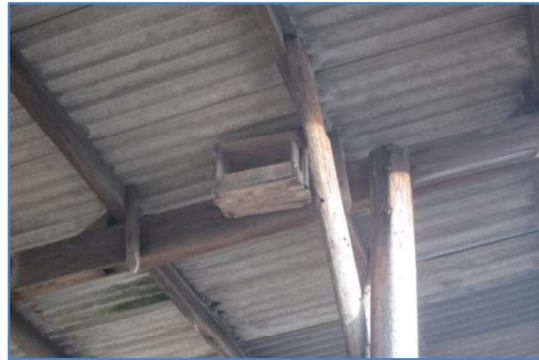
Photo 20 – Box attached to timbers in building 9.

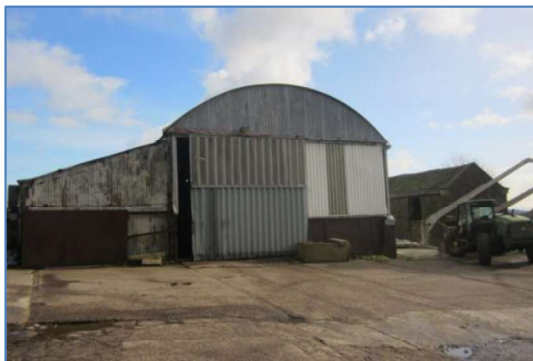
Large metal nissen hut and lean-to on a steel frame. *The structure offers no potential bat roosting habitat.*

Photo 21 – Building 10.

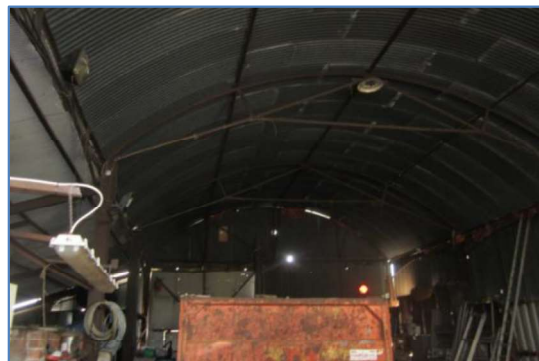
Photo 22 – Inside building 10.

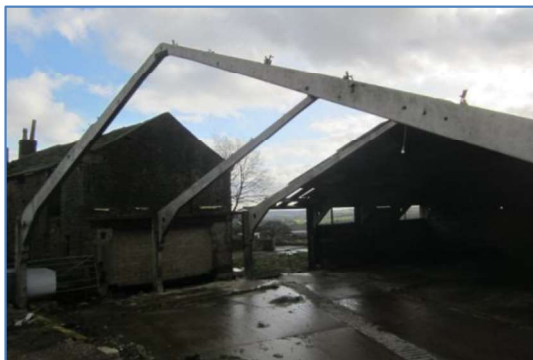
Large shed, corrugated roof on concrete frame and breeze-block walls. Partially demolished. There is a large crack in the internal wall, where it connects with building 12: this area is however very damp (see photo 24). *No/negligible bat roosting potential.*

Photo 23 – Building 11.

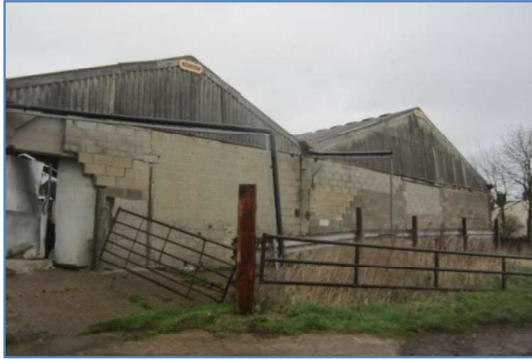
As building 11. Full of timber and rubble. The south wall is in a poor condition with large gaps and cracks in the block-work. *Negligible bat roosting potential.*

Photo 25 - Rear (south) elevation of buildings 11 and 12.

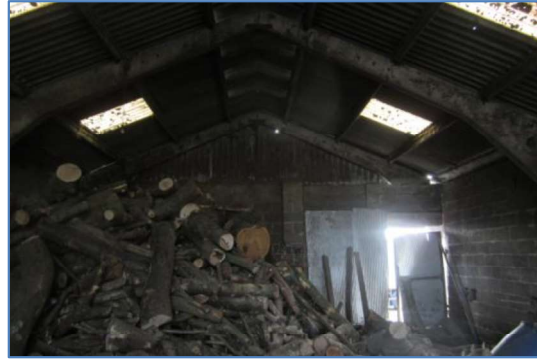
Photo 26 - Interior to building 12.
