Bat Presence / Absence Survey

Serpentine Road, Cleckheaton, West Yorkshire,
BD19 3HU

Address	Serpentine Road, Cleckheaton, West Yorkshire, BD19 3HU		
Client	McCarthy & Stone Retirement Lifestyles Ltd	Ecologist	Victoria Telford
Our Ref	E2402161302	Director	Andy Hobbs
Report Date	07 July 2016	Quality Checked	Jonathan Jones
Scope of Report	Bat Absence / Presence Survey – Buildings

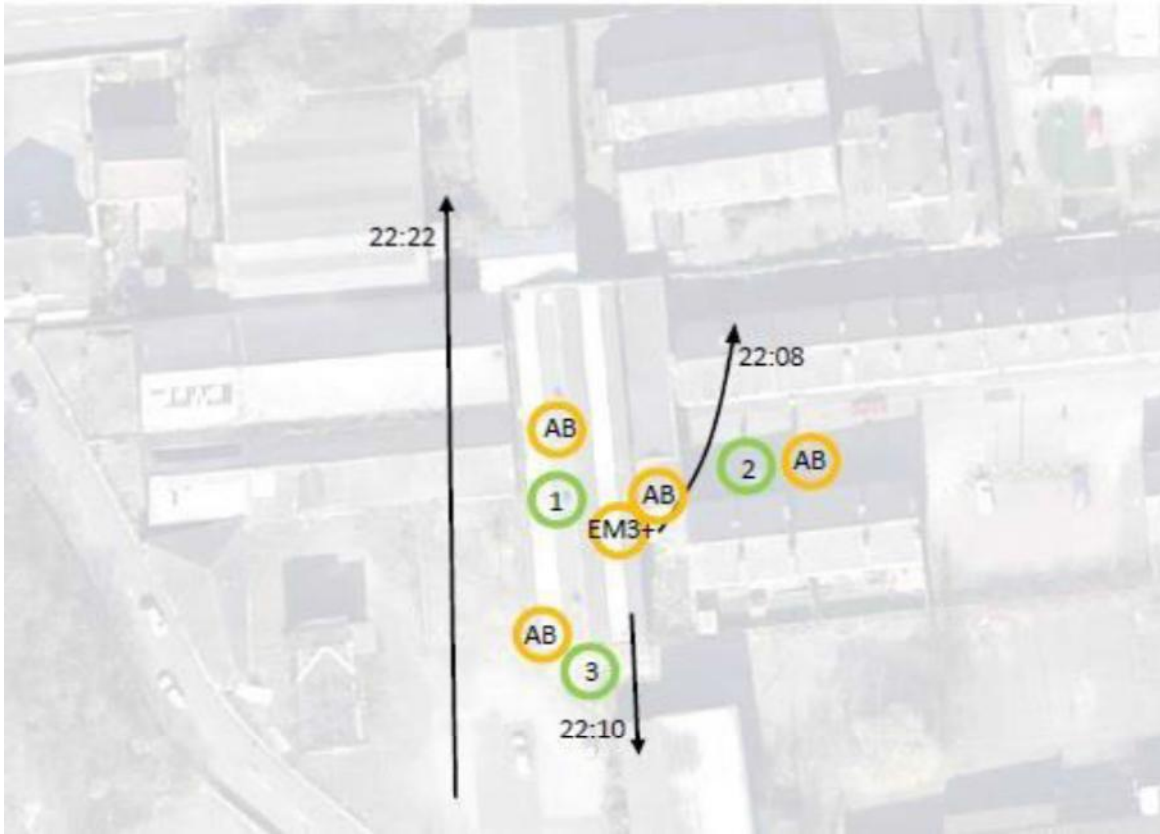
Location of Surveyors and Flight Lines: Dusk 8th June 2016

1	Surveyor 1	P Hiscocks
2	Surveyor 2	J Jones
3	Surveyor 3	T Hiscocks
AB & EM3+	Anabat and EM3+ Recording Device Locations

Bat flight lines	Common Pipistrelle
