# Quarry House, 12a The Dell, Huddersfield

## Bat Survey Report

26<sup>th</sup> May 2017

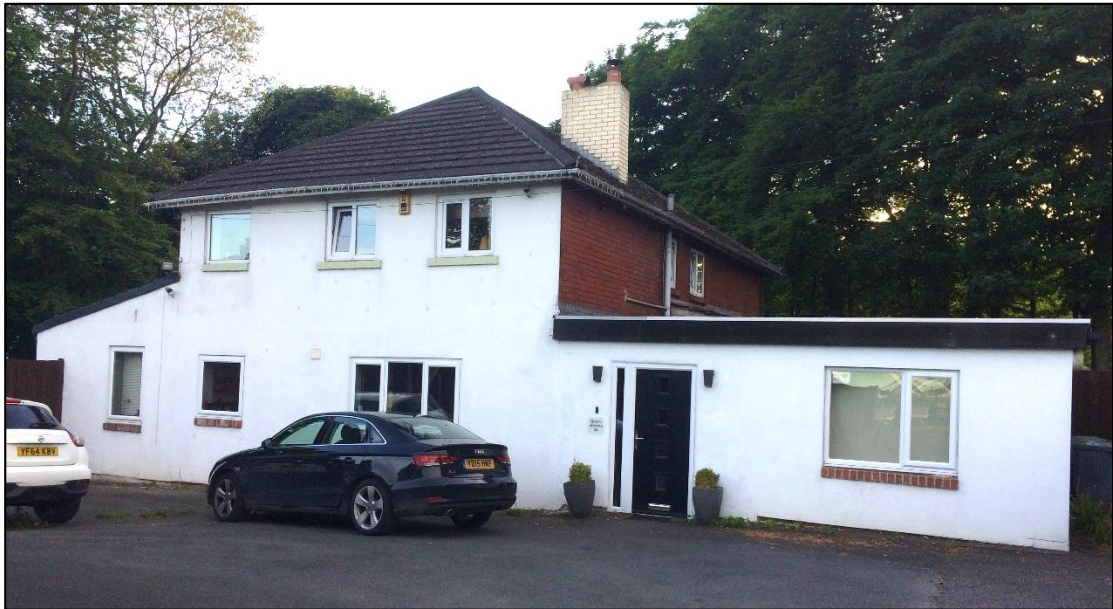
**Plate 1. The east elevation of the surveyed building**

5.2.2 Quarry House is a c1910 detached two storey brick built dwelling with a pitched concrete tile roof with ridge and hips. The south and east elevation are cement rendered as is the three single storey extension which occupy three sides of the building. The south and east elevation extensions have mono pitched concrete tile roofs whilst the north elevation extensions contain a small mono pitched concrete tile roof and a somewhat large flat bitumen felt covered roof (see Plates 1 & 2).

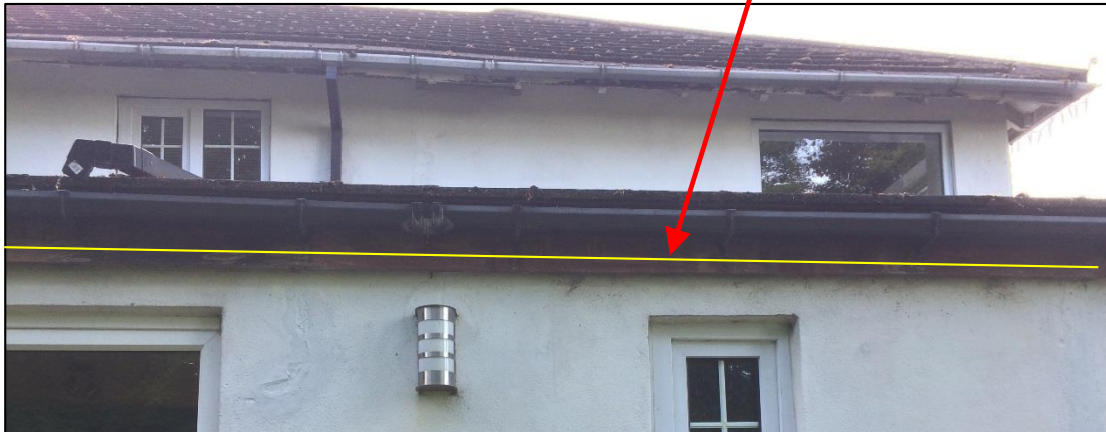
**Plate 3. South elevation extension**

However, the west elevation fascia was easily inspected with the aid of a torch and it was found to be a little too wide (50mm) for crevice dwelling bats and somewhat 'cobwebby'. No bats were found. The south elevation extensions fascia was again inspected with the aid of a torch and the wall top was only one centimetre above the bottom edge of the fascia which is likely to make the feature less suitable for crevice dwelling bats because of the large void (see Plate 3).

Wall top here behind fascia

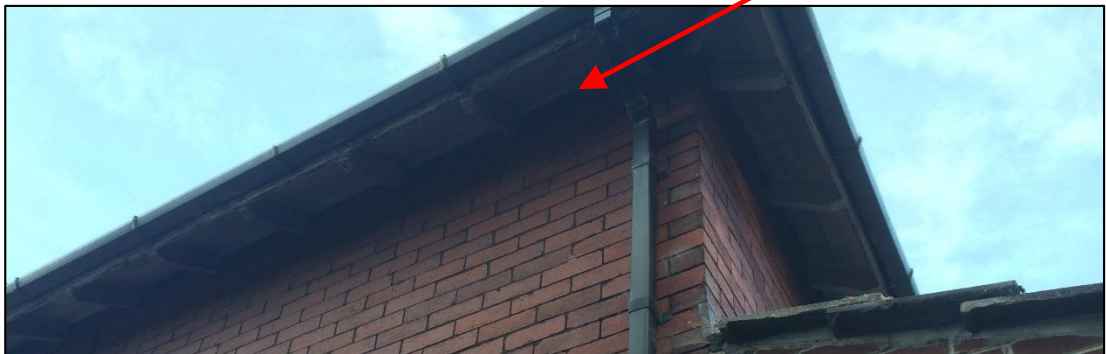
**Plate 4. Northwest corner**

5.2.3 The building walls were found to be devoid of features with potential to accommodate bats because of cement render on two sides and well maintained brickwork on the remainder. The roof tiles are relatively new and consequently the mortar bed beneath ridge and hip tiles is in good condition. Therefore the only feature on the roof is perhaps under the flashing of the chimney where the sheet lead is a little lifted. A narrow crack was noted at the wall top under the soffit at the northwest corner of the building (see Plate 4) and the south and west extensions have a gap behind the fascia.

Crack at wall top here
