## Phase 1 Geoenvironmental Study

**Project:** Land off Fullwood Drive  
Golcar, Huddersfield  
HD7 4JD

**Reference:** S10474 Ph1 Geo

**Date:** October 2017

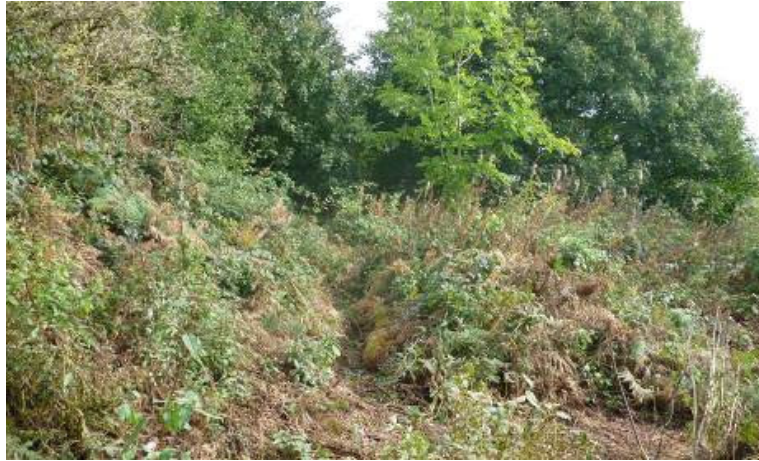
2.1.2 The site walkover was undertaken on 10/10/2017. The majority of the site is largely overgrown with brambles and self seeded tree's making access into the site difficult. Access was gained via a shallow wall from the public pathway on the north west boundary of the site (photo 1). The site is set on a steep hillside.

**Photo 1: From the north eastern side of the site adjacent to the public pathway**

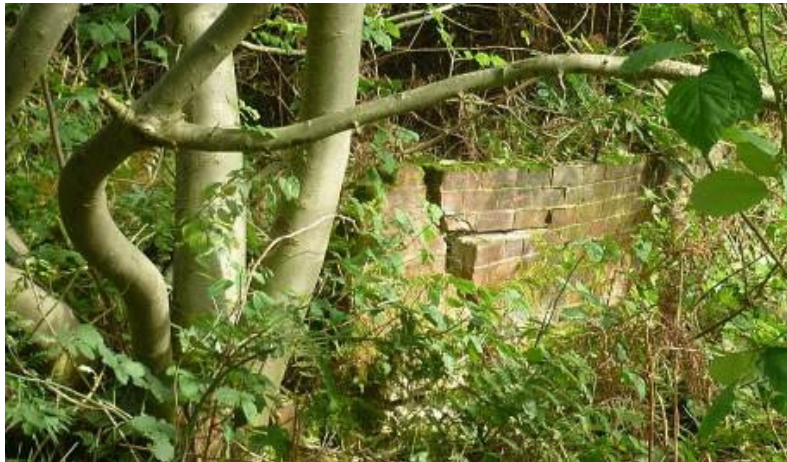
2.1.3 The site is indicated on the location plan as allotment gardens, with evidence of the remains of former outbuildings that once stood on the site. Badger setts are evident on the north west side of the site which also shows evidence of fly tipping and incinerator waste debris.

**Photo 2: Indicating the remains of the brick outbuilding in the middle of the site**

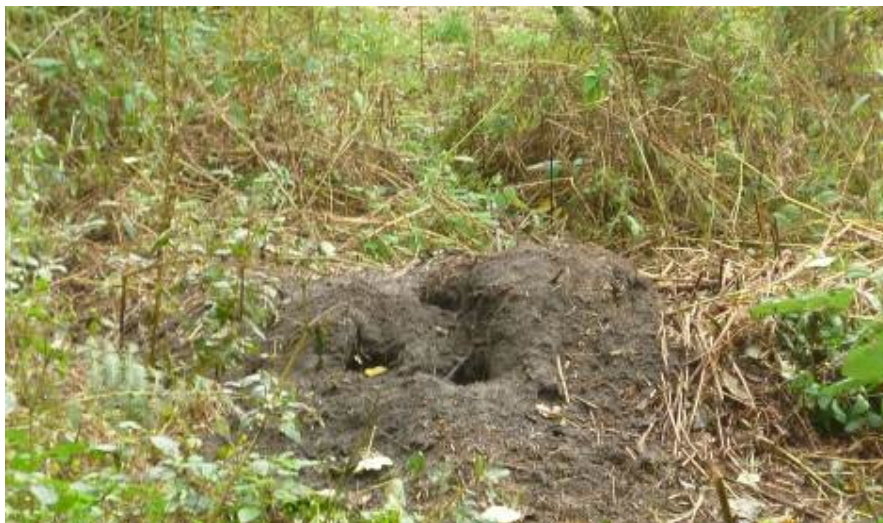
**Photo 3: Assumed badger setts on site adjacent to public pathway along western boundary**

- 8.1.1 The desk study has identified that the geological succession below the site comprises Millstone Grit and Guiseley Grit Group. The Lockwood Beck is located 38m to the southwest but at a lower elevation. Possible badger setts were noted on site.
- 8.1.2 The desk study identifies that the site had a potentially contaminative use as allotment gardens and subsequently has been left overgrown with waste debris and fly tipping.
- 8.1.3 Based on information contained within the desk study it is the opinion of **jnp group** that the potential site conditions provide a **MEDIUM to LOW** environmental risk and hence further investigation and assessment is required.
- 8.1.4 Less than 1% of homes above the radon action level. Therefore, no radon protection measures are considered necessary.
- 8.1.5 The site is not located in an area considered to be at risk of fluvial flooding.
