**Whitcher Wildlife Ltd.  
Ecological Consultants.**

**13 OAKFIELD ROAD, BIRKBY.**

**BAT SURVEY.**

**Ref No:- 180238.**

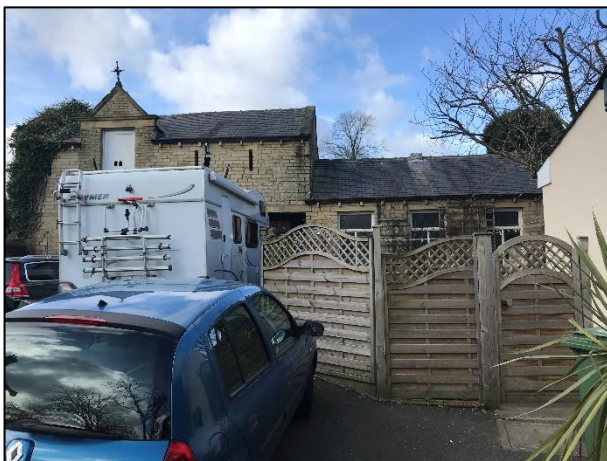
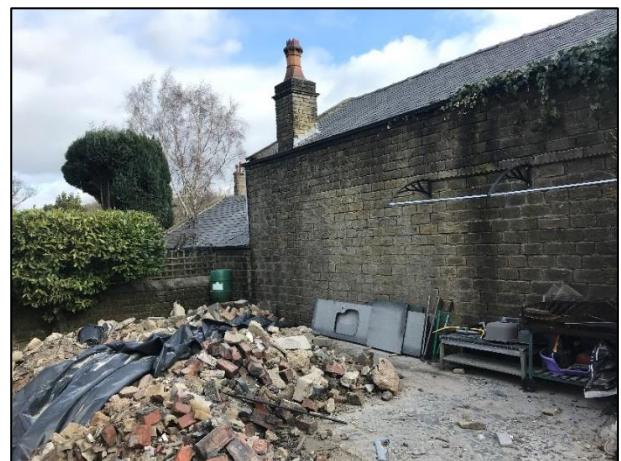
3.3.1.1. The former stable is currently used for storage and was generally in a good state of repair. The photograph below shows the eastern elevation of the former stable on the left and shows the western elevation of the former stable on the right.

3.3.1.2. The northern elevation of the building was single storey and the southern elevation of the building was two storey which was interconnected.

3.3.1.3. The building was constructed from tight fitting dressed stone which was solid with no cavity. The building has tight fitting brick on the internal walls.

3.3.1.4. The roof of the two-storey elevation is pitched with a dormer on the eastern elevation. The roof was covered with tight fitting blue slate with tight fitting capped angle ridge tiles. There were stone coping stones on the northern and southern gable ends and the eastern gable end which are generally tight fitting with only shallow mortar loss which could be thoroughly investigated during this survey. There was dense ivy on the southern wall and gable end. This could not be thoroughly inspected during this survey but will not provide a suitable habitat for roosting bats.

3.3.1.5. The roof of the single storey elevation was also pitched and connected to the northern wall of the two storey section with tight fitting lead flashings. The single

storey section has a gable end on the northern elevation. The roof was covered with tight fitting blue slate with tight fitting capped angle ridge tiles. There are stone coping stones on the northern gable end which are generally tight fitting with only shallow mortar loss which could be thoroughly investigated during this survey. There was a thin layer of ivy on the northern wall and gable end which could be thoroughly surveyed during this survey.

4.1.2. The building was generally in a good condition and will not provide a suitable habitat for roosting bats as there are no substantial cracks or crevices. The impact on bats has been assessed as negligible due to the condition of the roof and the stonework. Therefore, no further survey work in connection with bats is recommended in connection with the proposed works.

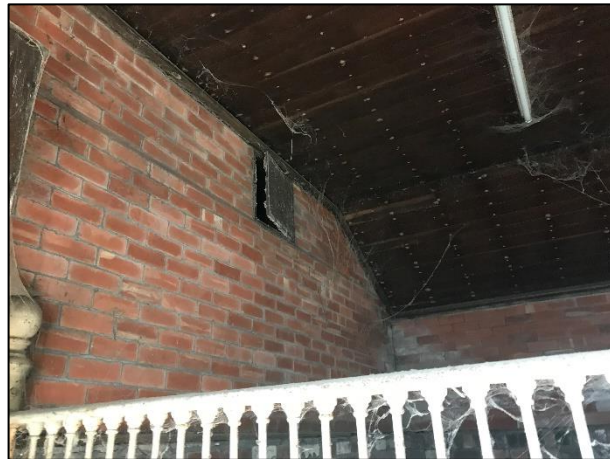
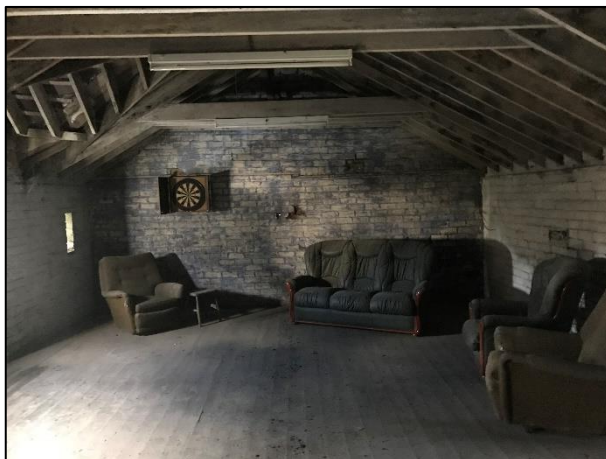
3.3.1.7. Inside the northern elevation of the building the roof was constructed from a rafter and purlin design frame which was lined with wooden sarking, leaving a small loft space which could not be inspected during this survey as shown in the photograph opposite.

3.3.1.8. Inside the southern elevation of the roof the roof was open with a rafter and purlin design frame with no lining. The roof space had large amounts of cobwebs in the ridge and the wall tops as shown in the photograph opposite.

3.3.1.9. There were no bat field signs or bat roosts identified internally or externally during this survey.

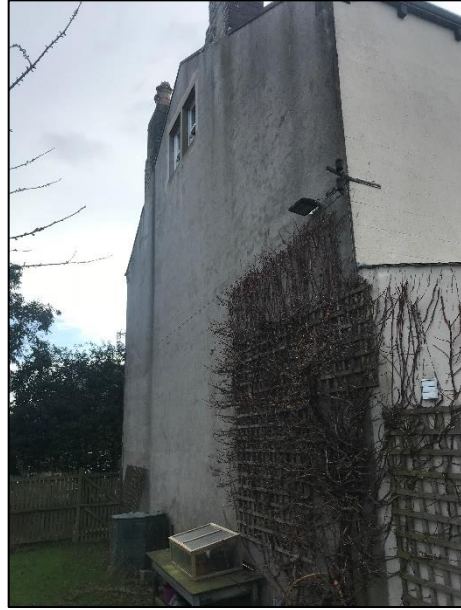
3.3.2.1. The surveyed building was a three storey structure which was rendered on the northern western and southern elevation with dressed stone on the eastern elevation. The grounds around the northern elevation of the building was well tendered grass and garden with no substantial trees near to the proposed canoe store.

3.3.2.2. The surveyed area of the building was the northern wall which was in a good condition with tight fitting coping stones on the northern gable end.

3.3.2.3. There were no bat field signs or bat roosts identified internally or externally during this survey.

4.2.2. The building was in an immaculate condition and will not provide a suitable habitat for roosting bats as there are no substantial cracks or crevices. The impact on bats has been assessed as negligible due to the condition of the roof and the stonework. Therefore, no further survey work in connection with bats is recommended in connection with the proposed works.
