**FORMER COMBS HOSTEL, HALL LANE,  
DEWSBURY.**

**PRELIMINARY ECOLOGICAL APPRAISAL.**

**Ref No: 210150.**

**Date: 8<sup>th</sup> February 2021.**

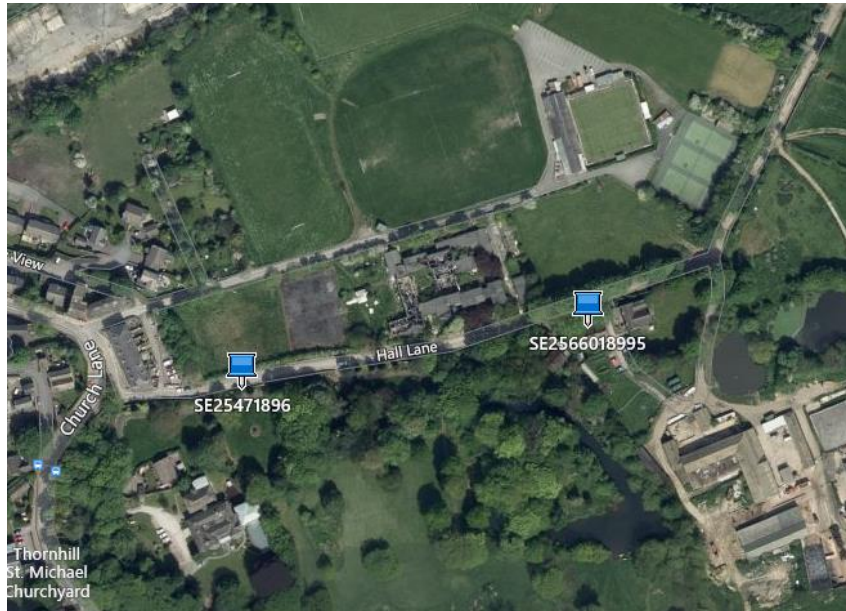
3.1.4. There is a field record of a Common Pipistrelle bat located 40m to the southeast of the survey area, recorded in 2015. The map below shows this record, on the right.

3.1.5. There is a record of a Vesper bat species roost of 315 bats, recorded in 2004 and located 20m from the survey area, on the opposite side of Hall Road. The map below shows this record, on the left.

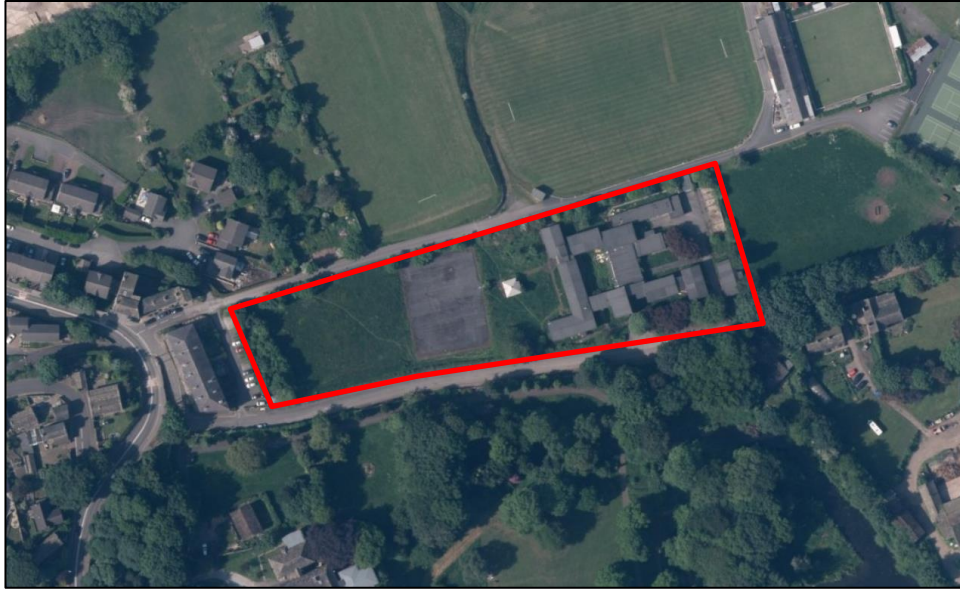
3.2.1. The surveyed area was the Former Combs Hostel, off Hall Lane, Dewsbury. The site includes all the old residential and maintenance buildings on site and the area of land to the west. The aerial photograph below shows the surveyed area and the immediate surrounding area.

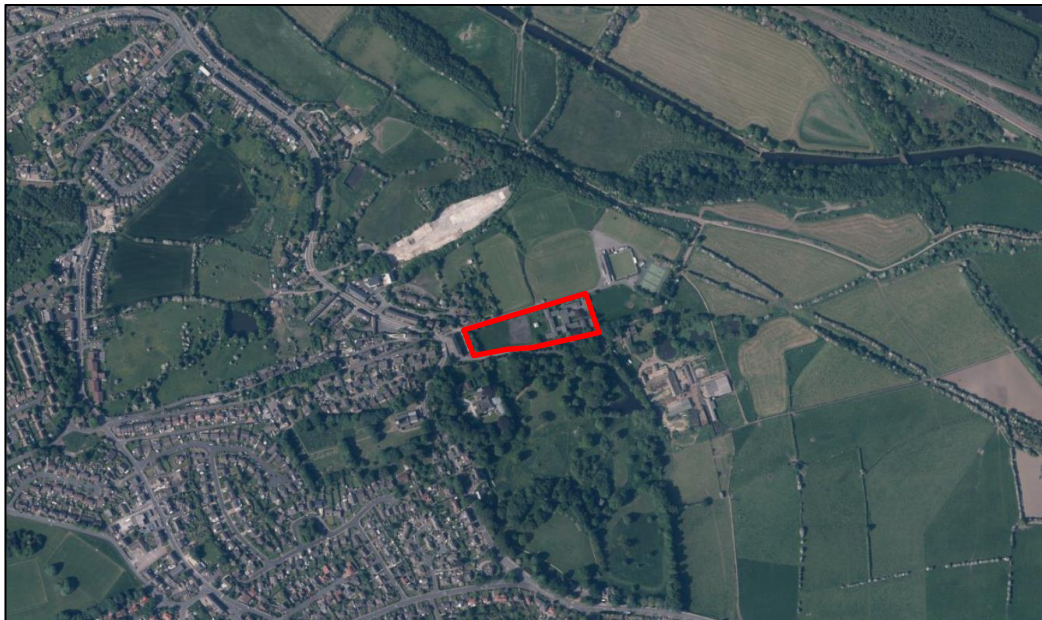
3.2.2. The aerial photograph below shows the surveyed area and the wider surrounding area.

3.2.3. The area surrounding the surveyed site consist of sports fields to the north, a farm and scattered woodland to the east, parkland containing pockets of woodland to the south and built up residential areas to the west.

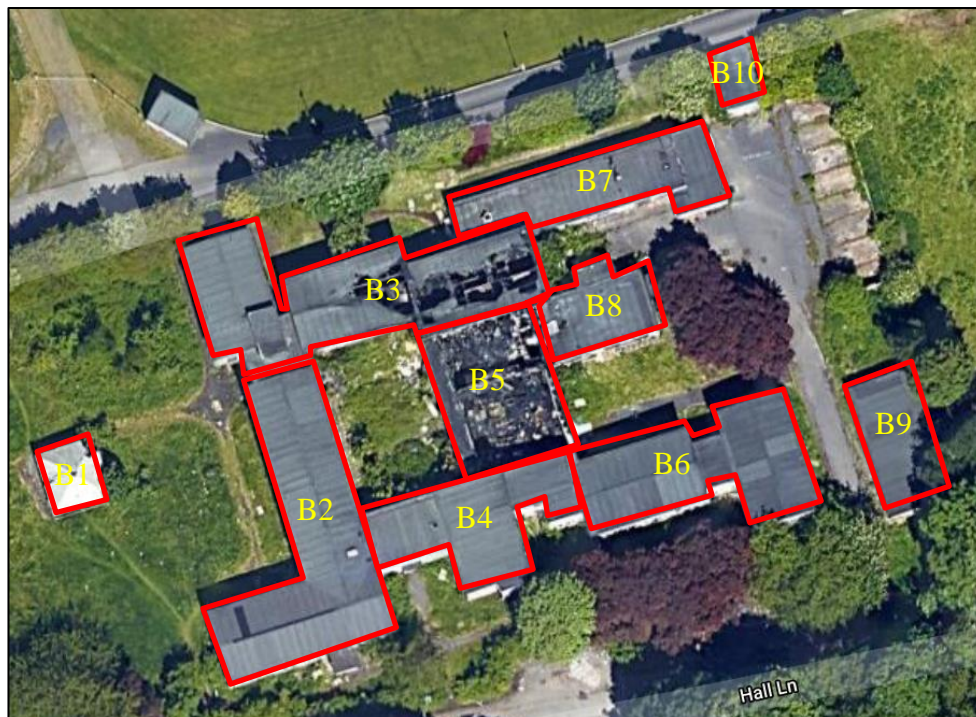
The residential and maintenance buildings on site have been split and each given a number for the purpose of this report. Below is a map and brief description of each building with the buildings numbered 1 to 10.

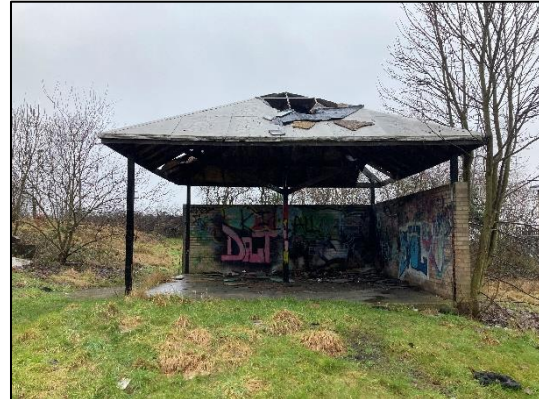
### 3.3.1.1.1. Building B1.

B1 is a small pavilion building at the western end of the main buildings. The pavilion is open on two sides and supported with a steel frame with two brick walls to the north and eastern elevations, that are in a good state of repair. The roof is hipped and covered with timber and felt and is in a poor state of repair. The adjacent photograph shows B1.

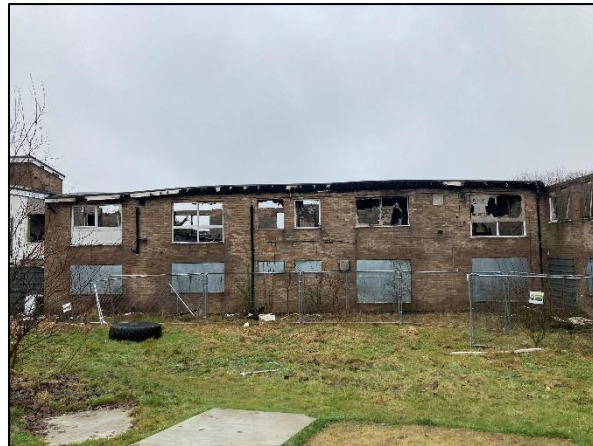
### 3.3.1.1.2. Building B2.

B2 lies at the western end of the residential area and is a two-story building constructed with brick cavity walls that are generally in a good state of repair, although where some of the windows are missing, there are gaps into the cavity walls. All the windows and doors have been boarded up but some of the boards have been broken or removed. This building has been fire damaged with the roof completely missing with no loft space. The adjacent photograph shows B2.

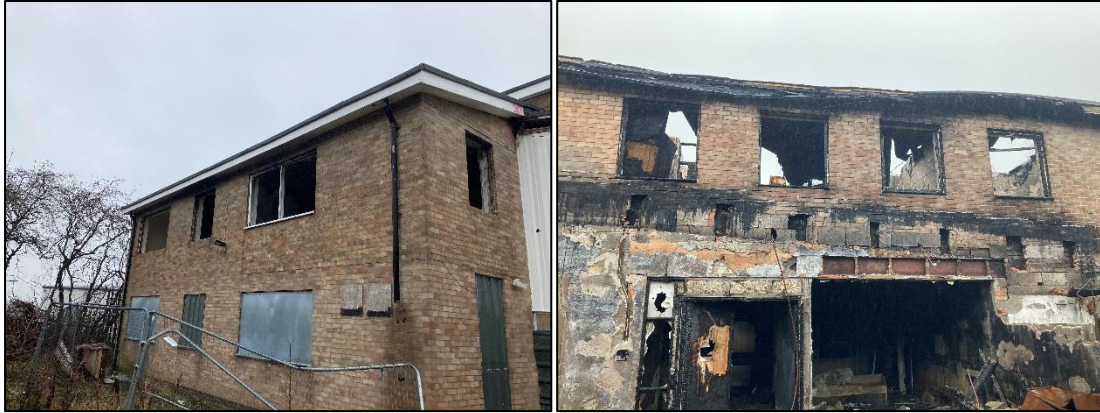
### 3.3.1.1.3. Building B3.

B3 is attached to B2 on the northern elevation and is a two-story building constructed with brick cavity walls that are in a mixed state of repair. Some of the walls have been fire damaged with gaps created into the cavity walls. The windows and doors have been boarded up but some of the boards are now missing. The roofs of B3 are pitched with the western end intact, although the eastern roof has been fire damaged, as can be seen on aerial maps. The photographs below show the open windows at the western end of B3 and the fire damaged walls.

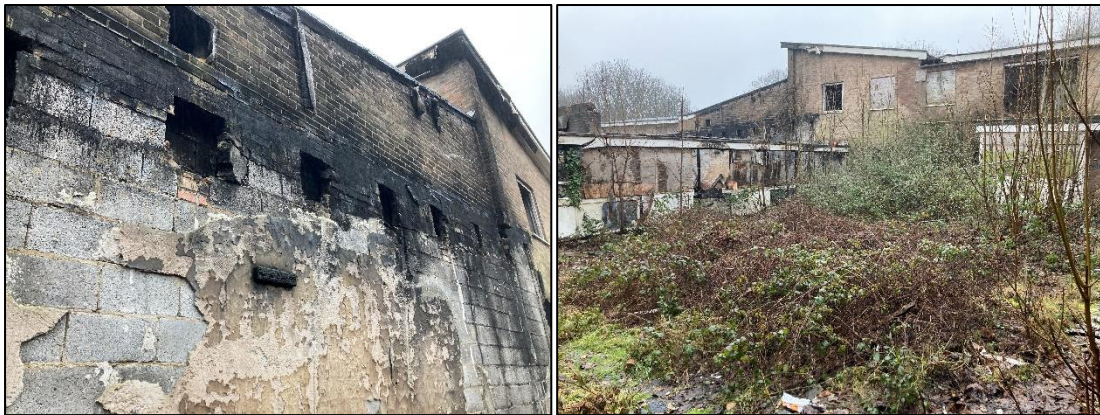
#### **3.3.1.1.4. Building B4.**

B4 is attached to B2 on the western elevation and is a two-story building constructed with brick cavity walls. The walls are generally in a good state of repair although there are areas that have been fire damaged leaving access into the cavity. The windows and doors have been boarded up but some of the boards are now broken or missing. The soffit and fascia boards are generally well fitted although there is some fire damage in places. The roof of B4 is semi pitched and appears to be intact although it could not be seen from ground level. No access was available to check for loft spaces. The photographs below show B4.

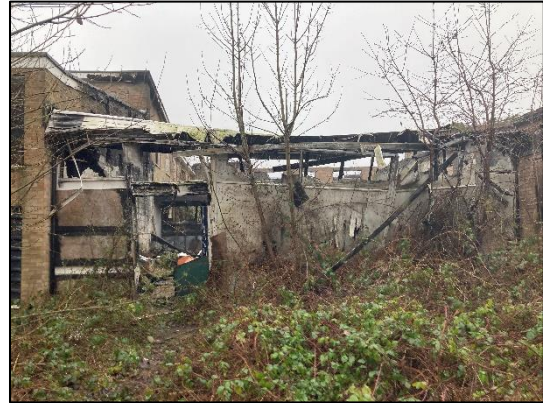
### 3.3.1.1.5. Building B5.

B5 lies between B3 and B4 and has been completely gutted by fire with only a timber shell and an internal solid brick wall still standing. The adjacent photograph shows the remainder of B5.

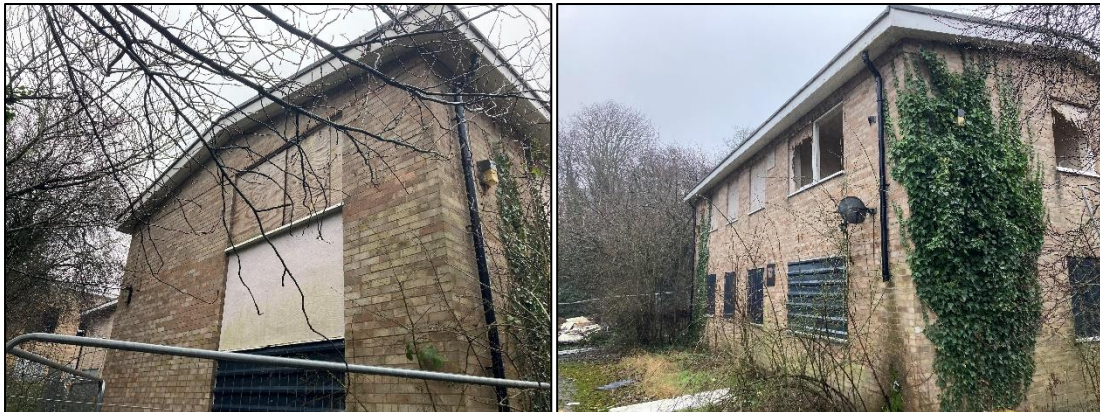
### 3.3.1.1.6. Building B6.

3.1.6. Previous bat surveys have been carried out on the site, with a large bat roost identified within the southern corner of Building 6.

B6 is attached to B4 on the western elevation and is a two-story building constructed with brick cavity walls. The walls are in a good condition with no gaps to the cavity. The windows and doors have been boarded up but two of the boards on the first story are now missing. The fascia and soffit boards are generally well fitted although there is a small gap at the southeast corner. The roofs of B6 are pitched and covered with felt and appear in a good state of repair, although not all the roof could be seen from ground level. The photographs below show B6.

5.5. It is recommended that a bat dusk emergence survey is carried out on the buildings before the works commence to ensure bats are not using them as a roosting site.

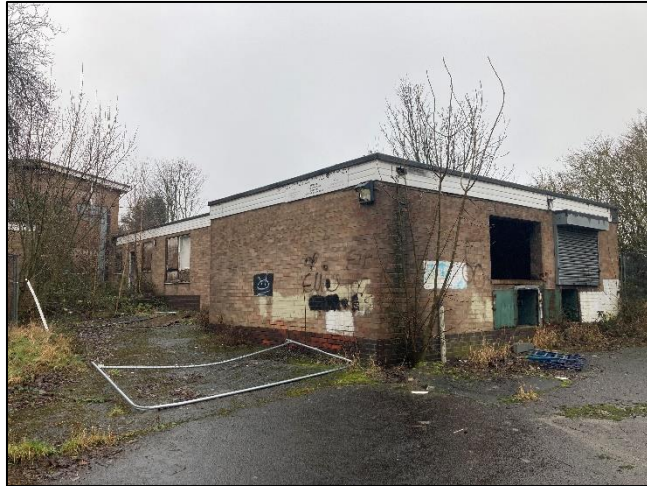
### 3.3.1.1.7. Building B7.

B7 is attached to B3 on the western elevation and is a single-story building constructed with brick cavity walls. B7 is the old boiler house and was open at the time of this survey. The roof is flat and covered with felt and has no loft space and is generally in a good state of repair, although there are gaps around a metal chimney flue and there are small areas where there are gaps behind the fascia boards. The adjacent photograph shows B7.

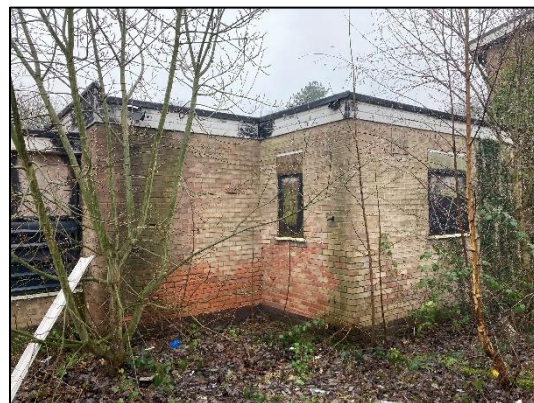
### 3.3.1.1.8. Building B8.

B8 lies just south of B7 and is a single-story building constructed with brick cavity walls. The walls are in a good state of repair with no gaps, cracks or missing bricks. The roof is flat and appears in a good state of repair with all fascia boards intact and well fitted. No access was available into B8 during this survey as all the windows and doors are boarded up. The adjacent photograph shows B8.

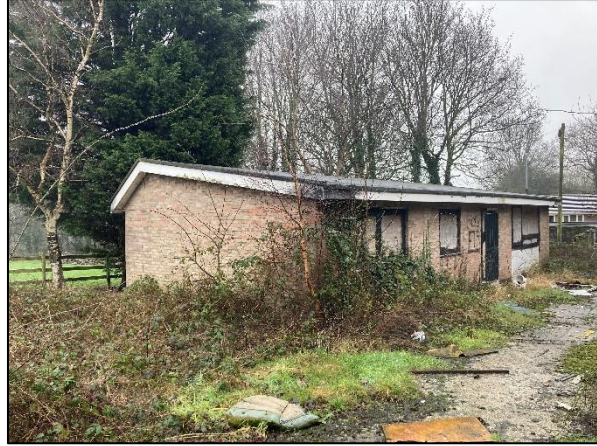
### 3.3.1.1.9. Building 9.

3.1.3. There is a record of a Common Pipistrelle roost, recorded in 2007 and located within the survey area around Building 9. The map below shows the location of the grid reference for this record. There is no more information on the roost.

B9 lies in the southeast corner of the site and is a single-story building constructed with brick cavity walls. The walls are generally in a good state of repair although there is an area of missing brick in the eastern elevation. All windows and doors are boarded up with only a small broken piece of glass missing above the door. The roof is pitched and covered with felt and is in a good state of repair and all soffit and fascia boards are well fitted. No access was available into B9. The adjacent photograph shows B9.

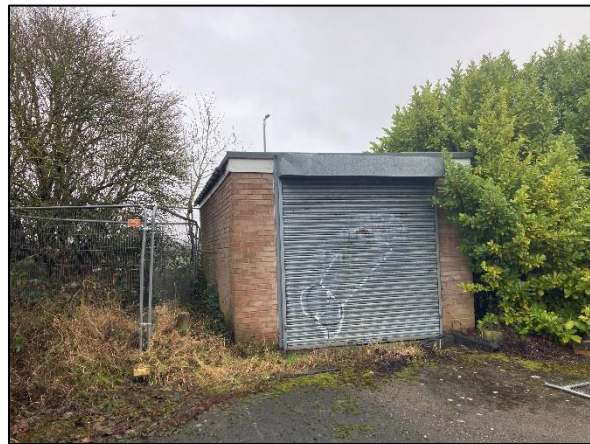
### 3.3.1.1.10. Building B10.

B10 lies in the northeast corner of the site and is a small brick garage that has a steel roller shutter door with no windows. The garage has a flat roof and is in a good state of repair. No access was available into B10. The adjacent photograph shows B10.

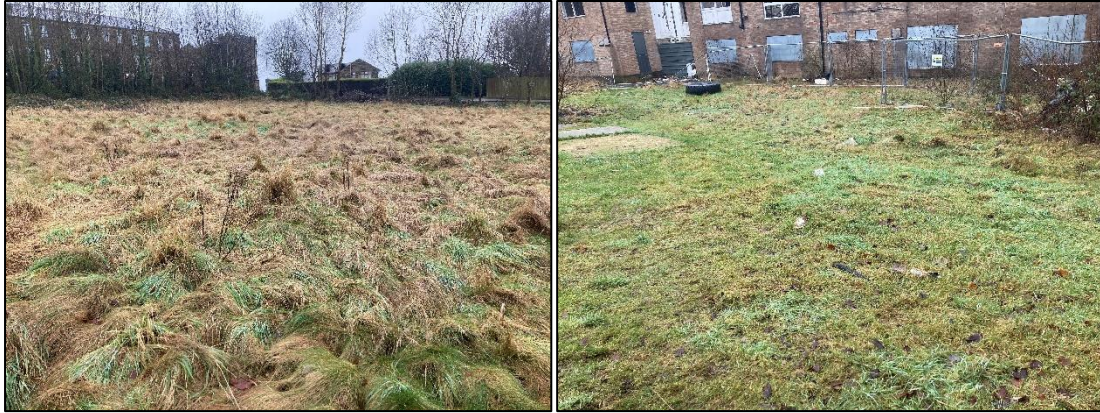
At the western end of the site there is a large area of improved grassland and there are four small areas scattered around the buildings. The improved grassland contains species including perennial rye grass (*Lolium perenne*), Yorkshire Fog (*Holcus lanatus*), cocks foot (*Dactylis glomerata*) and false oat grass (*Arrhenatherum elatius*) with some tall ruderal species also identified including willowherb (*Chamaenerion sp(p)*), dock (*Rumex sp.*), nettle (*Urtica dioica*) and thistle (*Cirsium sp(p)*). These areas will have been Amenity Grassland in the past but have been left unmanaged. The photographs below show two areas of Improved Grassland.

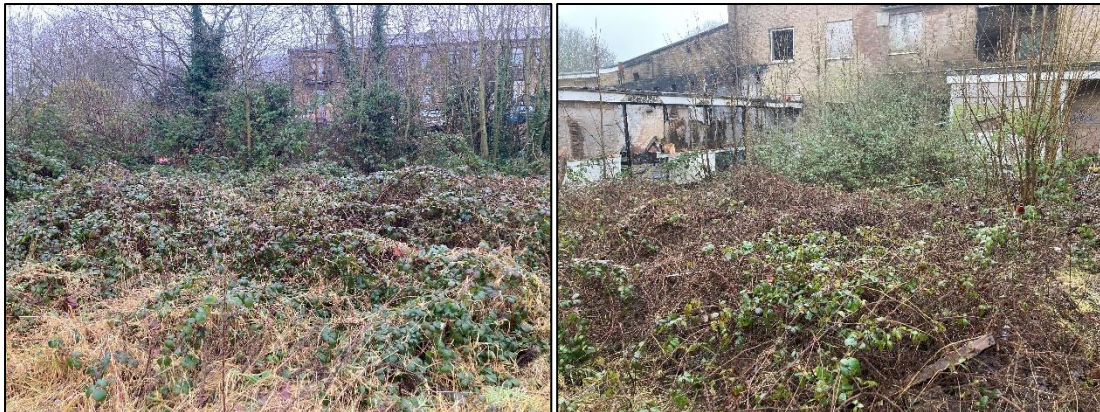
Throughout the surveyed area there are pockets of dense scrub that predominantly consist of bramble (*Rubus fruticosus*) with buddleia (*Buddleia davidii*), ivy (*Hedera helix*), dog rose (*Rosa canina*), dogwood (*Cornus sp.*), laurel (*Prunus laurocerasus*), Cotoneaster (*Cotoneaster spp.*), hazel (*Corylus avellana*), hawthorn (*Crataegus monogyna*), elder (*Sambucus nigra*), sapling silver birch (*Betula pendula*), ash (*Fraxinus excelsior*) and oak (*Quercus sp(p)*) trees also present. The photographs below show areas of dense scrub.

5.15. It is recommended that the Cotoneaster that is growing within the site is removed and disposed of as contaminated waste. All parts of the plant including its berries should be removed.

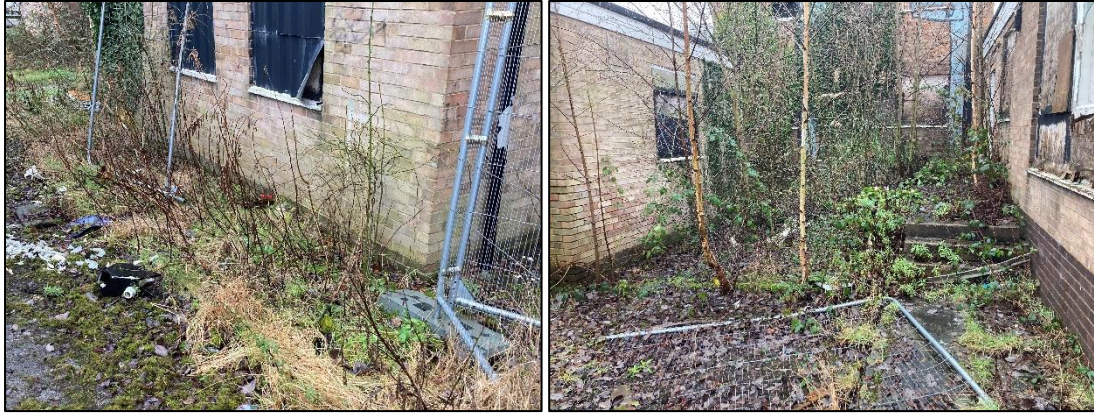
There are patches of scattered scrub and tall ruderal species in the footprint of B5, between B7 and B8 and within an area of bare ground towards the eastern end of the site. These areas consist of bramble (*Rubus fruticosus*), buddleia (*Buddleia davidii*), willowherb (*Chamaenerion sp(p)*), nettle (*Urtica dioica*), thistle (*Cirsium sp(p)*), ivy (*Hedera helix*), elder (*Sambucus nigra*) and immature silver birch (*Betula pendula*) trees. The photographs below show two of these areas.

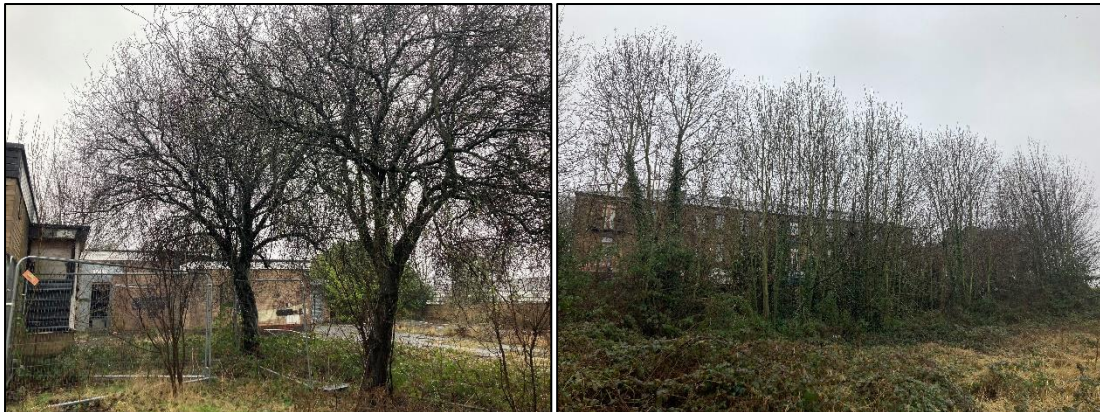
There are various scattered trees along the perimeter of the site and around the main buildings that include plum (*Prunus sp(p)*), sycamore (*Acer pseudoplatanus*), silver birch (*Betula pendula*), ash (*Fraxinus excelsior*) hawthorn (*Crataegus monogyna*) and Leyland cypress (*Cupressocyparis leylandii*). The photographs below show some of the trees.

5.7. It is recommended that none of the trees on site are removed as part of the works as some of the trees provide low roosting bat potential. If the trees have to be removed, they must be soft felled and left in situ for a twenty-four hour period before being chipped or removed from site to allow any bats roosting within them to safely escape.

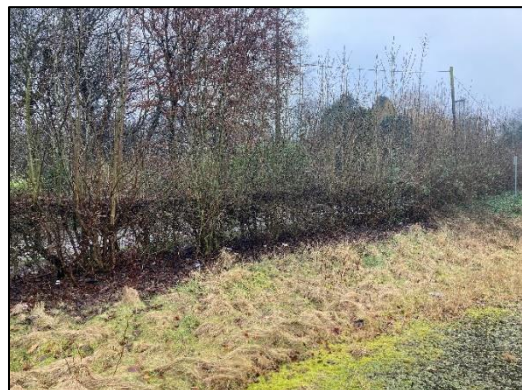
### 3.3.1.6. Defunct Hedge Species Poor

Along the southern site boundary there is a hedgerow that consists predominantly of hawthorn (*Crataegus monogyna*) and elder (*Sambucus nigra*) but also has some sapling ash (*Fraxinus excelsior*) and hazel (*Corylus avellana*) trees with bramble (*Rubus fruticosus*) and ivy (*Hedera helix*) tangled in the hedge. The adjacent photograph shows a section of the hedge.

5.3. It is recommended that the hedgerow along the southern site boundary is left undisturbed as part of the works. If the hedgerow will be affected by the works, the Local Authority must be contacted for further advice before the works to the hedge commence.

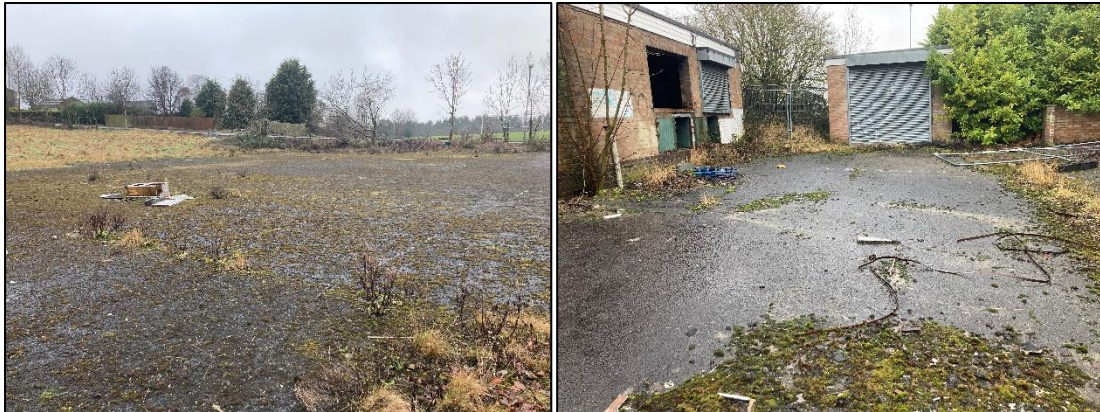
There are areas of bare ground scattered around the site that include a large tarmac area to the west, a tarmac and concrete parking area to the east and various tarmac and concrete paths linking the buildings. The photographs below show two of the areas of bare ground.

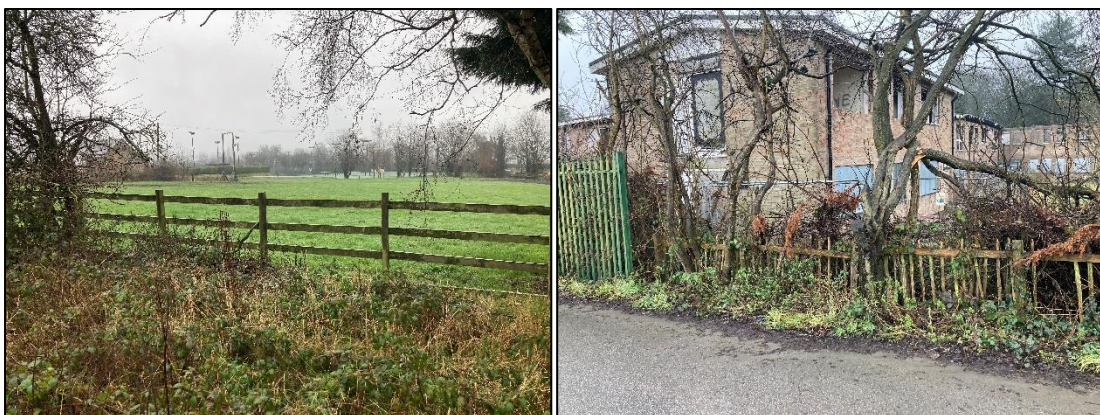
Within the surveyed area there are several fences that include Heras fencing, which has been erected around the buildings, timber lath fencing within a section of the hedgerow to the south, timber ranch fencing along the eastern site boundary and chain link and palisade fencing at the northeast corner of the site. The photographs below show three types of fence.

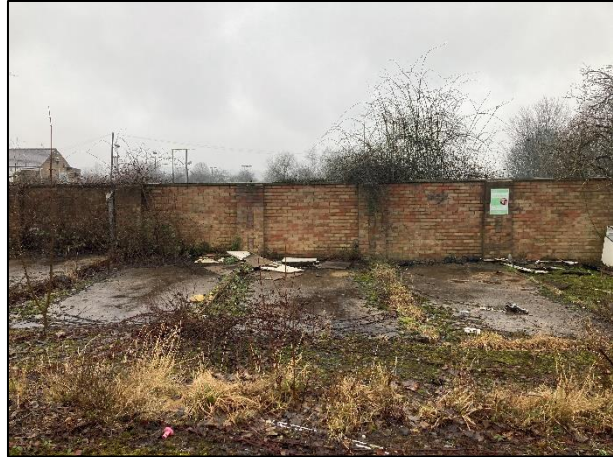
Three walls were identified within the surveyed area, a brick wall was located at the eastern end of the site, a stone wall at the southeast corner and two small brick walls either side of a small set of steps to the west of the buildings. The adjacent photograph shows the wall to the east.

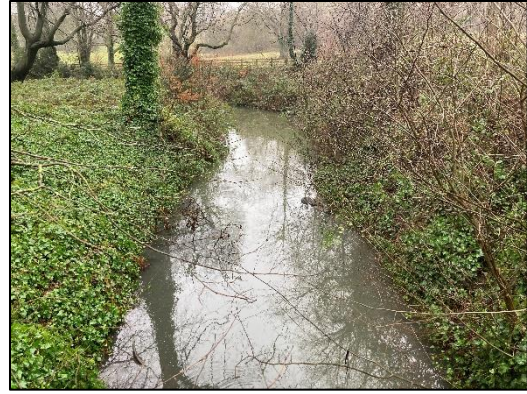
3.4.6.2. Pond 1 is a moat located within the woodland to the south of the site. The pond was given a HSI score of 0.7, Good. The adjacent photograph shows part of the moat.

5.9. It is recommended that an eDNA survey is carried out on Ponds 1, 2, 3 and 4. eDNA surveys involve taking water samples from the pond that are sent off for analysis to see if great crested newts are/ or have been present within the ponds.

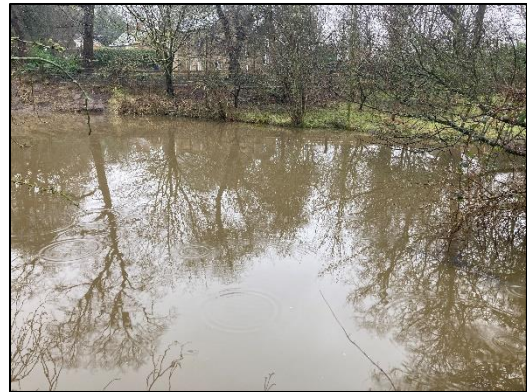
3.4.6.3. Pond 2 lies to the southeast of the site within a farm. The pond lies on the west side of a public footpath. The pond was given a HSI score of 0.68, Average. The adjacent photograph shows the pond.

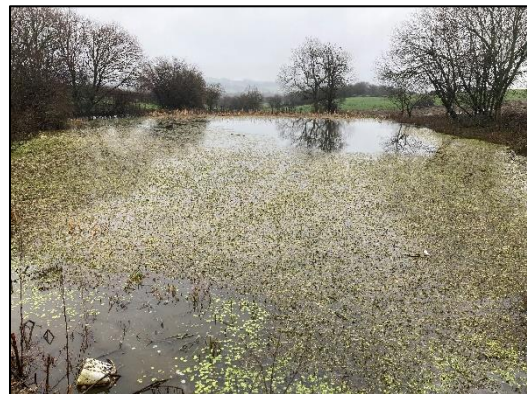
3.4.6.3. Pond 3 lies to the southeast of the site within a farm. The pond lies on the eastern side of the public footpath and is joined by flowing water to Pond 2. The pond was given a HSI score of 0.71, Good. The adjacent photograph shows the pond.

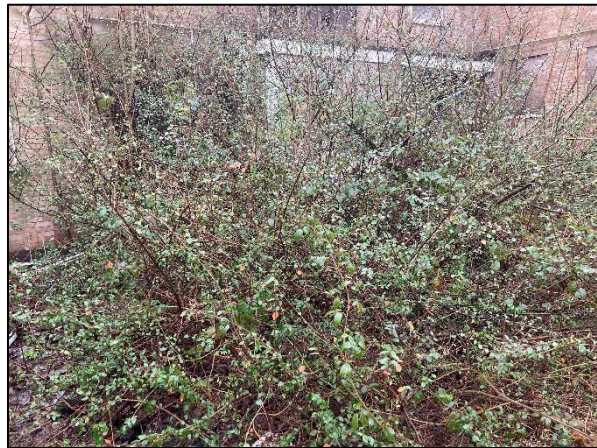
3.4.11. Cotoneaster is a non-native, alien, invasive, plant species, listed on Schedule 9 of the Wildlife and Countryside Act 1981. Cotoneaster was identified within the surveyed area adjacent to B4 and B5 and B5 and B6. The adjacent photograph shows the plant.
