WYAS
**Archaeological
Services**

Castle Hill
Almondbury
West Yorkshire

Archaeological Trial Trenching

Report no. 3211
December 2018

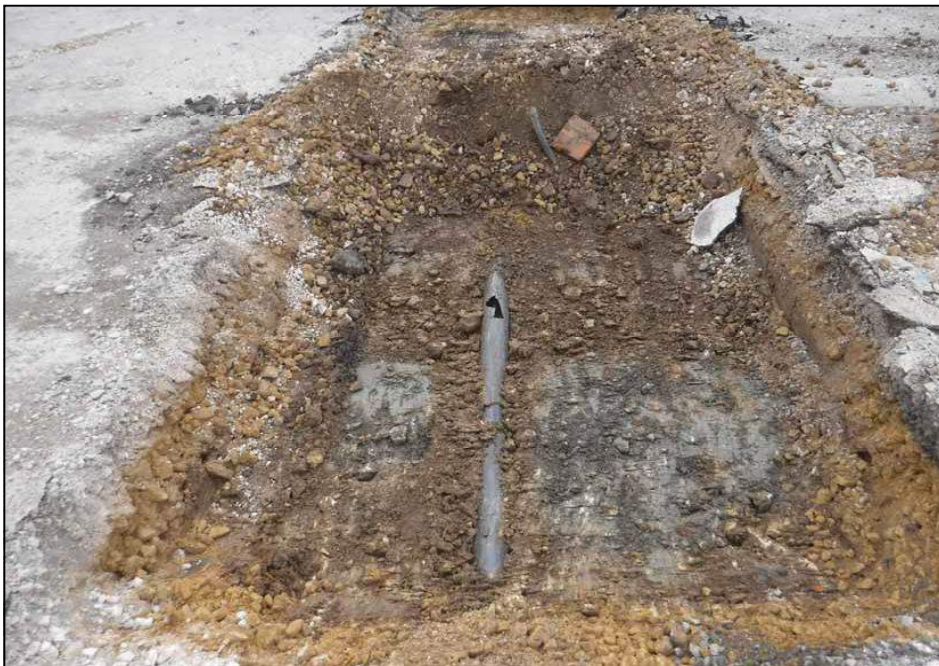
Plate 4. Plastic duct containing services 005 in Trench 1, looking southwest

Along the axis of the trench, these deposits were disturbed and truncated by modern service placements: plastic ducting within a trench which ran southwest from the northeast end of the trench (005; Plate 4). Layer 004 also provided indications of a feature cut (006), filled with a less stony grey-brown silty clay (007; Plate 5), but this failed to materialise as an archaeologically significant feature and its fill was devoid of any finds or environmental material (Sample 1). Layer 004 lay directly above the natural (000), which comprised a sandy clay with inclusions of small to medium sandstone fragments. The natural was tested via a sondage (Fig. 7.1), and bedrock was reached at a depth of 1.18m. A silted-up brick-lined culvert (022; Plate 6) was seen cut into the natural towards the northeast of the trench at a depth of 1.10m. The silted fill of the culvert (042) was sampled for datable material (Sample 2) but only modern seeds were recovered.

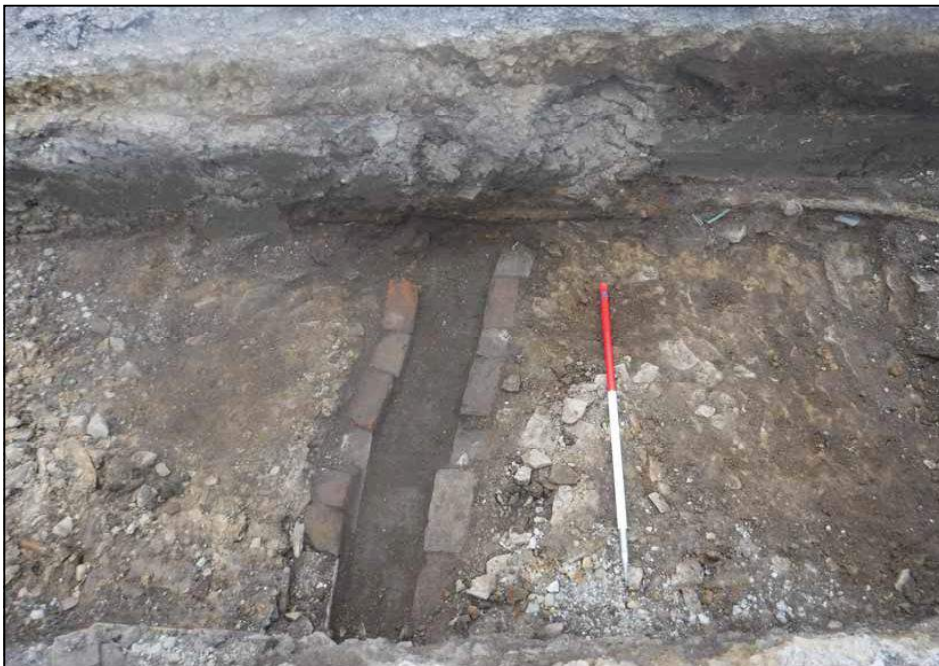
Plate 6. Brick culvert 022 in Trench 1, looking north

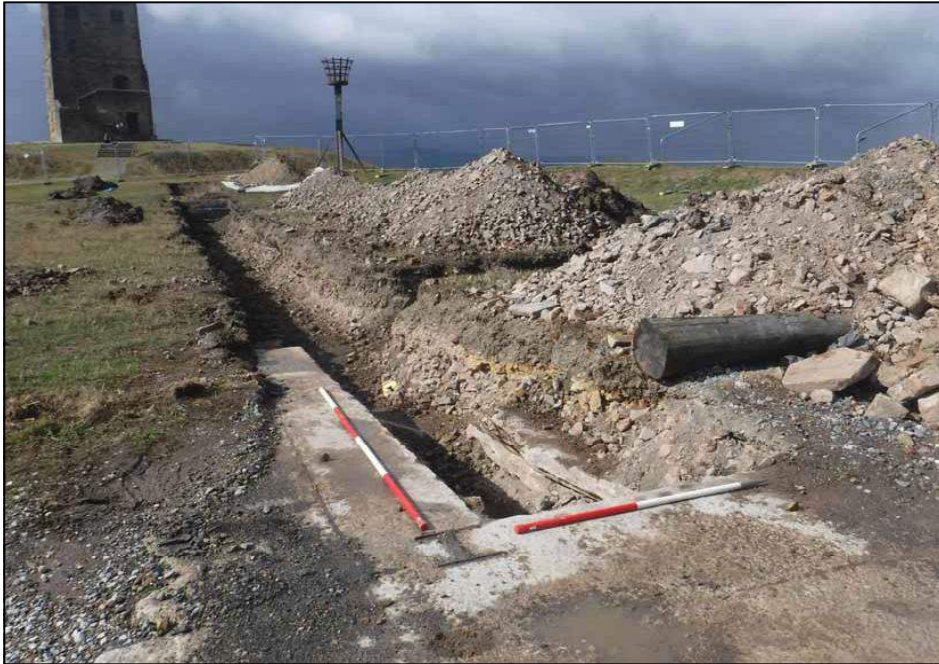
Plate 7. Concrete base for cellar superstructure in Trench 1, looking northwest

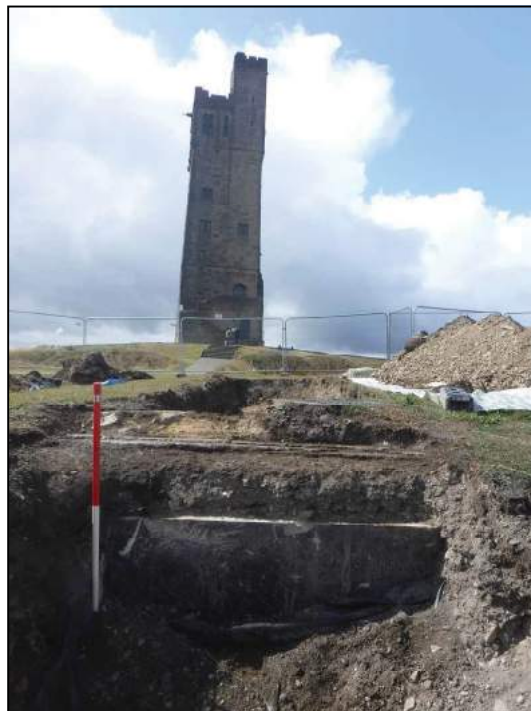
Plate 8. Southwest cellar wall in Trench 1, looking southwest

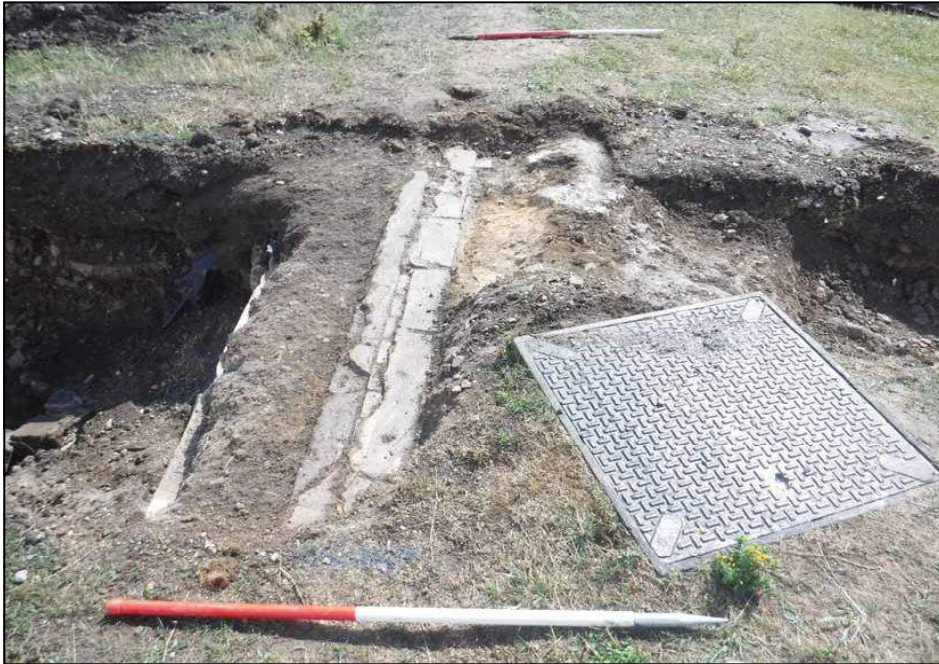
Plate 9. Manhole and cellar wall in Trench 1, looking southeast

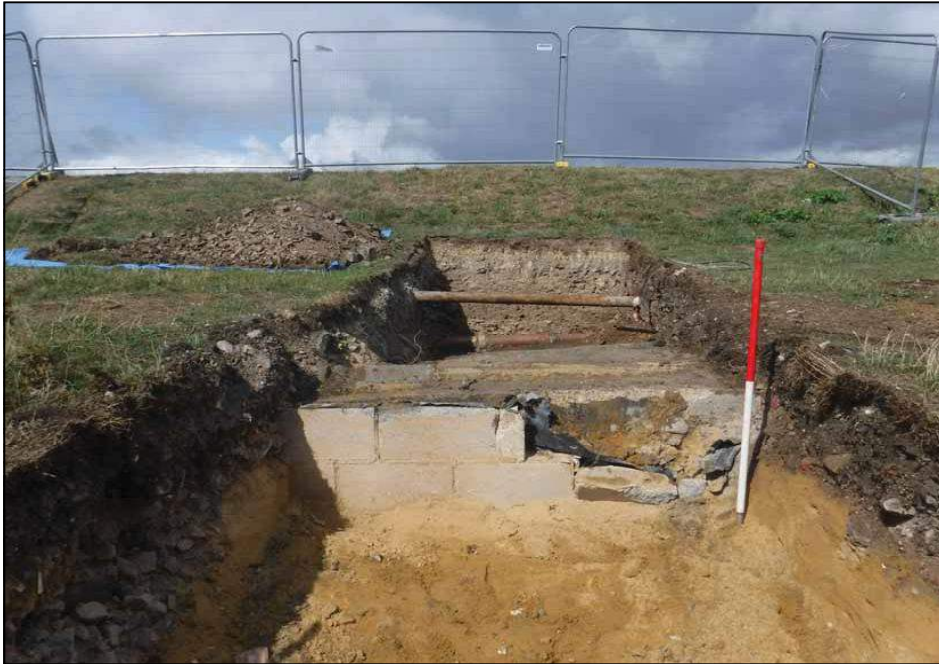
Plate 11. Block walling forming northwest side of Cellar 014 in Trench 2, looking northwest

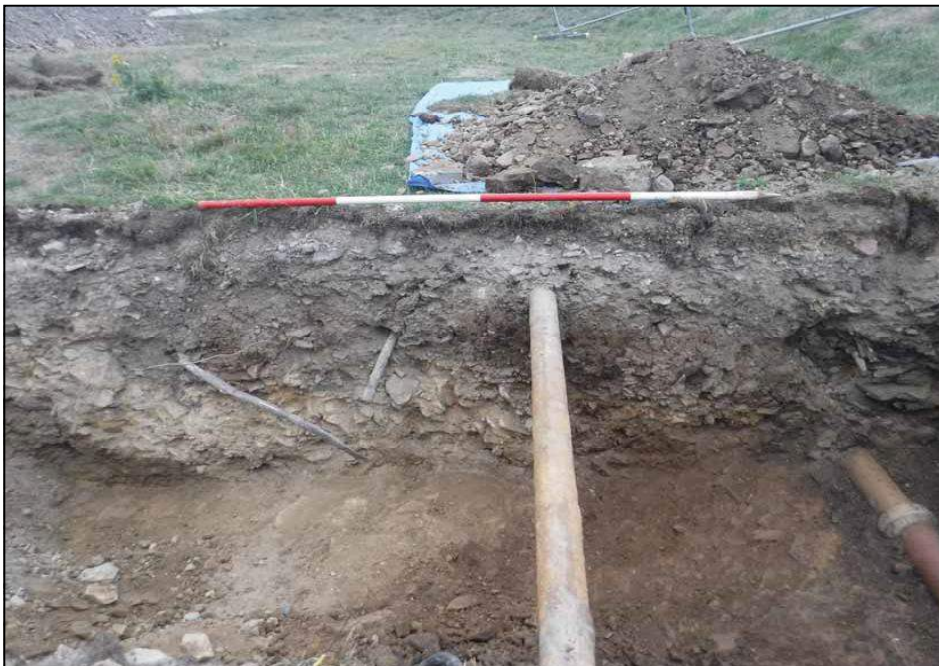
Plate 12. Services in section in Trench 2, looking southwest

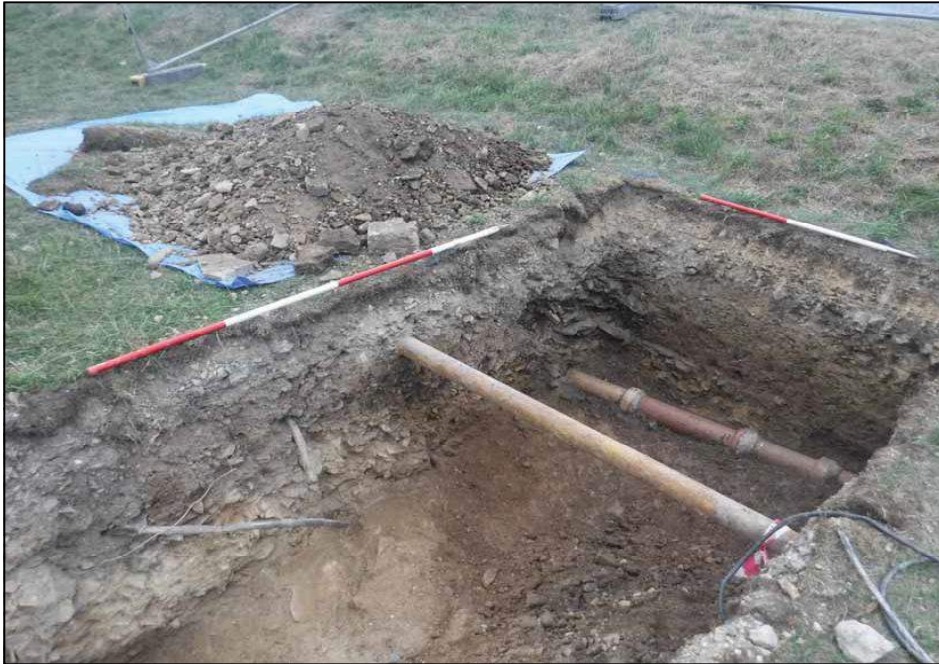
Plate 13. Service pipes in Trench 2, looking northwest

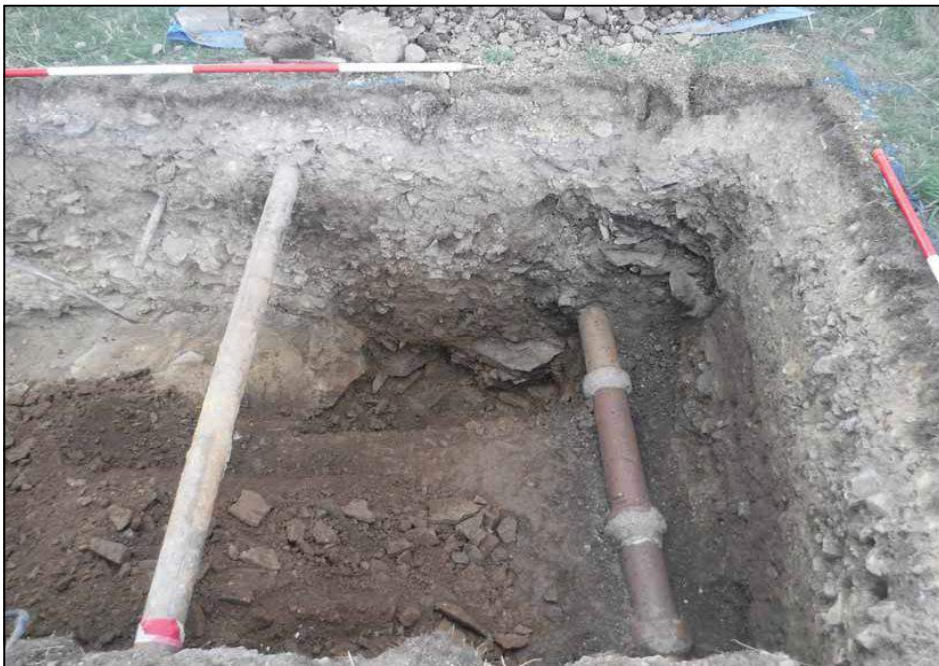
Plate 16. Cut feature 029 re-cut by service trenches in Trench 2, looking southwest

In any case, a much deeper feature, marked by cut 029, preceded all the cut features described above (Plate 16 and 17). It had been cut through natural gravels and shales to a depth of about 0.8m, and it may originally have been about 2m wide or more. Its primary fill (028) was a mid-brown clayey silt from which sample 004 was taken (see below), and above it was a fairly similar material (033). Above this was a more compacted layer of silt and stones (032) which may, as noted above, have been the fill of the trench containing the cast-iron pipe, rather than the fill of this deeper and earlier cut.

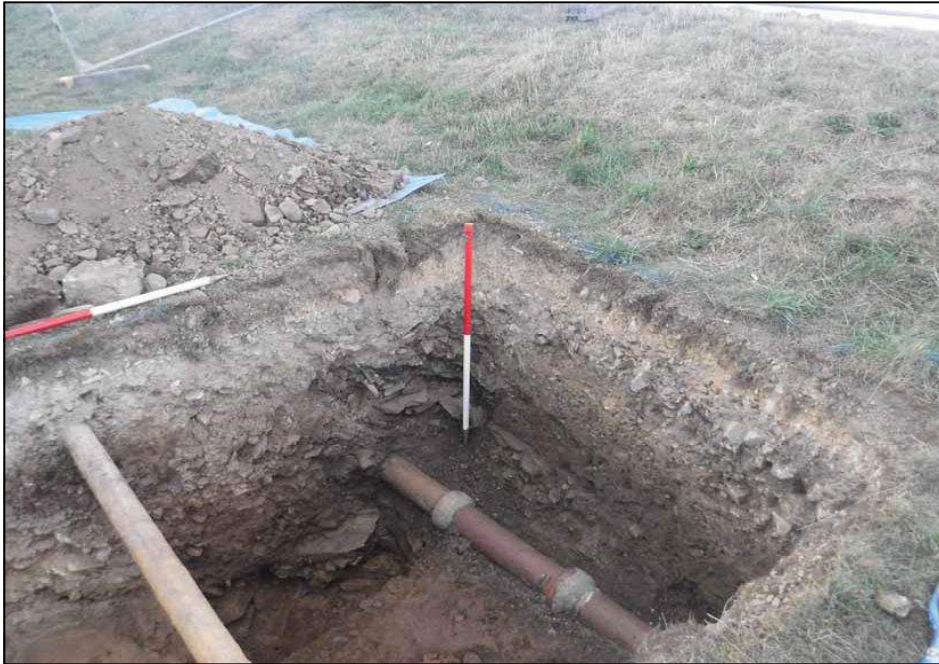
Plate 17. Cut feature 029 re-cut by service trenches in Trench 2, looking west

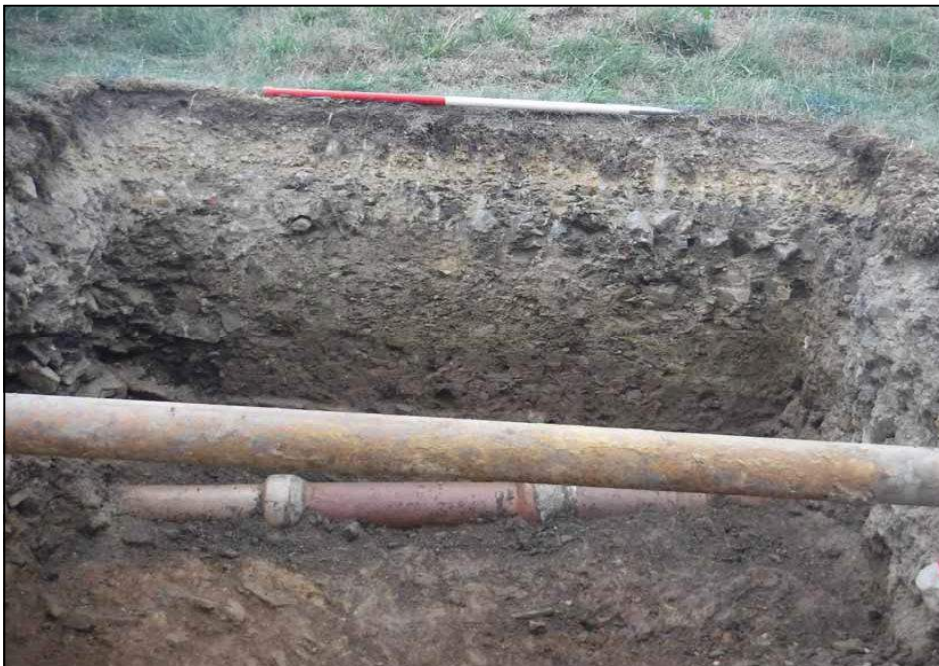
Plate 18. Service pipes and northwest end of Trench 2, looking northwest

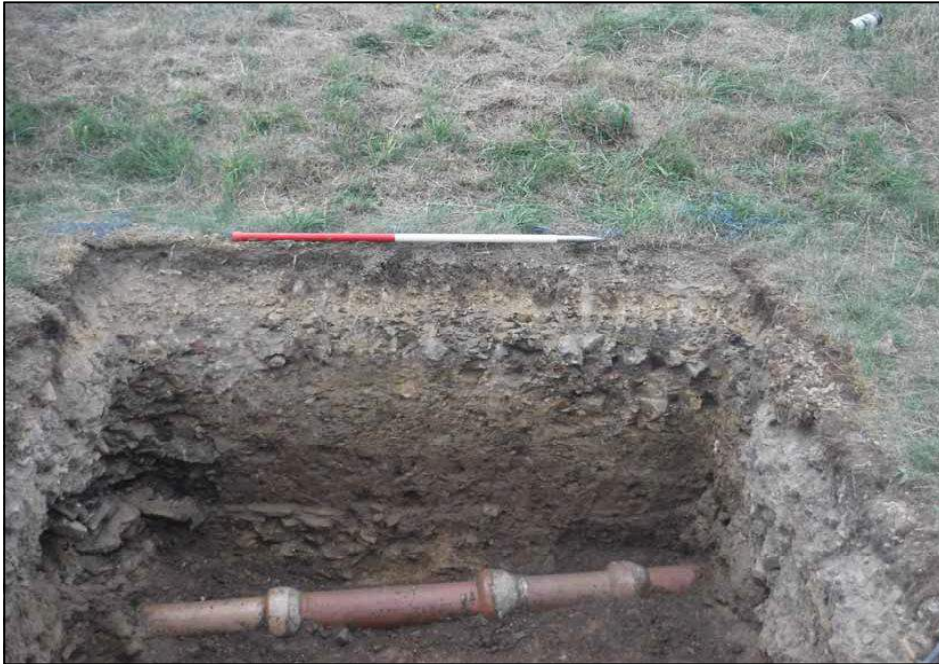
Plate 19. Lower level pipe at northwest end of Trench 2, looking northwest

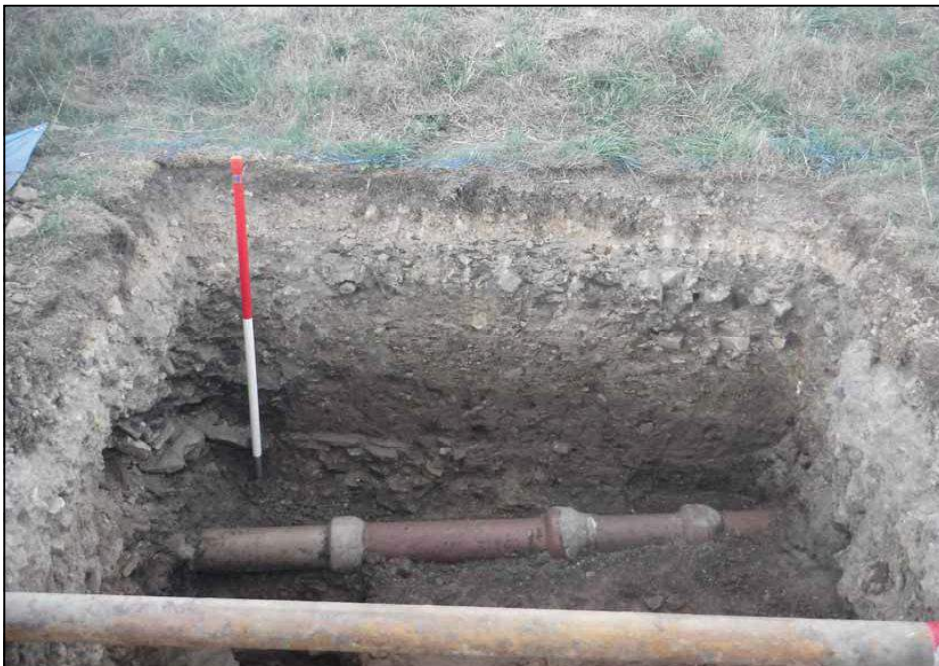
Plate 20. Stratigraphy at northwest end of Trench 2, looking northwest

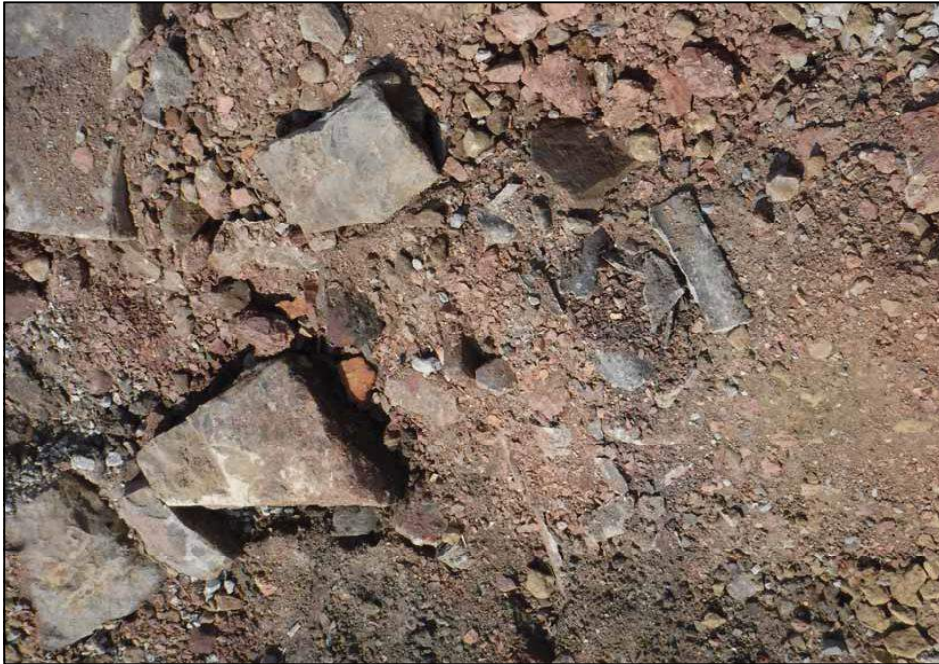
Plate 21. Detail of ACM roof sheeting deposit 002, Trench 3

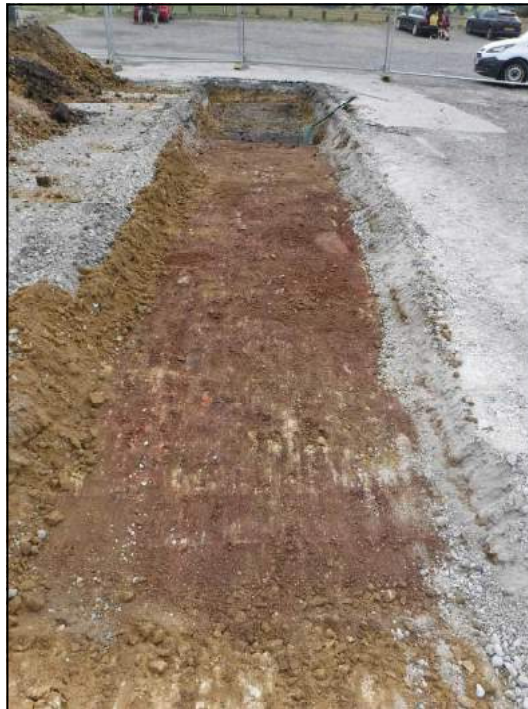
Plate 24. Crushed brick and stone surface 002 and dark grey silty clay layer 003 in Trench 3, looking southeast

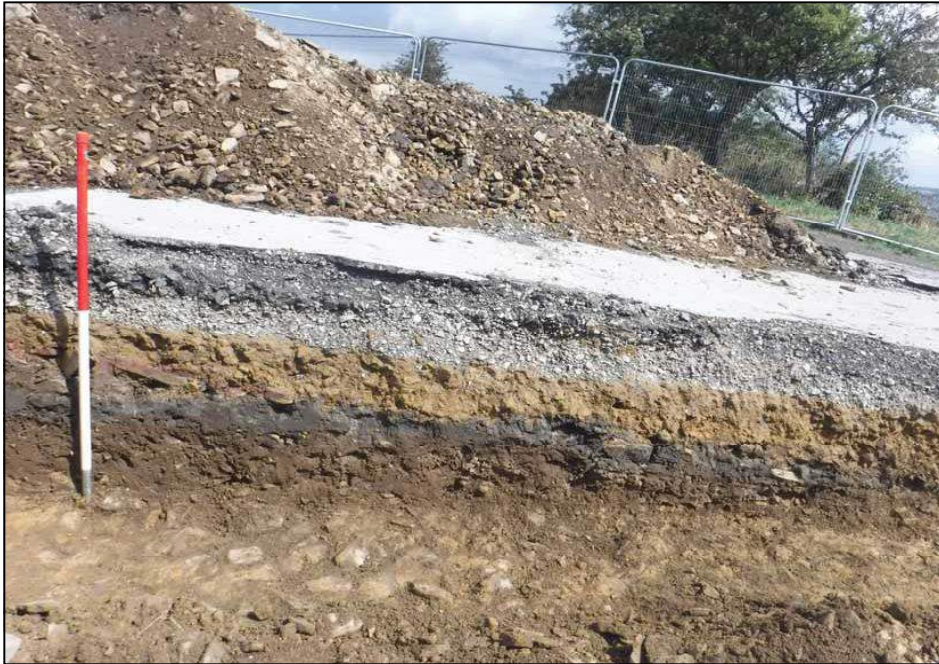
Plate 27. Southwest side of Trench 3, showing natural silty clay and sandstone fragments at base, looking northeast
