PHASE 2 GEOENVIRONMENTAL APPRAISAL  
HEATON AVENUE, CLECKHEATON  
for  
Planned Contracts Ltd

October 2017

<b>H17074</b>	<b>Phase 2 Geoenvironmental Appraisal, Heaton Avenue, Cleckheaton</b>
---------------	---

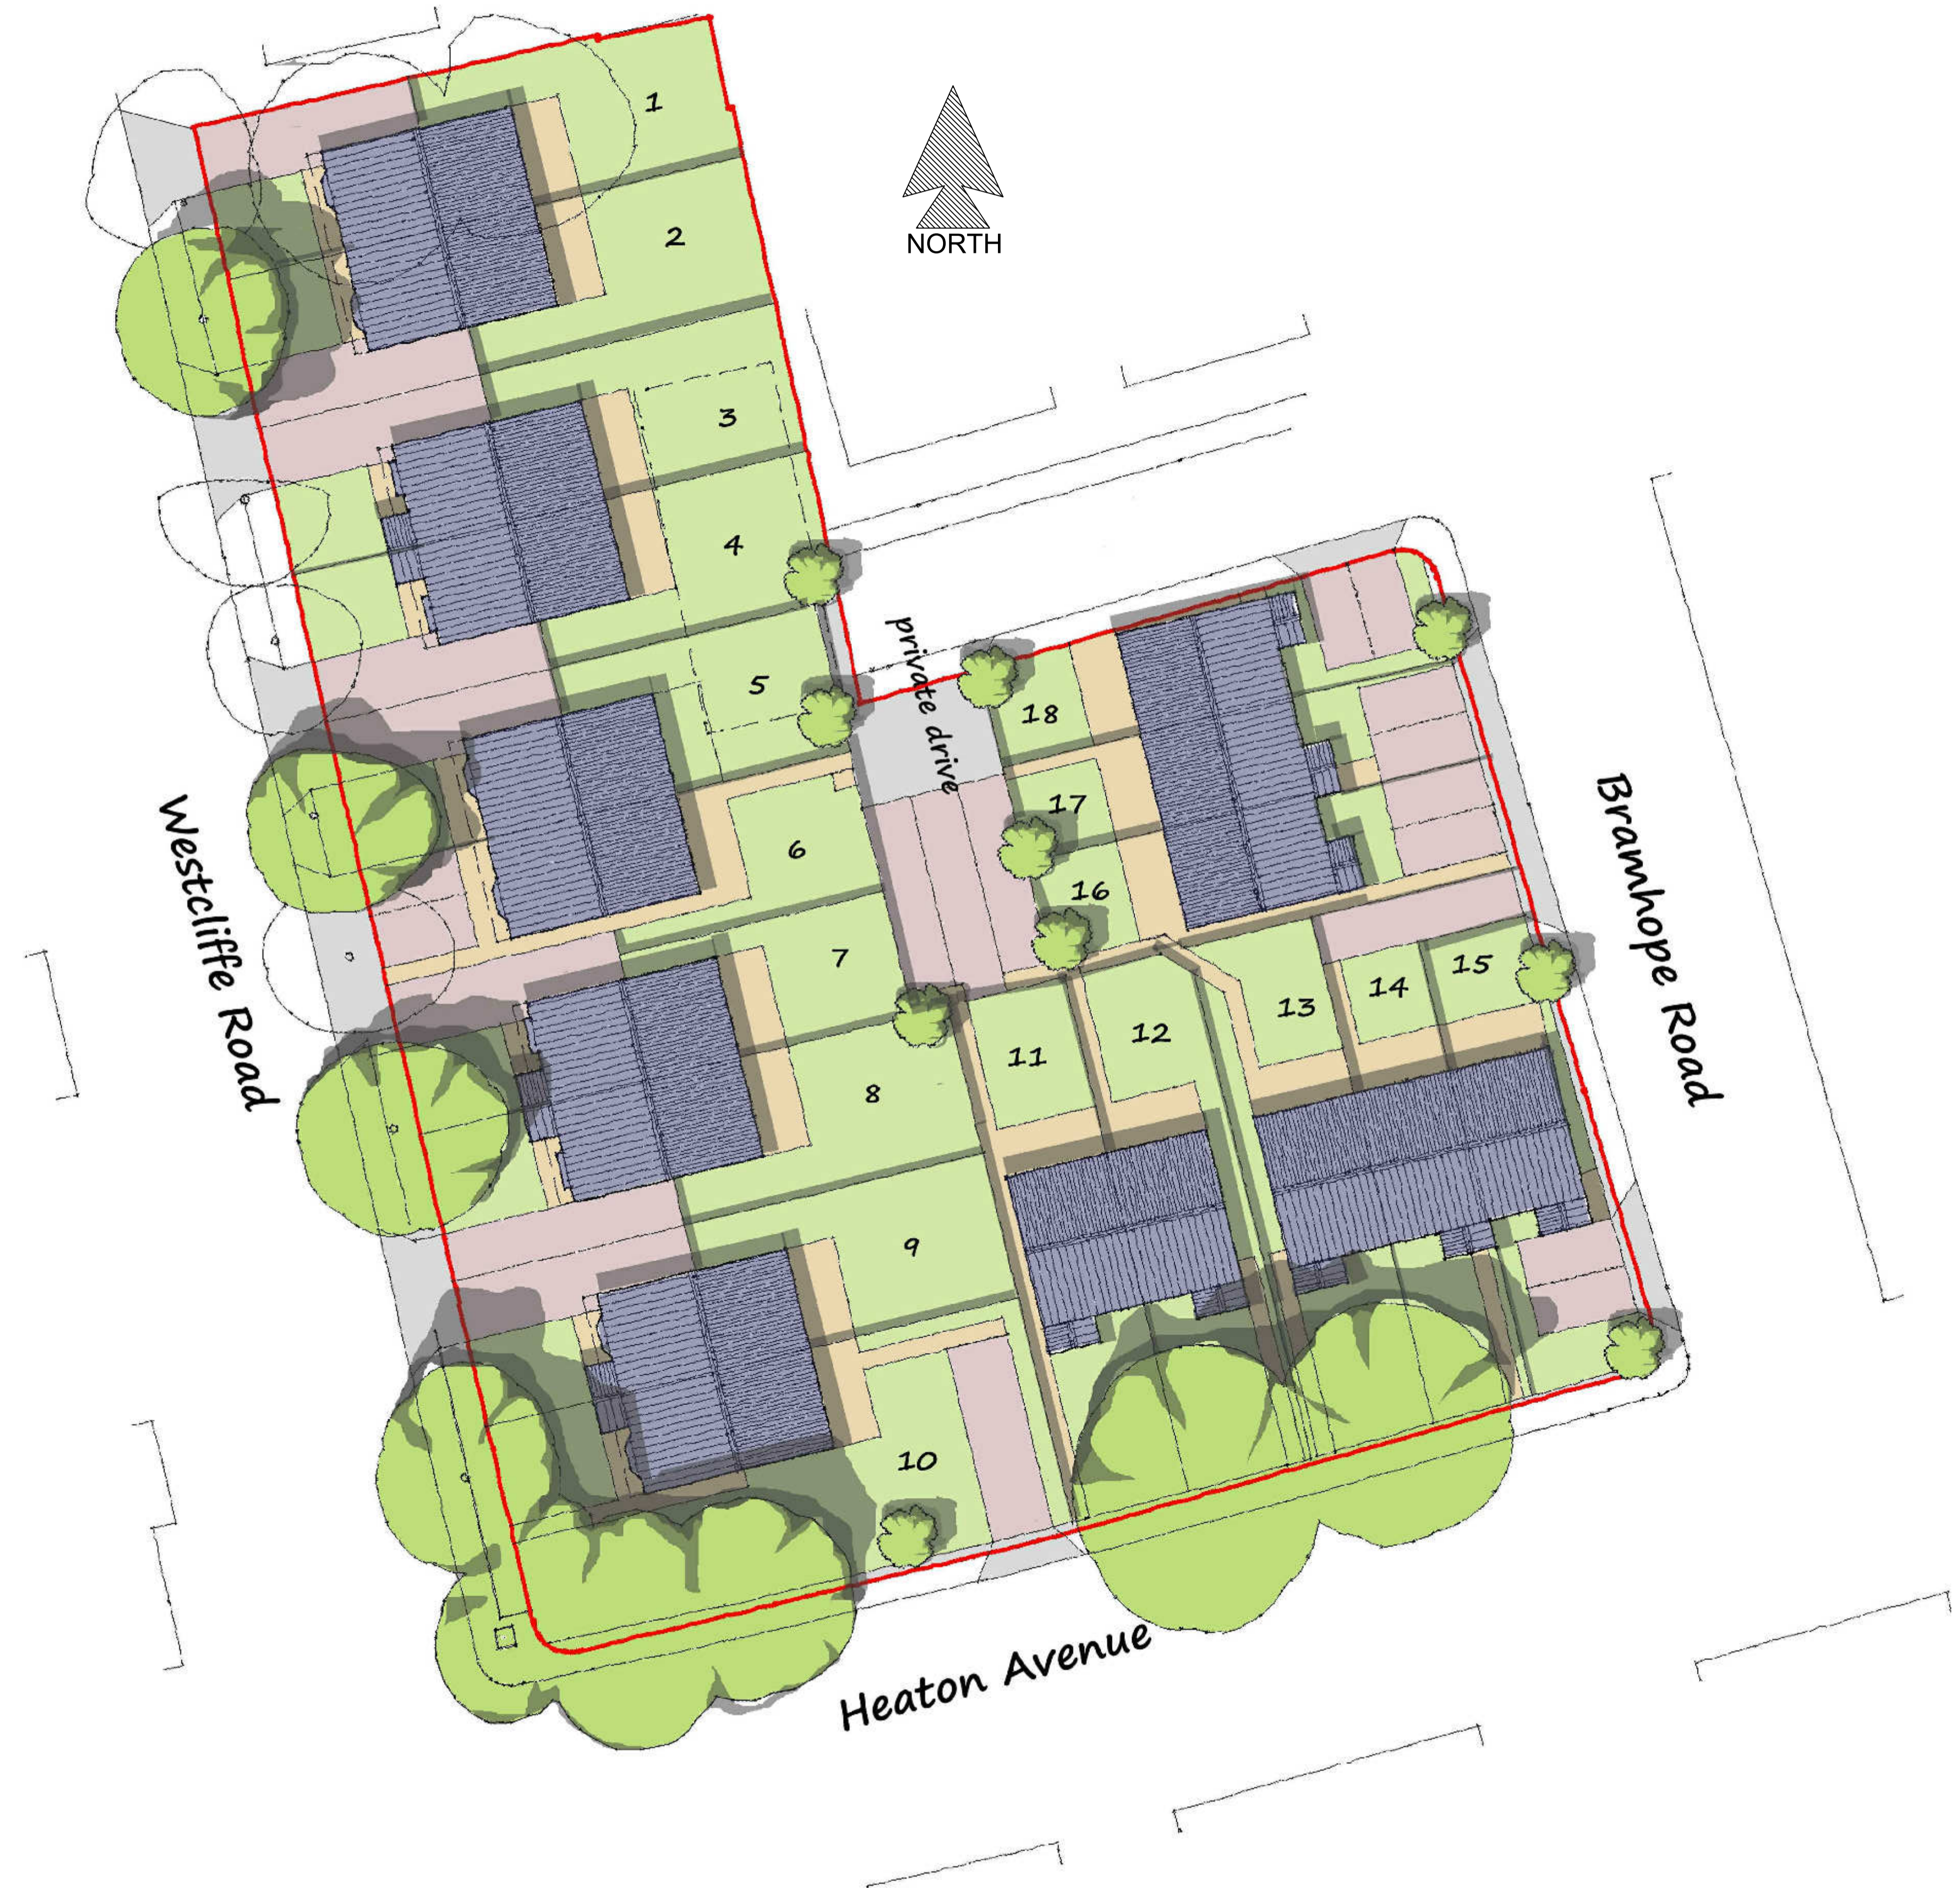
Key			
Plot No.	Type	sqm	sqft
1	semi	89.0	957.64
2	semi	89.0	957.64
3	semi	90.78	976.79
4	semi	90.78	976.79
5	semi	89.0	957.64
6	semi	89.0	957.64
7	semi	90.78	976.79
8	semi	90.78	976.79
9	semi	90.78	976.79
10	semi	90.78	976.79
11	semi	89.0	957.64
12	semi	89.0	957.64
13	end tce	72.53	780.42
14	mid tce	72.53	780.42
15	end tce	72.53	780.42
16	end tce	72.53	780.42
17	mid tce	72.53	780.42
18	end tce	72.53	780.42
Totals		1,480.92	15,934.70

It is understood that PCL propose to construct 15 no. low rise semi-detached and terraced residential properties with gardens and drives on the site. A proposed site layout plan by Chris Finn Architect, Dwg. No. 2587-01-01F April 2017 is presented in Appendix A.

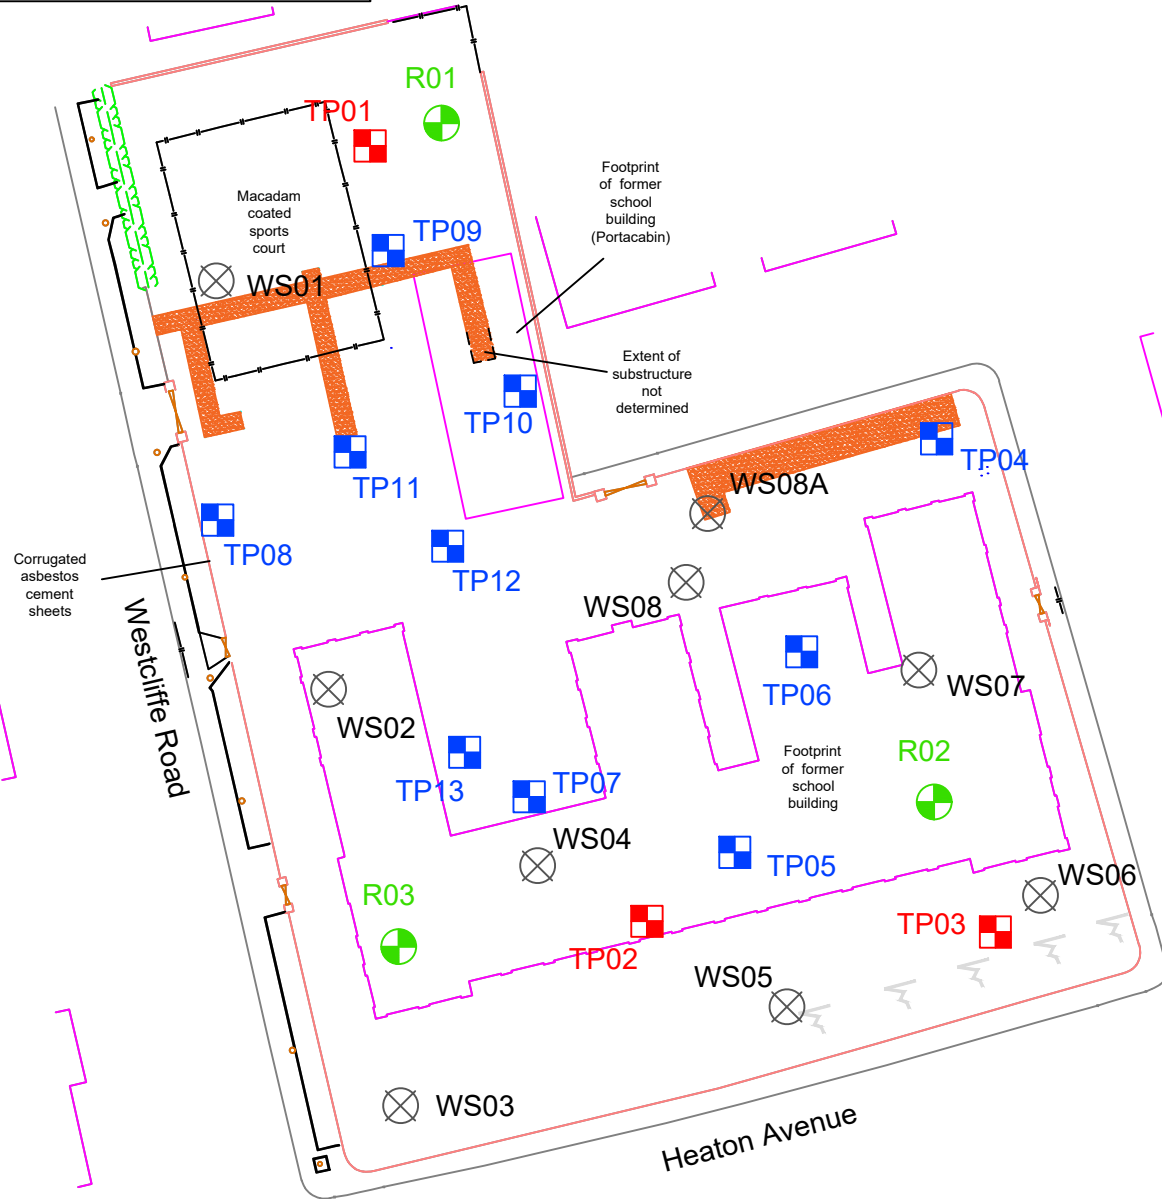
- TP01 - Trial Pit (Infiltration test)
- ⊗ WS01 - Mini Percussive Borehole
- TP04 - Trial Pit
- ⊕ R01 - Rotary Openhole
- Approximate extent of underground air raid shelters (as determined by intrusive investigation)

A plan showing the location of the exploratory holes is included as Drawing No. H17074-703 in Appendix A and copies of the exploratory hole records are provided in Appendix B.

Evidence of buried substructures (former WW2 air raid shelters) was recorded within the central northern and eastern parts of the site (TP04, TP09, TP10 and WS08A). These structures were generally constructed to between 2.2 and 2.6m begl, linear (approximately 2.5m wide externally) and of concrete and brick construction. The concrete roof slab was noted as reinforced and between 100 and 250mm thickness.
