**DRUB LANE BARN, GOMERSAL.**

**BAT SURVEY.**

**Ref No:- 130803.**

**Date: 8<sup>th</sup> August 2013.**

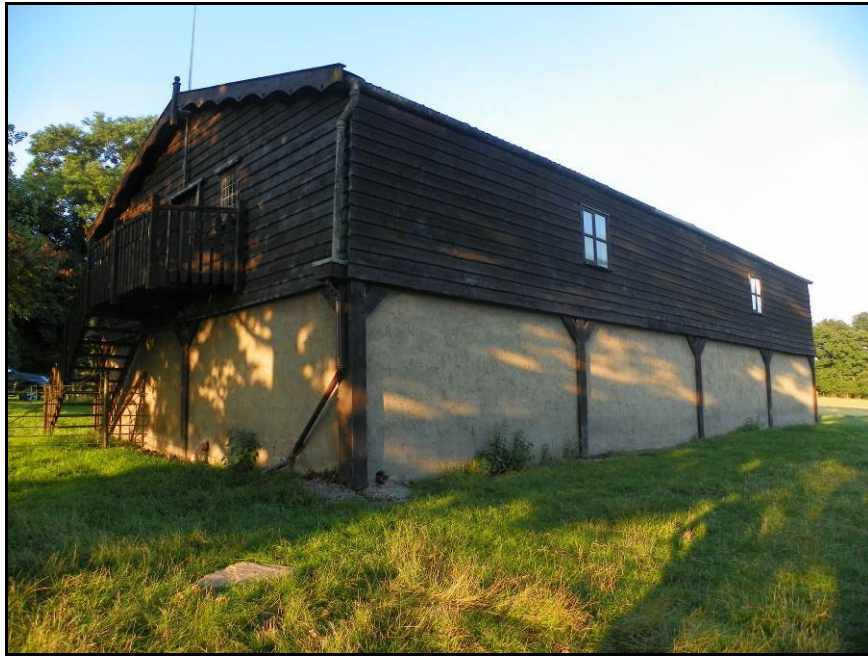
3.2.3. The barn is a tall, single storey structure, Building A, as shown in the photograph below.

3.3.2. Building A is a metal framed barn with block work lower walls, rendered on the outside and with timber cladding to the upper walls. The roof is pitched and cement sheet covered with ridge ventilators.

3.3.3. The walls and the roof have been well maintained and there are no opportunities for roosting bats, except in the roof ventilators. These could not be closely inspected to determine whether they were meshed internally but they are quite large and therefore very unlikely to provide a protected roost site for bats.

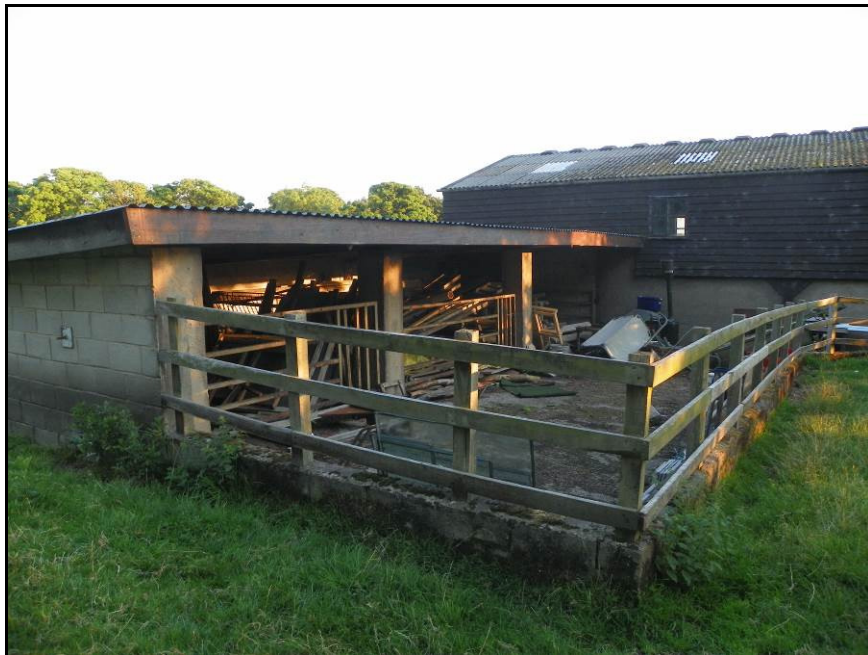
3.2.4. On the north eastern side there is a further single storey building, Building B, used as a storage area, as shown below.

3.3.6. Building B is a single storey, open fronted building with solid block work walls and a mono pitched roof covered with corrugated metal sheets, used for storage. No bat roosting opportunities were identified in this building and no bats or bat field signs were found.

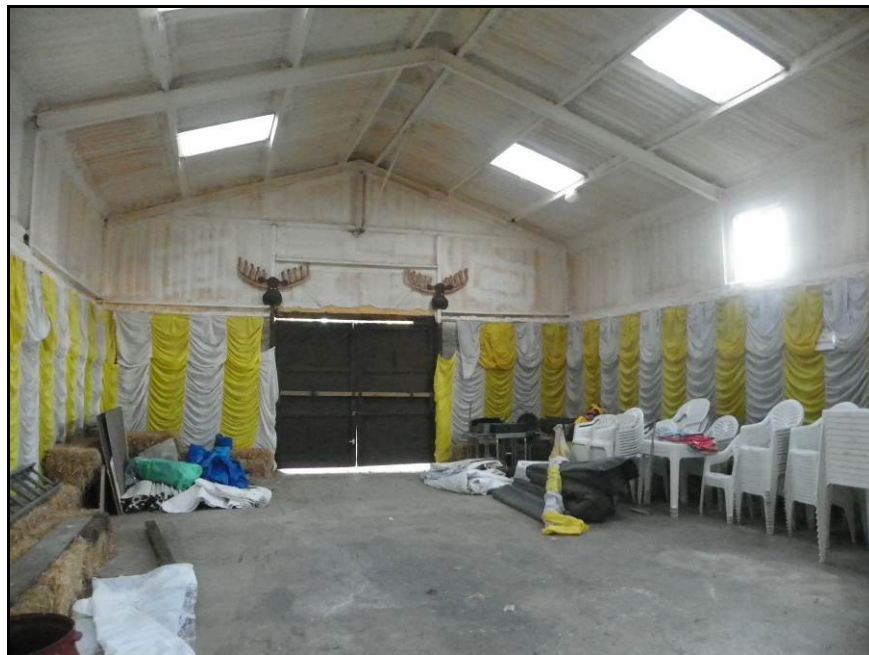
3.3.4. Internally the building has a mezzanine floor at the western end accessed from inside and by an external staircase. The whole of the inside has been sprayed throughout with a thick layer of insulation material. This effectively seals the inside completely including the eaves and the ventilators.

3.3.5. No bats or bat field signs were identified anywhere inside or outside the building and the building was assessed to have minimal bat roosting potential.

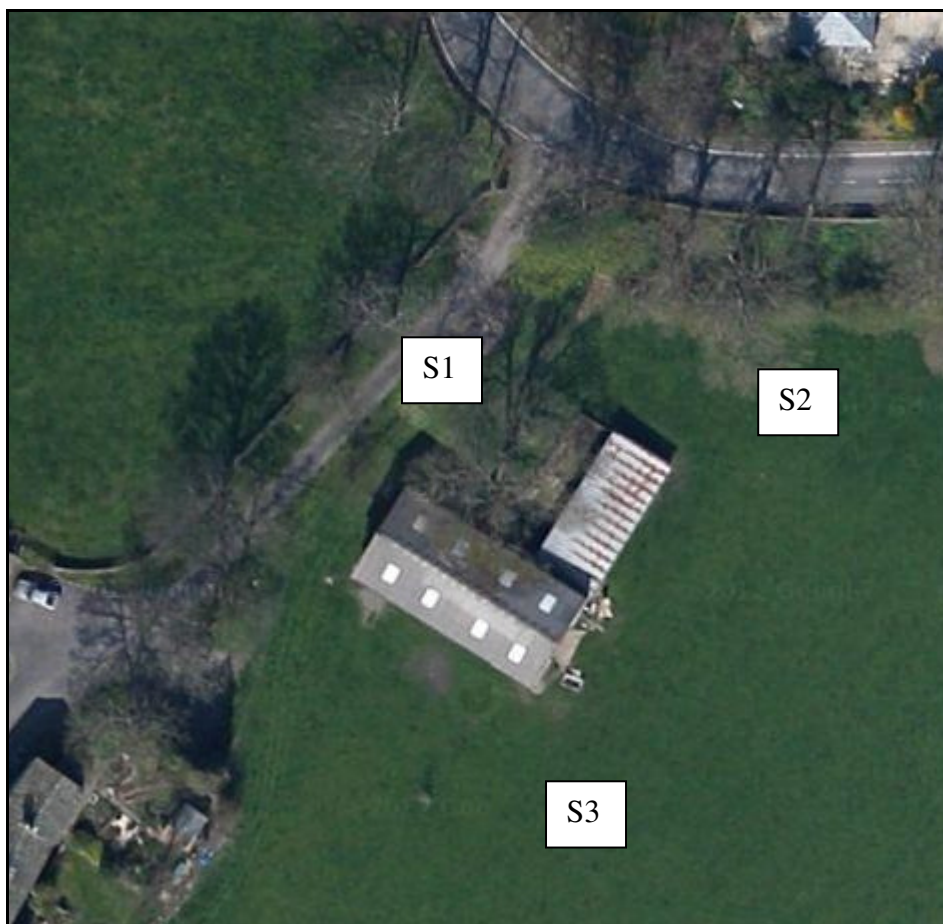
3.4.2. The surveyors were positioned to be able to view all sides of the building simultaneously as shown on the aerial photograph below. Anabat recorders were placed with each surveyor.
