## PRELIMINARY BAT ASSESSMENT

1 OUZELWELL LANE, DEWSBURY, WF12 9EP

Report Reference: AE17.216  
November 2017

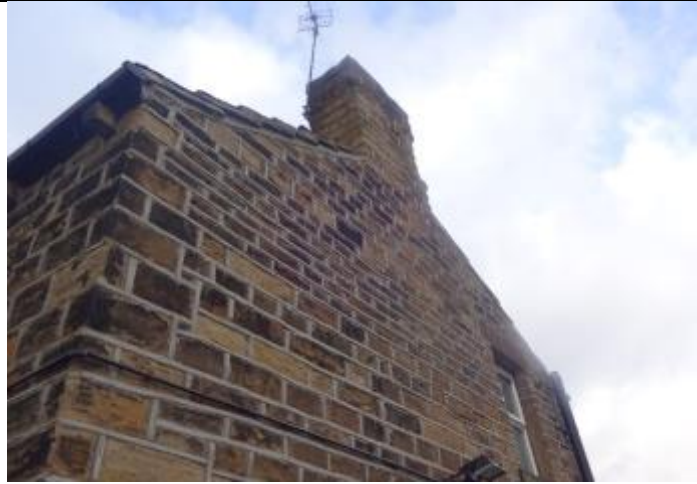
**Eastern Elevation**

The eastern elevation walls were in good condition with no obvious PRFs.

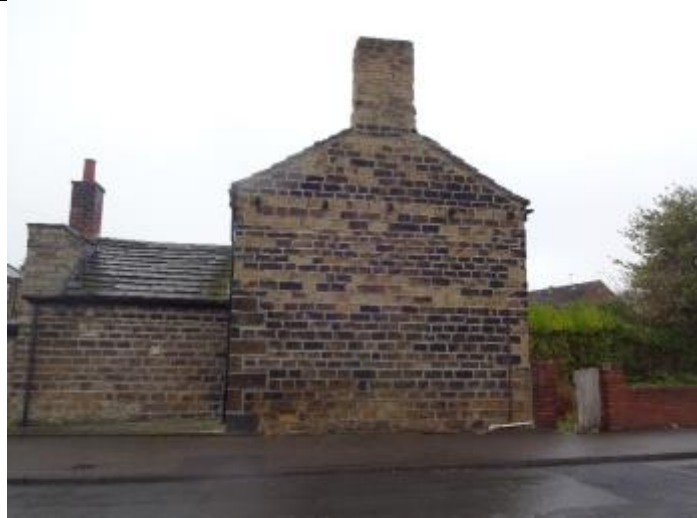
**Western Elevation**

The external walls at the western elevation were in good condition with no obvious PRFs.

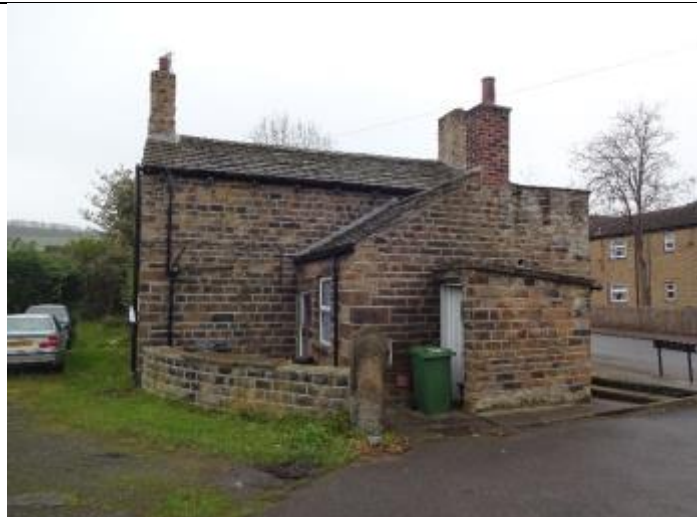
**Northern elevation**

The northern elevation featured a one storey extension.

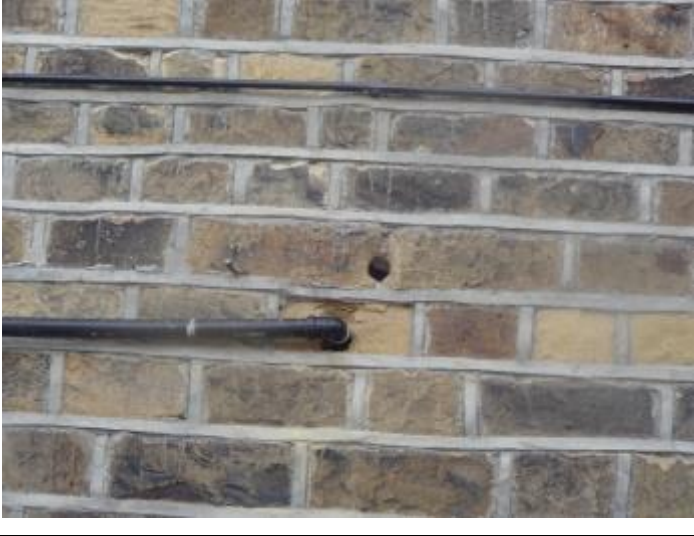
<p><b>Northern Elevation</b></p> <p>A hole was present between brickwork at the northern elevation, assessed as a Low PRF.</p>

- The building was overall assessed to have 'Moderate Potential' to support roosting bats. The proposed plans indicate that the low and moderate potential roosting areas will be destroyed. To avoid potential infringement of legislation (see below) and impacts to bats, 1x Dusk Emergence survey and 1x Dawn Re-entry survey are required between May and September (inclusive) in accordance with Bat Conservation Trust Guidelines to either; prove likely absence and allow works to proceed, or in the event bats are found using the building, to provide information for specific mitigation.

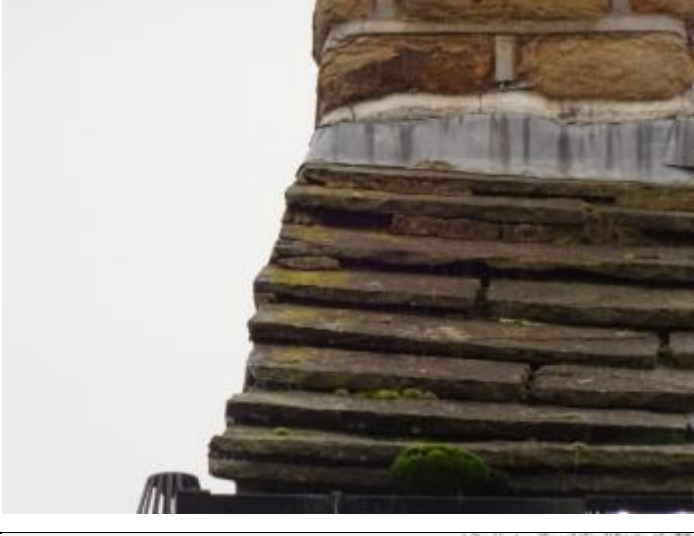
A close-up photograph of a brick wall. A small, dark, circular hole is visible in the mortar joint between two bricks. A black pipe or rod is visible running horizontally across the wall below the hole.
<p><b>Northern elevation</b></p> <p>Close-up of gaps between roof tiles at the eastern end of the northern roof elevation, assessed as moderate PRFs.</p>

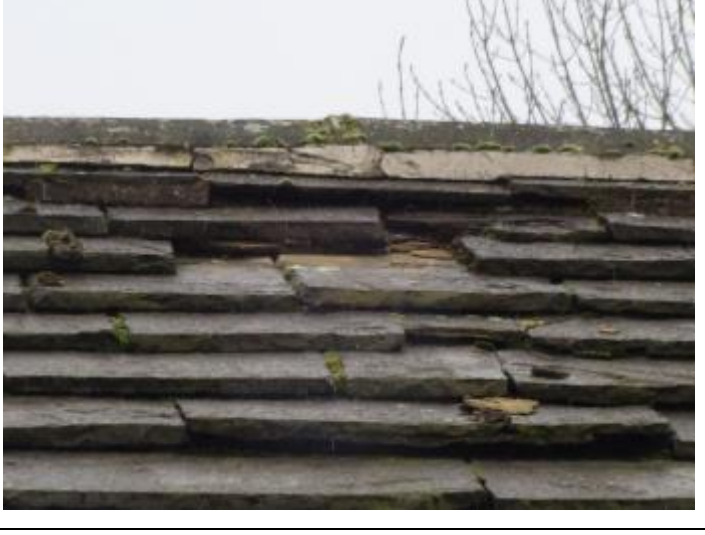
A close-up photograph of the edge of a roof. Several dark, rectangular roof tiles are visible, showing significant gaps between them. Some moss is growing on the tiles.
<p><b>Northern elevation</b></p> <p>Example of large gaps due to missing tiles and cracks in ridge tiles on the northern elevation roof.</p>

A photograph of a roof ridge. The ridge tiles are dark and show large gaps between them. Some tiles appear cracked or missing. Moss is visible growing on the tiles.

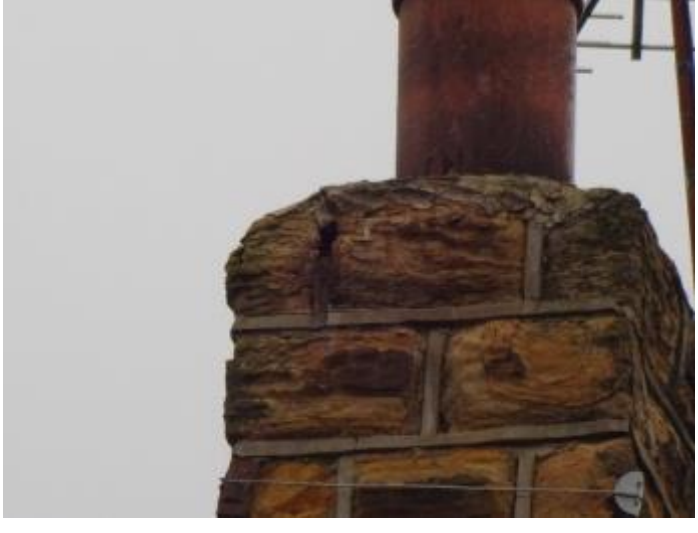
<p><b>Northern elevation</b></p> <p>A Low PRF gap was present on the eastern chimney stack at the northern elevation.</p>

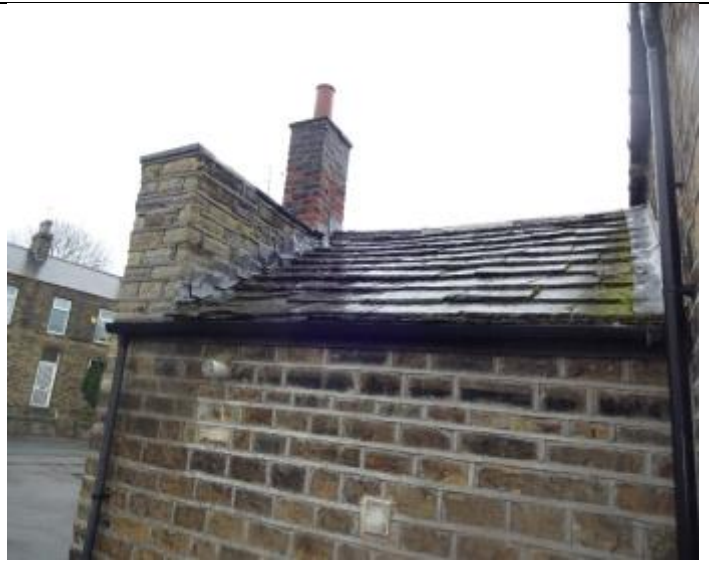
### **Extension**

The roof of the one-storey extension featured several lifted tiles at both elevations, presenting Low PRFs. Pictured here at the western elevation.

The internal roof of the extension was not accessible.
