# **GEO-ENVIRONMENTAL PHASE 1 DESK STUDY**

**Greenside Mills**

**SAVILLE ROAD  
SKELMANTHORPE  
HUDDERSFIELD  
HD8 9EE**

**Project ref: 163-11**

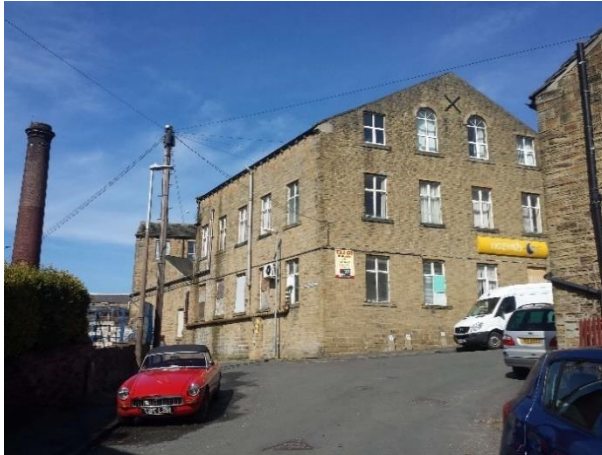
1

| Photo No. | Site Area | Observations and potential sources |
|---|---|---|
| 1. | Junction of Saville Rd., Marsden St. | Assumed office building. Visible site incline. |

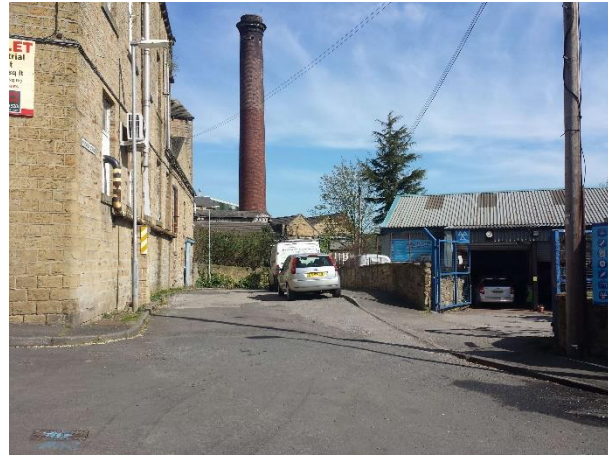
2

| Photo No. | Site Area | Observations and potential sources |
|---|---|---|
| 2. | Marsden St. | Motor vehicle repair garage on lower ground than the adjacent site building. |

The motor repair garage and former gasworks (see section 3.2) to its rear are both situated on land topographically lower than buildings on the Site. However, the vegetated area close to the railway is lower than these and so more vulnerable to the impacts of any historical contamination if present.

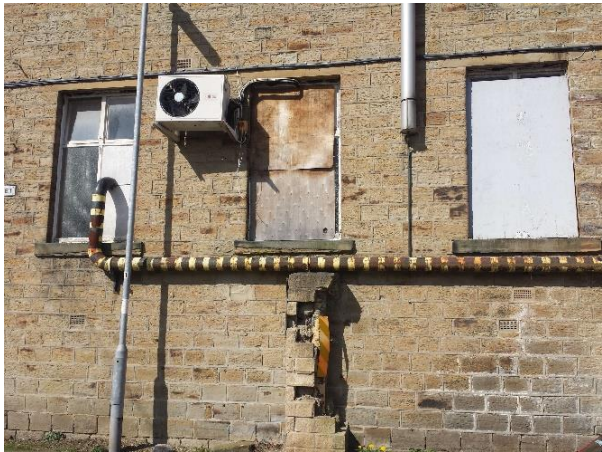
3

| Photo No. | Site Area | Observations and potential sources |
|---|---|---|
| 3. | Marsden St. | Gas supply/main. |

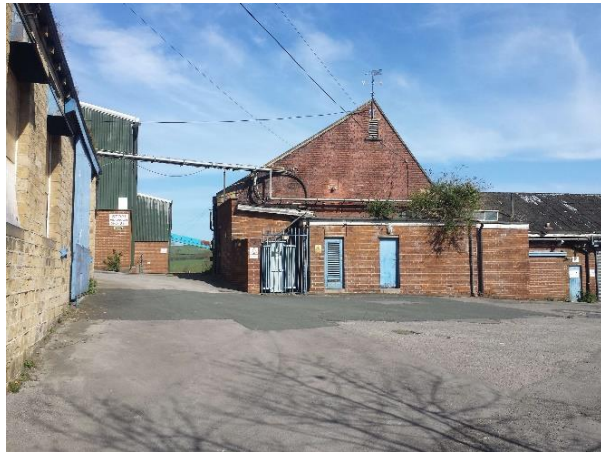
4

| Photo No. | Site Area | Observations and potential sources |
|---|---|---|
| 4. | End of Marsden St. | Electricity substation. No sign of seepage/spillage observed. |

There were no signs of leakage from the tank and electricity substation at the head of Marsden St.

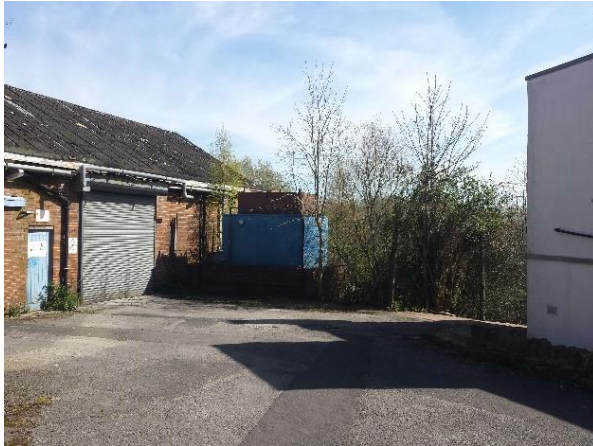
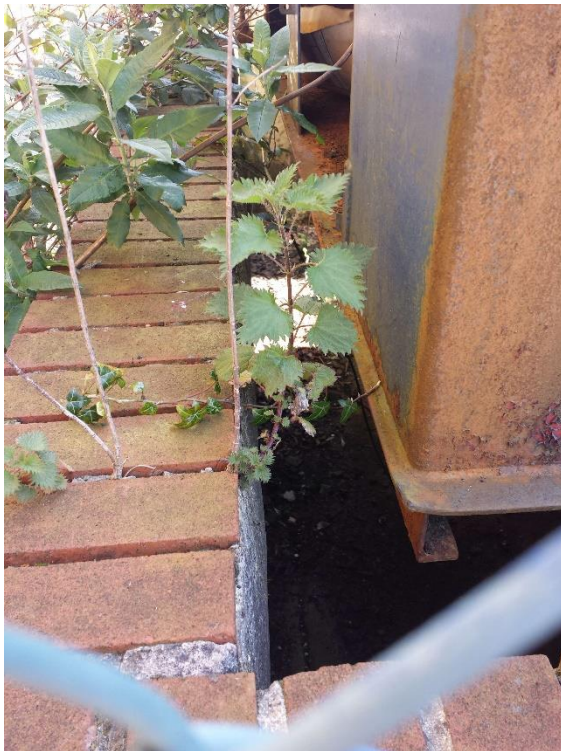
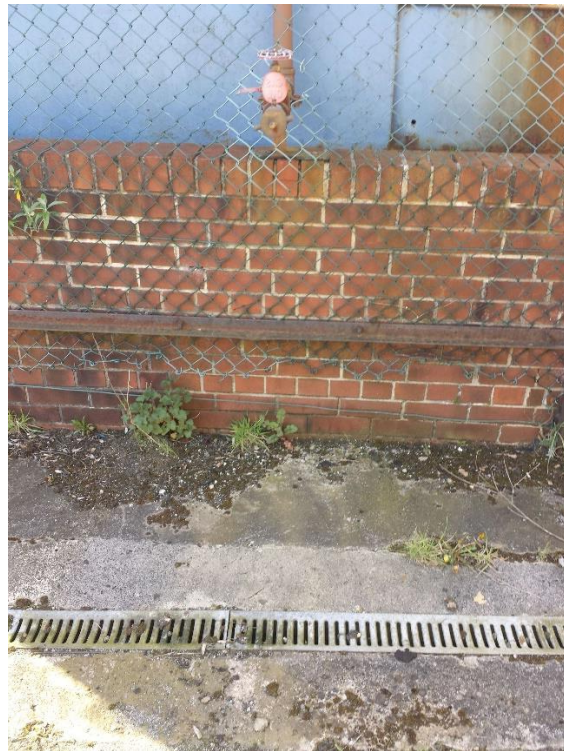
| Photo No. | Site Area | Observations and potential sources |
|---|---|---|
| 5, 6, 7. | As above. | Double-bunded tank. No sign of seepage/spillage observed within outer brick bund. Close proximity of pipe coupling to surface water drainage. |

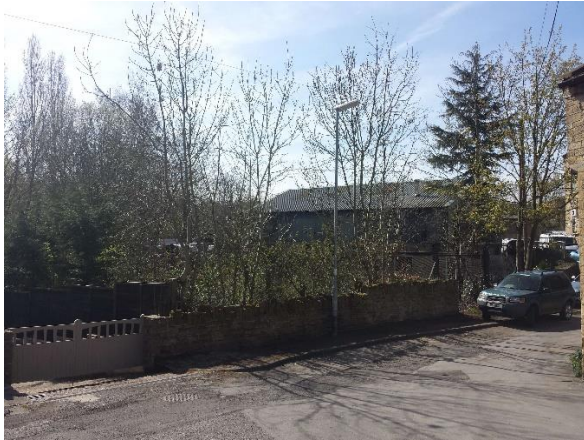
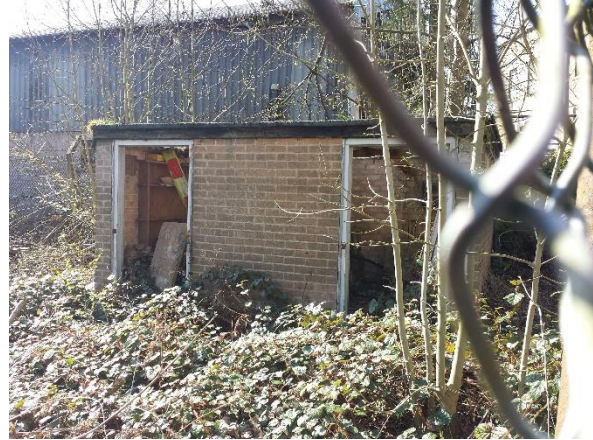
| Photo No. | Site Area | Observations and potential sources |
|---|---|---|
| 8,9. | Former gas works/gas holder site, Marsden St. | The only remaining above ground infrastructure appears to be a small brick building, but other structures may be hidden by vegetation. |

Enquiries were made with the local authority environmental department, but no knowledge of the former gas works or the circumstances of its removal was forthcoming.

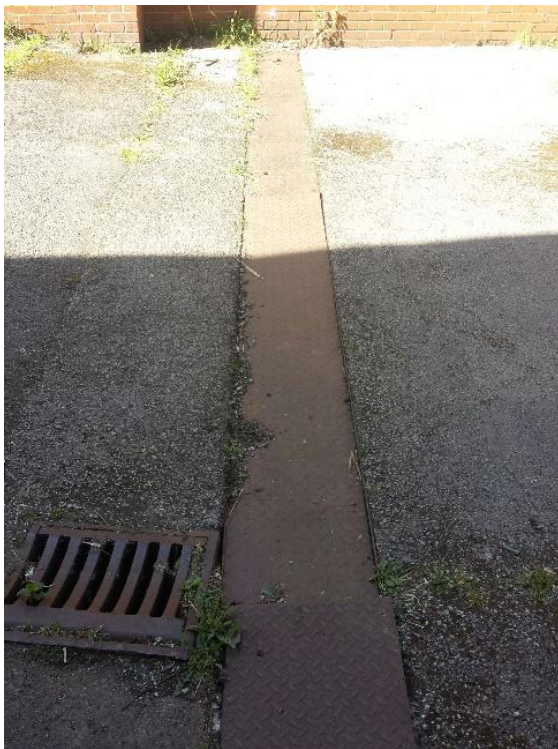
10

| Photo No. | Site Area | Observations and potential sources |
|---|---|---|
| 10. | Site road beyond Marsden St. | Surface water drainage and cable/pipe duct. |

Across the site there are a number of both surface drainage features and service ducts that might act as conduits for free-phase contaminants if released previously or during future construction works. The site is largely tarmac surfaced and it is not known whether the tarmac is coal tar or bitumen based.

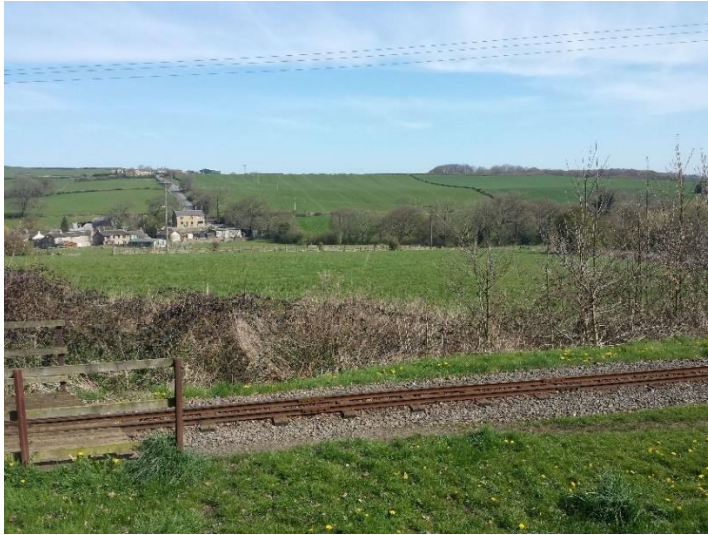
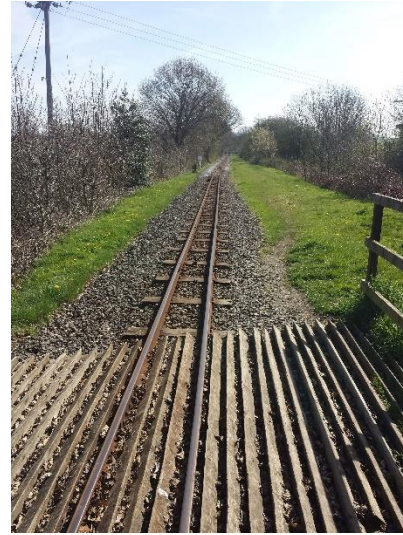
| Photo No. | Site Area | Observations and potential sources |
|---|---|---|
| 11a, 11b. | North site. Railway corridor. | Open fields beyond Railway corridor.<br>Kirklees Light Railway replaces the original heavy lines. Vegetation appears healthy. |

The railway corridor appears to support healthy vegetation and exhibits no obvious signs of contamination.

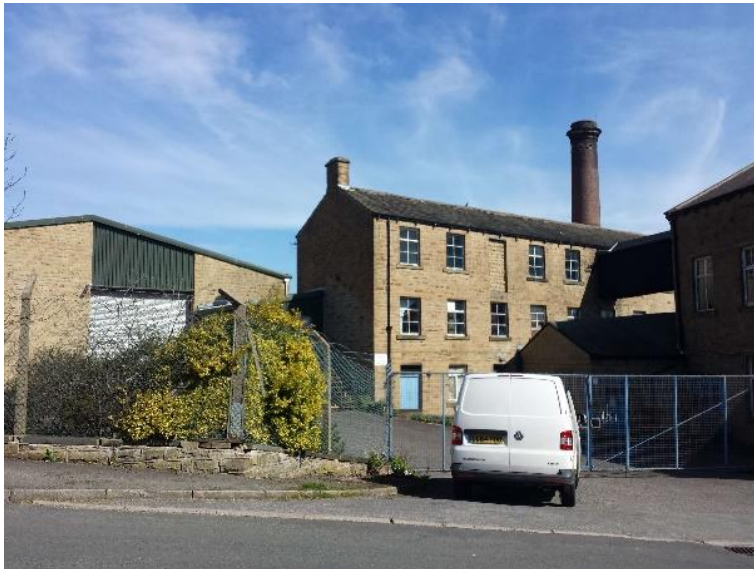
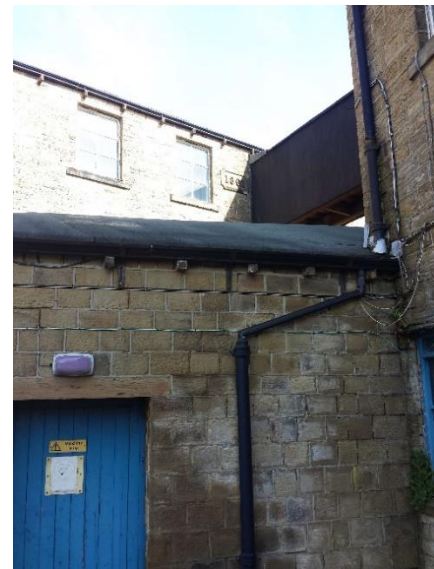
| Photo No. | Site Area | Observations and potential sources |
|---|---|---|
| 12, 13. | Saville Rd. entrance. | Buildings - 1861 date stone. |

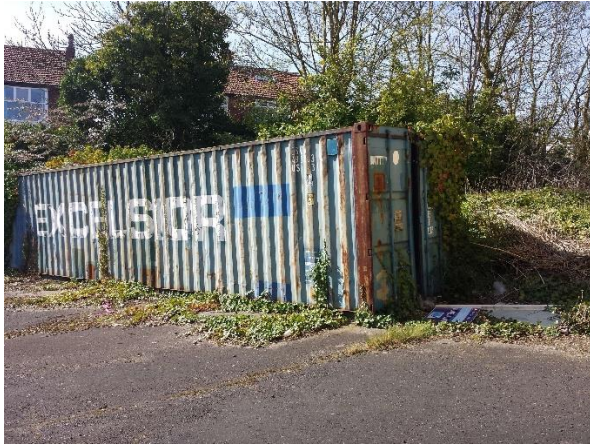
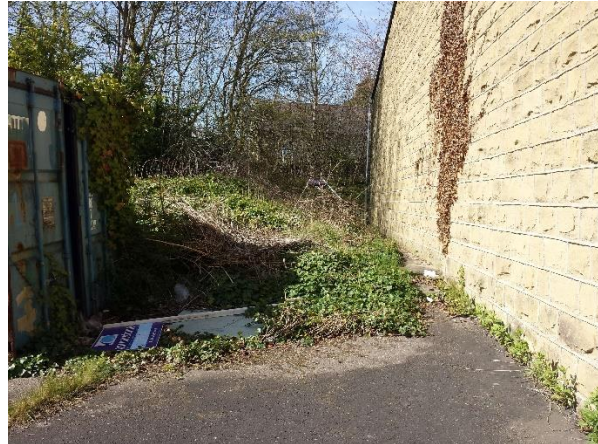
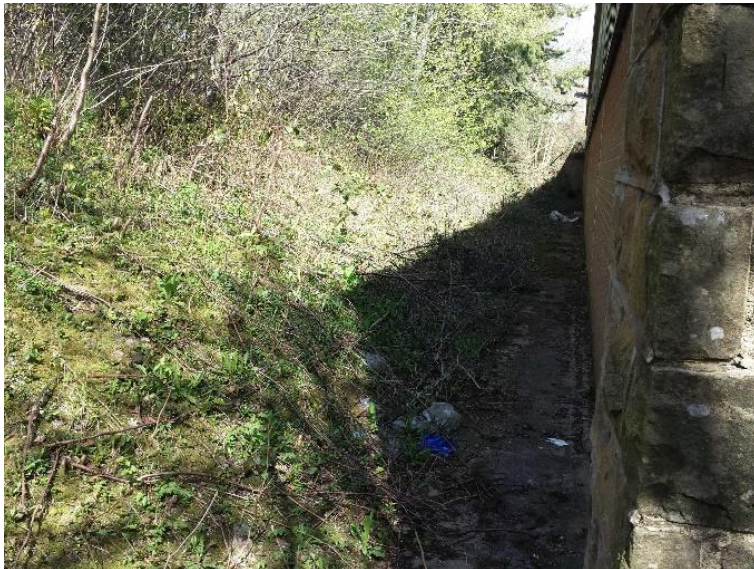
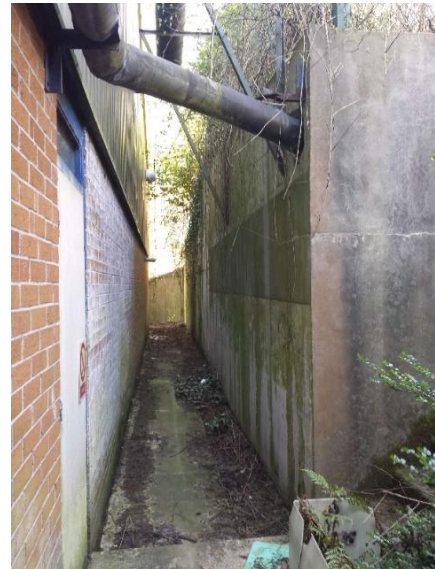
| Photo No. | Site Area | Observations and potential sources |
|---|---|---|
| 14, 15, 16, 17. | Yard and embankment off Saville Rd. | Shipping container. Sloping embankment parallel to Saville Rd, giving way to a substantial, modern retaining wall. Suggests significant excavation and backfilling – made ground. |

Infill material behind the large retaining structure against Saville Road may consist of reinstated natural material, but equally, may contain potentially contaminated materials deriving from on-site demolition works or imported from elsewhere.

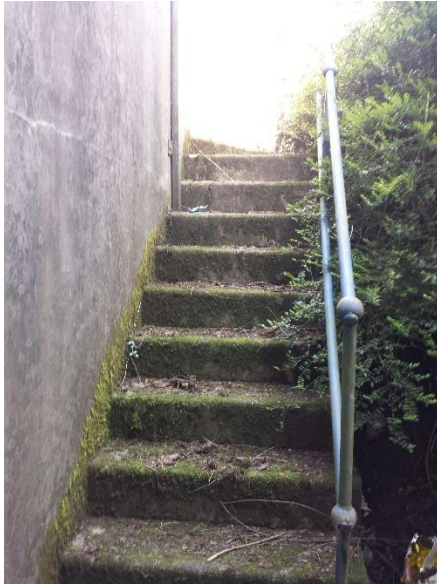
18

| 18. | As above. | Concrete staircase to ground level from foot of retaining wall. |

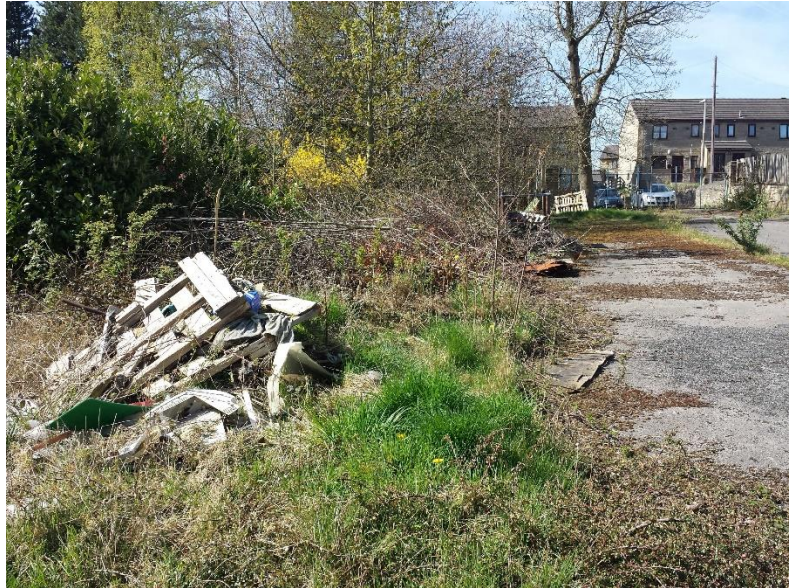
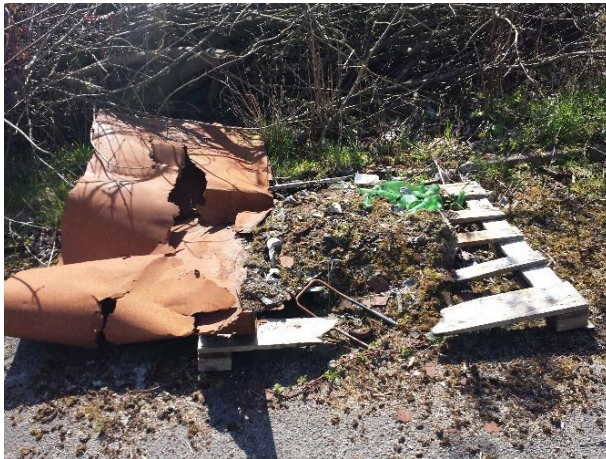
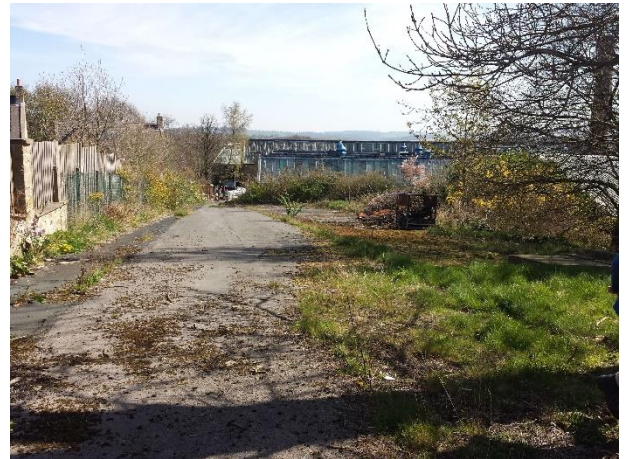
| 19, 20, 21. | Rear access lane from Saville Rd. | Small scale storage and burning of waste evident. Possible fly tipping. |

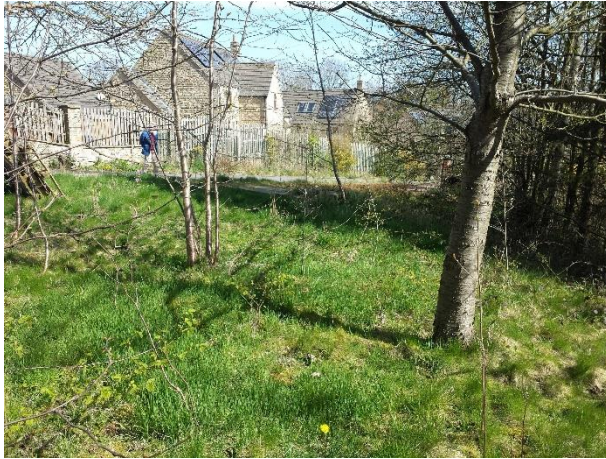
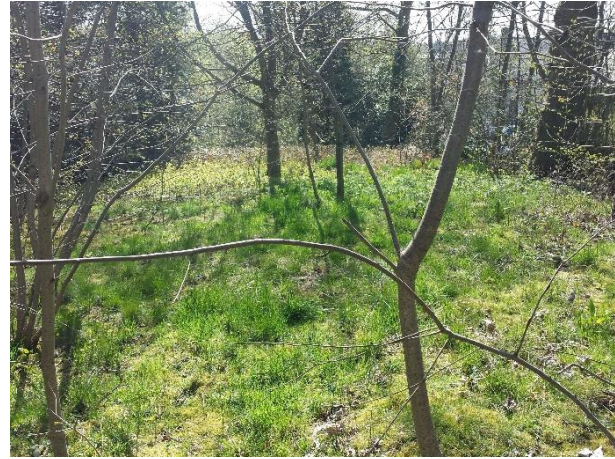
| 22, 23. | Land adjacent to Saville Rd. | Top of embankment and fill behind retaining wall. Grassy scrub; clumpy, uneven surface. |

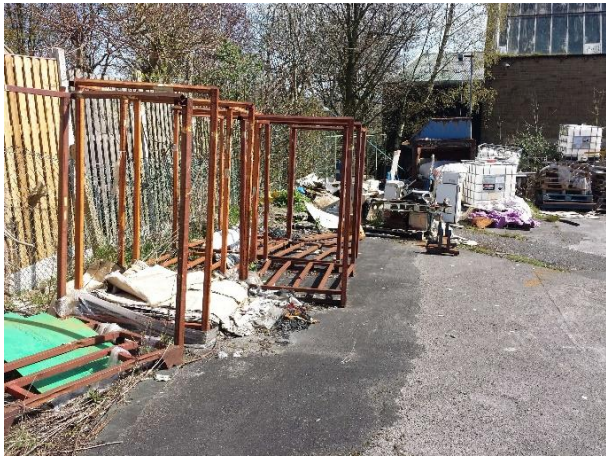
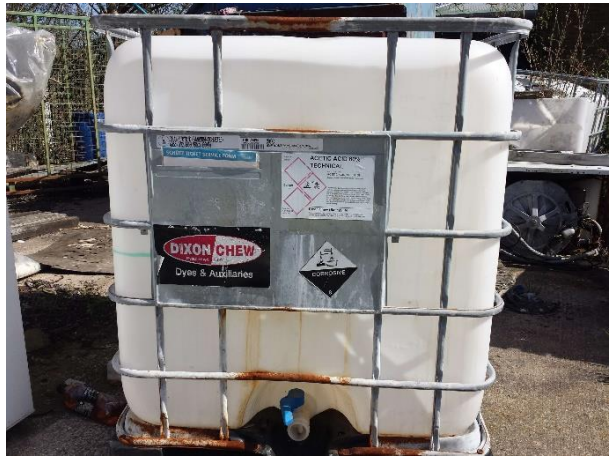
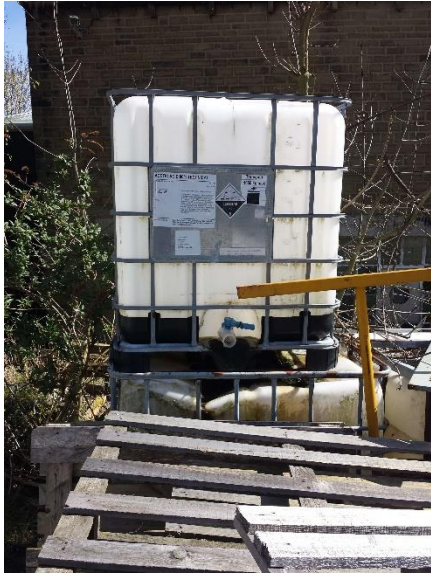
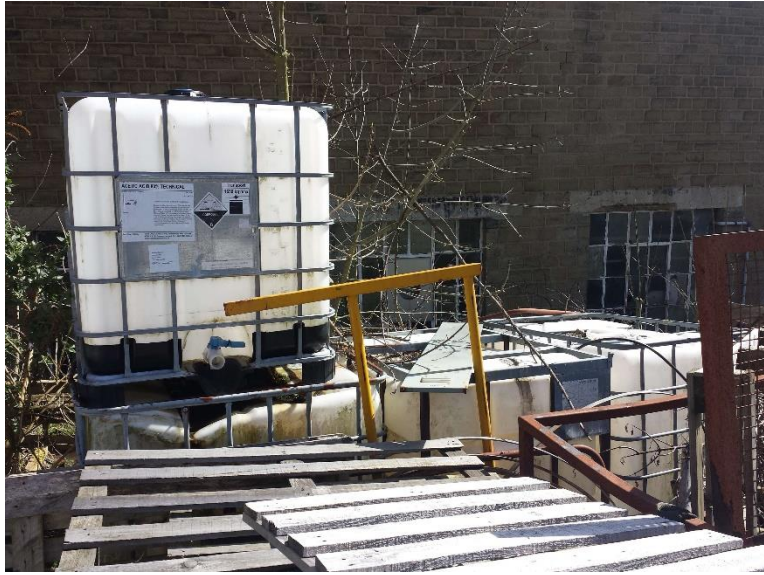
| 24, 25, 26, 27. | Rear storage area; accessed from Saville Rd. | Storage of discarded equipment: racking; white goods and numerous 1000L bulk chemical containers labelled as acetic acid. |

A large number of empty 1000L stillage tanks remain on the Site and appear to have contained acetic acid (80%), although these are largely sealed and were not seen to be filling with rainwater.

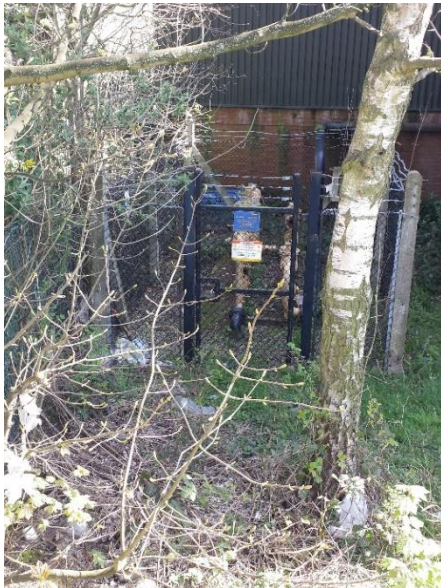
28

| 28. | As above. | Mains gas distribution. |

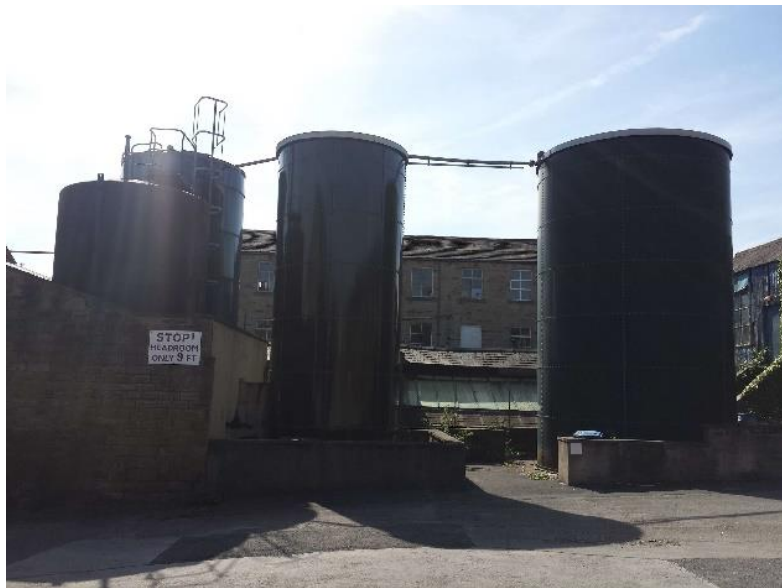
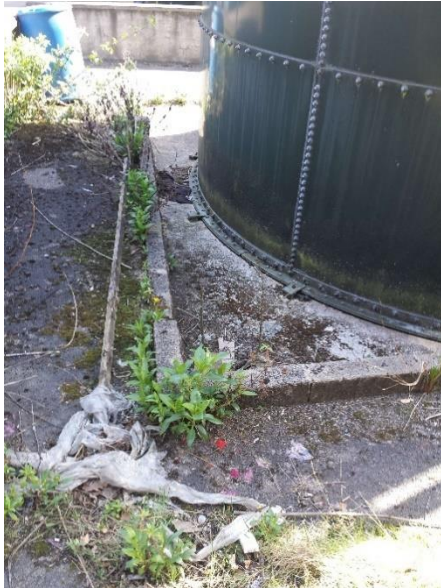
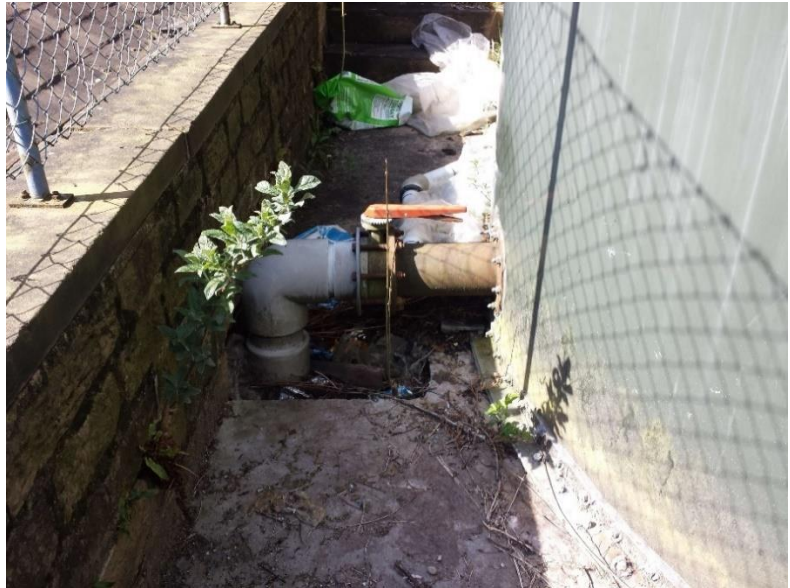
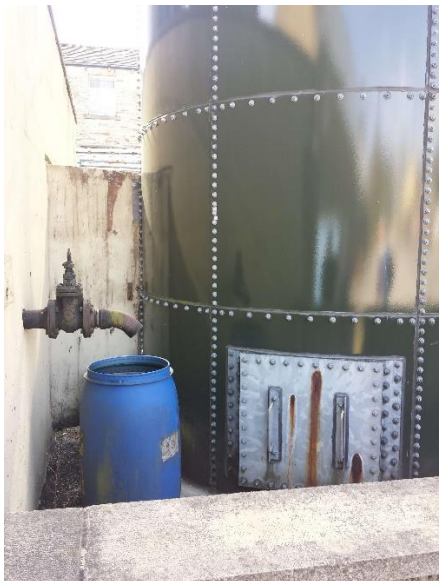
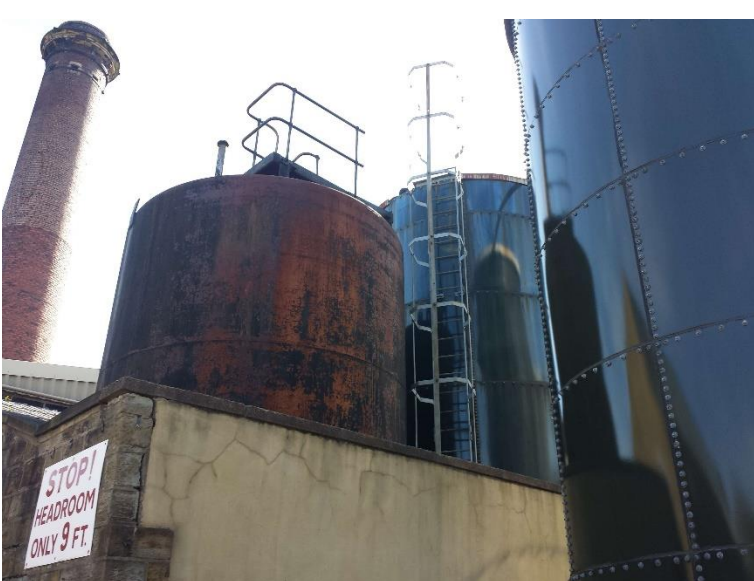
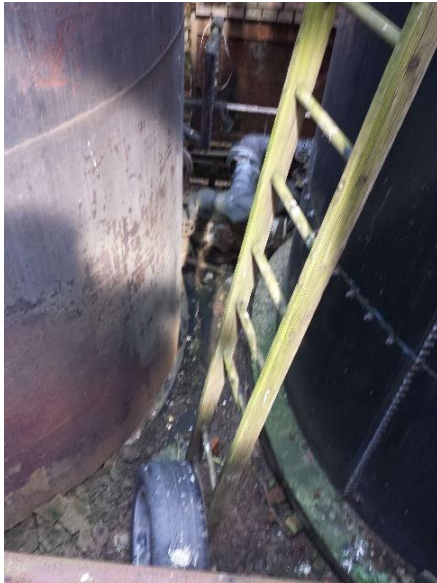
| 29, 30, 31, 32, 33, 34. | Tanks close to chimney/ boilerhouse. | Silos identified in the environmental data report appear to be tanks. No visual or olfactory evidence of gross contamination was observed, and we are advised that these contained water for fire suppression. |

The four large tanks identified as silos in section 4.5 are thought to be water tanks associated with the factory's fire suppression system and/or boiler, and appeared free from staining around their concrete bases. Within the boilerhouse a large tank potentially contains oil, but the floor slab appeared free from signs of spillage or staining. Some gas cylinders and smaller oil containers also remain, with minor staining of the slab in places. In front of the boiler itself a small patch of viscous black oily residue was noted.

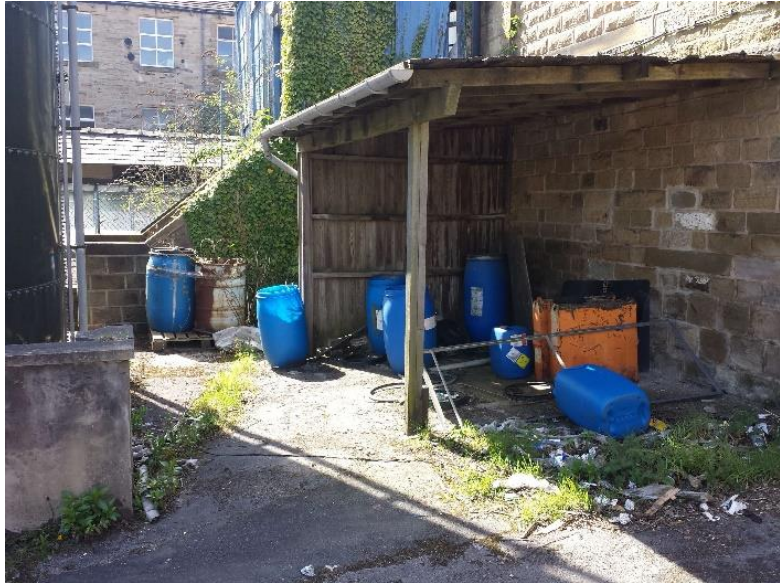
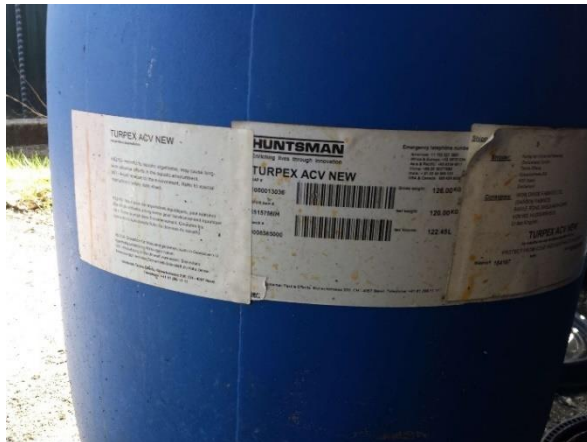
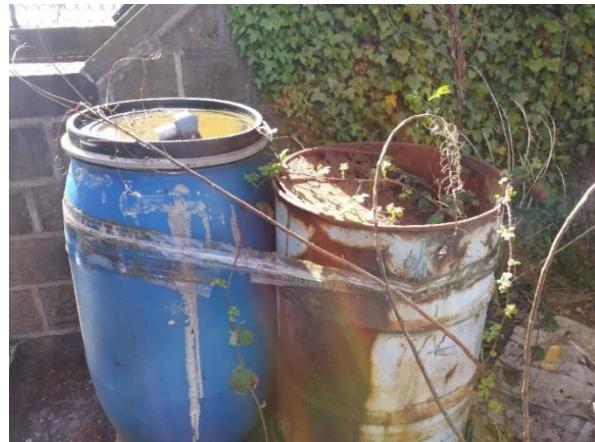
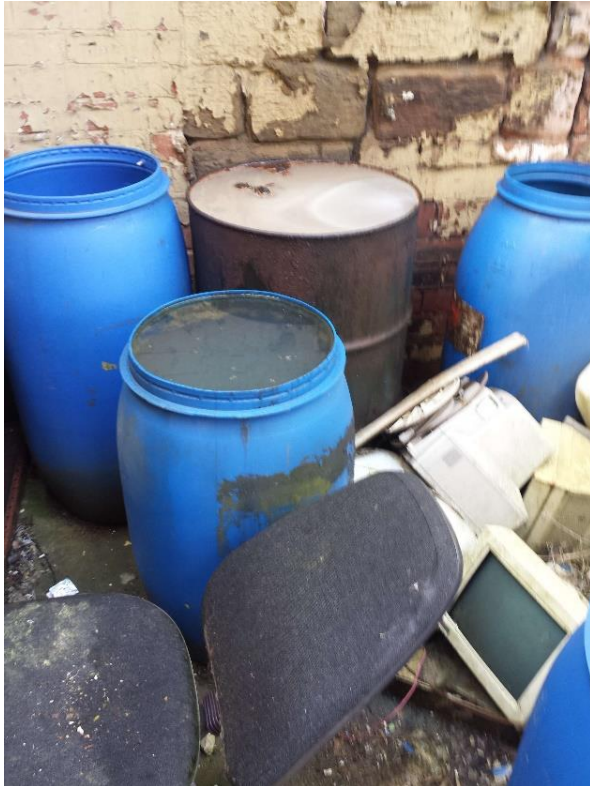
| 35, 36, 37, 38. | As above. | 25L container labelled flammable and corrosive.<br>Numerous plastic and metal drums containing rainwater with signs of chemical residues. Blue drums labelled Turpex ACV New. Forklift batteries. |

No visual or olfactory evidence of gross contamination was observed on-site. However, numerous open drums/containers were seen to have been overflowing with rainwater. These were mainly blue drums of the type labelled Turpex ACV New, and also 200-litre steel barrels of the kind typically used for fuels/oils/lubricants.

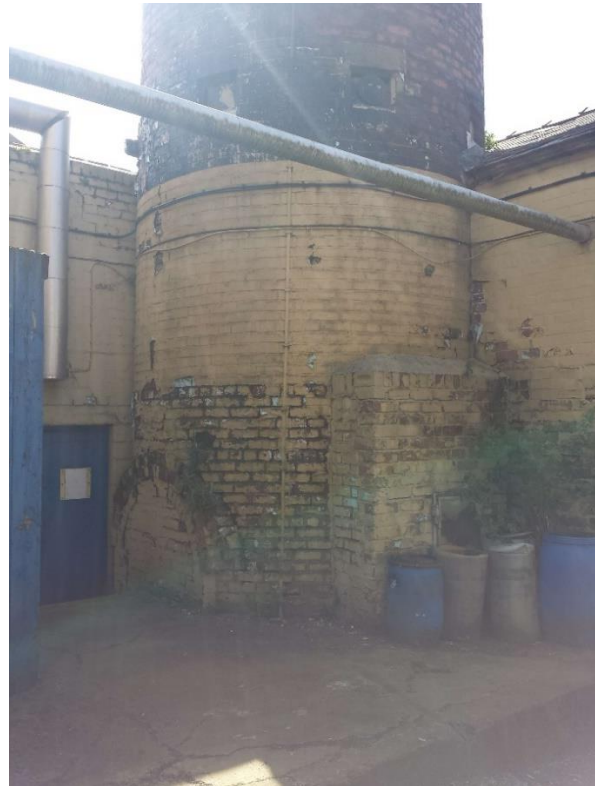
39

| 39. | Base of chimney. | As above. |

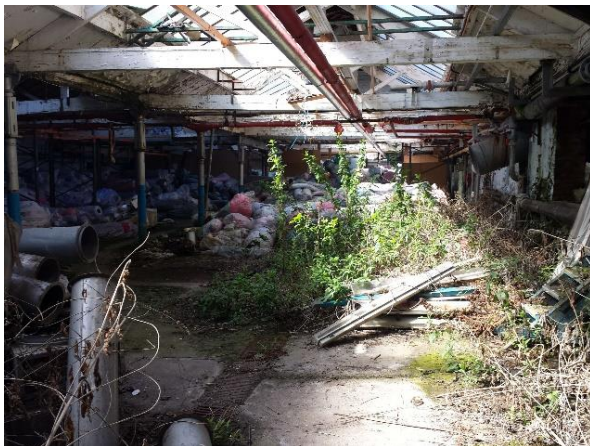
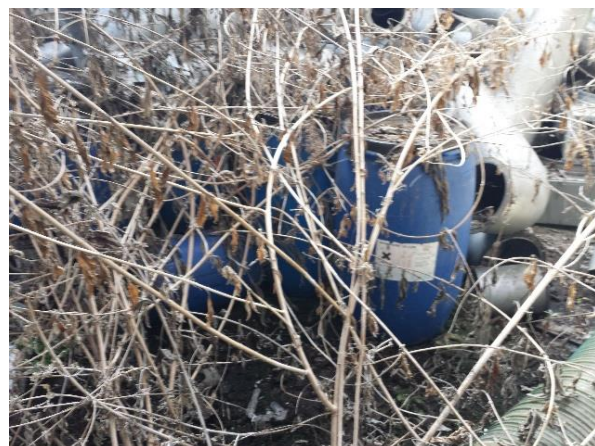
| 40, 41. | Low level sheds. | Vegetation internally. Discarded drums/containers. |

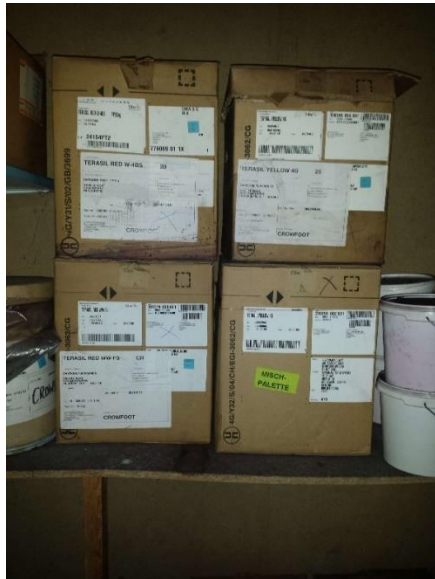
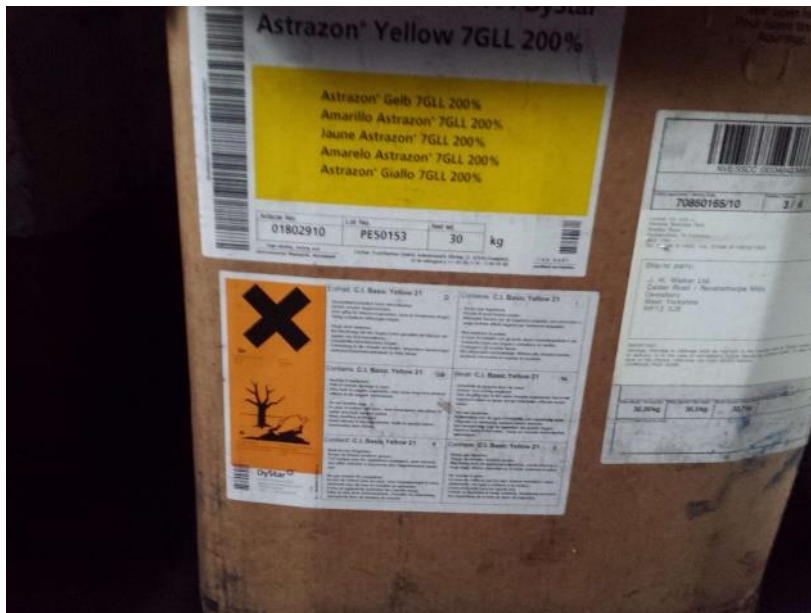
| 42, 43, 44. | Store-room close to chimney. | Numerous boxes; inks, dyes or similar.<br>Trade names include: Terasil; Avocryl; Astrazon. Some Labelled <i>hazardous</i> . |

Relatively small quantities of chemicals including dyes remain in the stores next to the boilerhouse; some are labelled harmful to the environment.

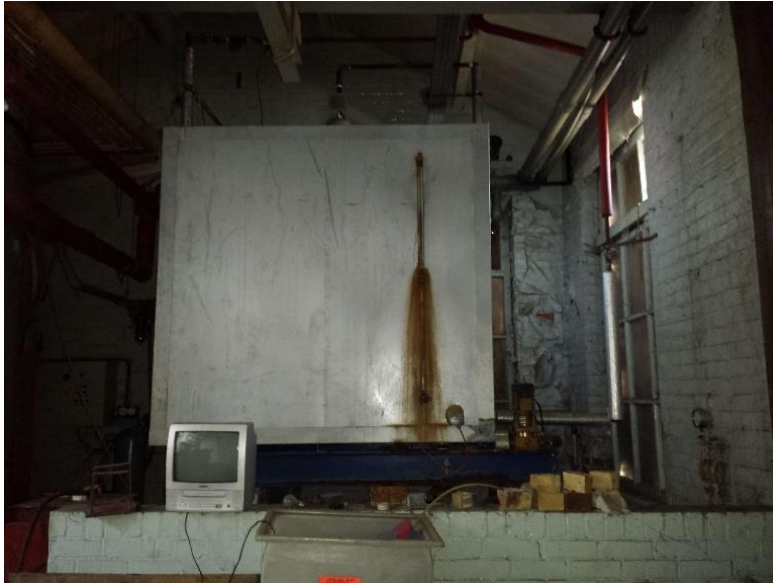
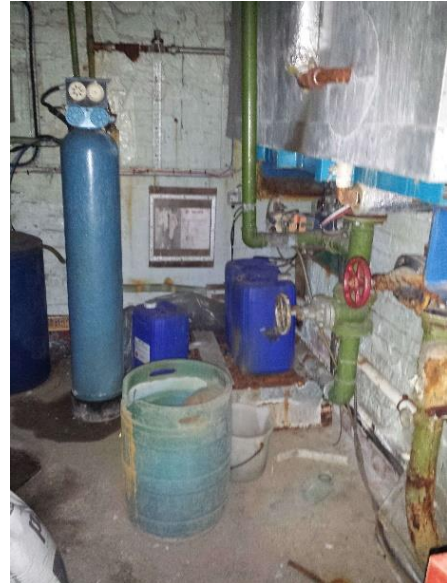
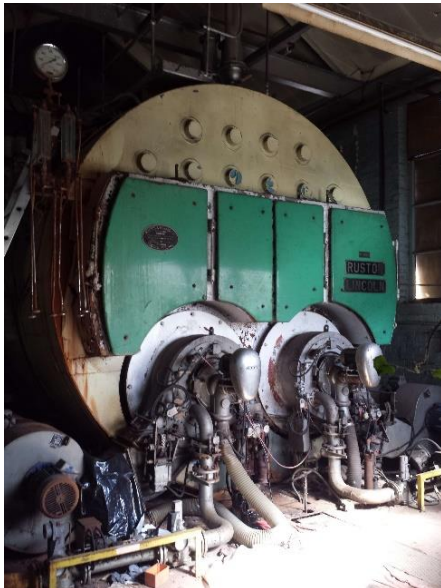
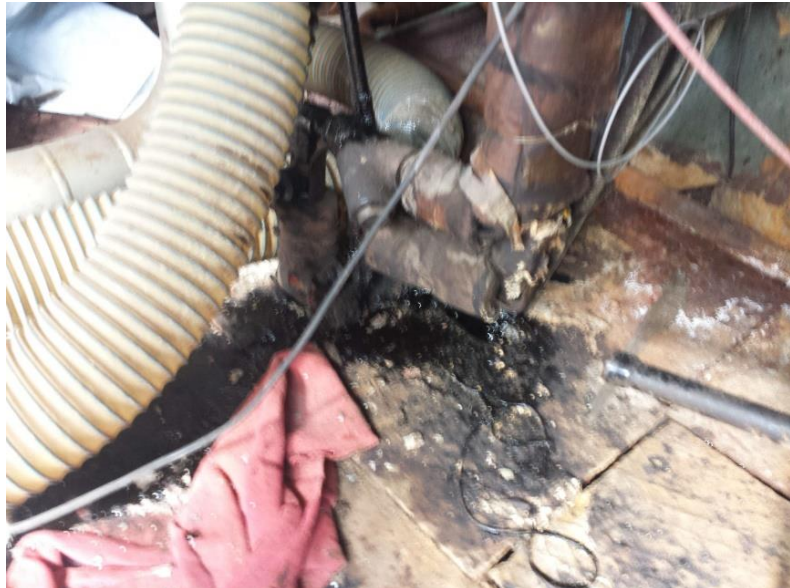
| 45, 46, 47, 48. | Boilerhouse. | Large tank – possible fuel-oil for boiler. Gas cylinders; small oil containers. A small patch of oily residue was observed in front of the boiler. |

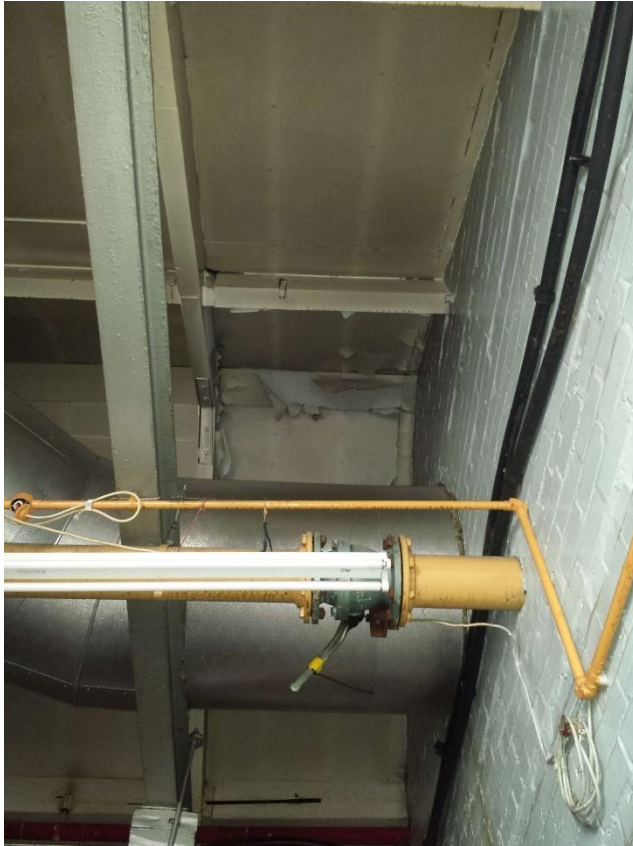
48

| 48. | As above. | Probable asbestos insulation board ceiling. |

It is probable that the internal liner board to the roof of the roof in this area is asbestos insulation board (AIB) (the identification of asbestos within buildings is beyond the scope of this report).

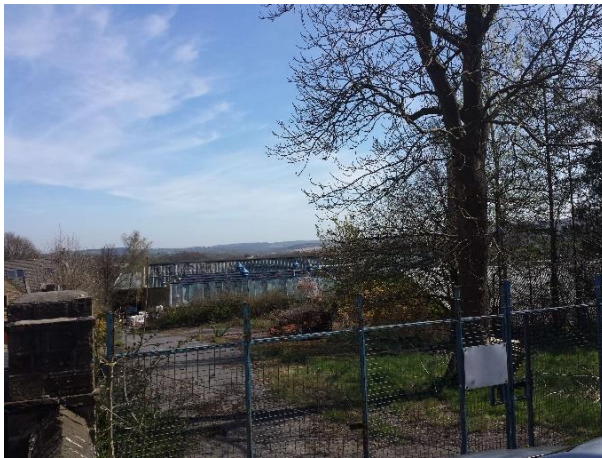
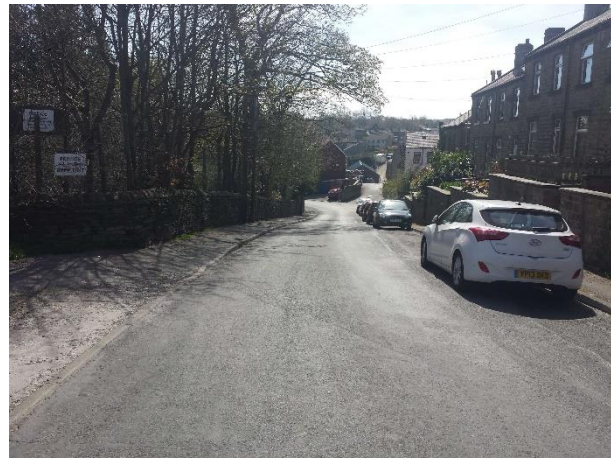
| 49, 50. | West gate. | High point: entrance at far west of Site. View south along Saville Rd. |
