## Phase II GeoEnvironmental Investigation & Coal Mining Risk Assessment

120 Laund Road

Huddersfield

**Report Ref: A0697/19/B.0  
October 2019**

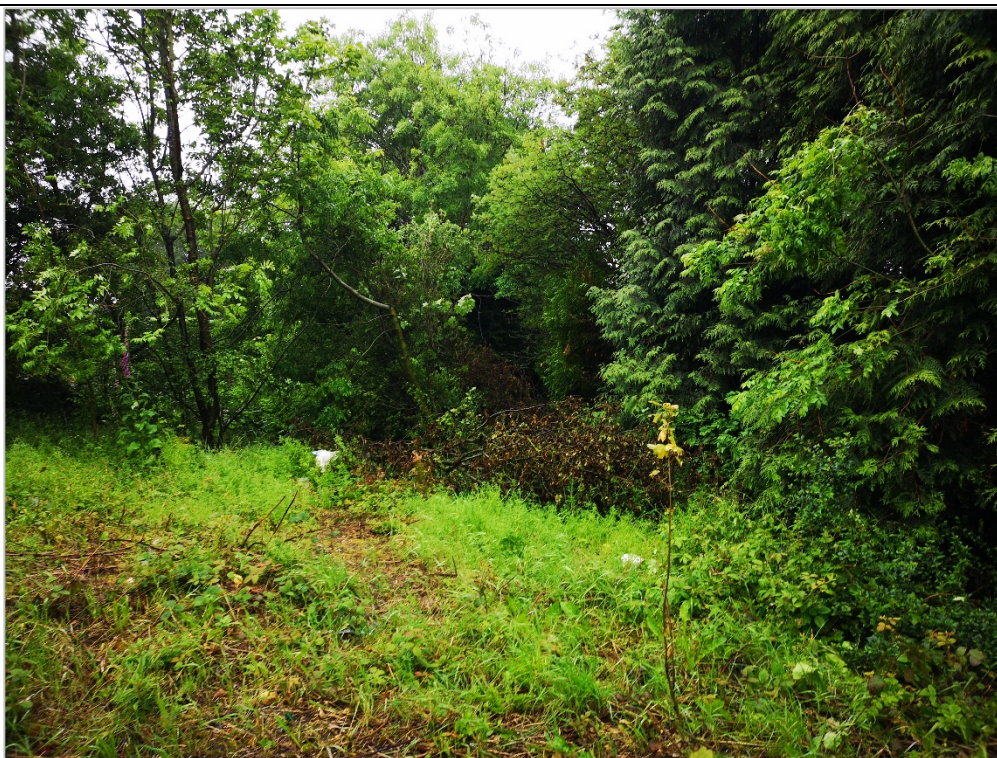
**Figure 4 Overview of the overgrown southeastern part of the site**

The rear garden was observed to be overgrown, elevated and sloping moderately to the west/southwest, with retaining walls along the northwest, northeast and southeast garden boundaries. Due to these obstructions, this part of the site was generally inaccessible for the drilling rigs and machine excavator.

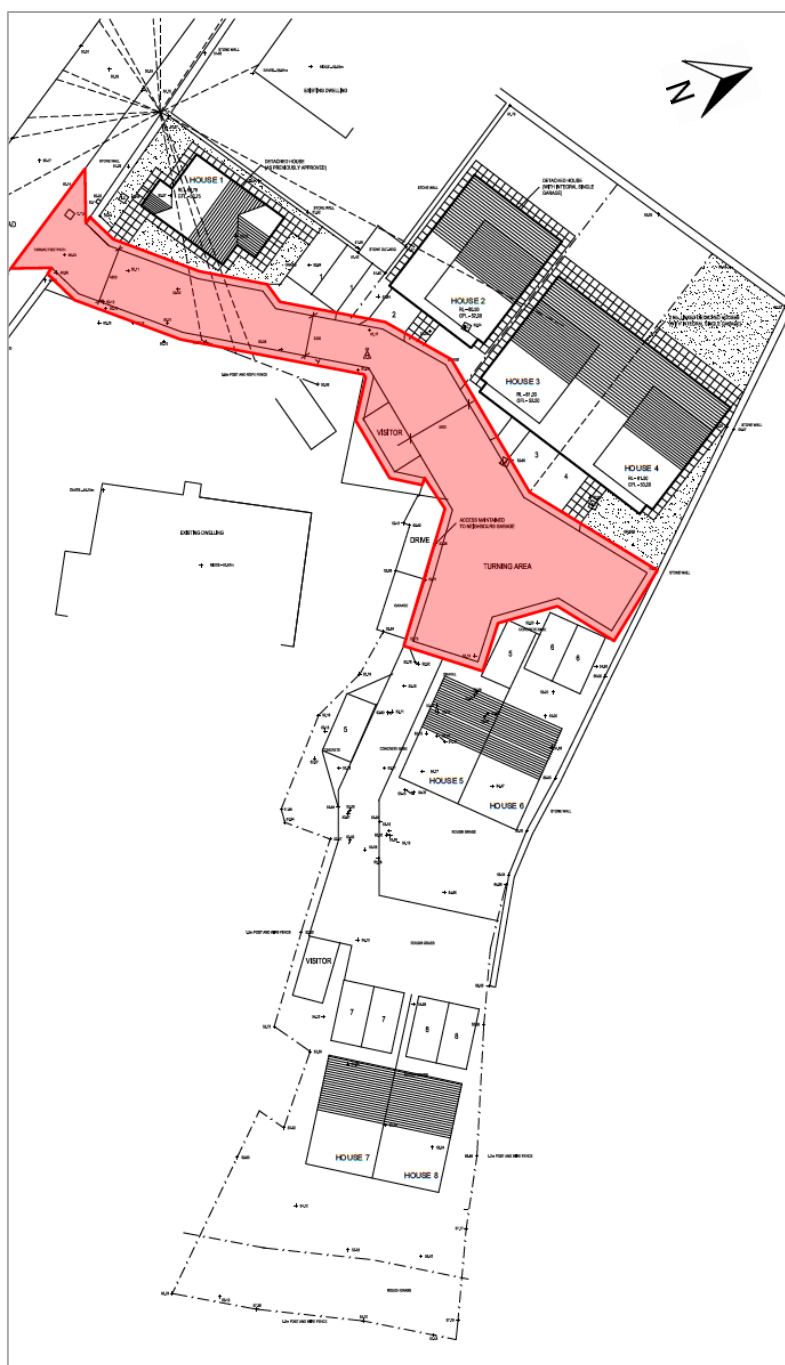
**Figure 6 Proposed Development Layout Plan**

It is understood that the client intends to demolish the existing bungalow (120 Laund Road) and construct 8no. new two-storey detached and semi-detached residential houses with parking, private gardens and associated infrastructure.

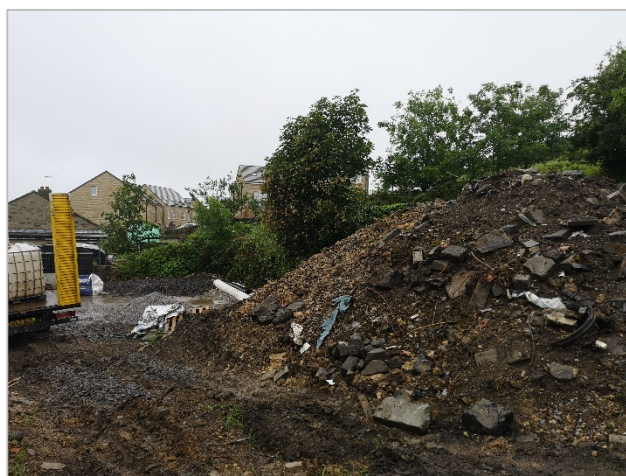
**Figure 9 Stockpile of Building & Demolition Waste**

The surface soils across the majority of the southeastern part of the site appeared to have been recently removed in advance of the pending construction works and stockpiled in the central part of the site (Figure 9). The stockpile was observed to contain building and demolition waste and inclusions as previously described. Fragments of suspected asbestos cement sheeting were also observed (Figure 10).
