## **Phase 2 Ground Gas Risk Assessment**

**120 Laund Road**

**Huddersfield**

**Report Ref: A0697/20/B.0**

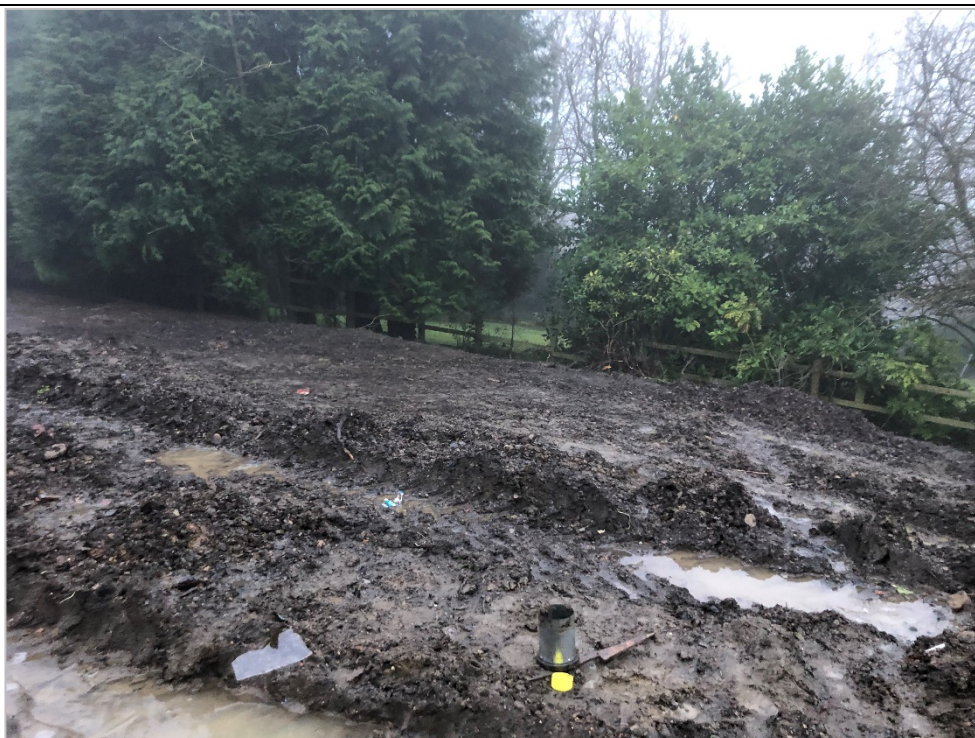
**Figure 2 Looking towards the southern part of the site**

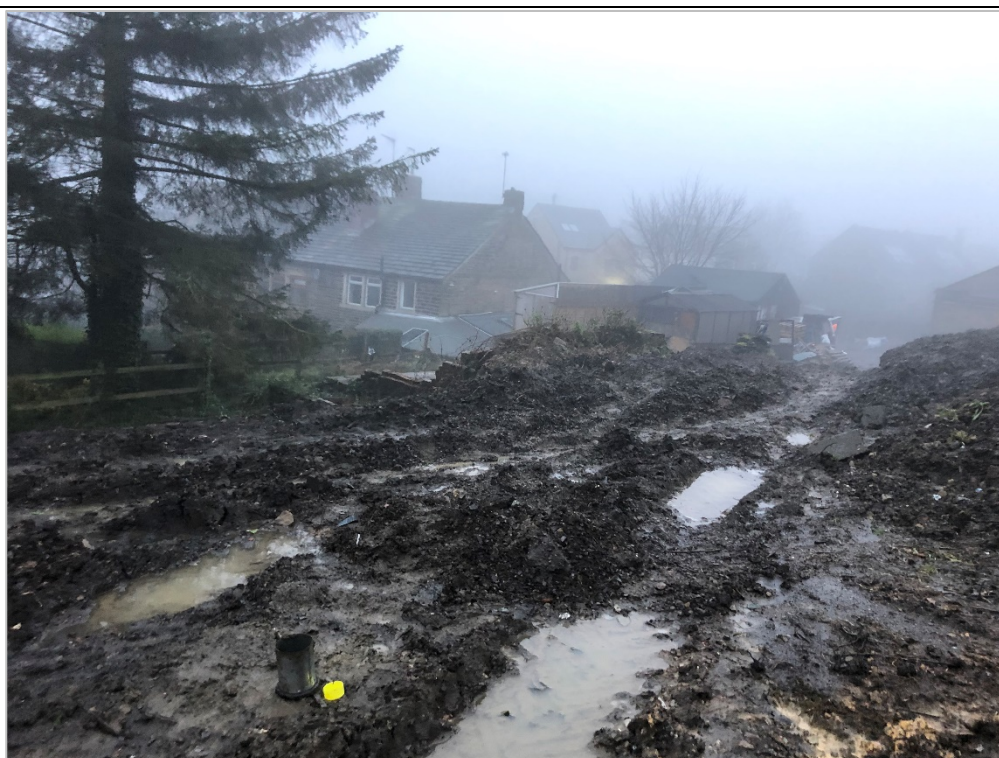
**Figure 3 Looking southeast across the site**

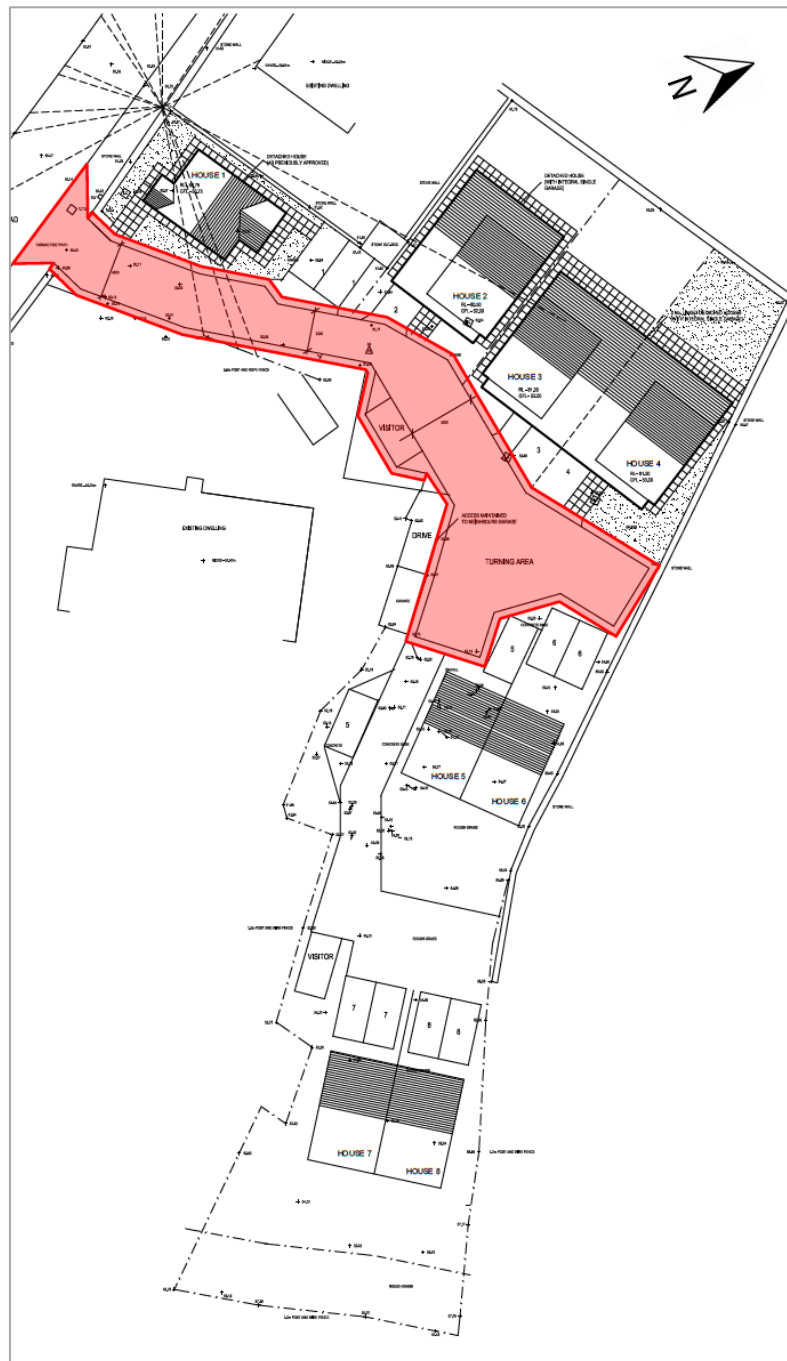
It is understood that the client intends to demolish the existing bungalow (120 Laund Road) and construct 8no. new two-storey detached and semi-detached residential houses with parking, private gardens and associated infrastructure.

**Figure 4 Proposed Development Layout Plan**
