GeoEnvironmental Investigation

Busker Lane

Scissett

Report Ref: A1819/17

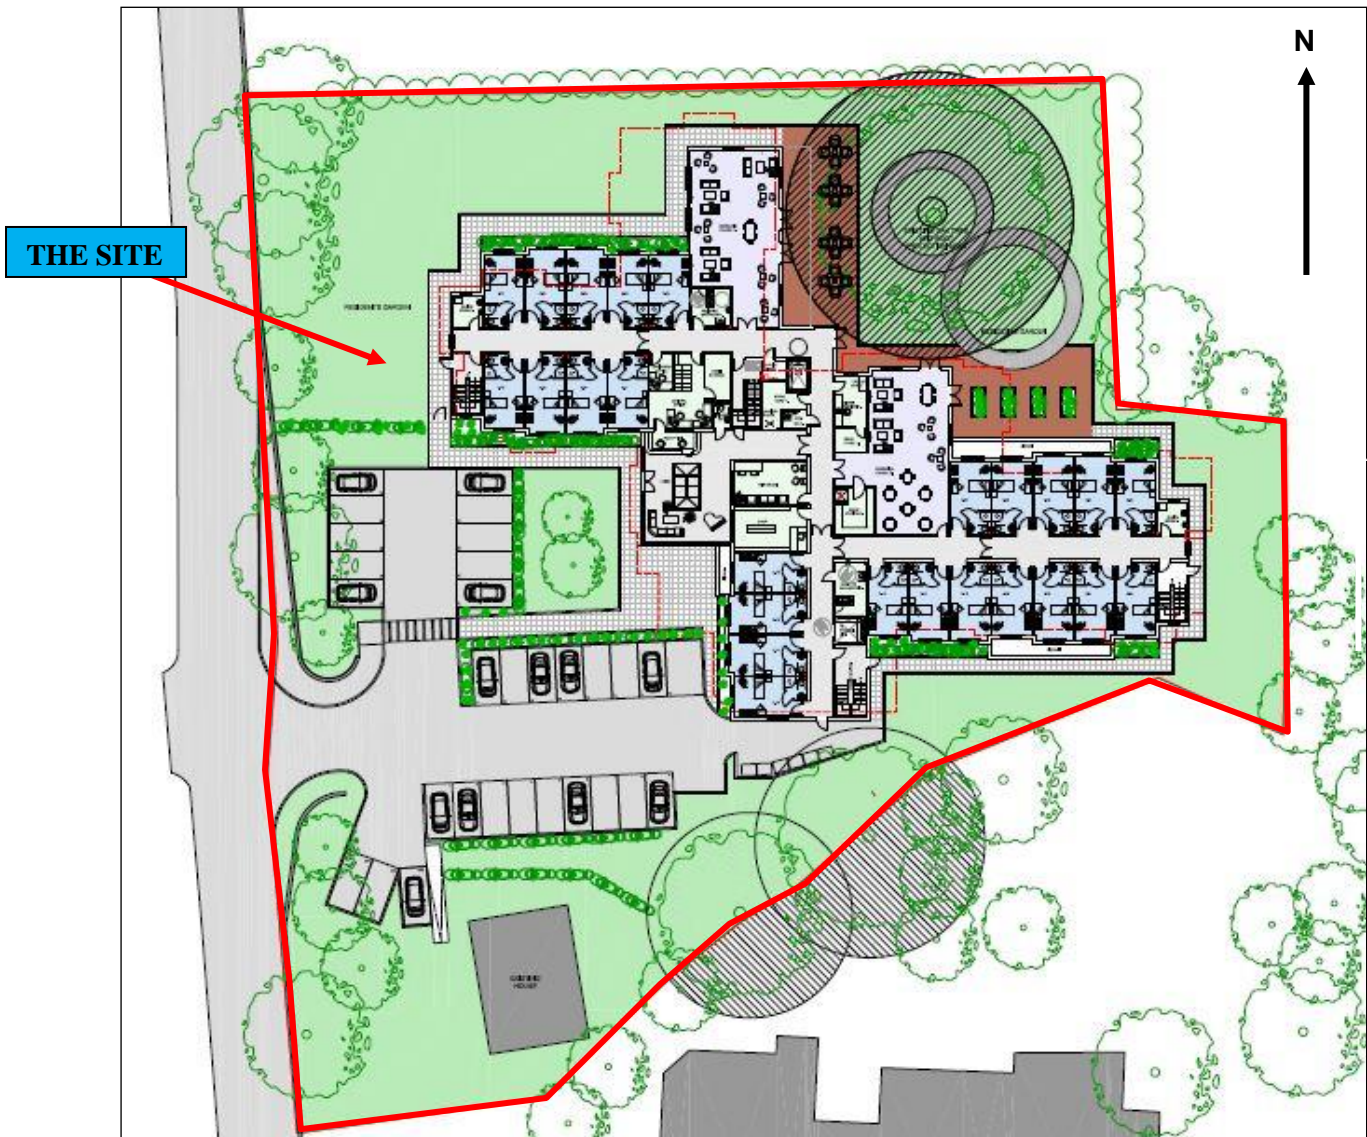
Figure 2: Development Layout Plan

The proposed site development plan is shown in Figure 2, below. It is understood the construction of a 2-storey retirement home with car parking facilities and communal gardens are proposed.

See Figure 2 below for the proposed development layout plan provided by the client with red dashed outline highlighting the previous building footprint prior to demolition.

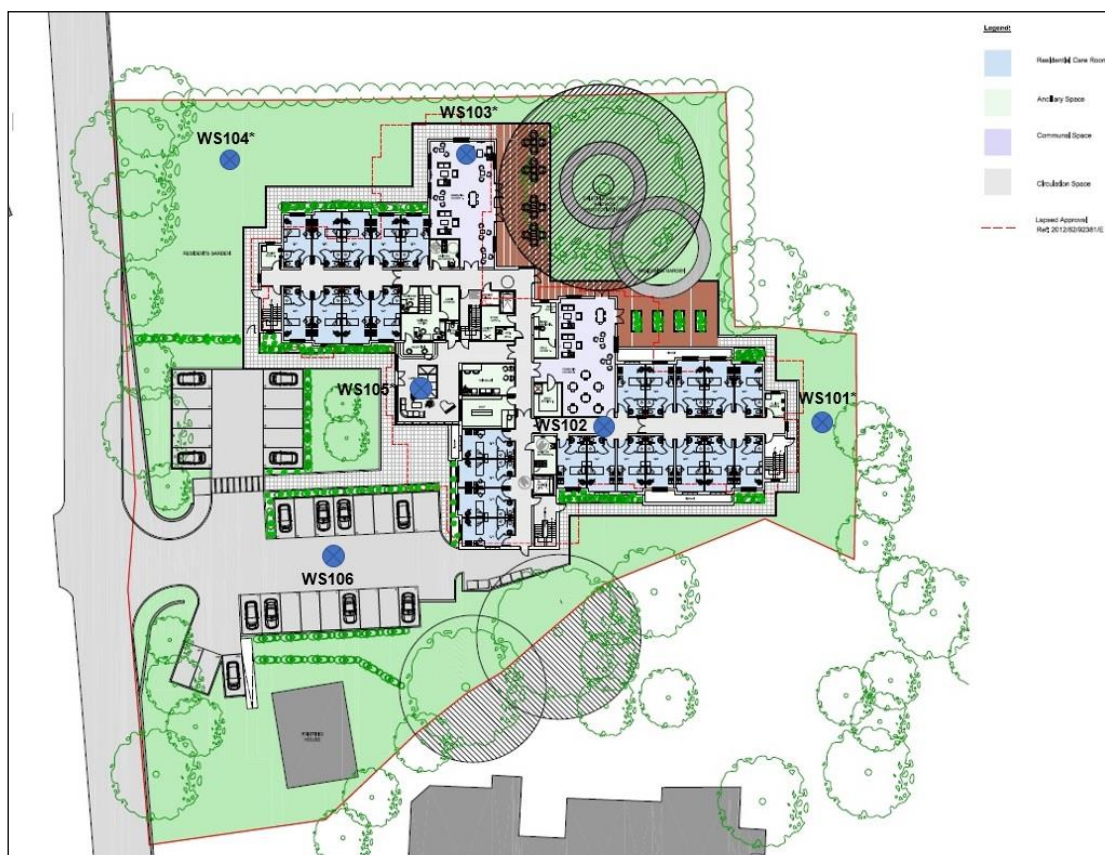
Figure 3: Sampling Location Plan

The ground investigation works took place on the 24th February 2017 and comprised of the drilling of six probeholes (WS101 to WS106) by use of a windowless sampling technique to a nominal depth of 5.00m bgl.

Four boreholes (WS101, WS103, WS104 and WS105) were fitted with combined ground-gas and groundwater installations.

The sampling locations are illustrated in Figure 3 (below) and the installations are detailed in Table 3.2.1 overleaf.
