# Bat Roost Assessment

**BE-1106.1a**

**2 Hill Park, Mirfield WF14 8JB**

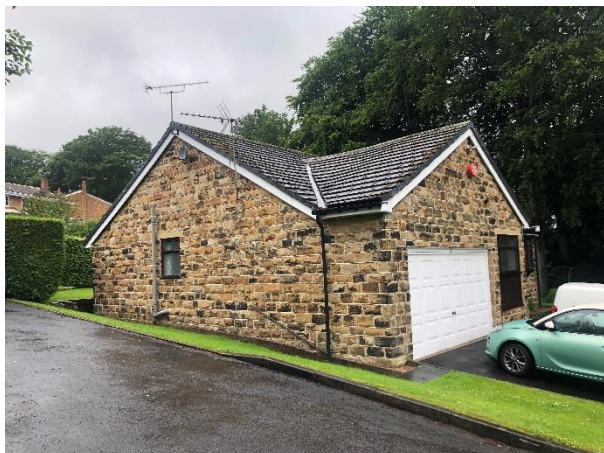
The building on site consisted of a modern bungalow with a pitched concrete tile roof. The stone tiles were well-sealed except several missing tiles located below the ridge on the southwest aspect of the roof close to the apex of the gable. The soffits were plastic and well-sealed. The fascias were also plastic; the northwest fascia was well sealed, and several small gaps noted beneath the southeast fascia particularly near to the apex of the gable. The exterior stonework was in good condition with no gaps or cracks observed. At the time of the survey an orangery was under construction to the west of the building, which was tying into the roof.

Plate 1 Southeast aspect of the building

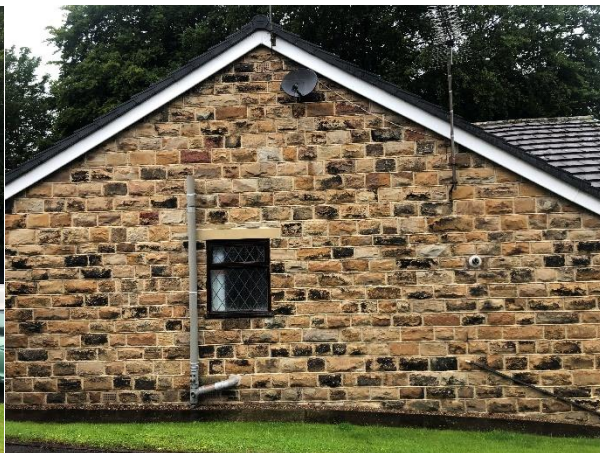
During the dusk emergence survey 97 common pipistrelle bats were observed emerging from a gap under the fascia in the apex of the southeast gable of the building between 21:22 and 22:09. Three common pipistrelles were also observed emerging from the missing roof tiles above of the apex of the gable.

There were several gaps into the building under the fascia of the southeast gable and missing roof tiles close to the apex of the gable to the southwest. A small number of old bat droppings were observed within the roof void.

Plate 2 Southeast gable and bat emergence point

To avoid disturbance to the roost it is recommended that work is carried out between October – April when the majority of bats will not be roosting within the building.

To prevent disturbance to bats during the works it is recommended a method statement is followed (Appendix 3). This should include supervision of aspects of the works by a licensed bat ecologist.

To avoid impacting commuting and foraging habitats it is recommended that wildlife friendly lighting is utilised on the site. Lighting should not be directed onto the trees to the north of the site or onto the bat roost on the southeast gable, where exterior lighting is considered necessary, the following recommendations prescribed by the Bat Conservation Trust (2018) should be followed:

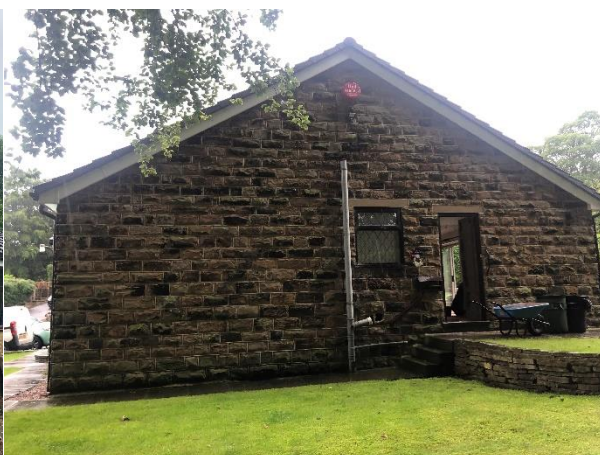
Plate 4 Northwest gable of the building

4. The ecologist will supervise the removal of the fascia on the northwest gable and any roof tiles which require removal to tie the new extension roof into the existing roof.

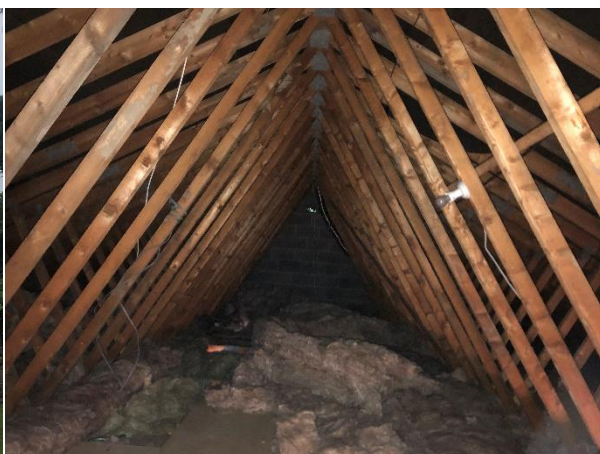
The interior of the building had a single roof void of modern truss construction. The roof beams were modern and well-sealed. The roof was lined with bitumen which was well-sealed with a small gap to the north where a ventilation pipe was positioned. The gables were of breezeblock construction and well-sealed. A small number of old bat droppings were observed scattered in the roof void.

Plate 6 Interior roof void

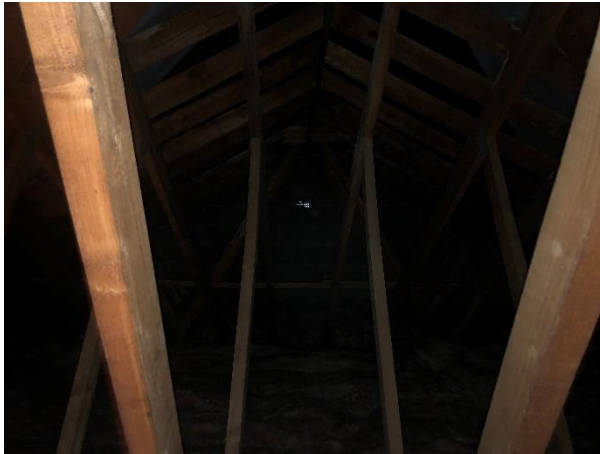
Plate 7 Interior roof void of the building

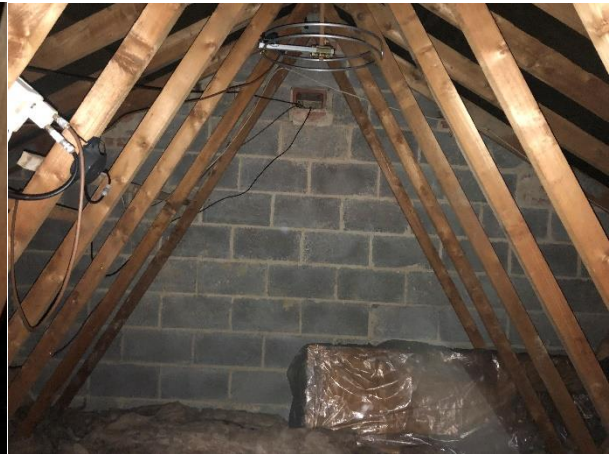
Plate 8 Interior roof void of the building

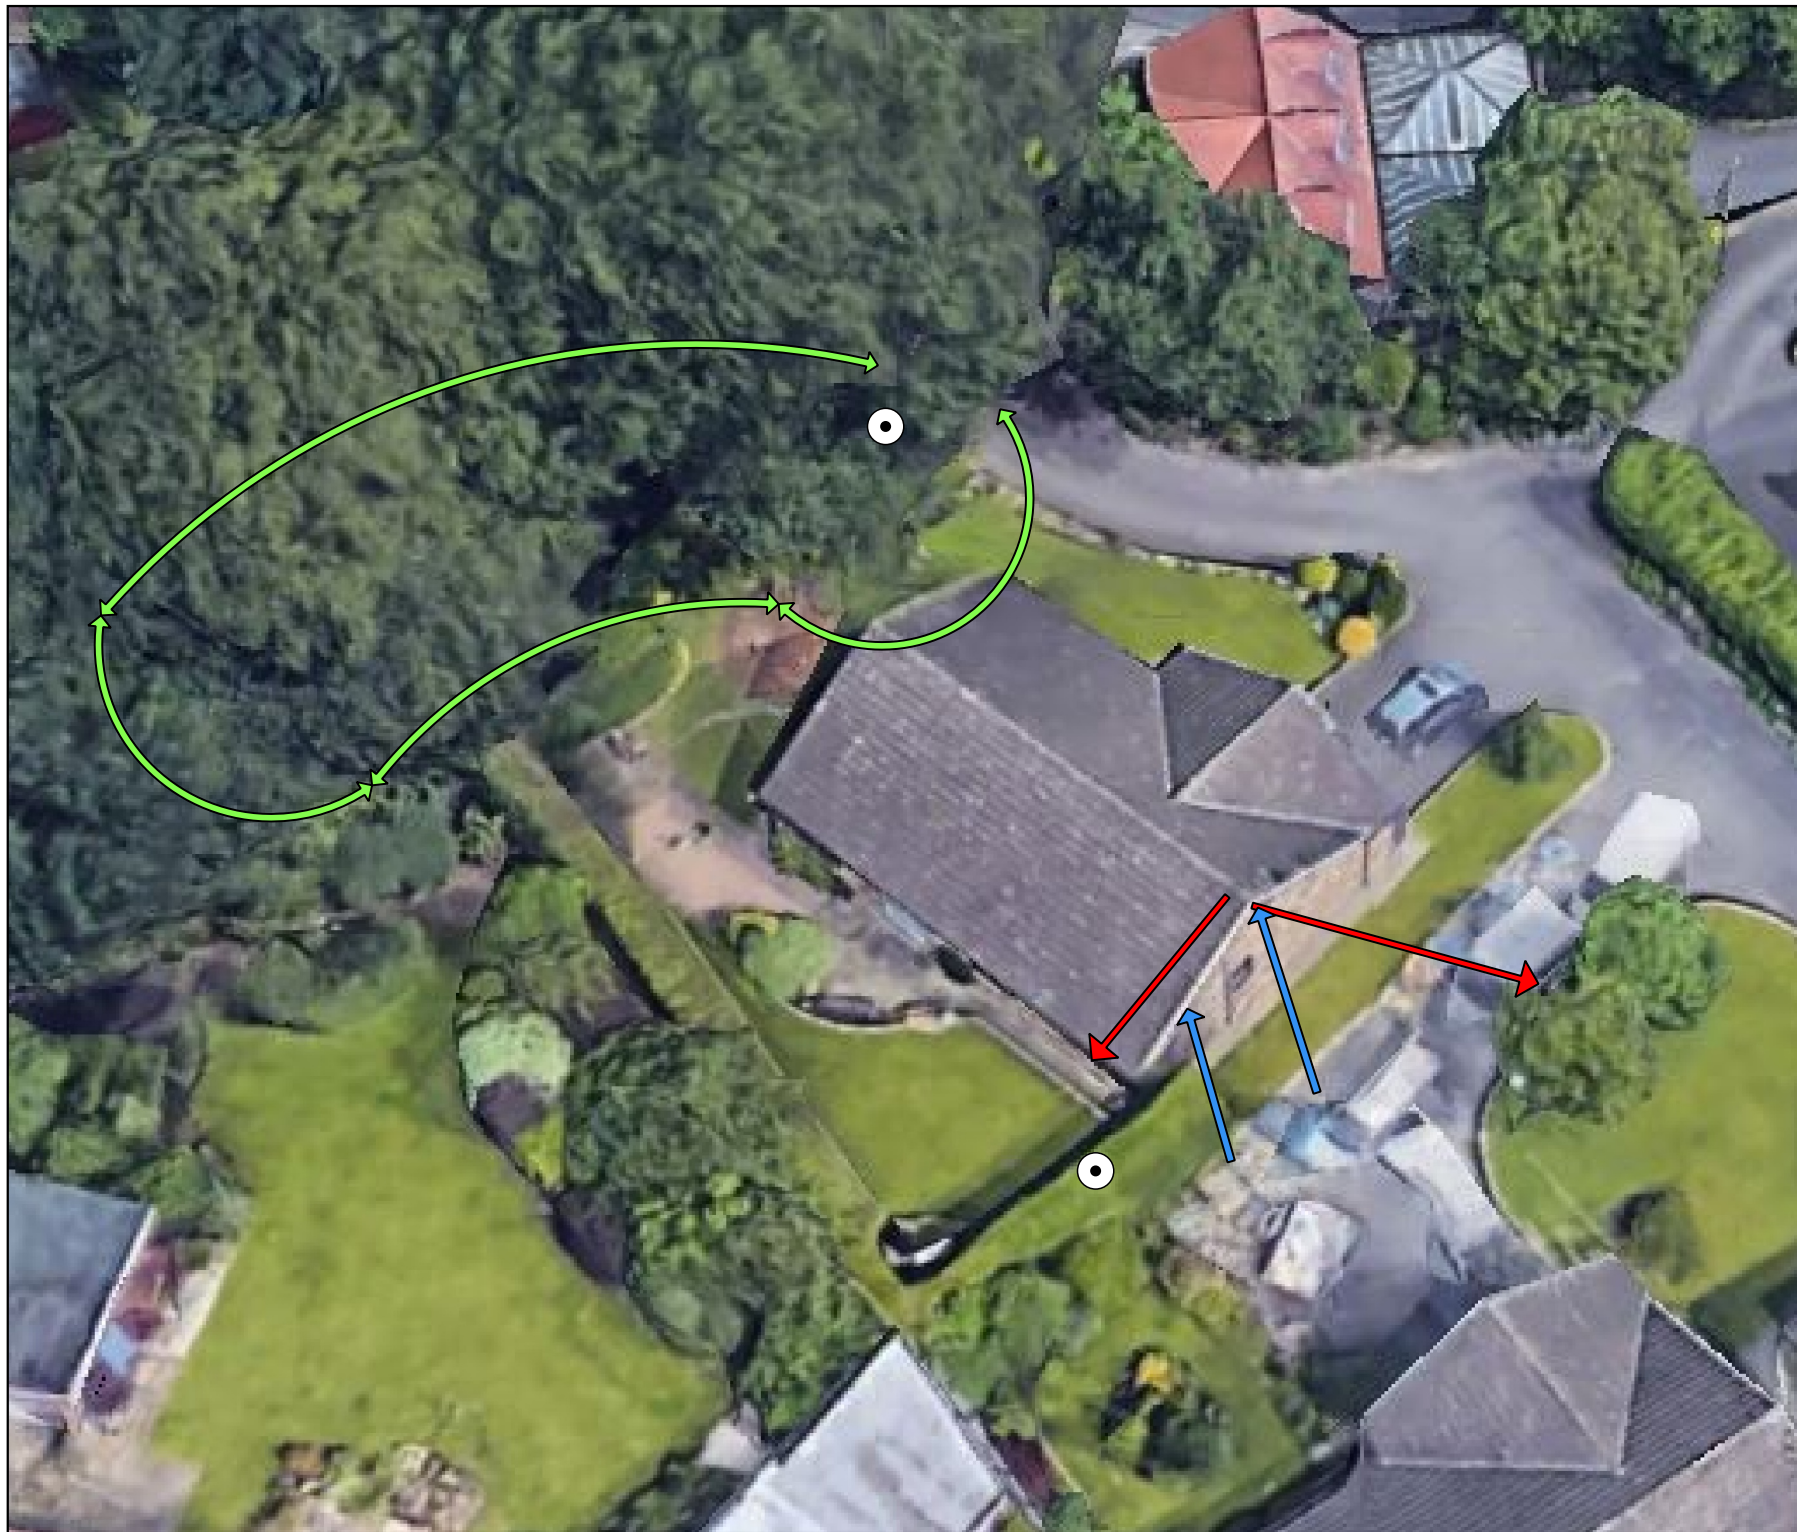
Appendix 2: Bat Activity Map

Bats were also observed re-entering the roost from 21:30 with a total of five bats re-entering the roost during the survey.

Bats were observed foraging throughout the trees to the north of the site for the duration of the survey.

- Key:
- Surveyor position
  - Bat re-entry point
  - Bat emergence point
  - ↔ Bat foraging activity
