**GROUND INVESTIGATION  
AT MACHAM STREET  
HUDDERSFIELD**

**FOR  
MADNI JAMIA MASJID**

**REPORT NO. NE3146C  
NOVEMBER 2012**

**ENGINEER: AMANAH STUDIO  
178 HEADFIELD ROAD  
DEWSBURY  
WF12 9JH**

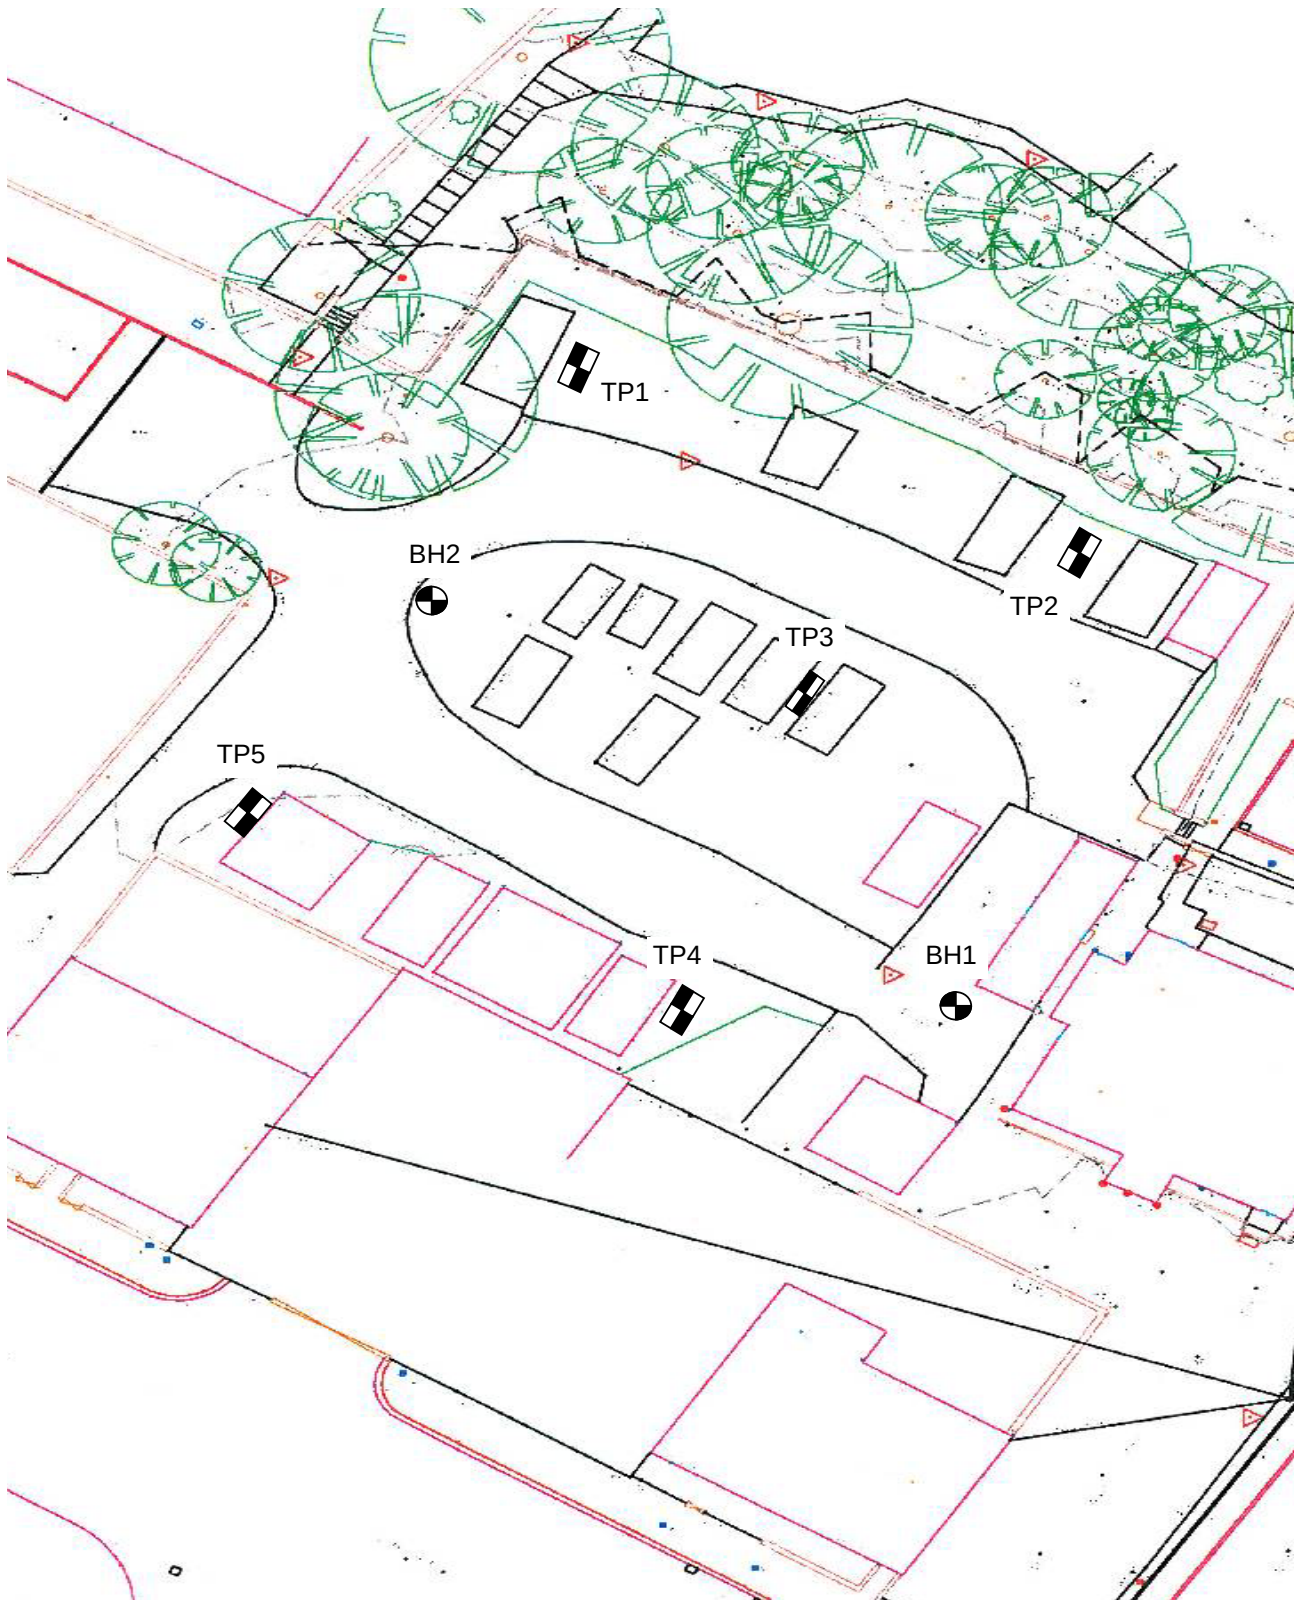
Two 150mm diameter boreholes were put down by cable percussive boring techniques at the positions determined and set out by the Clients Engineer, as shown on Figure 2. The boreholes were put down to depths of between 4.70 and 4.0 metres. The samples taken were logged in accordance with BS. EN. 14688 and 14689: 2002-2004 and the resulting Borehole Records are appended.

Five trial pits were taken out by a mechanical excavator at the positions determined and set out by the Clients Engineer, as shown on Figure 2. The trial pits were excavated to depths of between 0.90 and 3.0 metres, representative samples were taken and the materials were logged in accordance with BS. EN. 14688 and 14689: 2002-2004. The resulting Trial Pit Records are appended.
