5 Two Gates, Slaithwaite

Bat Survey Report

19th August 2019

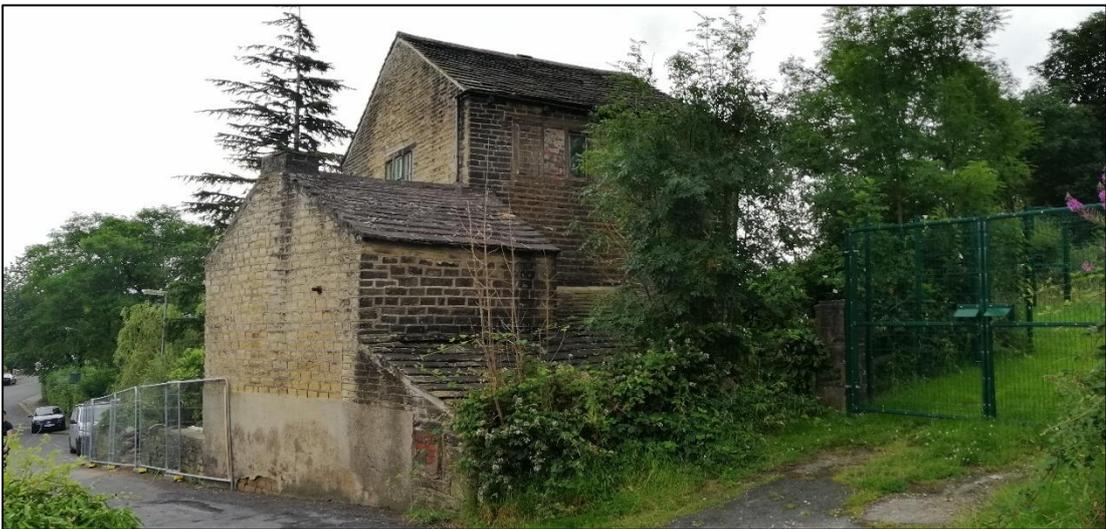
Plate 1. West elevation

- 5.2.2 The site comprises an old three-storey detached stone-built building beneath a pitched stone slate roof. Adjoining the northwest corner of the building is a small two-storey section with both pitched and mono pitched stone slate roofs (see Plate 1). The building is access through a doorway of the small building section that leads to the ground floor of the main building. There are stone mullion windows mainly on the east elevation which have had the glazing removed (see Plates 1, 2 & 3).

- 5.2.3 The east elevation of the building had recently been pointed and the remainder has been well maintained in the past. Consequently, the walls afford little potential to accommodate bats. There is a large hole where the mortar has fallen out at the roof verge of the two-storey section above the north gable, however, all other bat roost potential is associated with the roof. There is access to the wall plate under the eaves and the roof slates offer an abundance of potential roosting location between the slates and membrane and at the verges above the gables (see Plates 1, 2, & 3).

- Long-term bat roost retention will need to be provided in order to offset impacts to the local bat populations caused by the potential loss of existing bat roosts during any re-roofing works. It is advised that the existing bat roost and any other gaps sufficient to accommodate crevice dwelling at eaves level (wall top) be retained.

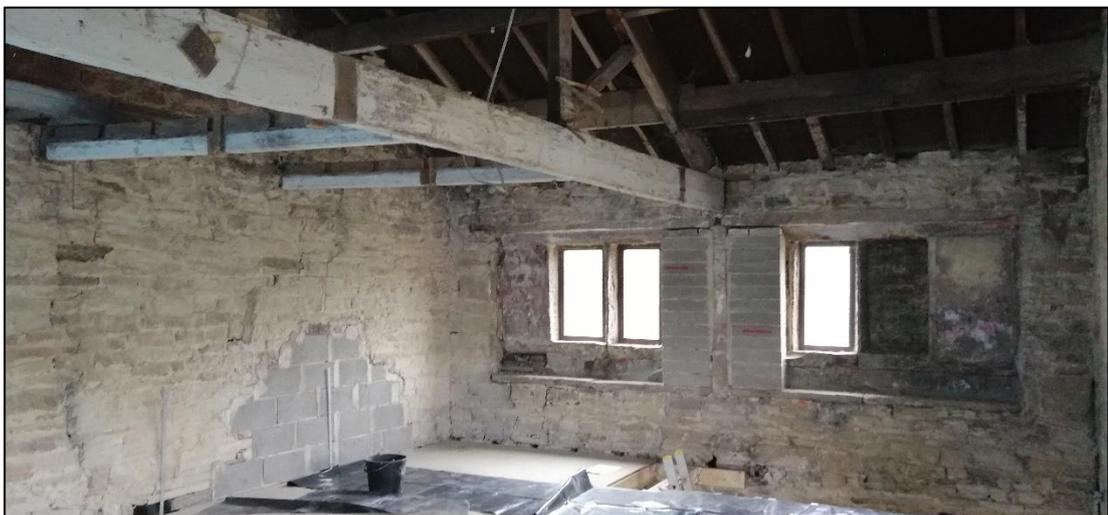
Plate 4. Inside (top floor)

- 5.2.4 Renovation of the building had already begun and consequently, the inside of the main building has been completely removed prior to the construction of two new floors. The ceiling of the upper floor has also been removed and the upper floor-space is open to the underside of the Type 1F felt beneath the slates (see Plate 4). No signs of bats were found.

- Use of Type 1F roofing felt only must be used during any re-roofing. Modern Breathable Roof Membranes (BRM) should not be used, as bats have been shown to become entangled within the component filaments of BRMs.

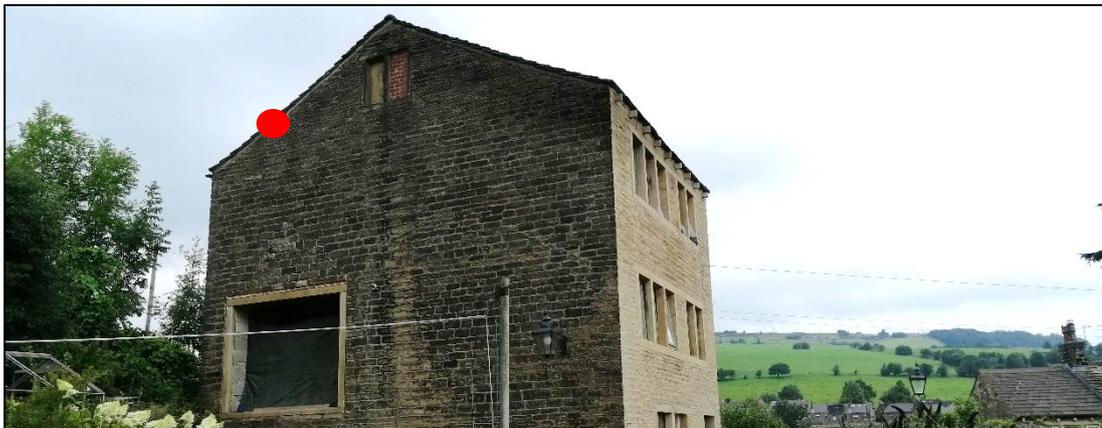
Plate 5. Location of emergence, as indicated by red circle

- 5.2.5 **Dusk survey, 2nd Aug 2019** – (Sunset 21:03) – The temperature at the beginning of monitoring was 17°C, with a Beaufort Scale Force 1 easterly wind and a clear sky. The cloud cover increased to 30% shortly after the start and the temperature dropped slightly to 16°C by the end of monitoring.
- 5.2.6 At 21:29 a common pipistrelle emerged from beneath the slates on the roof verge of the south facing gable before flying south (see Plate 5). A single common pipistrelle foraged intermittently thereafter, together with a brown long-eared bat *Plecotus auritus* on Two Gates (road) at 21:48 and a brief *Myotis* species pass on the south side of the building at 21:55.
